Inspection Photos  
Johnson 1 Flowline  
Spill ID 485936/Remediation No 34666

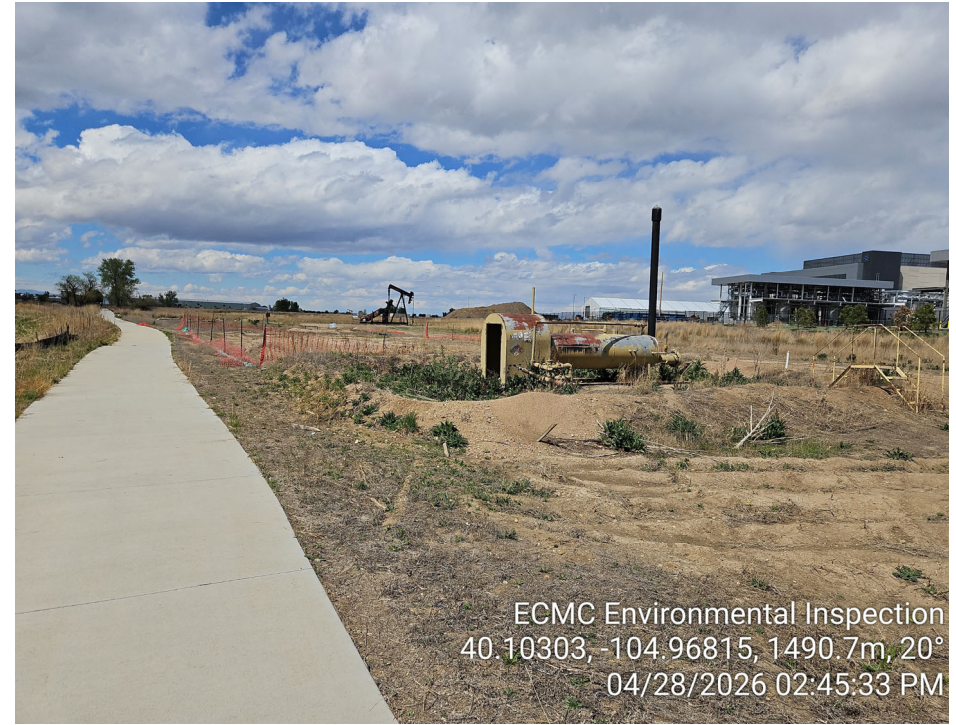
Photo 2 – Spill area. Fencing down around open excavation.

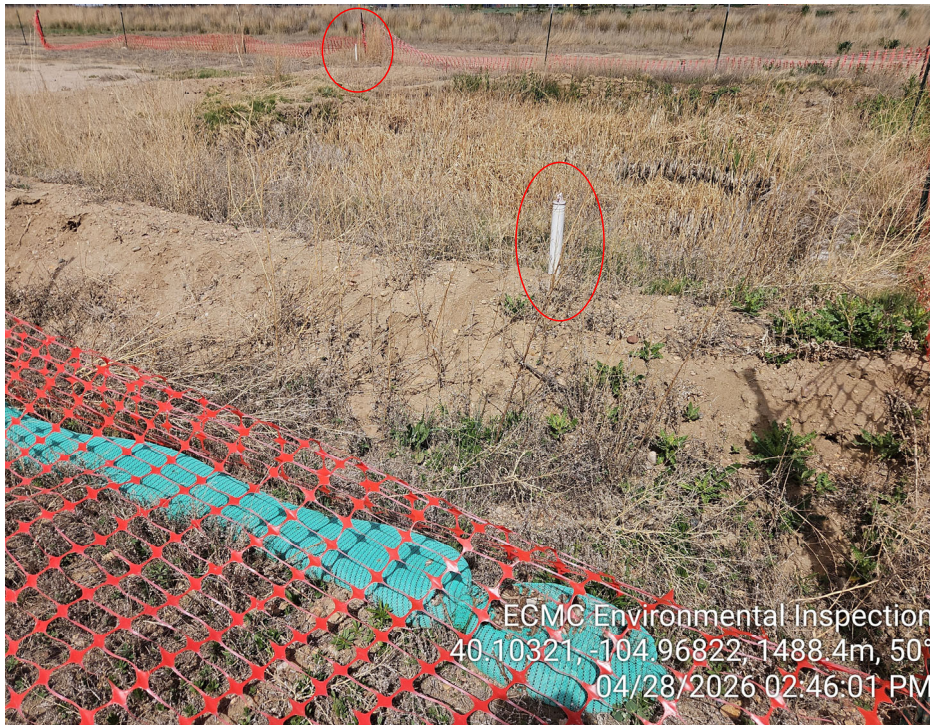
**Photo 3 – Fencing down around open excavation. Stormwater waddles have degraded and become trash. Monitoring wells present around open excavation (red).**

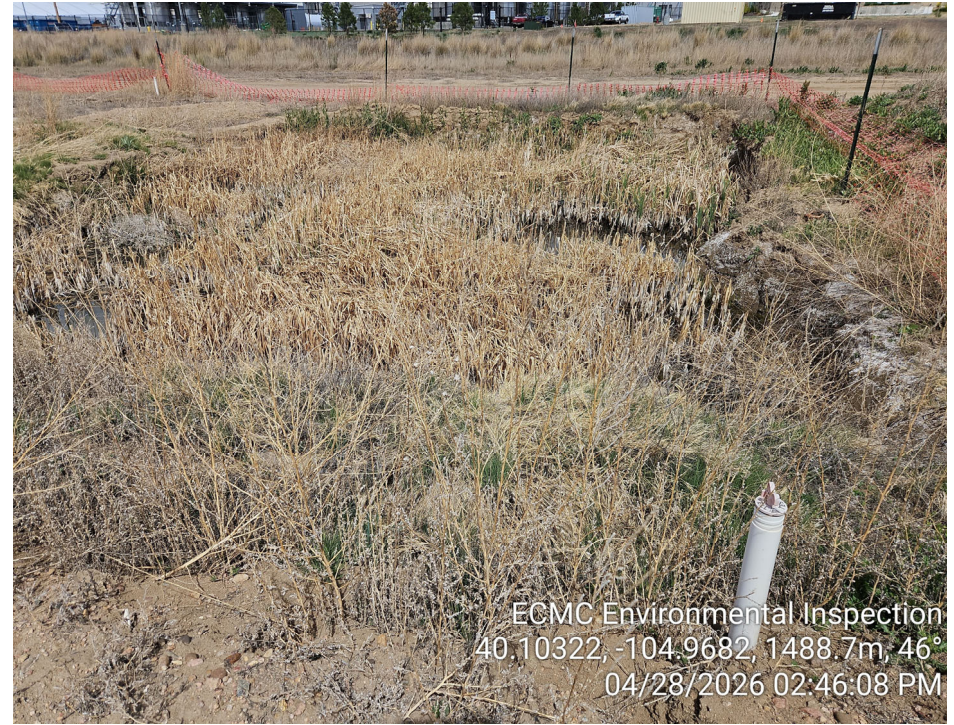
**Photo 4 – Open excavation. Excavation visibility largely obscured by weeds. Groundwater present in open excavation.**

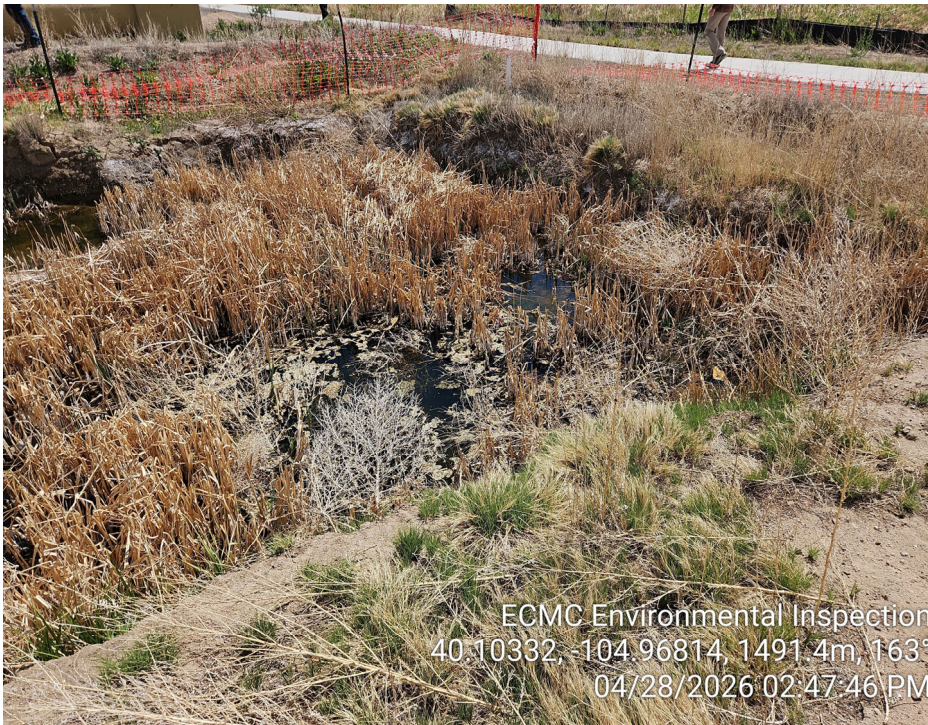
**Photo 5 – Open excavation. Excavation visibility largely obscured by weeds. Groundwater present in open excavation.**

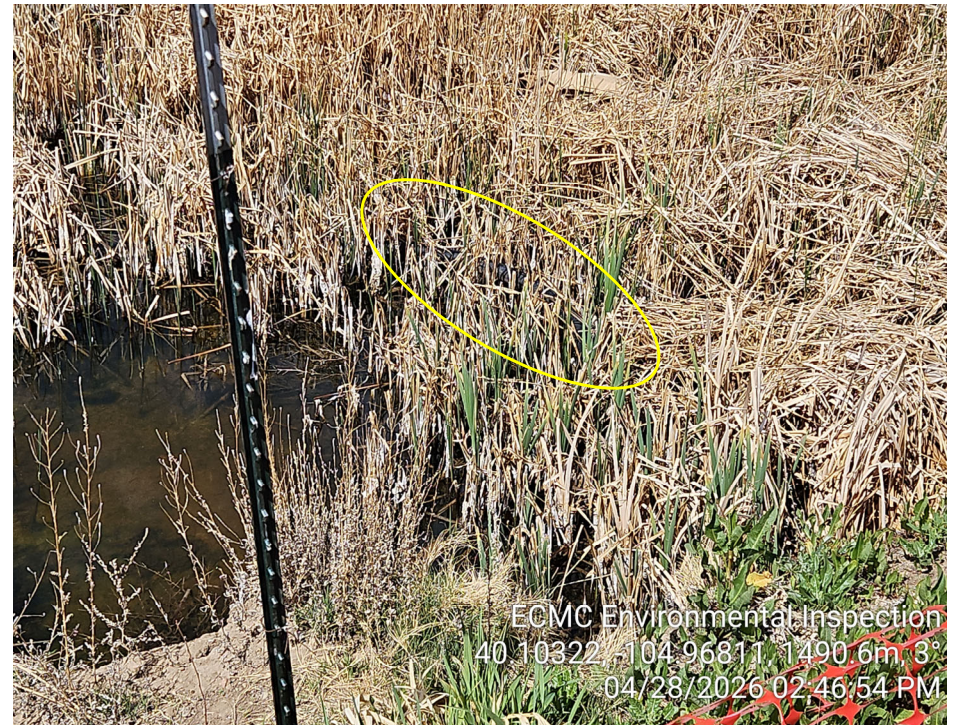
**Photo 6 – Groundwater in open excavation. Repaired flowline through open excavation largely obscured by weeds (yellow).**

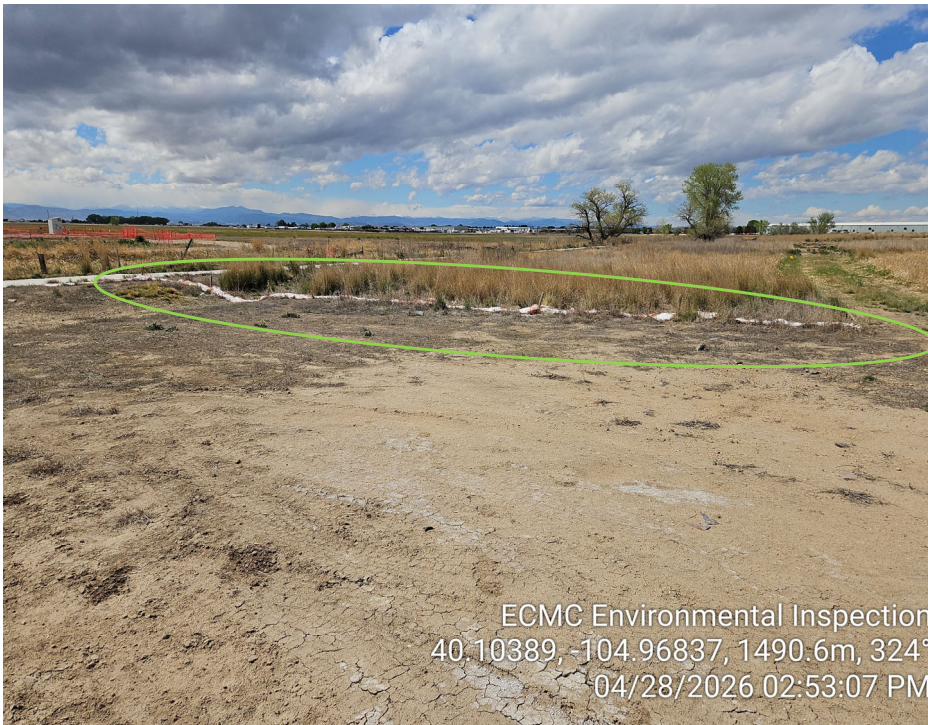
**Photo 7 – Stormwater waddles have degraded and become trash (green).**

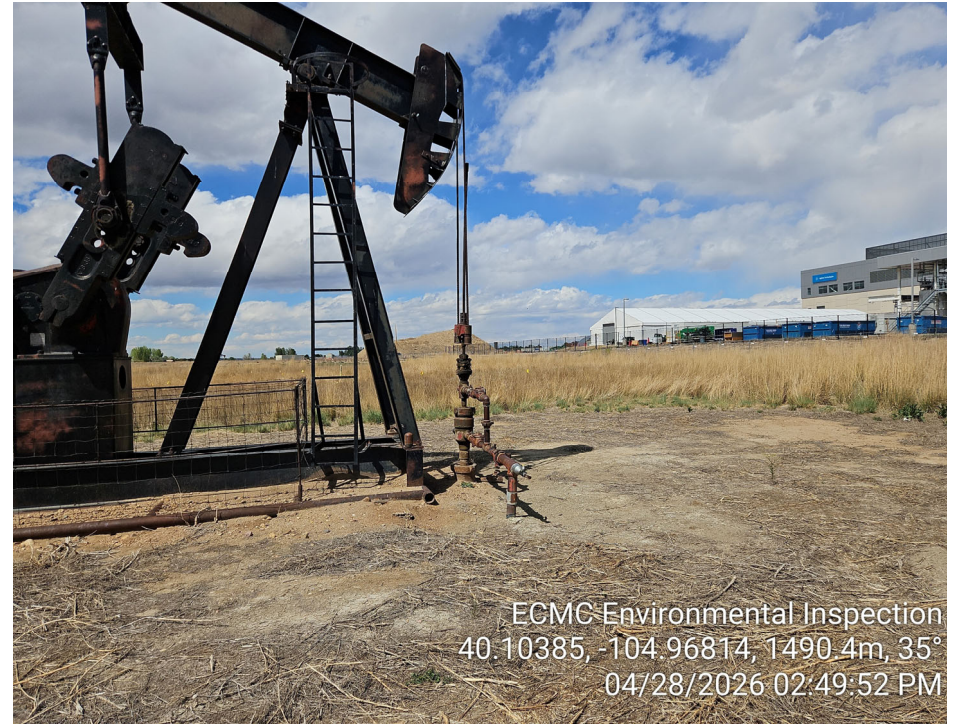
**Photo 8 – Excavation previously observed at wellhead has been backfilled.**
