**Inspection Photos
Paul Heinze 1 Flowline
Spill ID 479232 & 480128/Remediation No 18594**

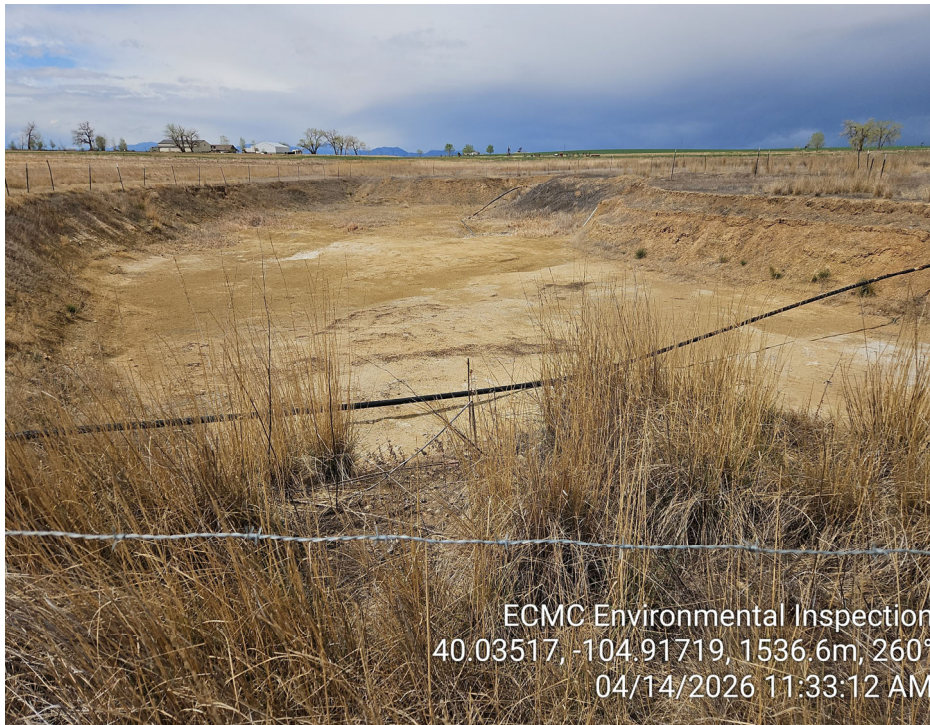
Photo 1 – Open excavation. Flowline runs through open excavation. No groundwater present. Weeds on excavation sidewalls.

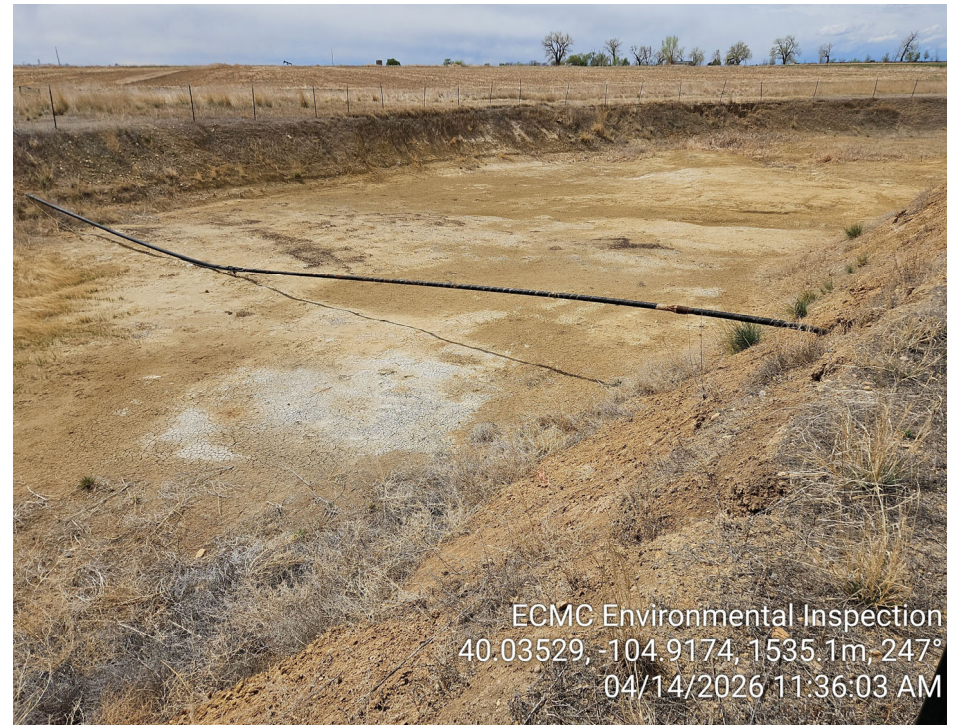
Photo 2 – Flowline Running through open excavation. Weeds on excavation sidewalls.

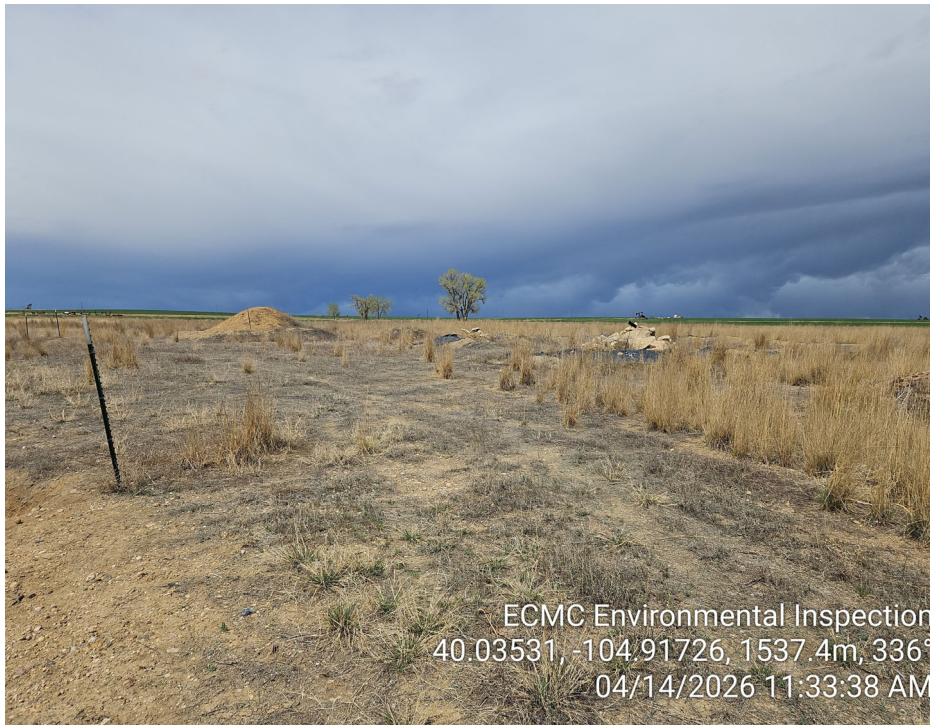
Photo 3 – Contaminated stockpile remains on location.

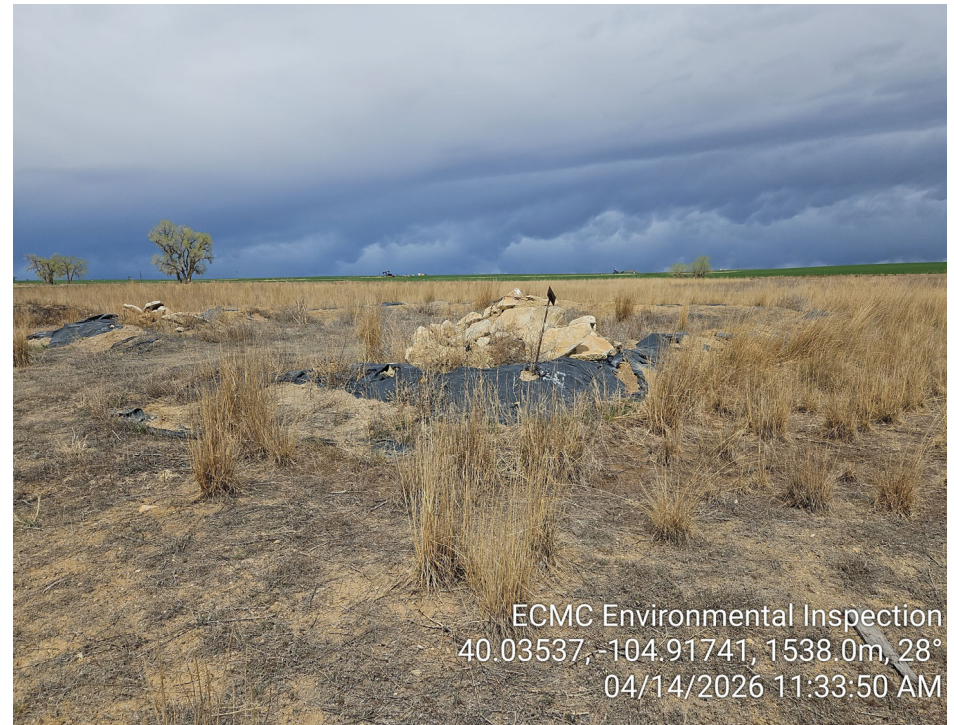
Photo 4 – Contaminated stockpile remains on location. Weeds growing through stockpile. Holes present in stockpile liner.
