QB ENERGY OPERATING LLC BENTLEY-67S95W 11SWSE Facility # 324168

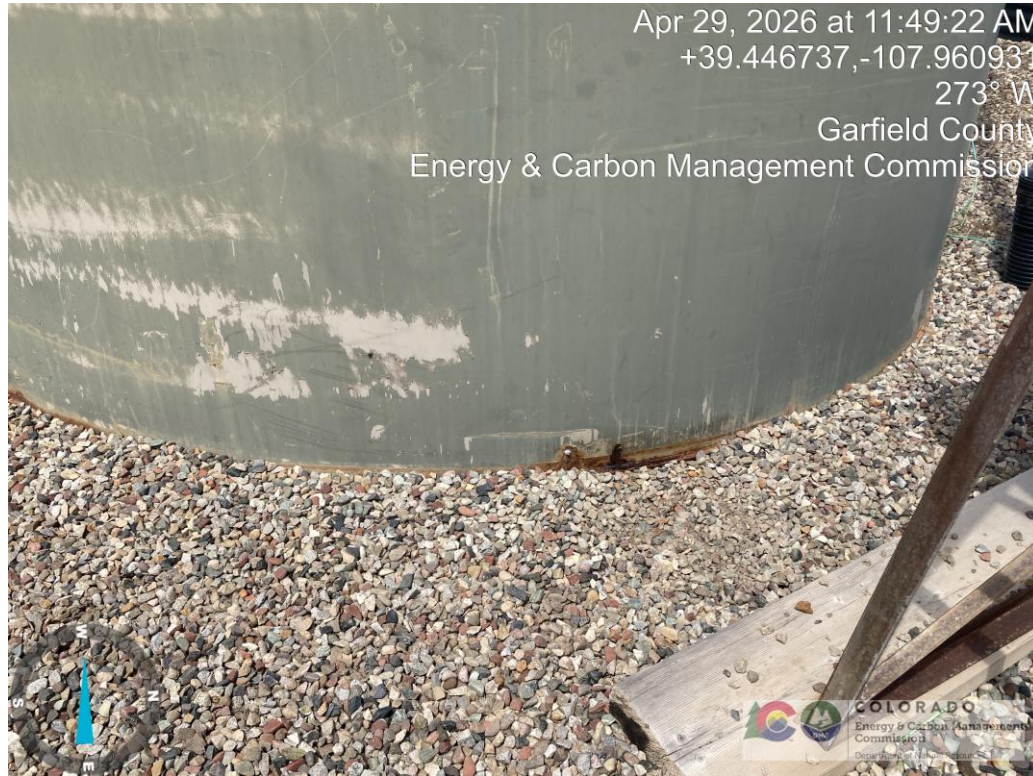
East tank was repaired with a screw. Another seep has shown up within inches of the last seep.

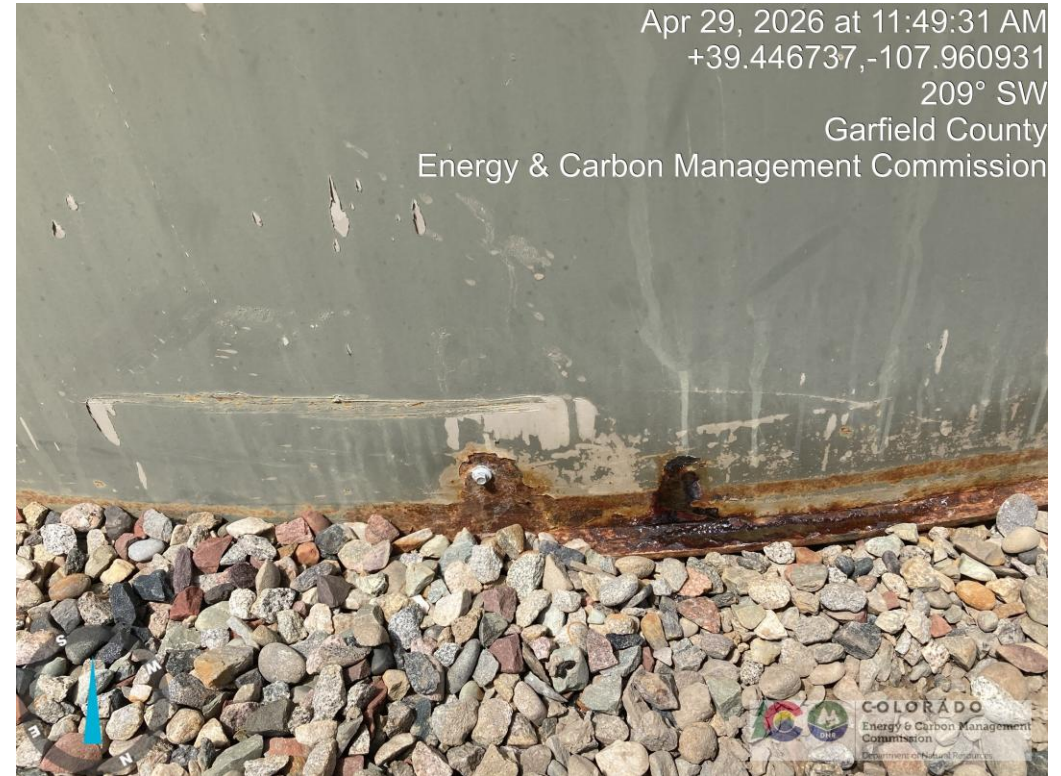
East tank was repaired with a screw. Another seep has shown up within inches of the last seep.

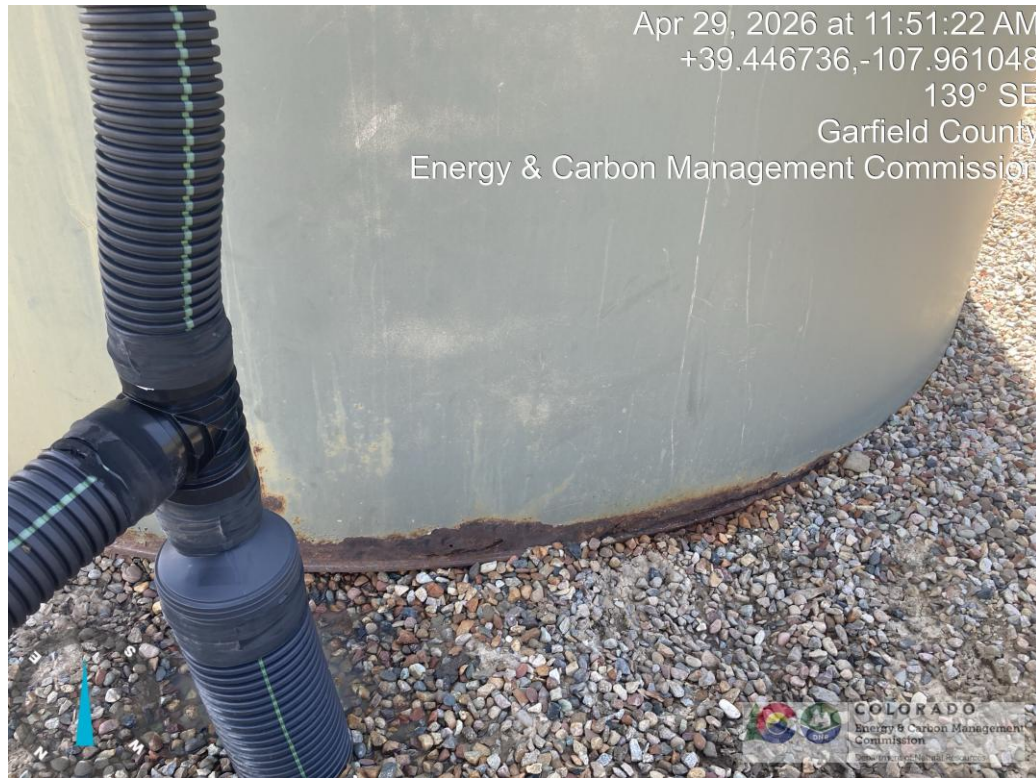
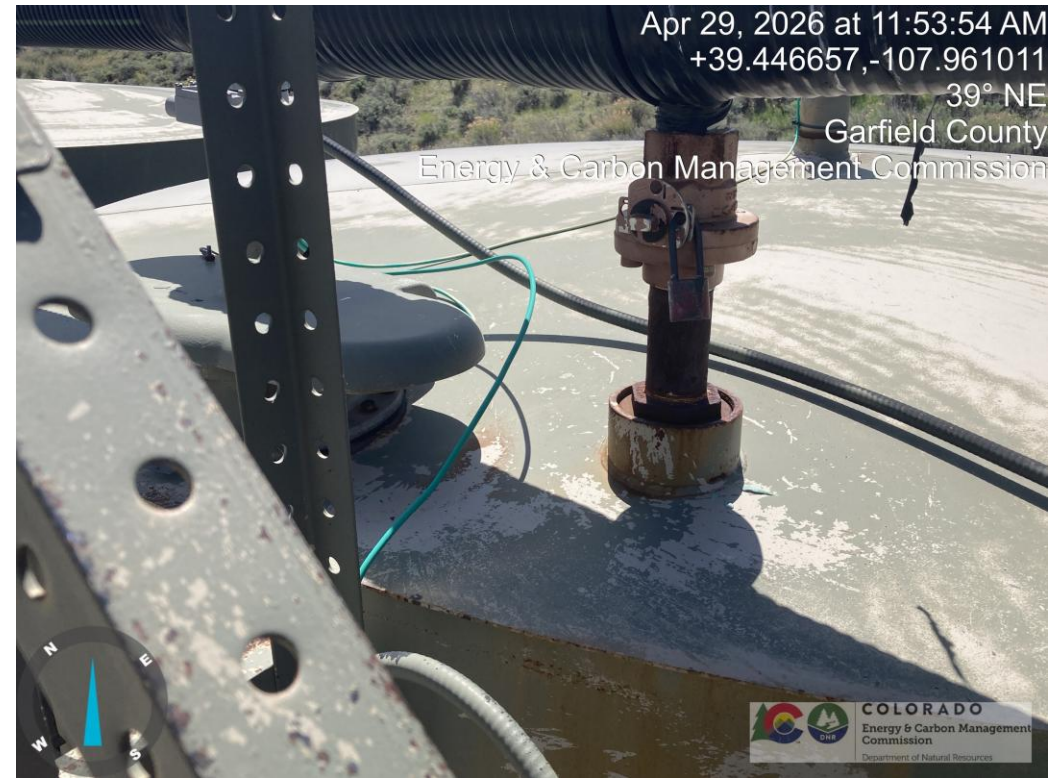
No OOSLAT tag
