Inspection Photos
Pete Montoya B Sales Line
Spill ID 493337/Remediation No 45017

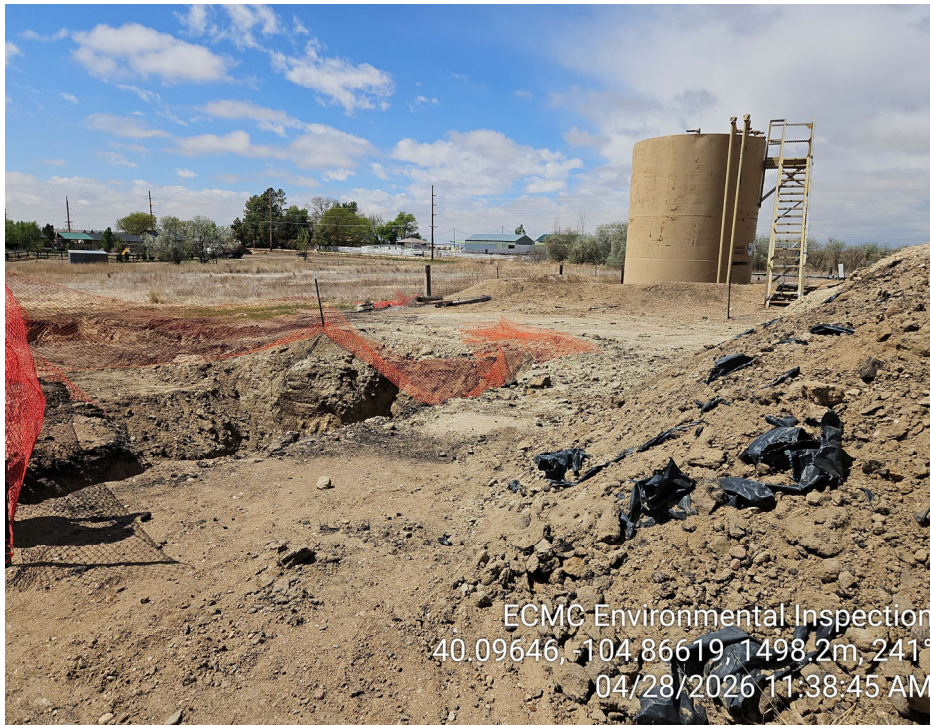
**Photo 1 – Fencing down around open excavation.
Soil stockpile with no liner or stormwater BMPs.**

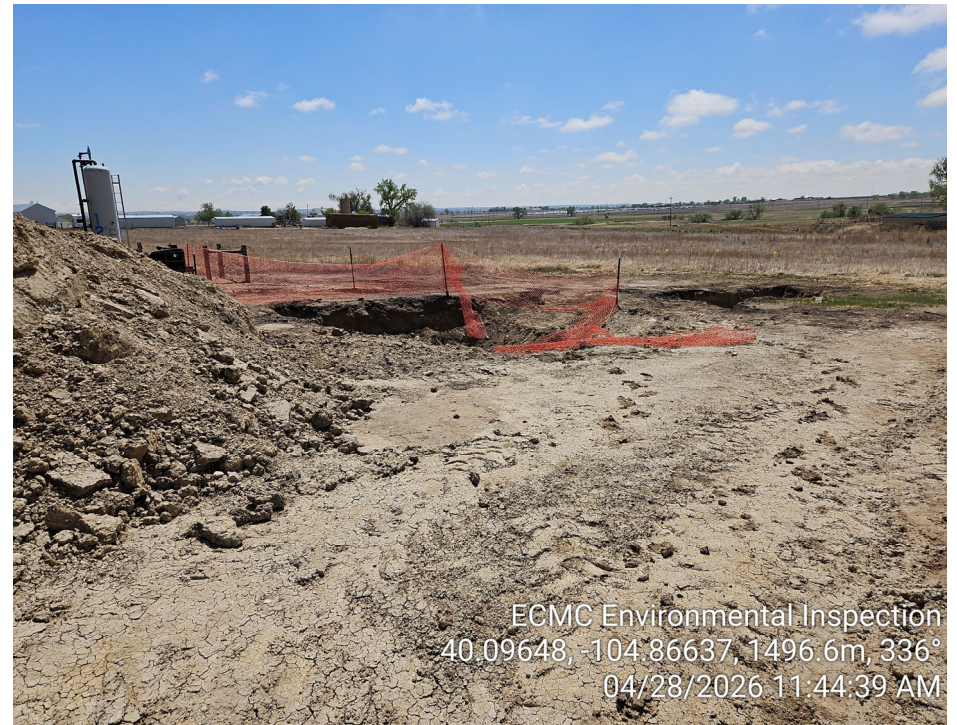
**Photo 2 – Fencing down around open excavation.
Soil stockpile with no liner or stormwater BMPs.**

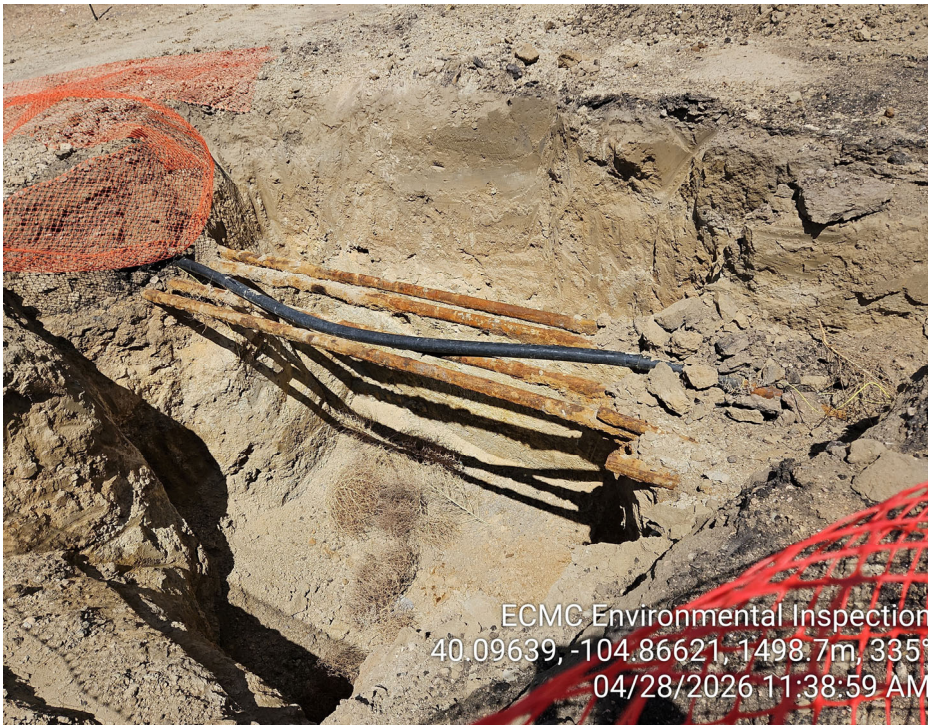
Photo 3 – Open excavation. Flowlines running through open excavation. Uncapped flowlines sticking out of excavation sidewall.

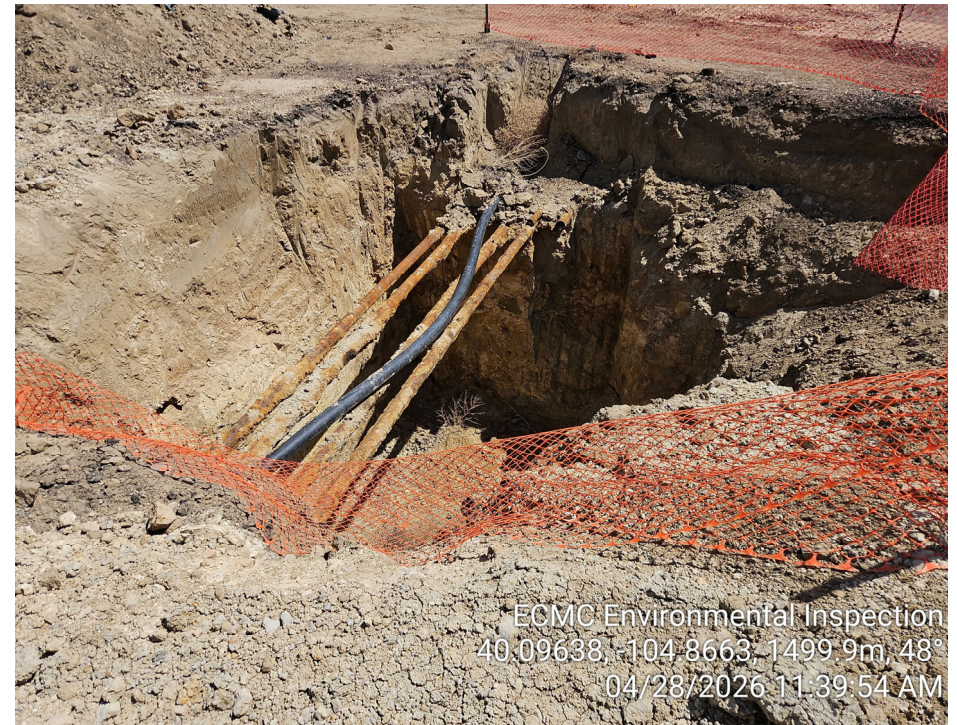
Photo 4 – Open excavation. Flowlines running through open excavation. Uncapped flowlines sticking out of excavation sidewall.

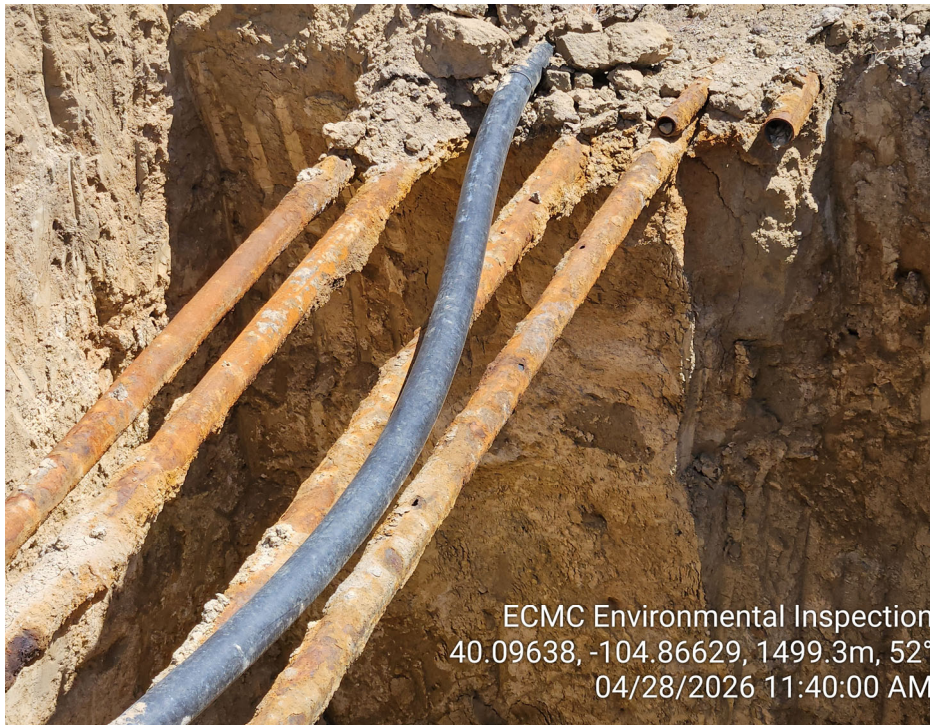
Photo 5 –Flowlines running through open excavation. Uncapped flowlines sticking out of excavation sidewall.

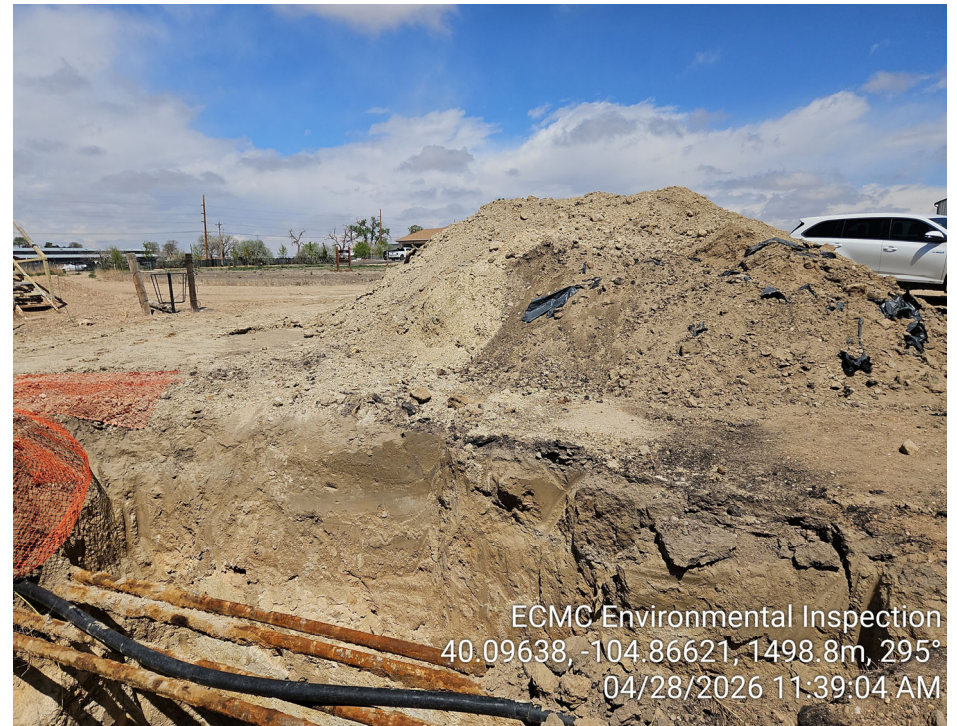
Photo 6 – Soil stockpile with no liner or stormwater BMPs.

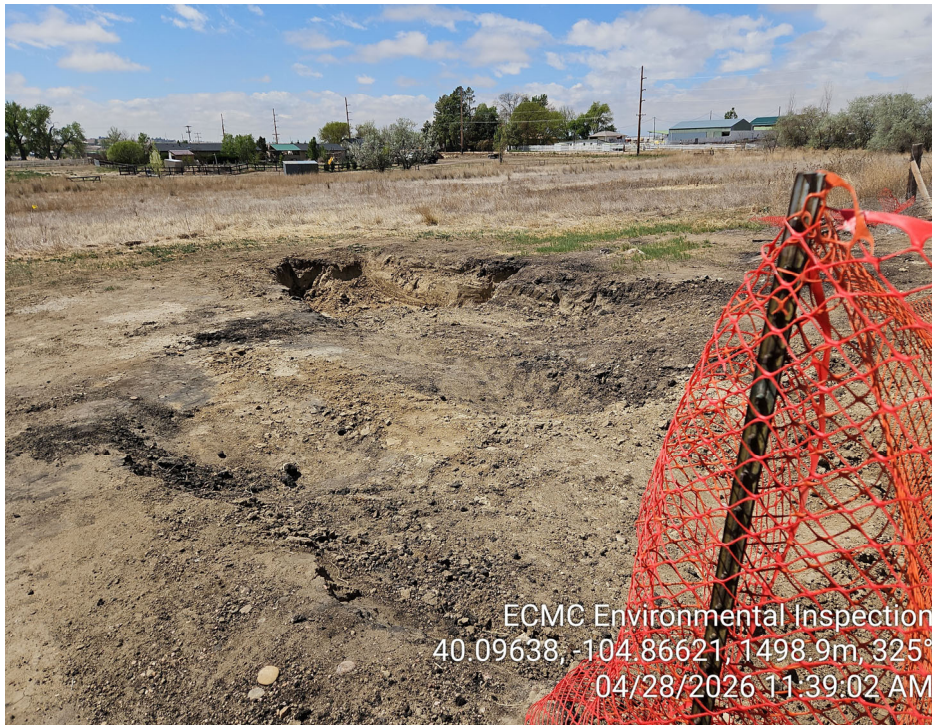
Photo 7 – Shallow excavation area with no fencing.

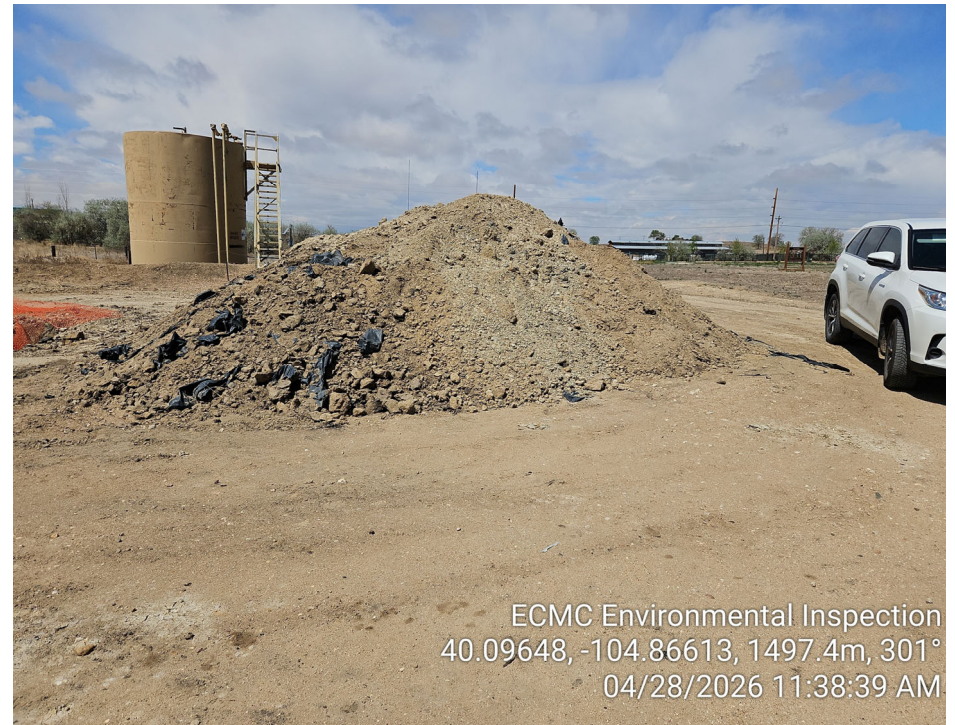
Photo 8 – Soil stockpile with no liner or stormwater BMPs.

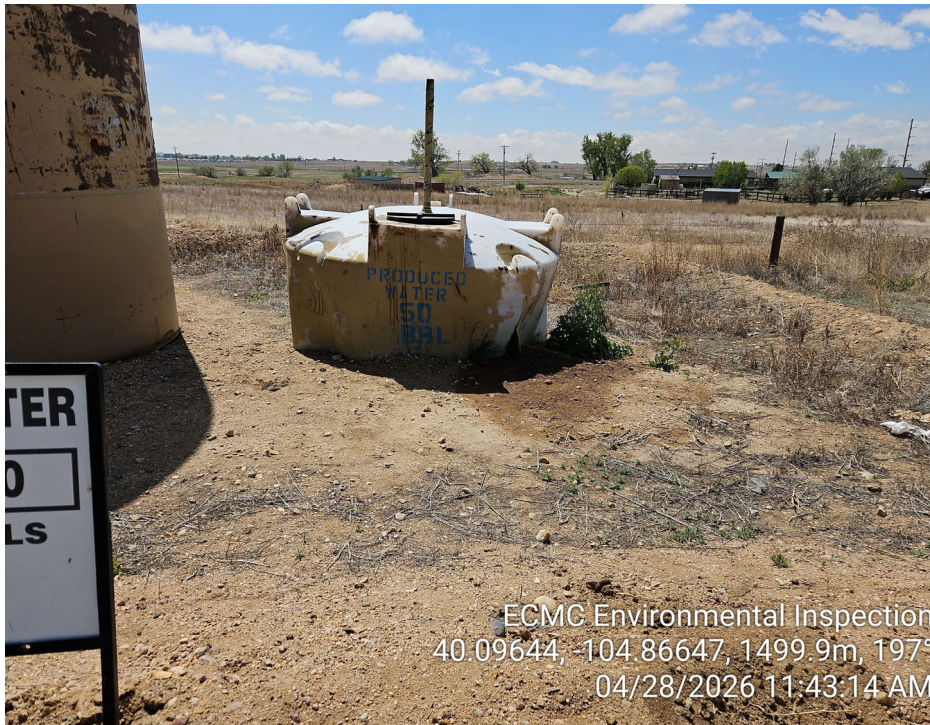
Photo 9 – Produced water tank is cracked. Stained soil next to tank.

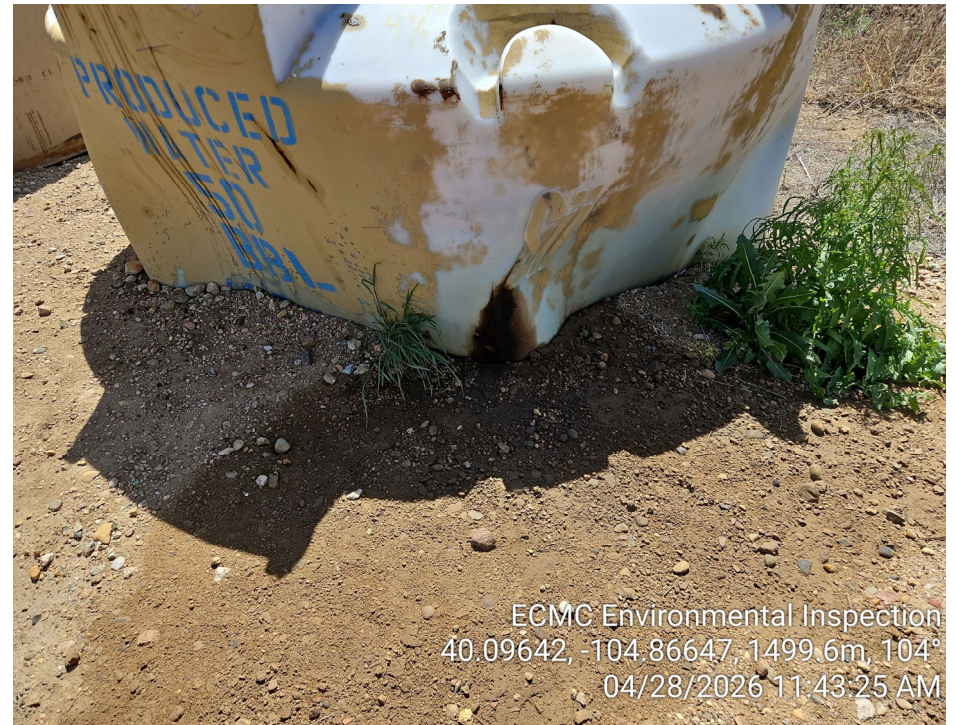
Photo 10 – Produced water tank is cracked. Stained soil next to tank. Weeds growing next to produced water tank.

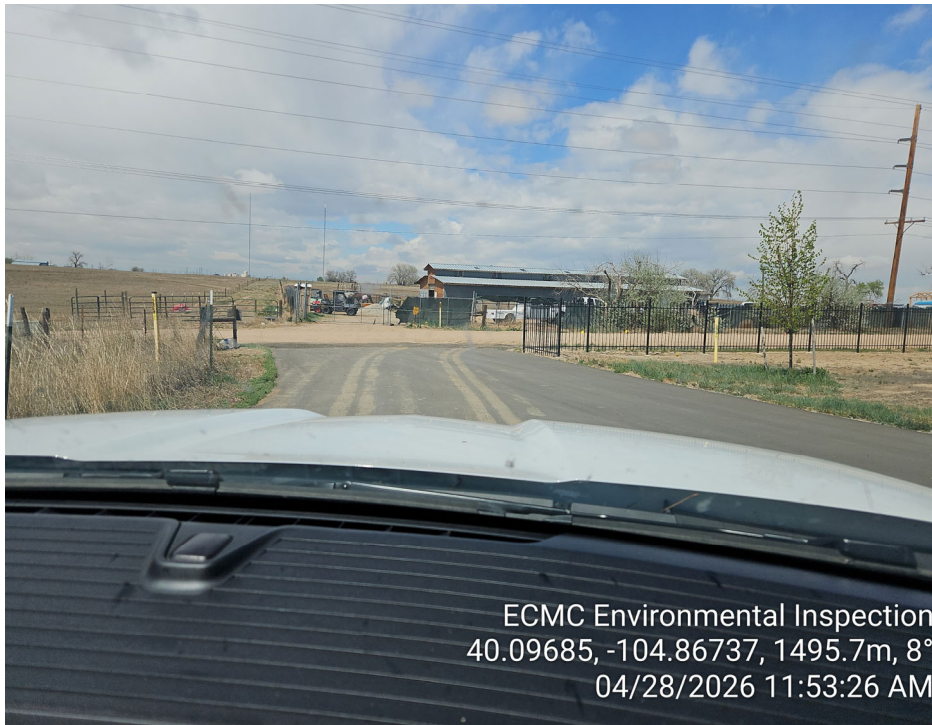
Photo 11 – Dirt being tracked off location
