Inspection Photos

Operator: **GUNNISON ENERGY LLC – 10515**

Location Name: **ALLEN 1291 12-24**

Inspection Date: **5/4/2026** Inspection Doc#: **693809266**

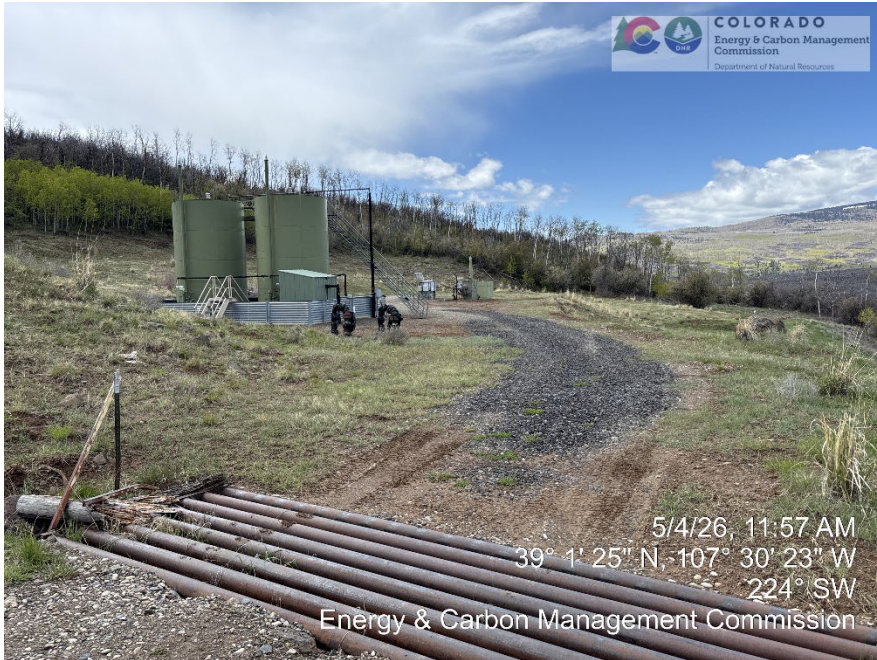
Location overview looking SW

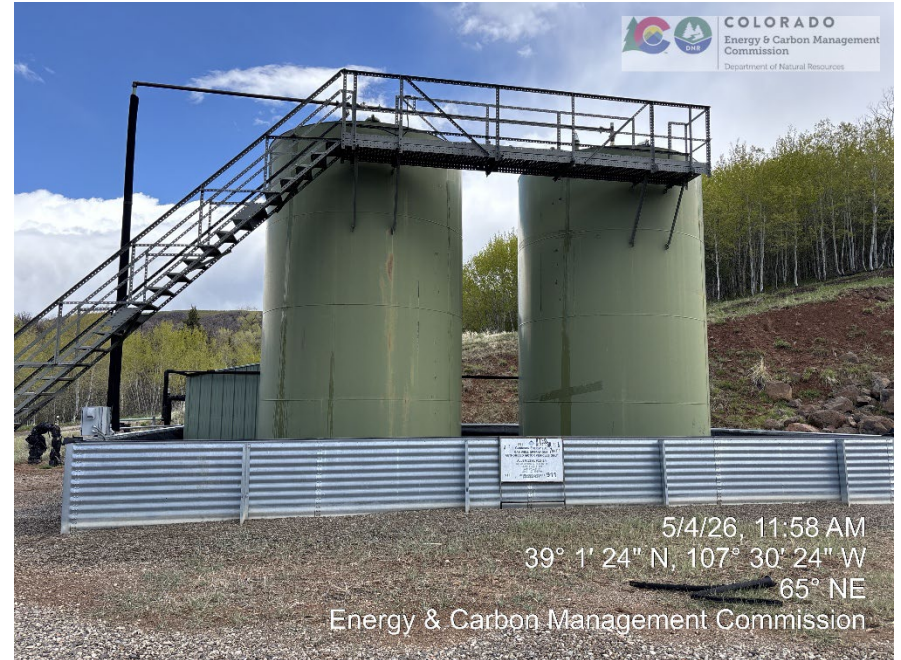
Tank Battery

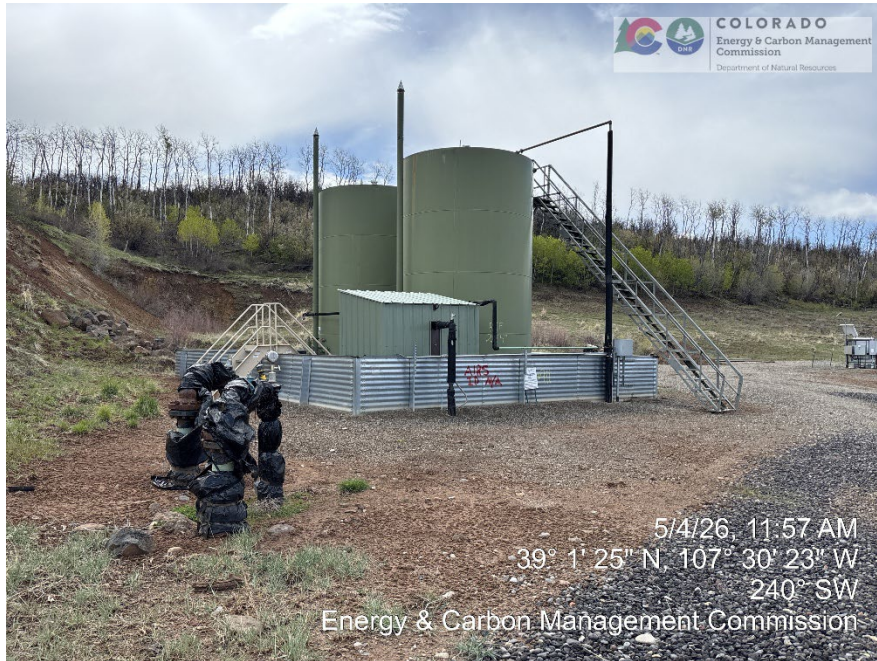
Off location flowline risers

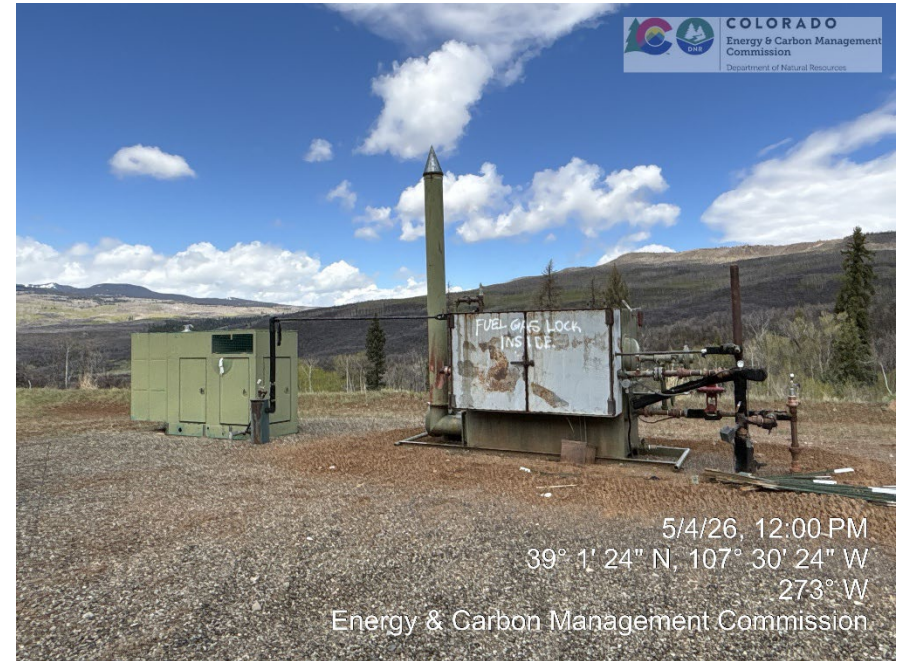
Separator and Generator

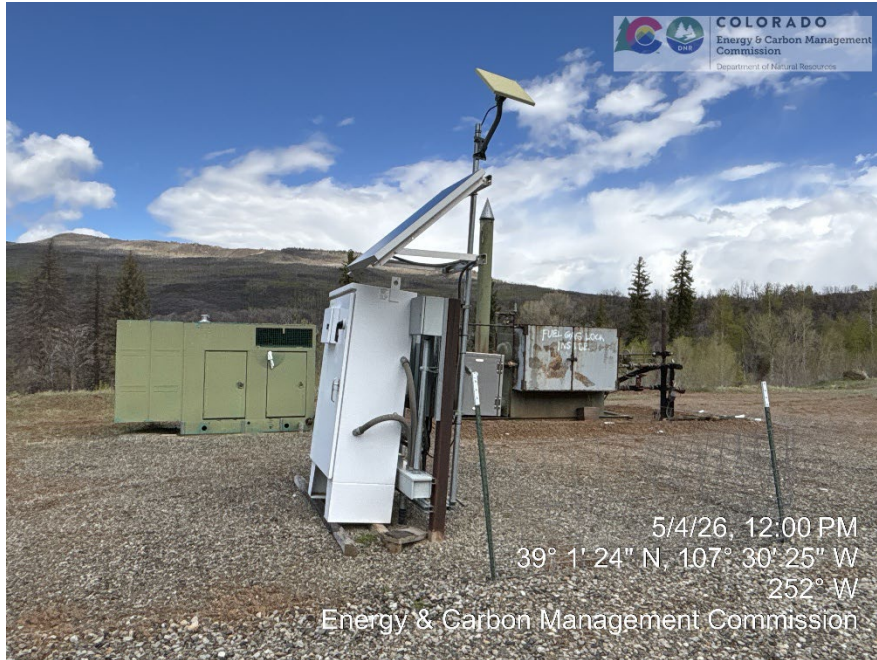
Electrical Control panel

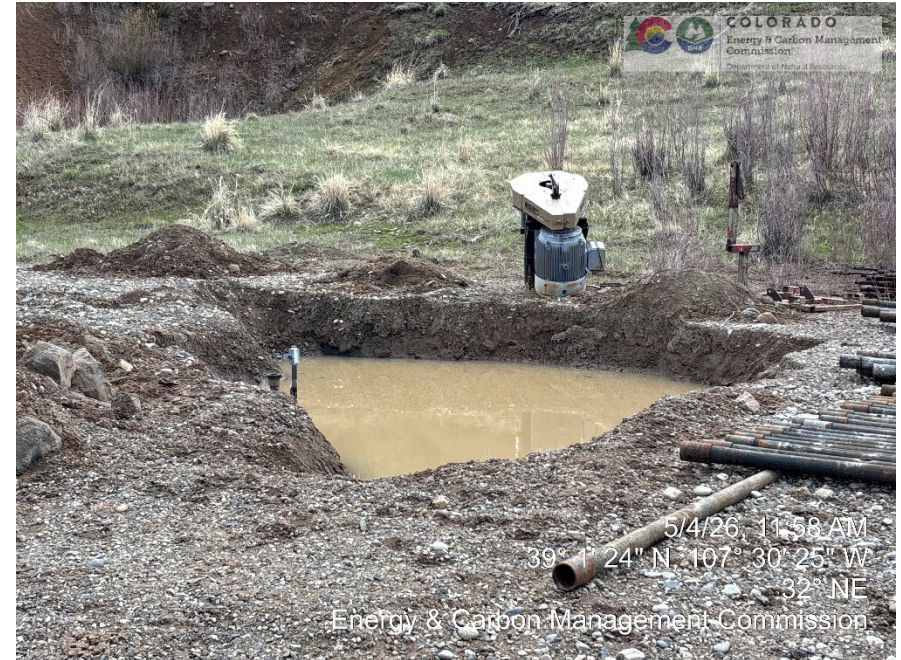
Excavations for Plugged and Abandoned well.

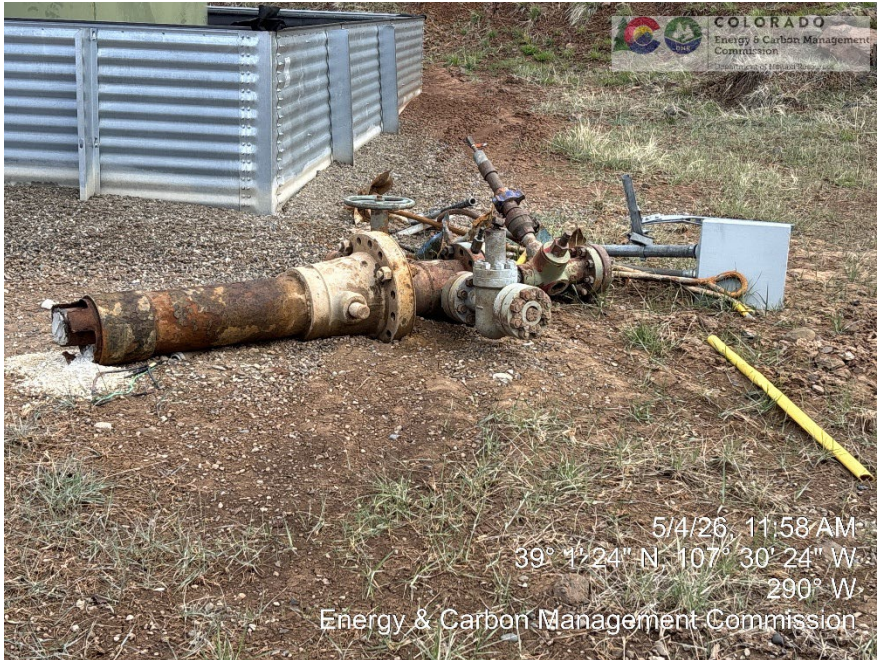
Cut off wellhead and valves

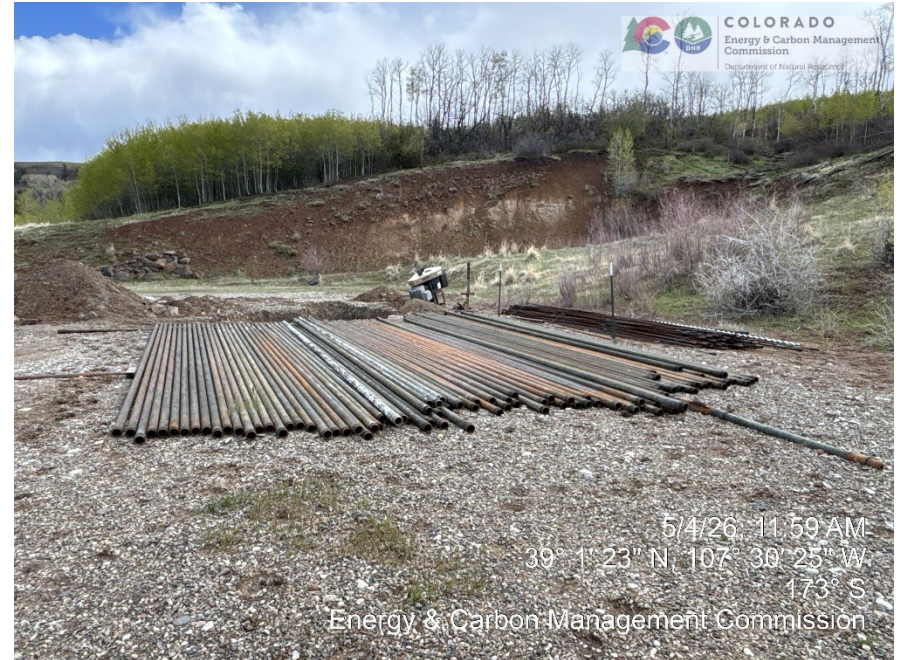
Tubing and Sucker rods from Plugged and Abandoned well
