Inspection Photos

Operator: TEP Rocky Mountain LLC #96850

Location ID: 335067

Inspection Doc: 719201111

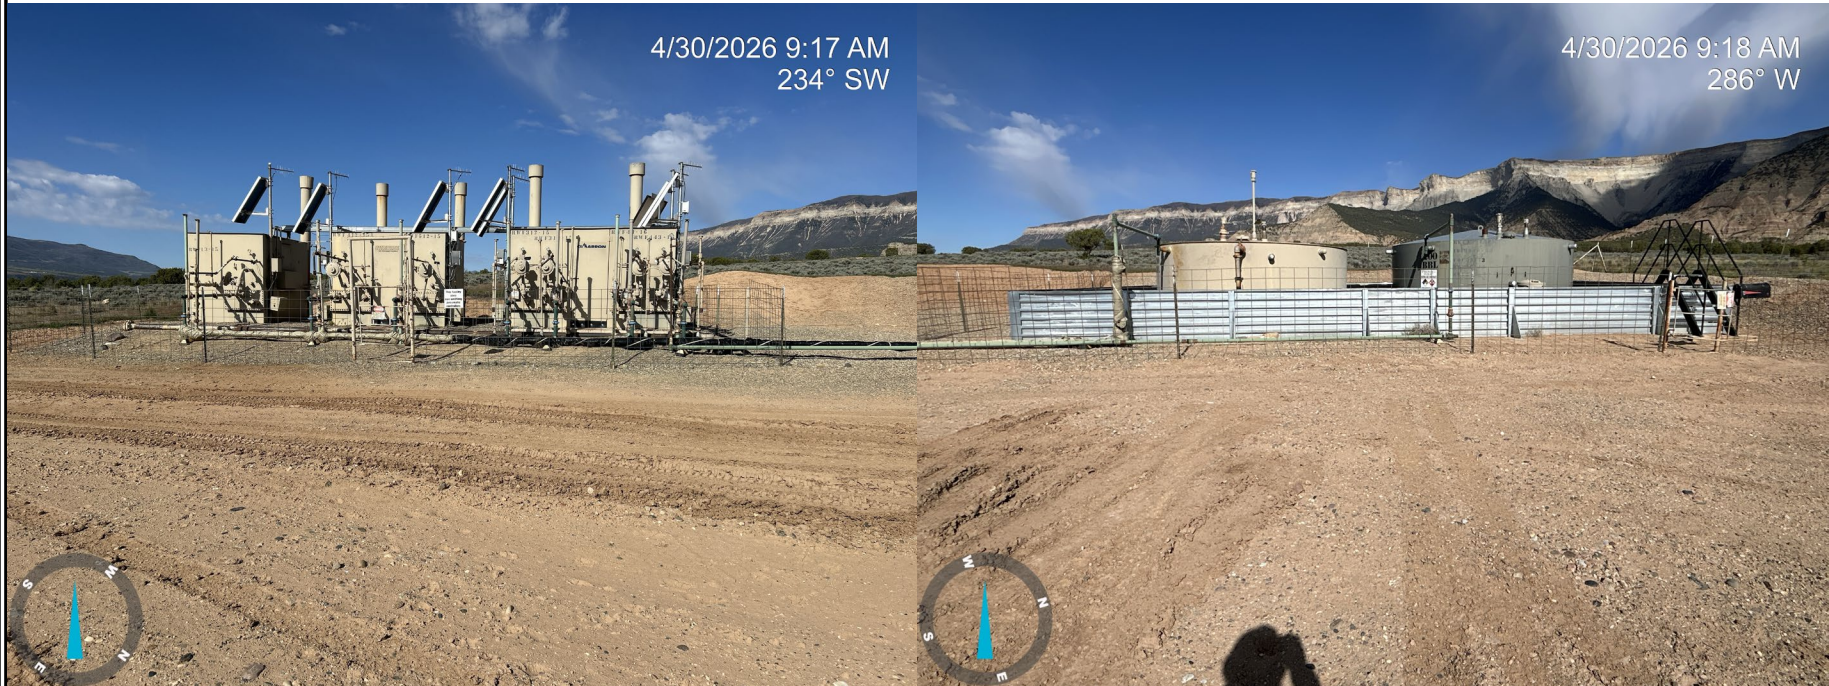
Photo 1: Photos showing an overview of separator and tank equipment at the location.

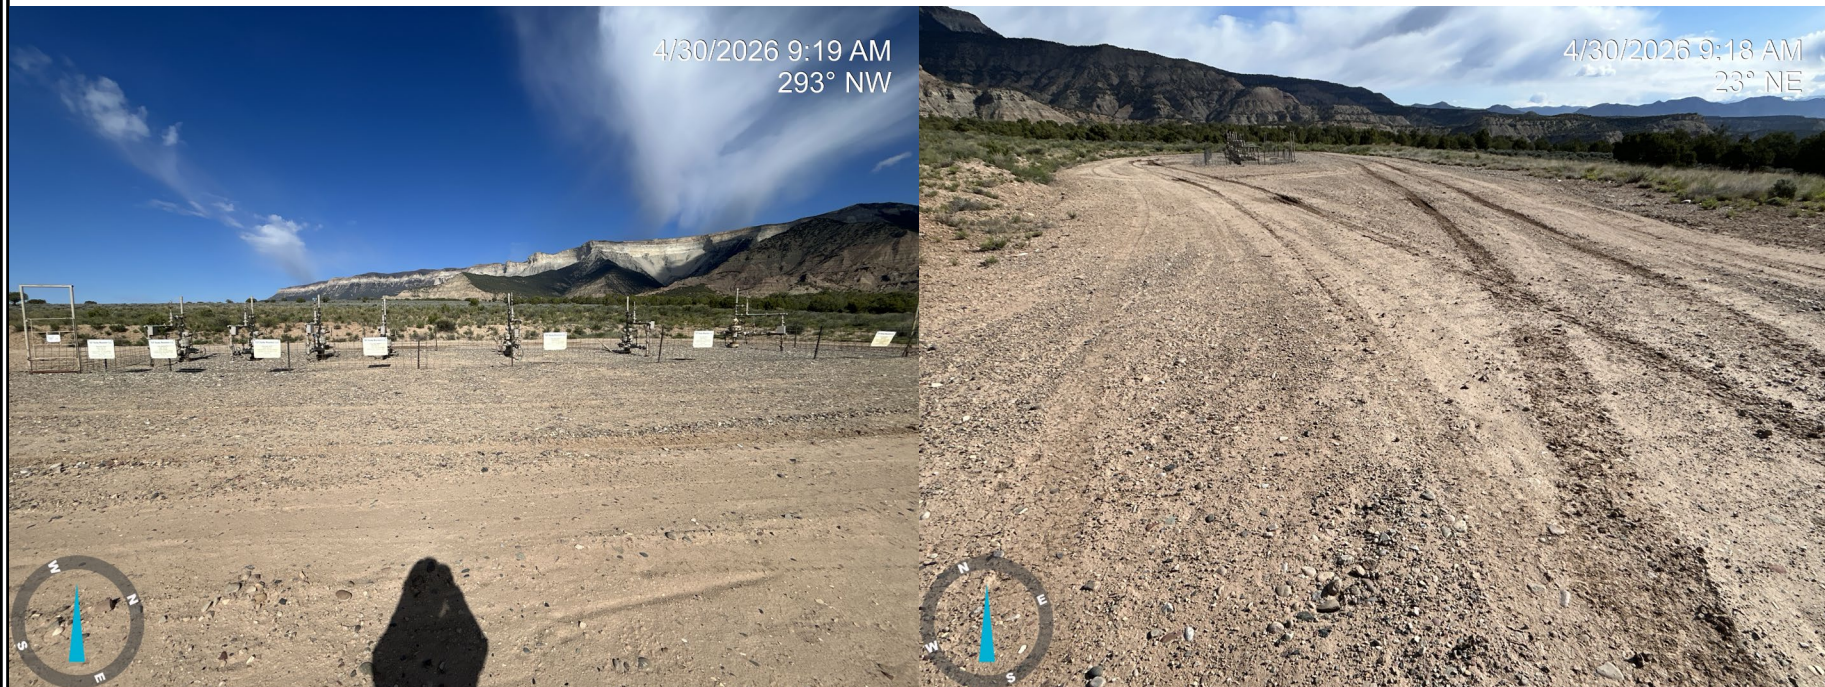
Photo 2: Photos showing an overview of the wellhead area at the location.

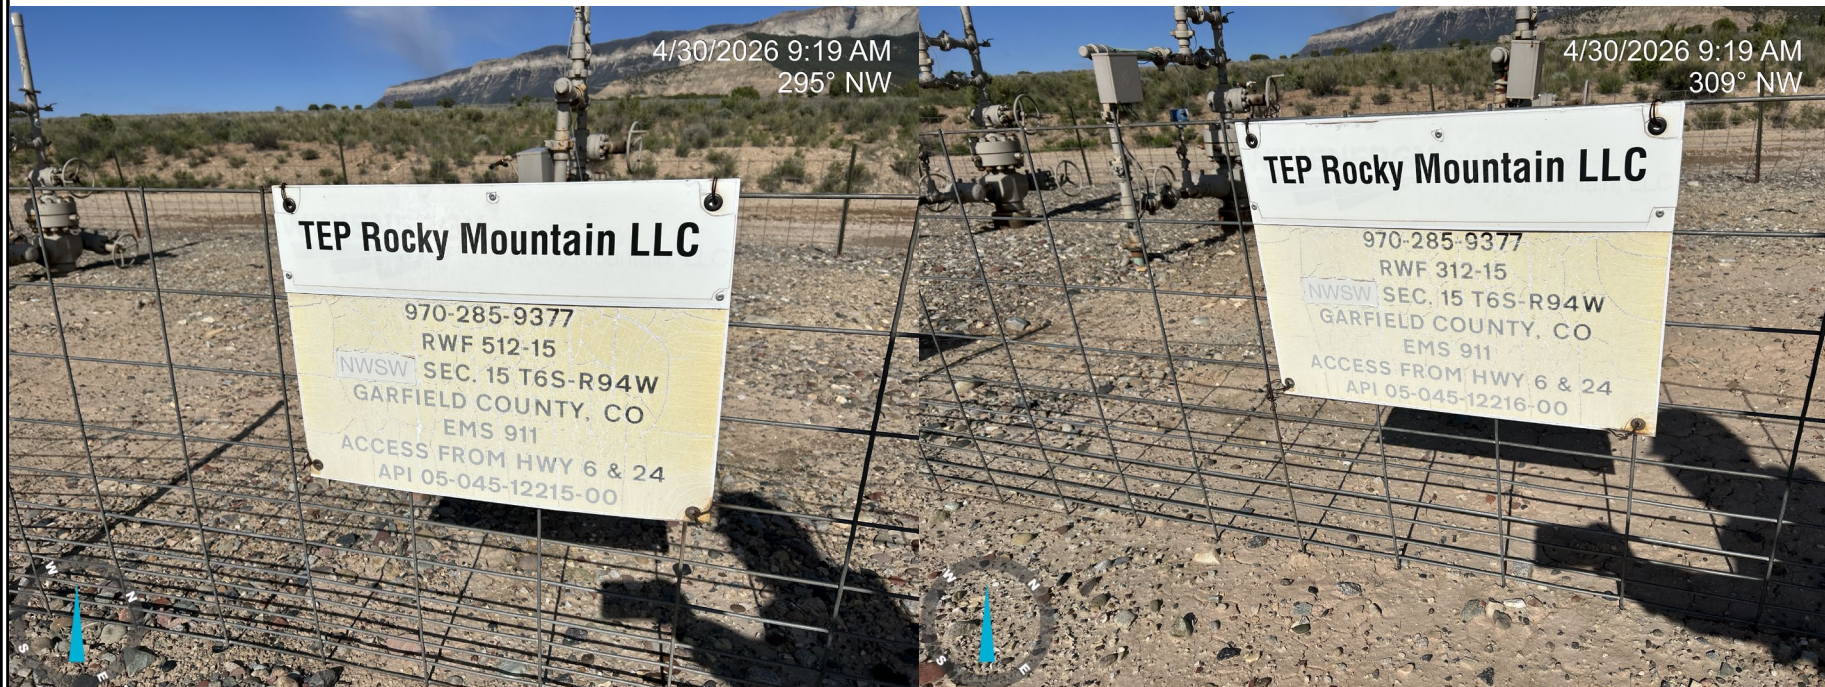
Photo 3: Photos showing an example of wellhead signage that is faded and becoming difficult to read. Maintenance is recommended.

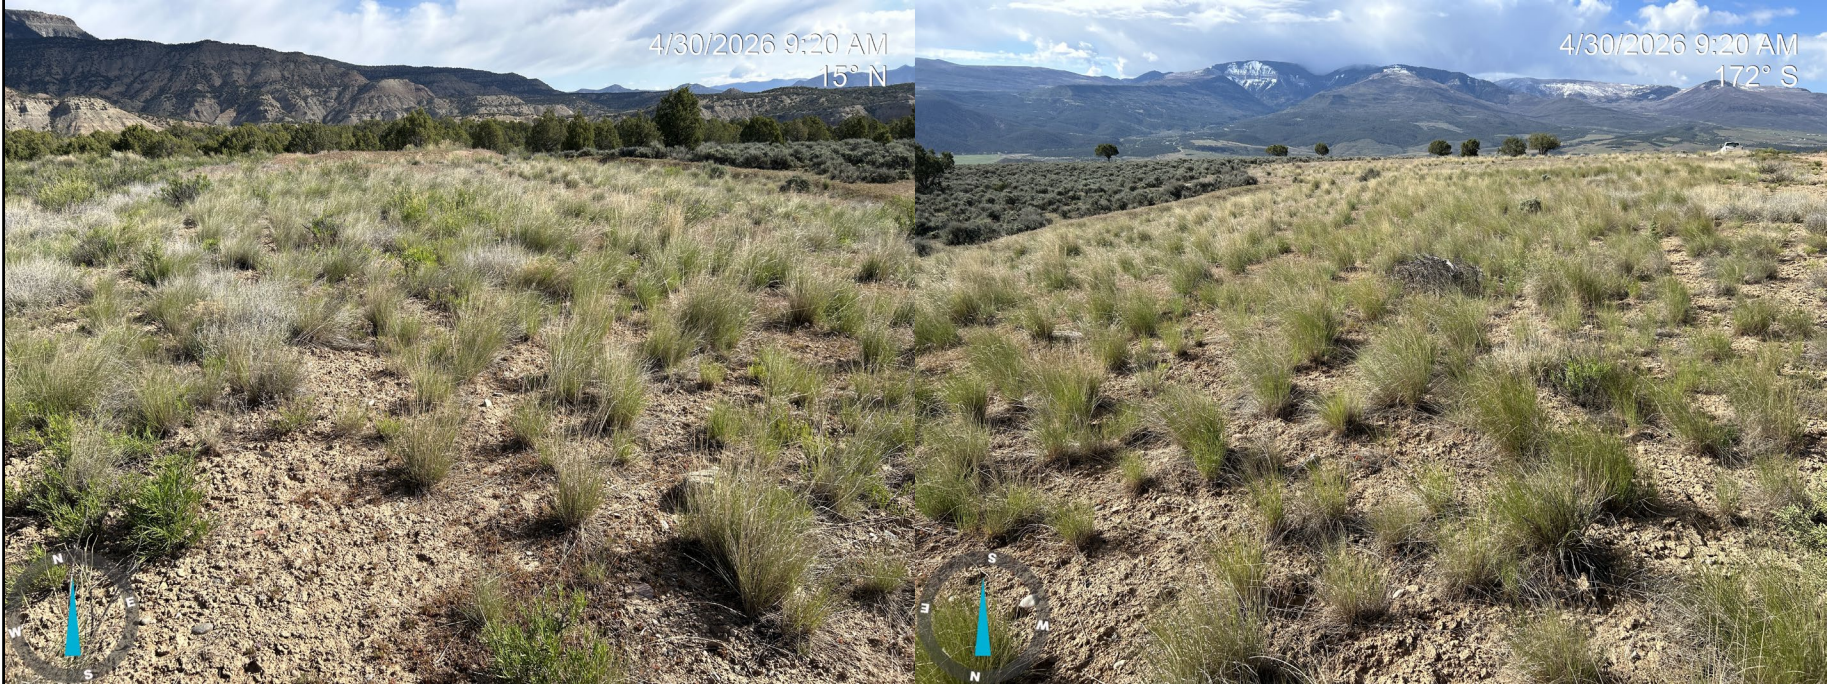
Photo 4: Photos showing an overview of the northern interim area. Perennial, desirable and uniform vegetation is well established throughout.

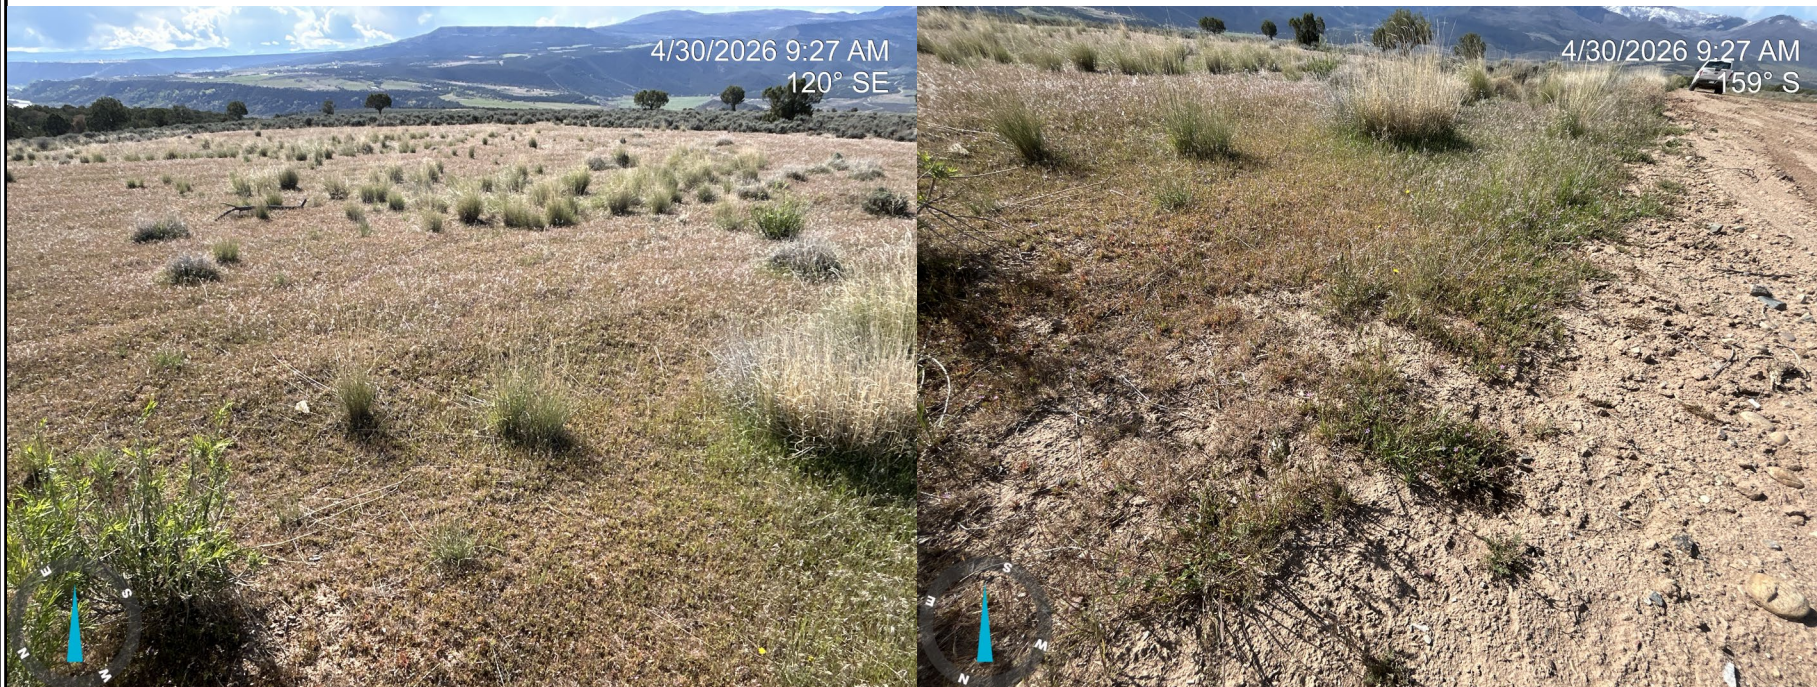
Photo 5: Photos showing the southeastern interim area is overtaken with cheatgrass. Redstem fillaree, prickly Russian thistle and bulbous bluegrass are present along the margins of the working pad surface. Weed maintenance is required; comply with Rules 606.c. and 1003.f.

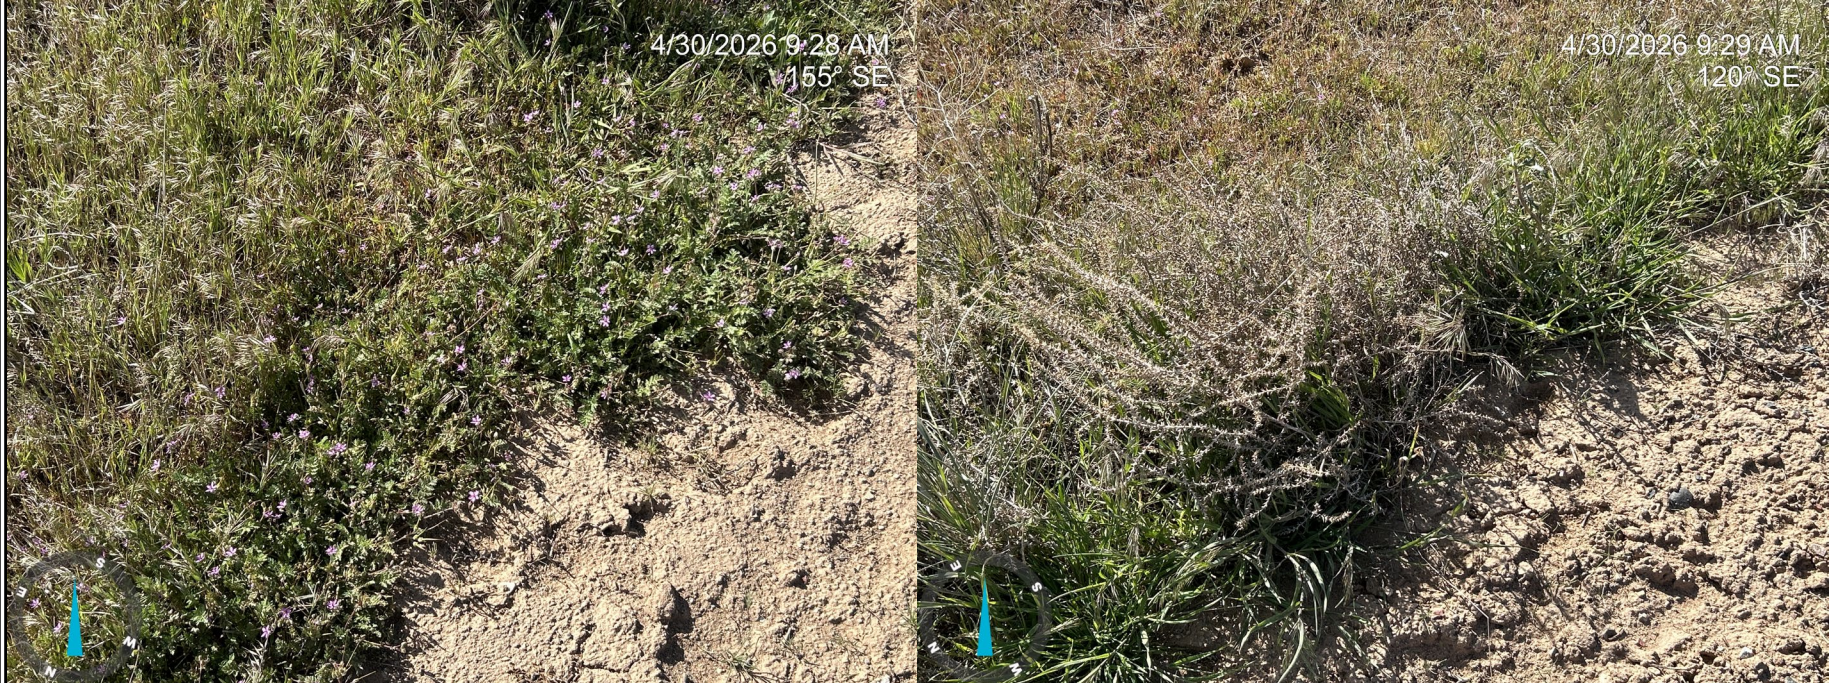
Photo 6: Redstem fillaree, prickly Russian thistle and bulbous bluegrass are present along the margins of the working pad surface.

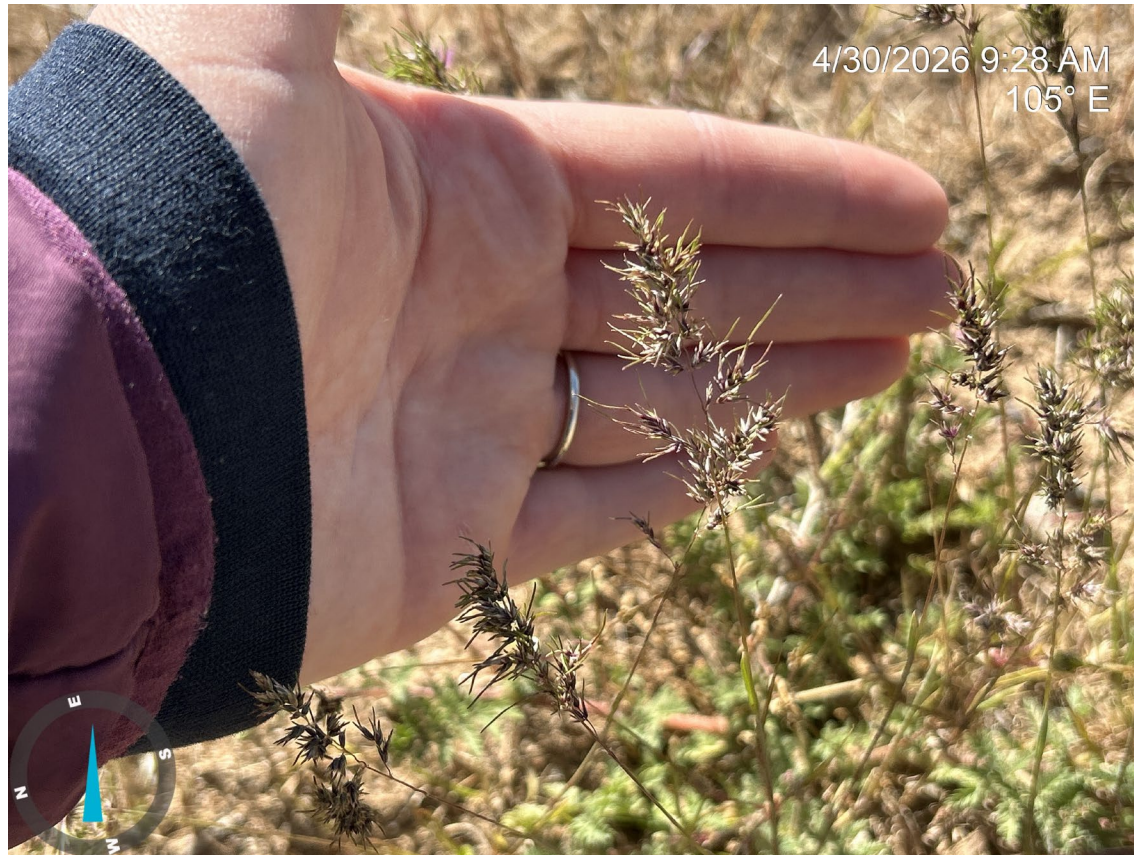
Photo 7: Bulbous bluegrass, a List C noxious weed species, is present throughout the interim areas.

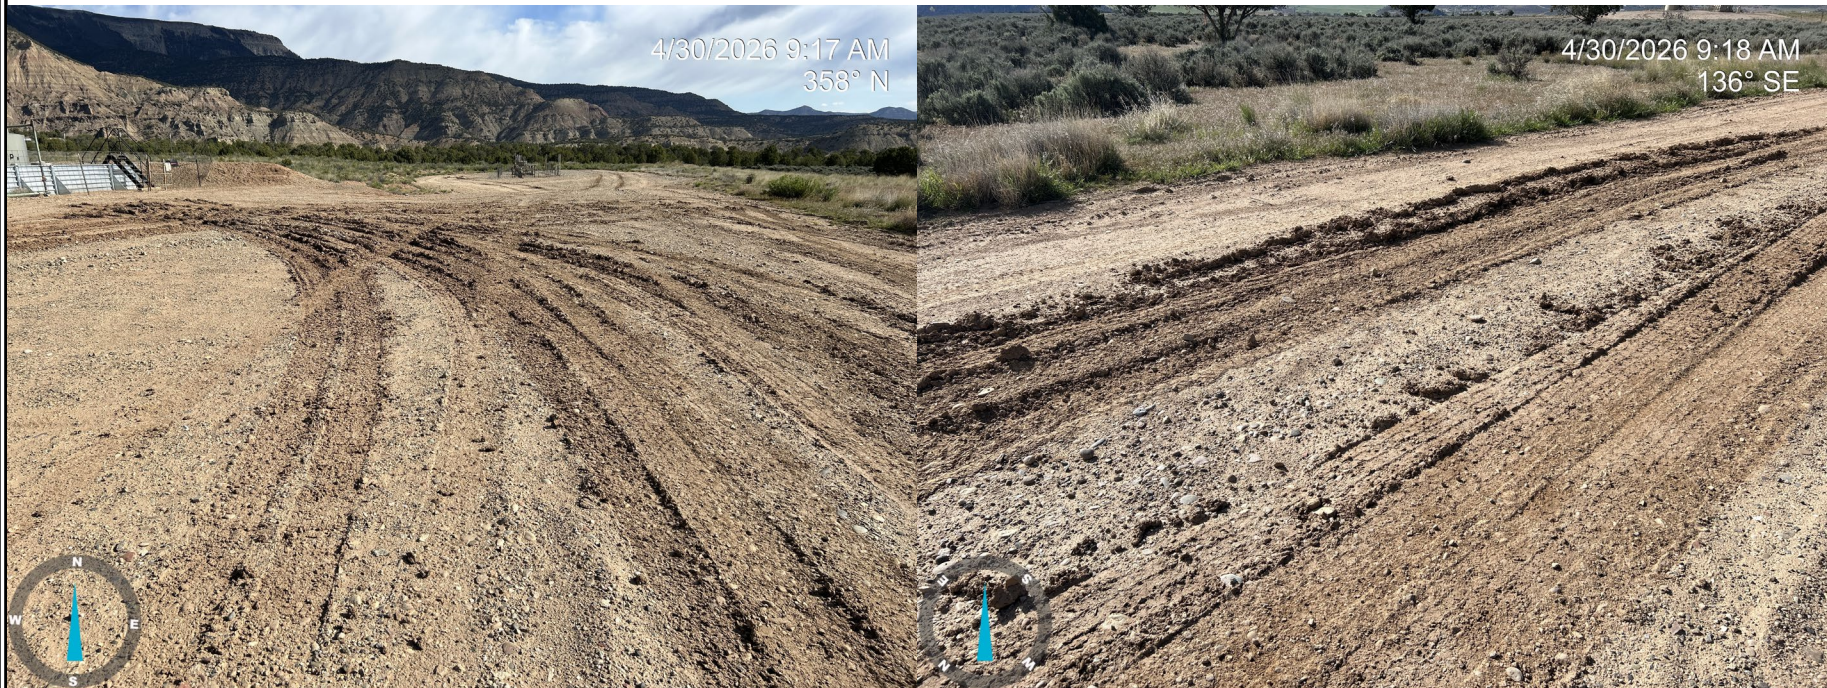
Photo 8: Photos showing deep vehicle tracking that is occurring throughout the working pad surface. Gravel appears to be sparse throughout. Maintenance is required; comply with Rule 1002.f.

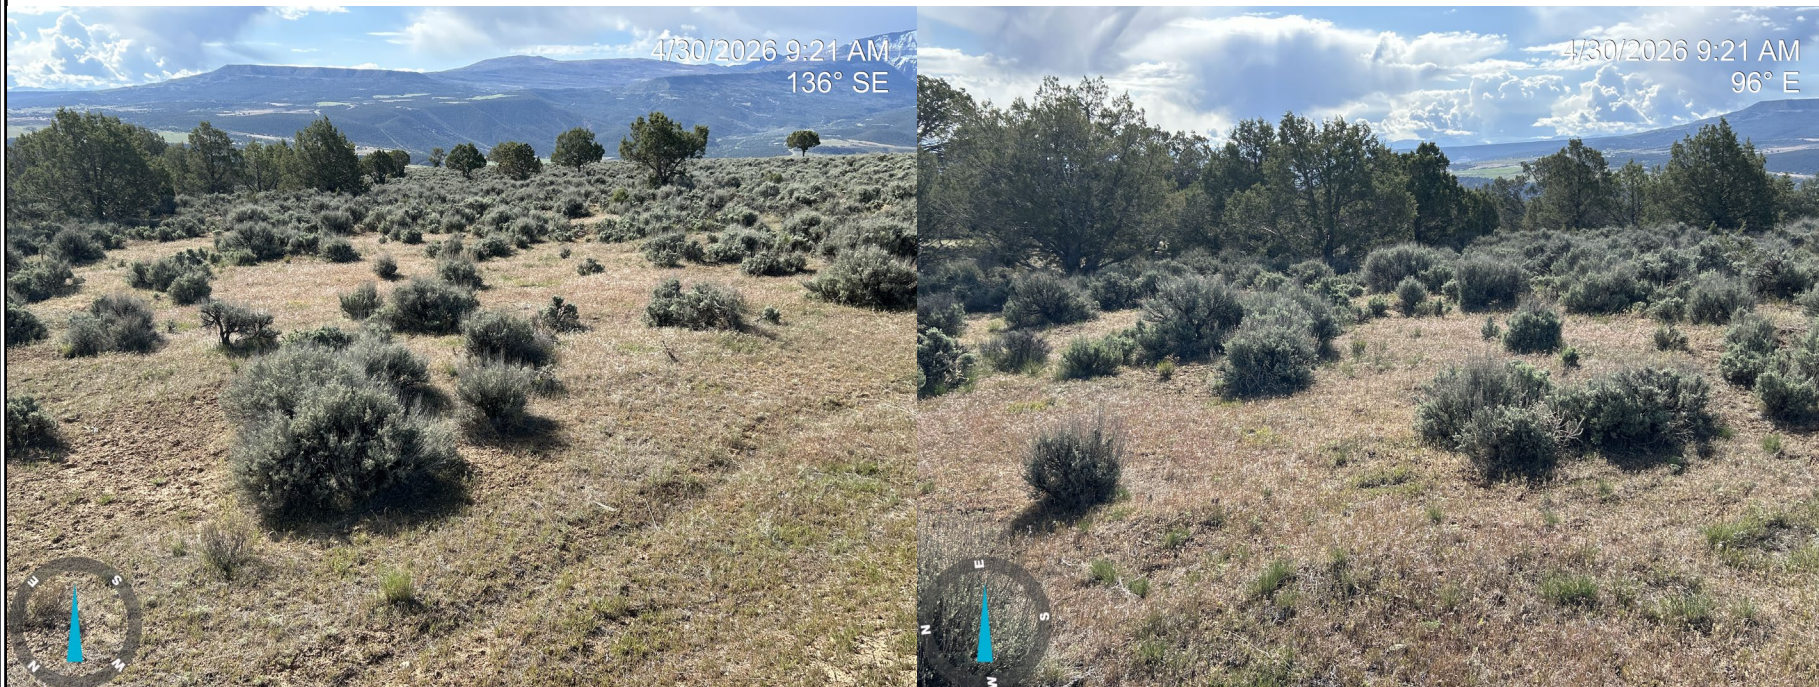
Photo 9: Photos showing an example of the nearby reference area, located directly east of the pad. The reference area is composed of mature big sagebrush and pinyon-juniper trees. Cheatgrass is present in the understory.
