Inspection Photos

Operator: TEP Rocky Mountain LLC #96850

Location ID: 335159

Inspection Doc: 719201113

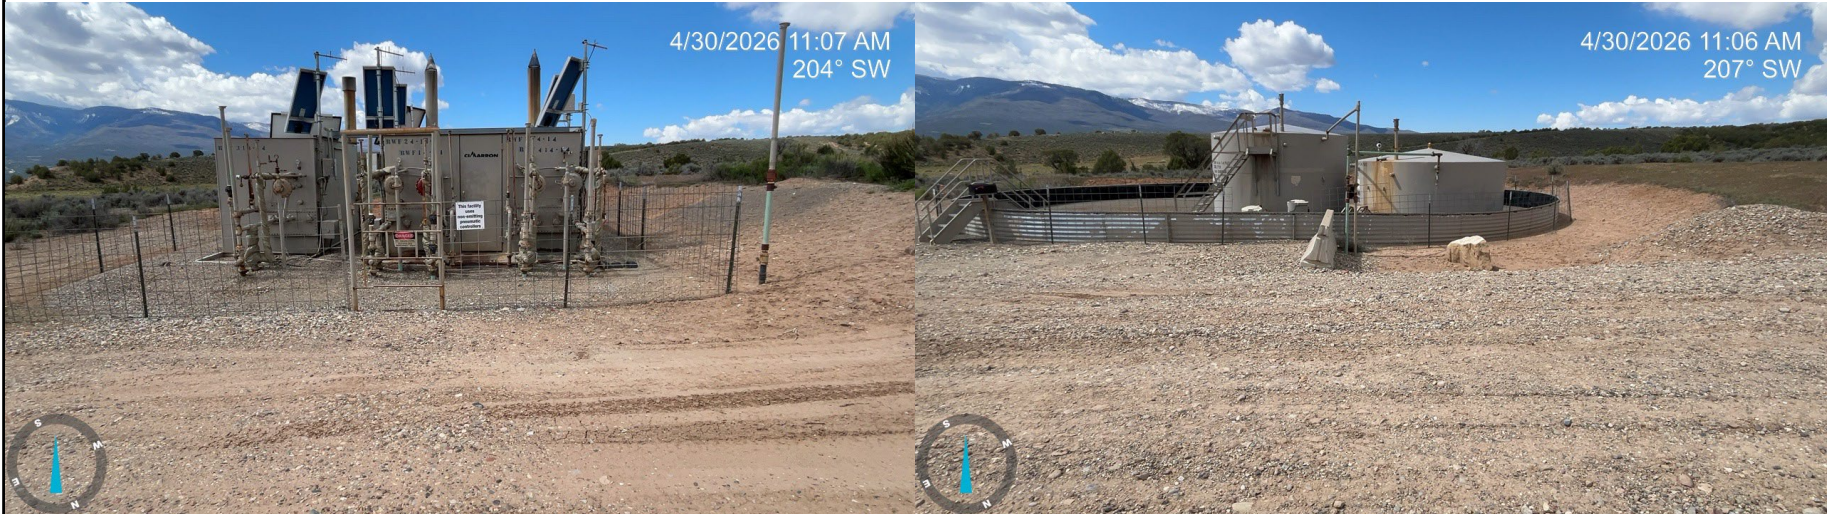
Photo 1: This is a two-tier location. Photos showing an overview of separator and tank equipment at the location.

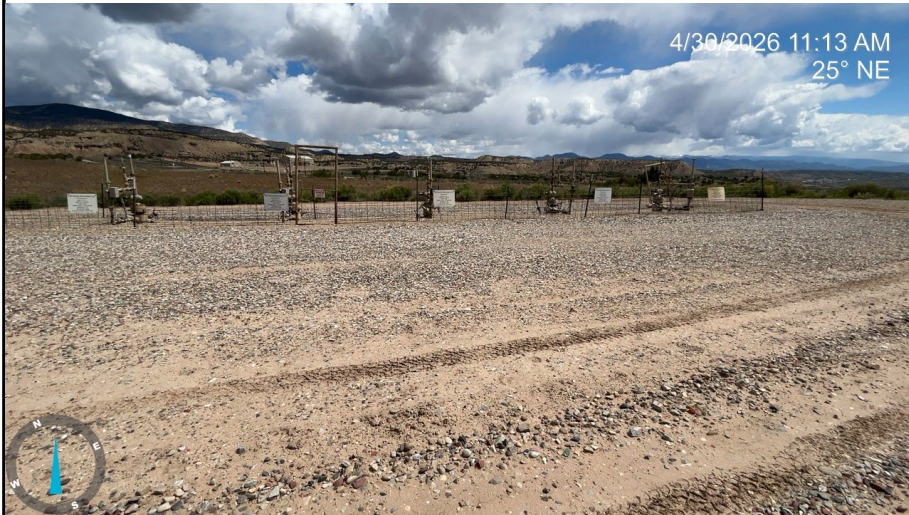
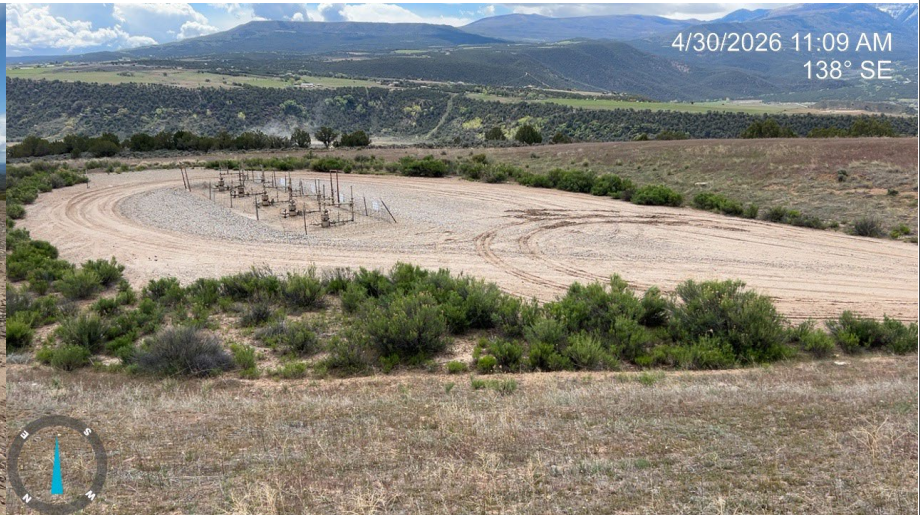
Photo 2: This is a two-tier location. Photos showing an overview of the wellhead area.

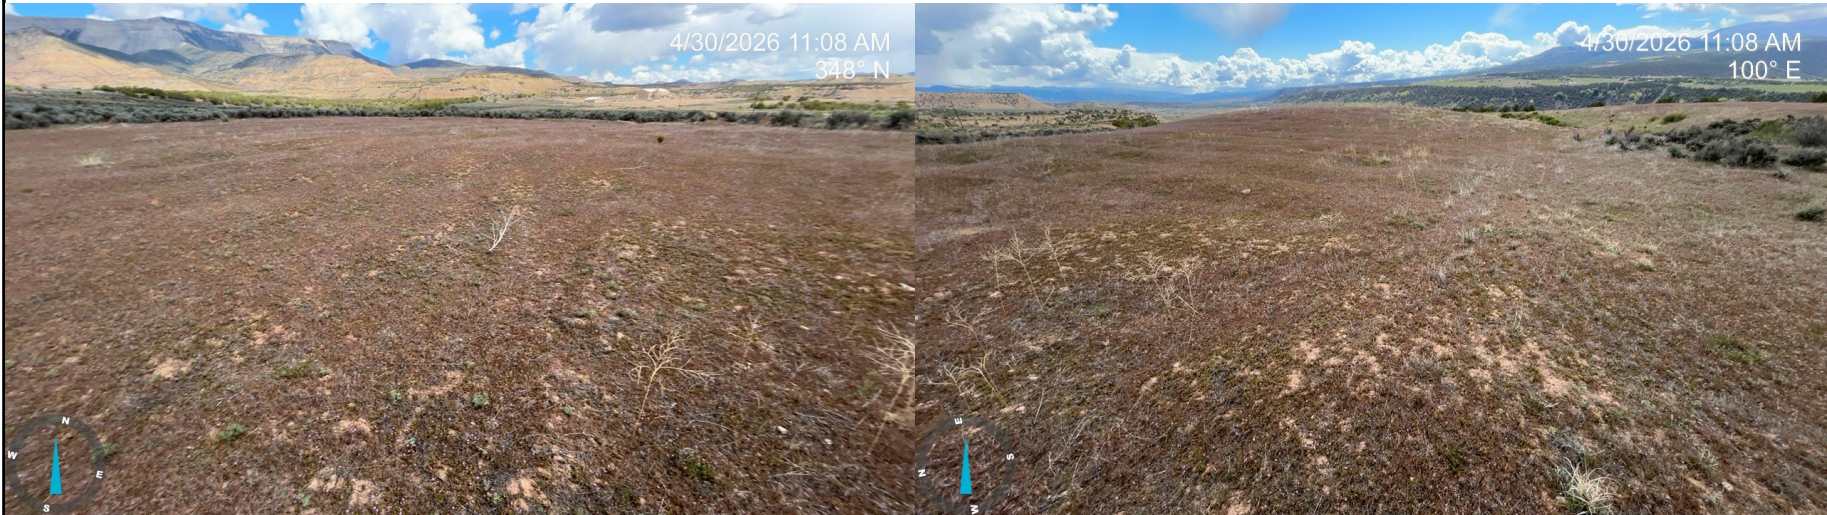
Photo 3: Photos showing an overview of the northern interim area. The interim areas are overtaken by cheatgrass, a List C noxious weed, and weedy annual mustards. Little to no desirable vegetation is present. Additional reclamation efforts are required to establish desirable, perennial and uniform vegetation of at least eighty (80) percent cover of the nearby reference area.

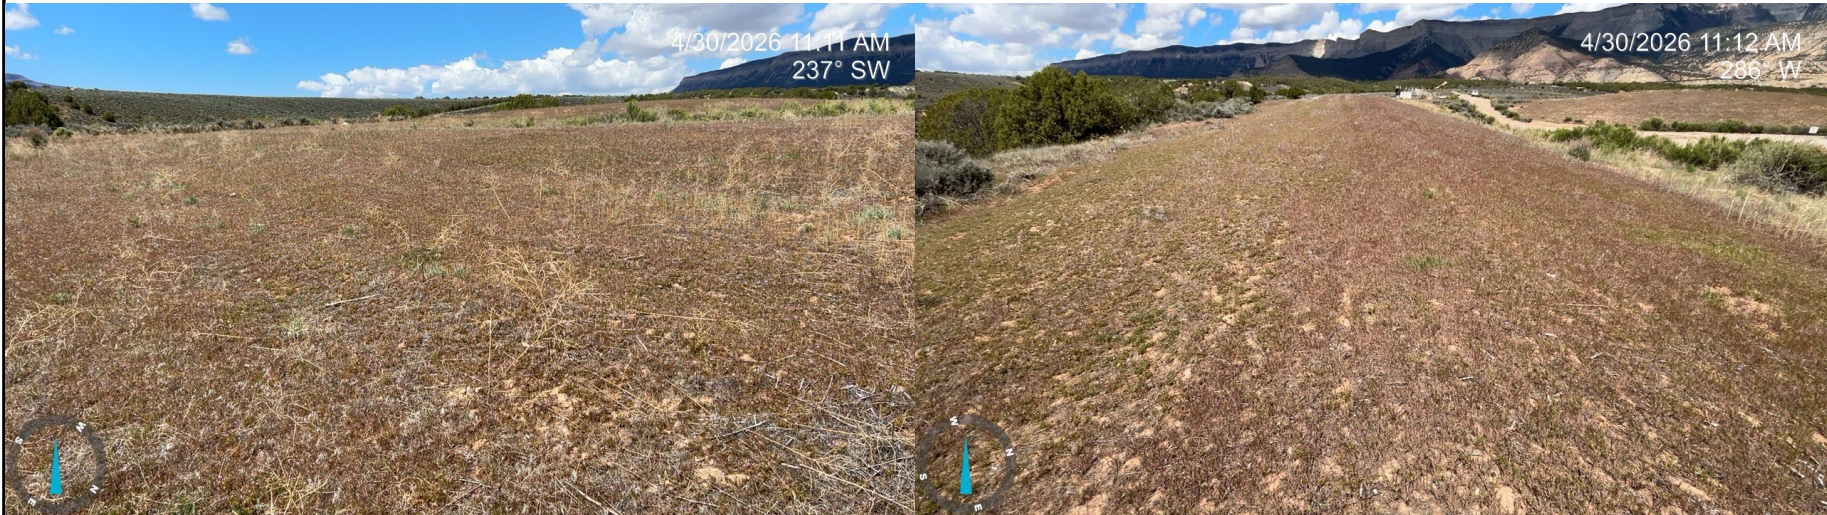
Photo 4: Photos showing an overview of the southern interim area. The interim areas are overtaken by cheatgrass, a List C noxious weed, and weedy annual mustards. Little to no desirable vegetation is present. Additional reclamation efforts are required to establish desirable, perennial and uniform vegetation of at least eighty (80) percent cover of the nearby reference area.

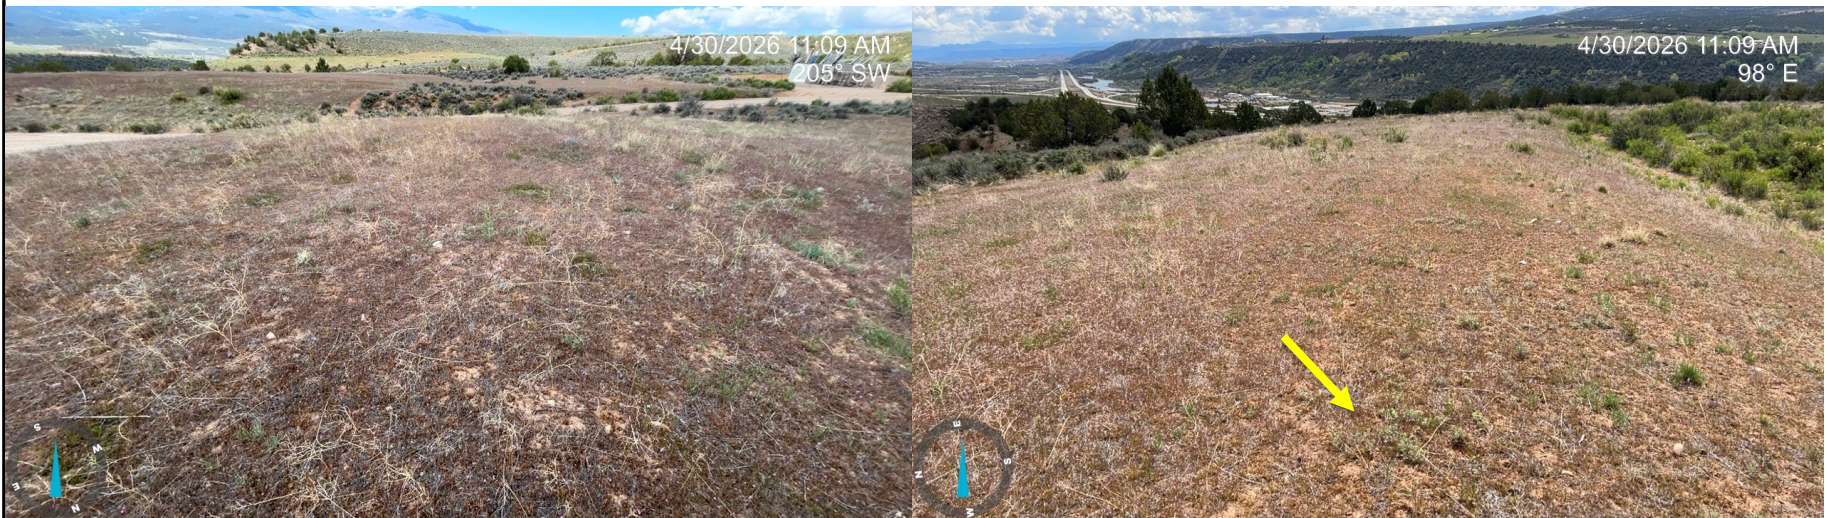
Photo 5: Photos showing an overview of the southern interim area. The interim areas are overtaken by cheatgrass, a List C noxious weed, and weedy annual mustards. The yellow arrow points to scarlet globemallow (a desirable perennial forb) individuals that are scattered throughout. Additional reclamation efforts are required to establish desirable, perennial and uniform vegetation of at least eighty (80) percent cover of the nearby reference area.

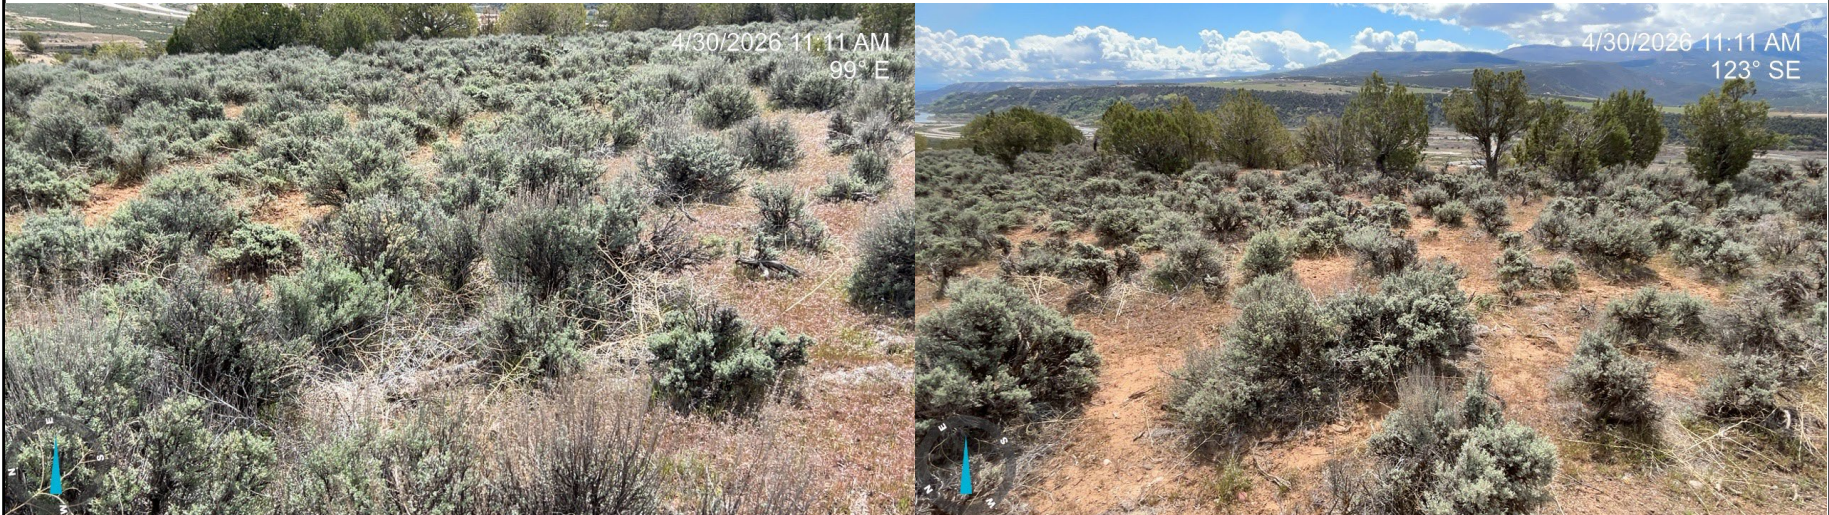
Photo 6: Photos showing the nearby reference area, directly east of the location. Cheatgrass is present in the understory; however, the area is a big sagebrush flat, with secondary to tertiary amounts of pinyon and juniper trees.

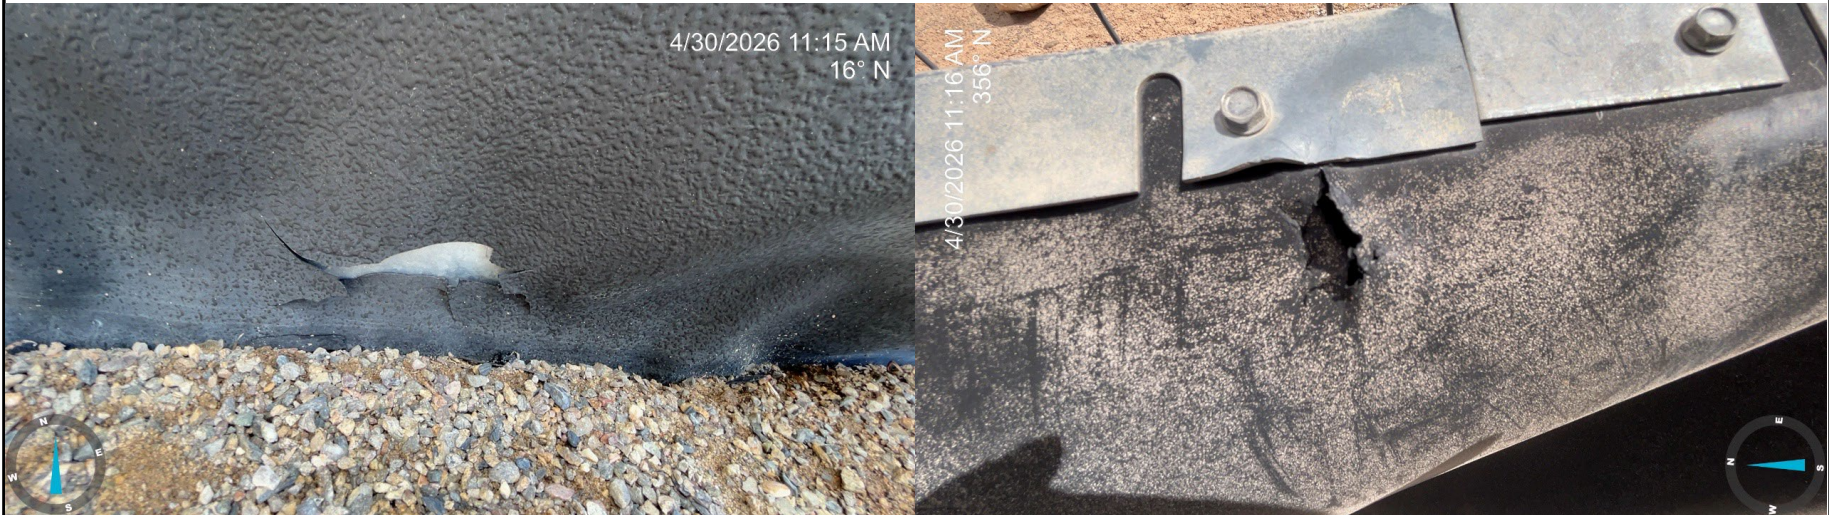
Photo 7: Photos showing holes in the black geotextile liner of the secondary containment system. Maintenance is required; comply with Rule 603.o.
