Inspection Photos

Operator: TEP Rocky Mountain LLC #96850

Location ID: 335202

Inspection Doc: 719201127

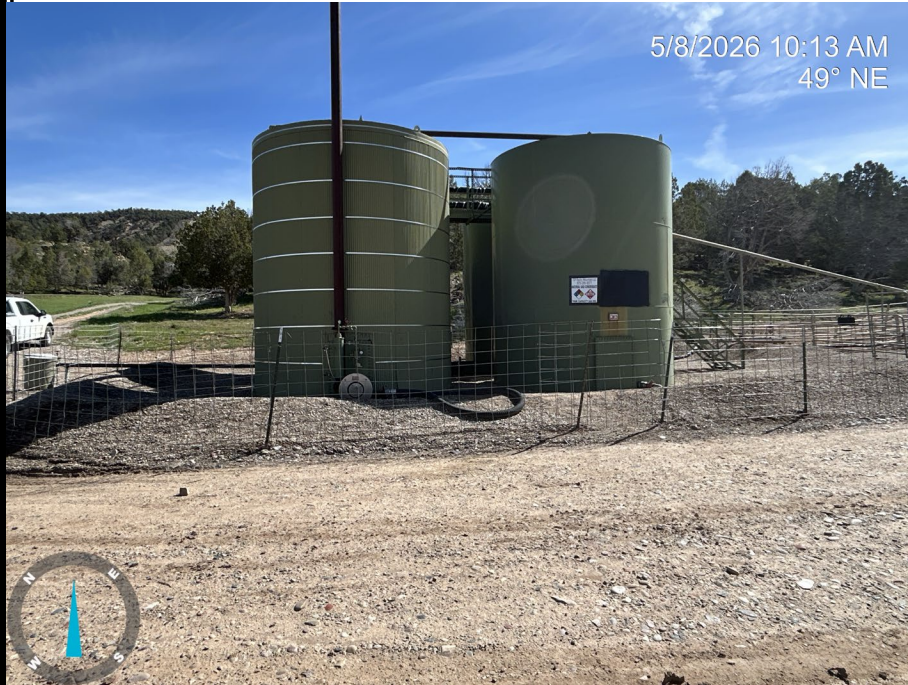
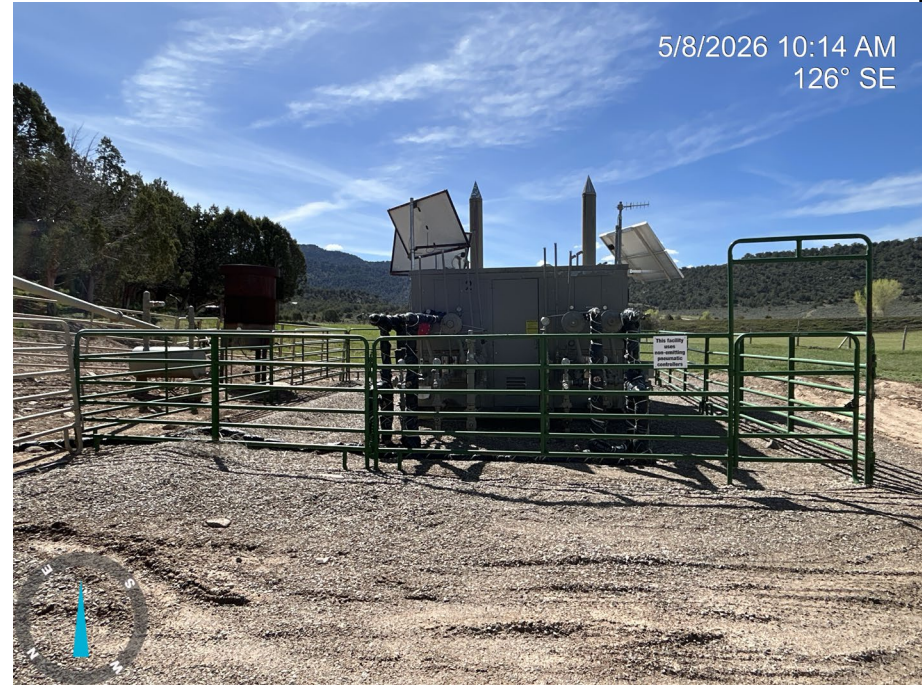
Photo 1: This is a two-tiered location. Photos showing tank and separator equipment.

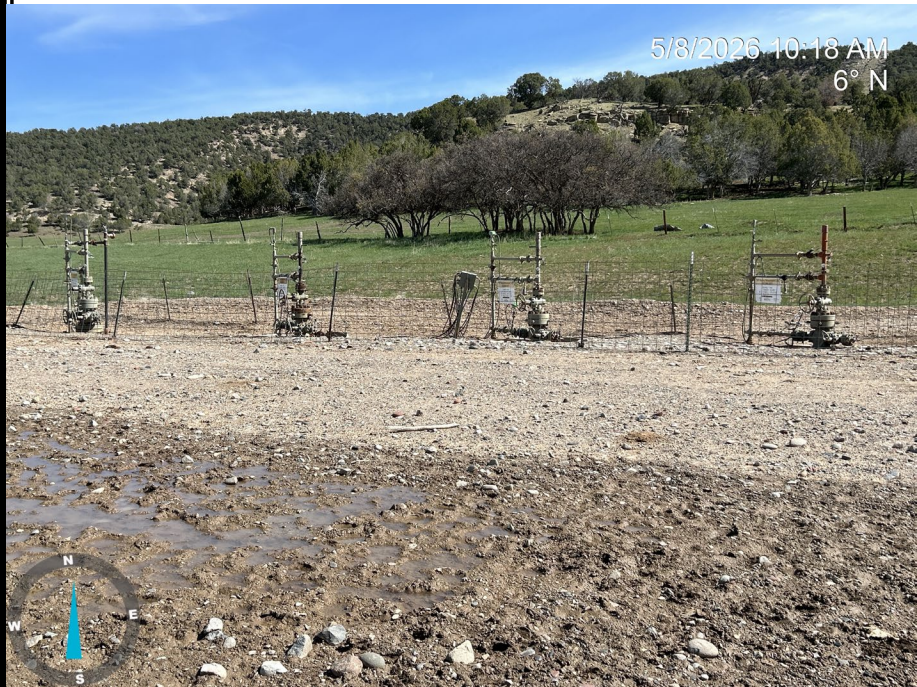
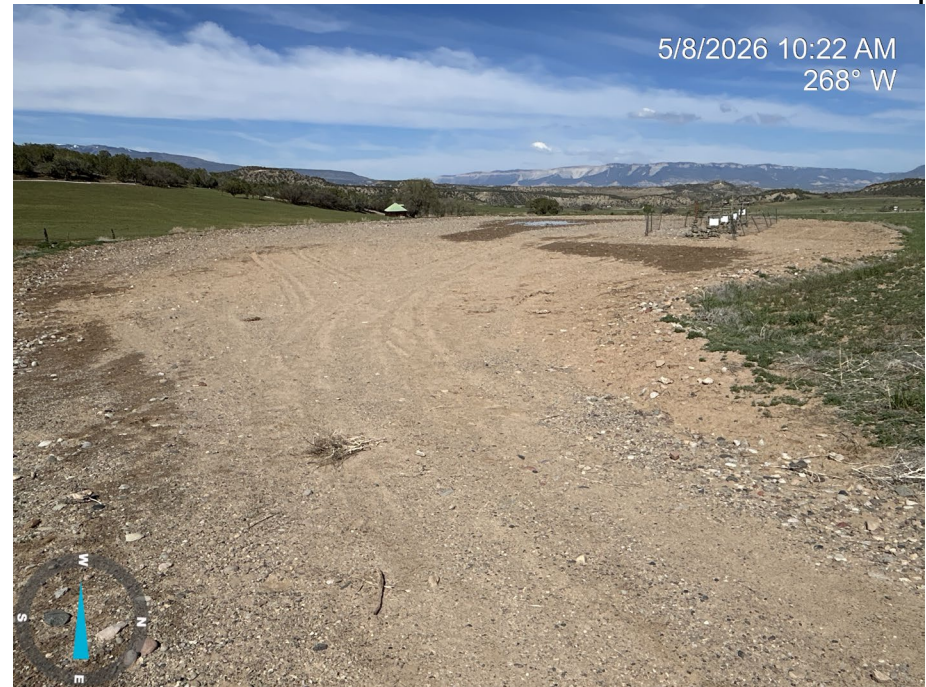
Photo 2: This is a two-tiered location. Photos showing the wellhead area.

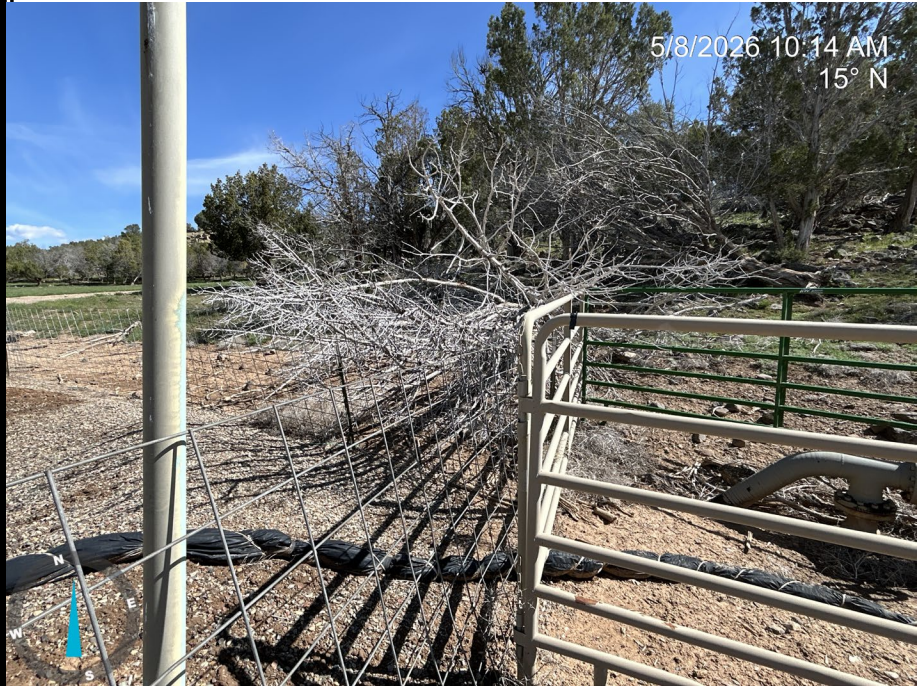
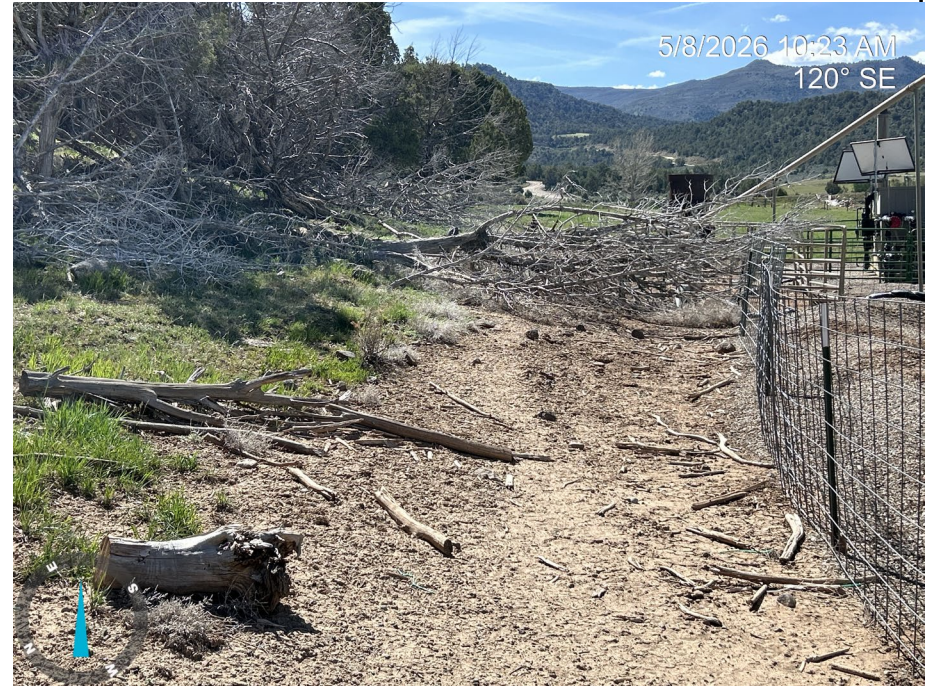
Photo 3: A tree has fallen and is partially lying on the fence directly behind production equipment; removal is required.

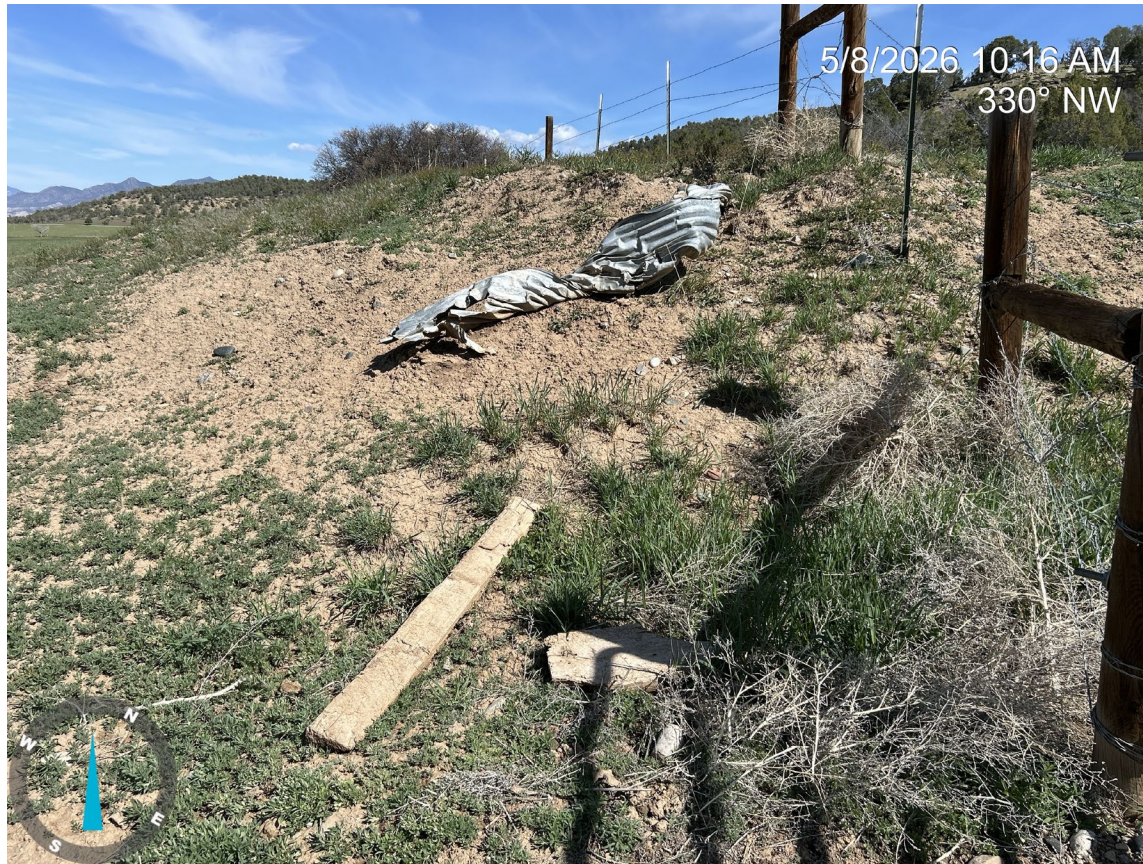
Photo 4: Photo showing debris/trash near the gate leading to the wellhead area that requires removal.

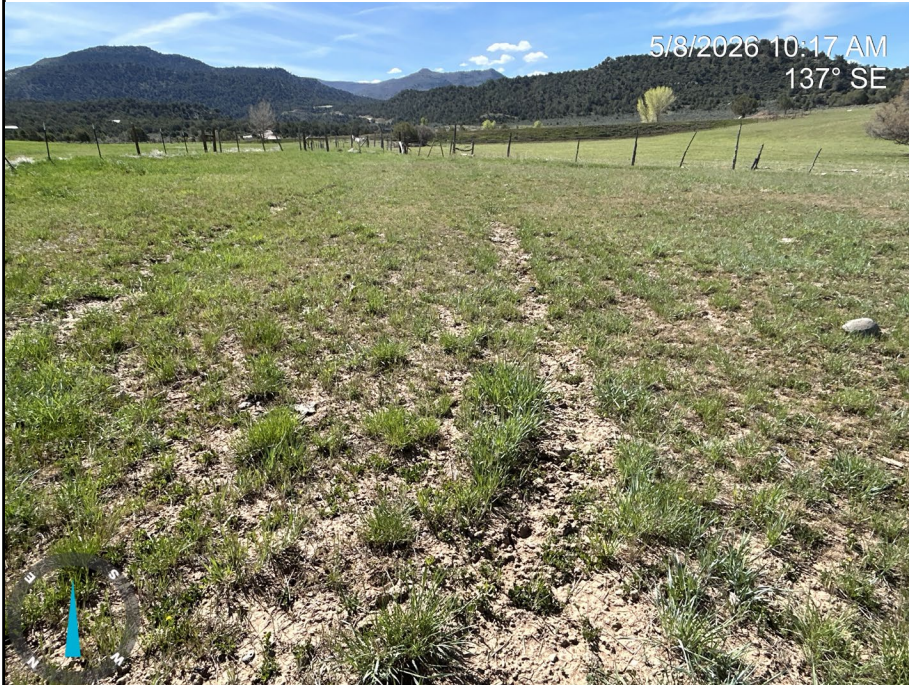
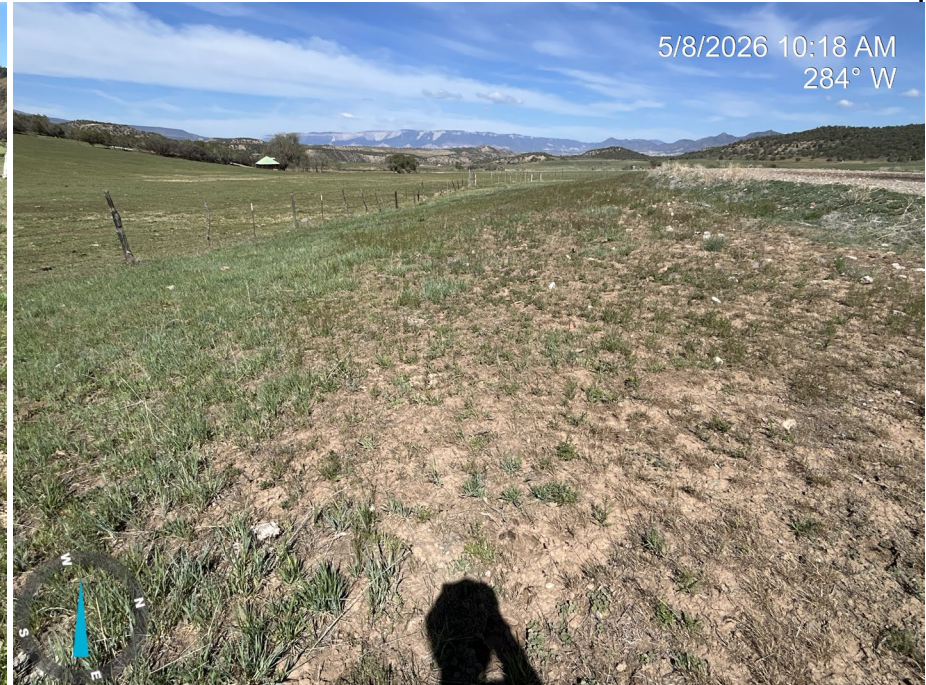
Photo 5: Photos showing the southern and western interim areas, respectively. Interim areas are composed of smooth brome, western wheatgrass and other mixed pasture grasses.

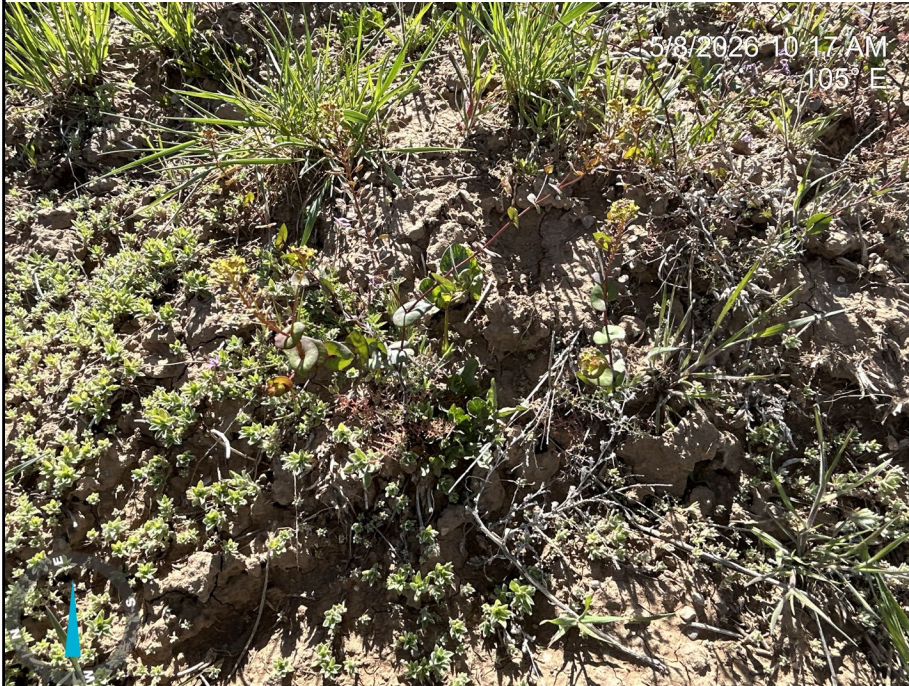
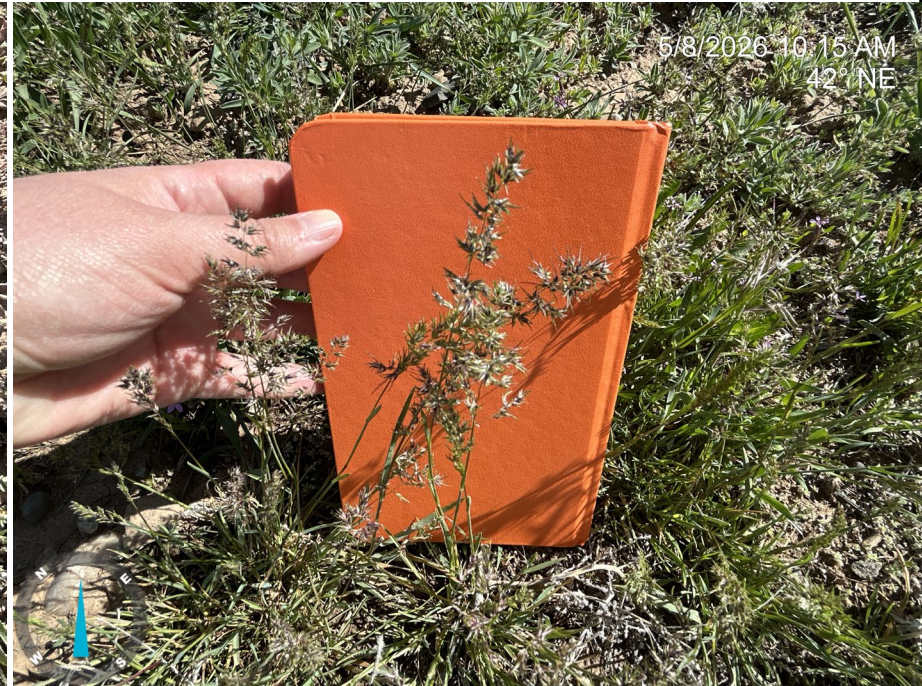
Photo 6: Photos showing an example of claspings pepperweed and bulbous bluegrass, an undesirable plant species and List C noxious weed, that are present throughout the interim areas.

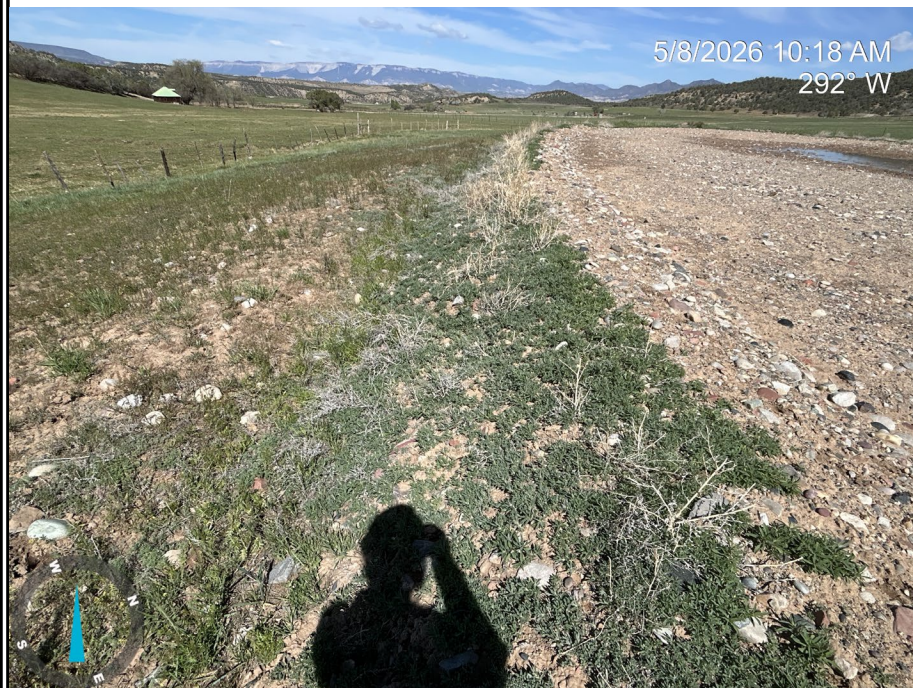
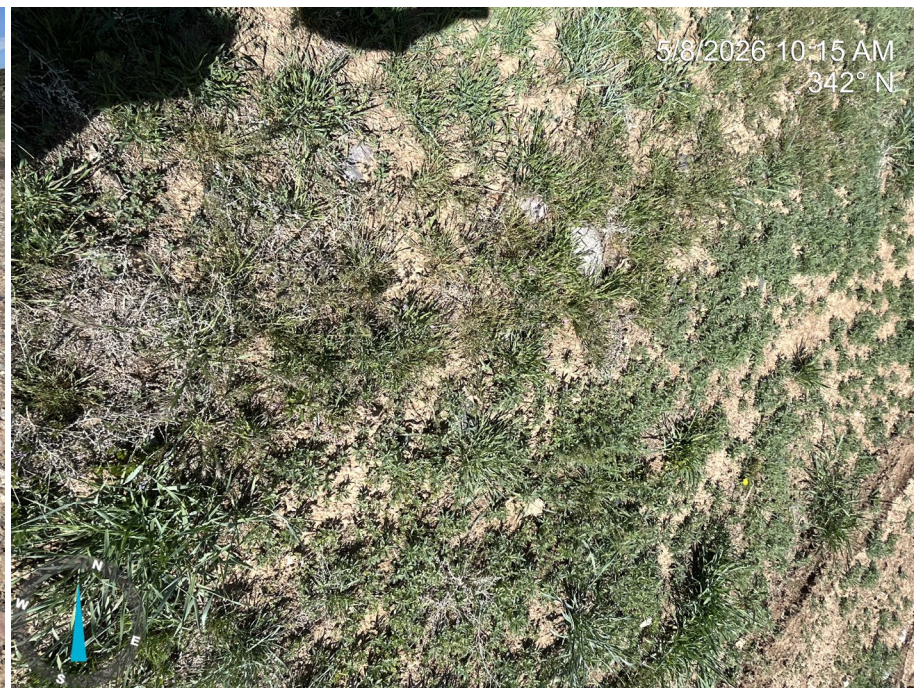
Photo 7: Photos showing an example of kochia and prickly Russian thistle present along the edges of the pad and an example of plant composition at the location, respectively. Bulbous bluegrass, cheatgrass, kochia, and redstem fillaree is present throughout the interim areas.

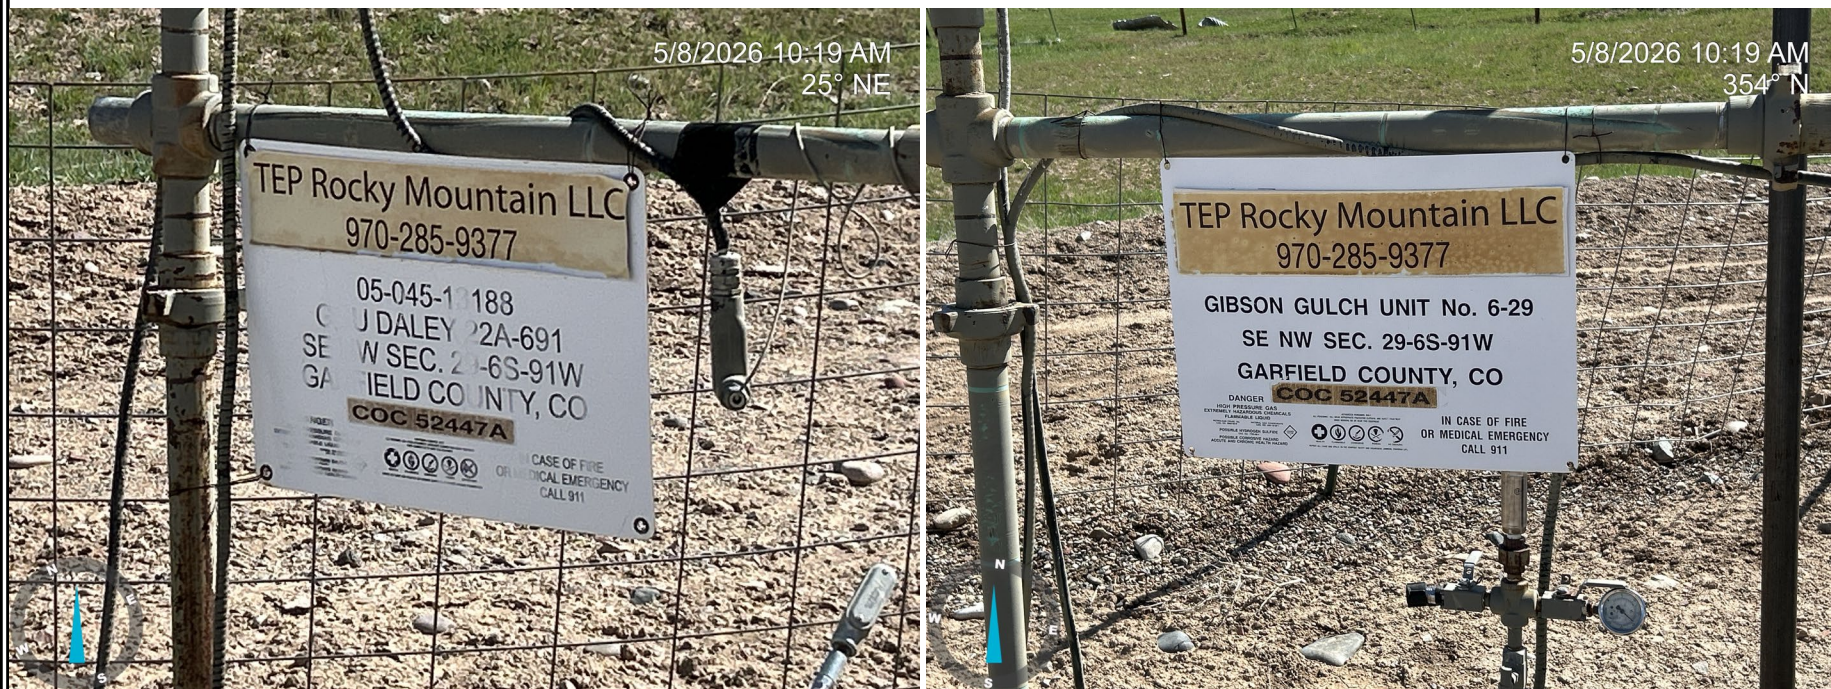
Photo 8: Photos showing an API # that is missing a numeral (left) and a wellhead sign that does not have an API # listed. Maintenance is required.

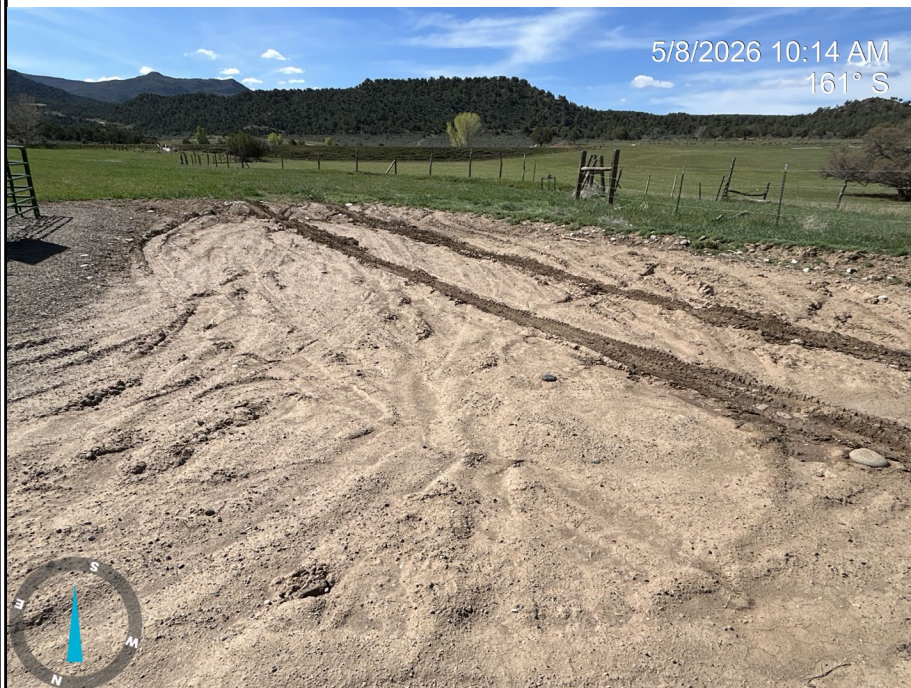
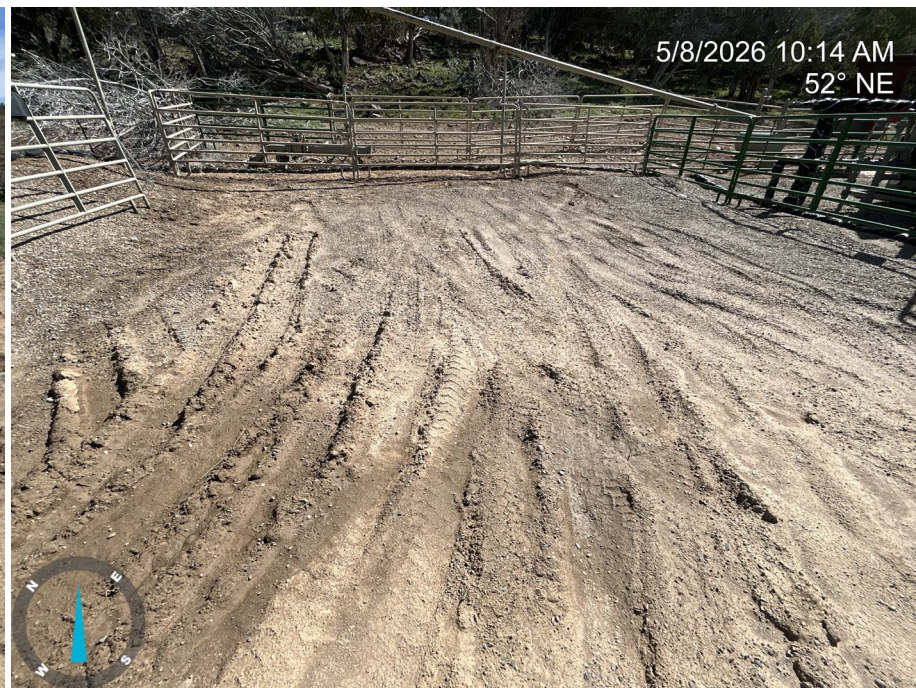
Photo 9: Vehicle tracking and rutting is present near the production equipment area. Maintenance is required pursuant to Rule 1002.f.
