**Inspection Photos**  
**Location Name: Simcoe Craig #2**  
**Location ID: API 05-067-08342**

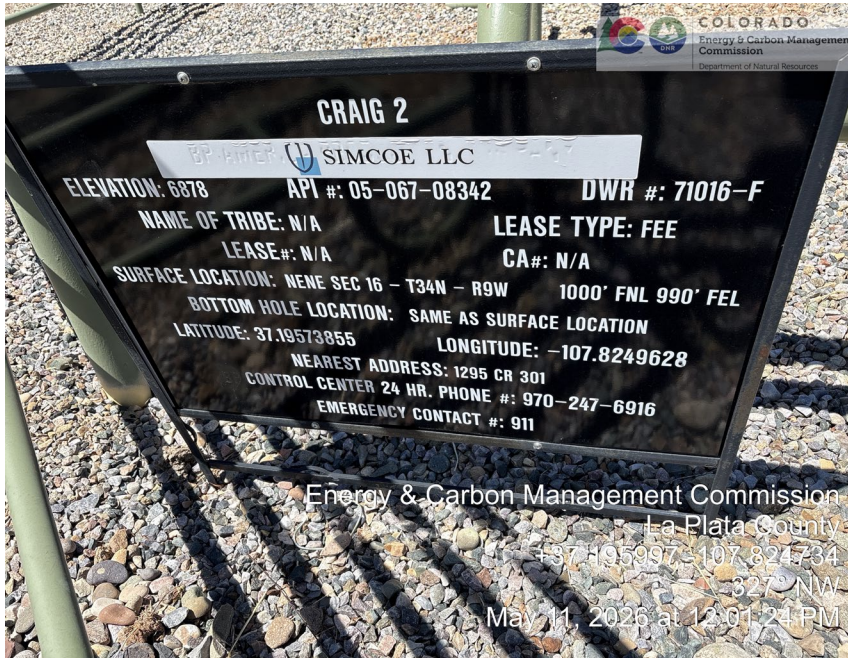
**1. Well sign inside cattle panel fence by pad entrance by production equipment.**

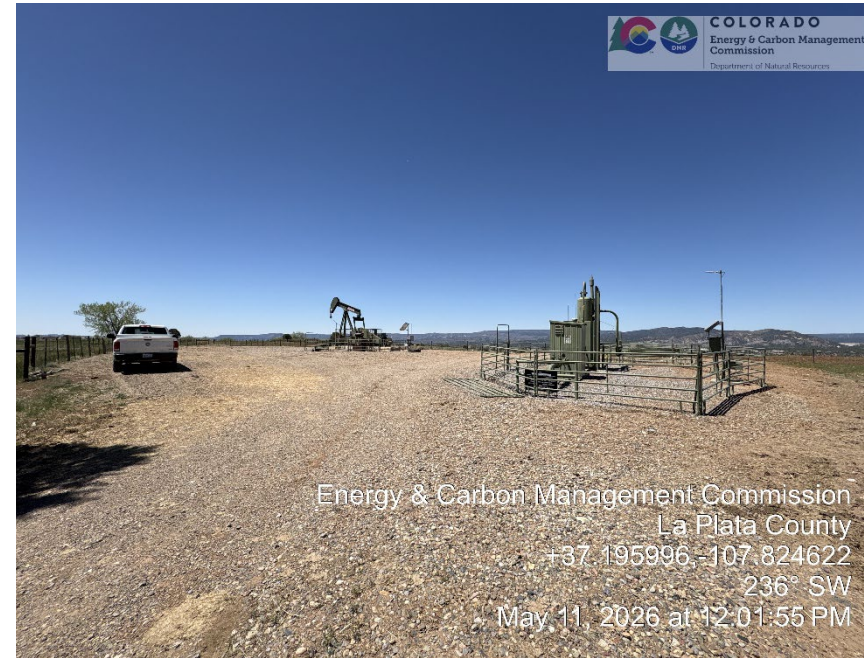
**2. Well location and pad overview from pad entrance. Sign is visible on left side.**

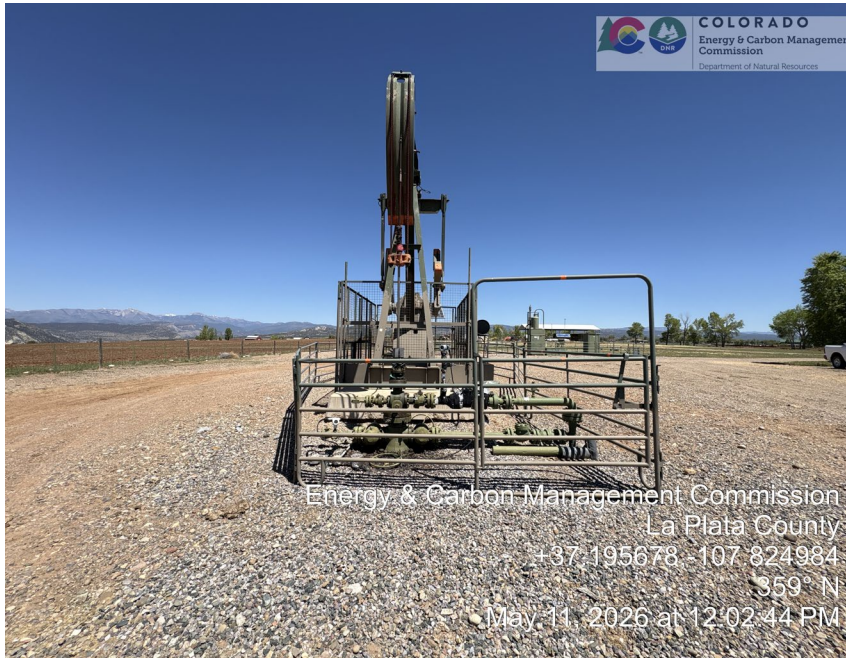
**3. Wellhead and pumpjack. There is stained gravel near the wellhead.**

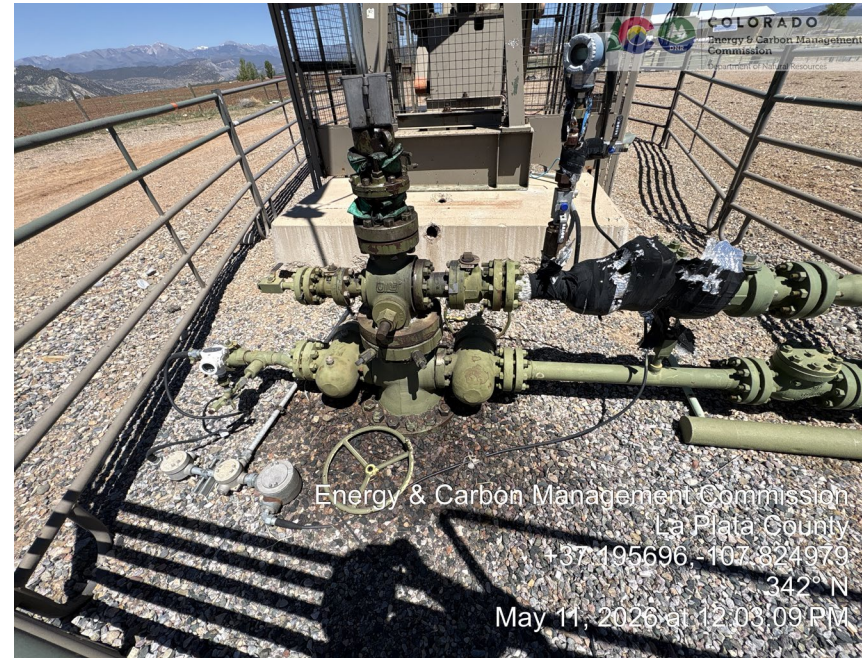
**4. Wellhead. Stained gravel surrounding wellhead appears oily. Absorbent pads wrapped around stuffing box. View looking N.**

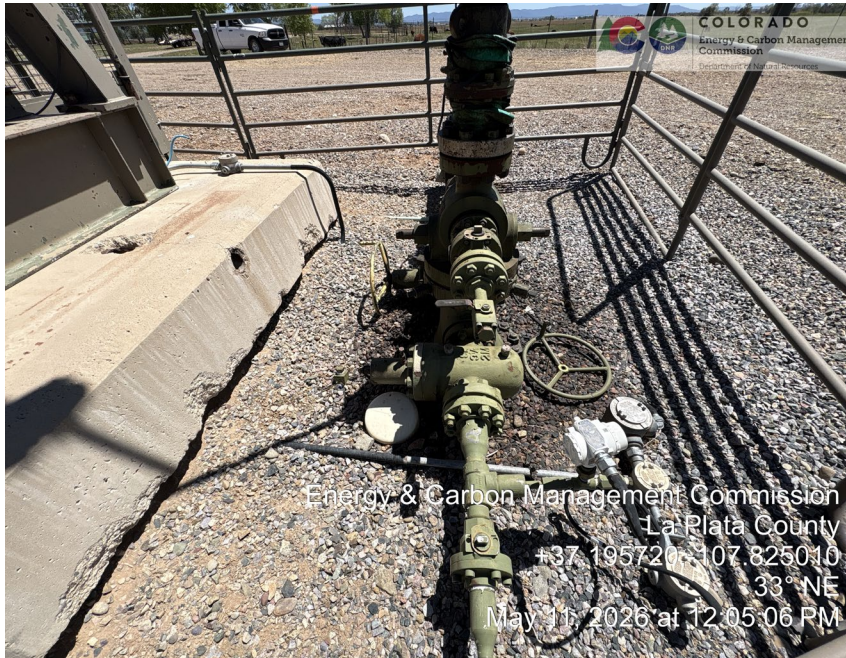
**5. Wellhead. Oil staining visible on gravel surrounding wellhead. View looking E.**

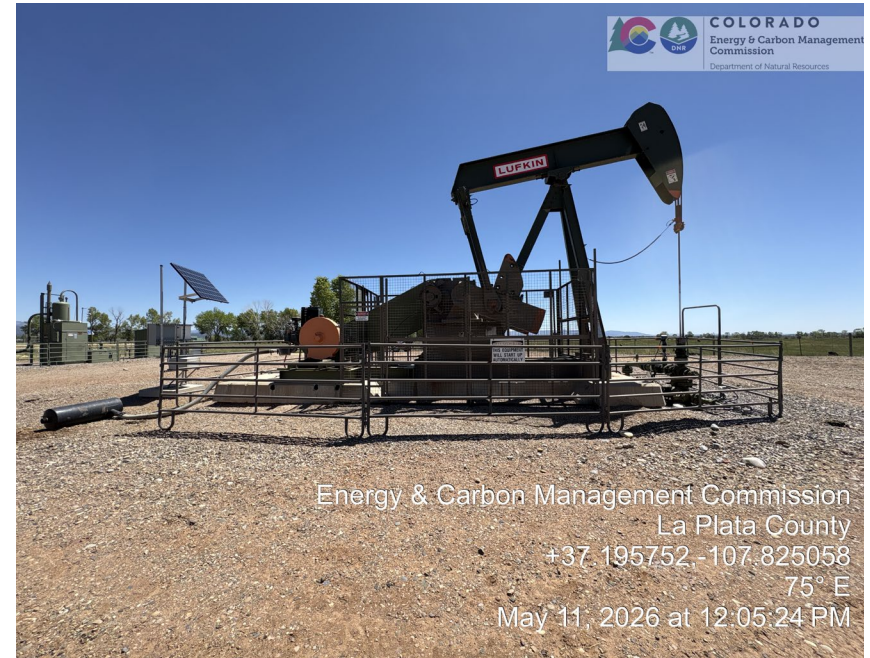
**6. Wellhead and pumpjack with gas prime mover. Was operating during inspection. Cattle panel barrier and solar telemetry.**

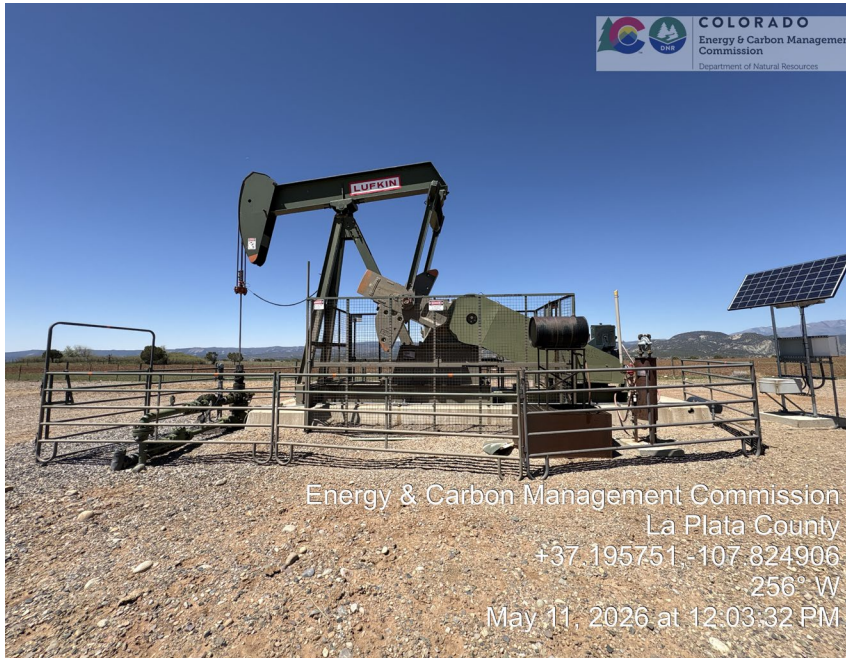
**7. Wellhead, pump jack and prime mover.**

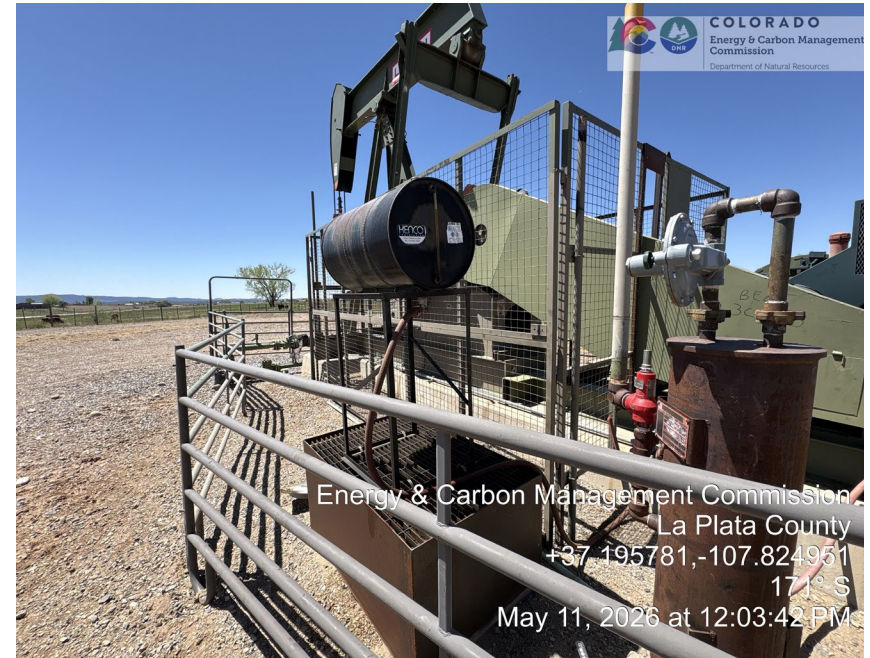
**8. Lube oil container of leak protection. Leak protection capacity is adequate. No stains observed below tank.**

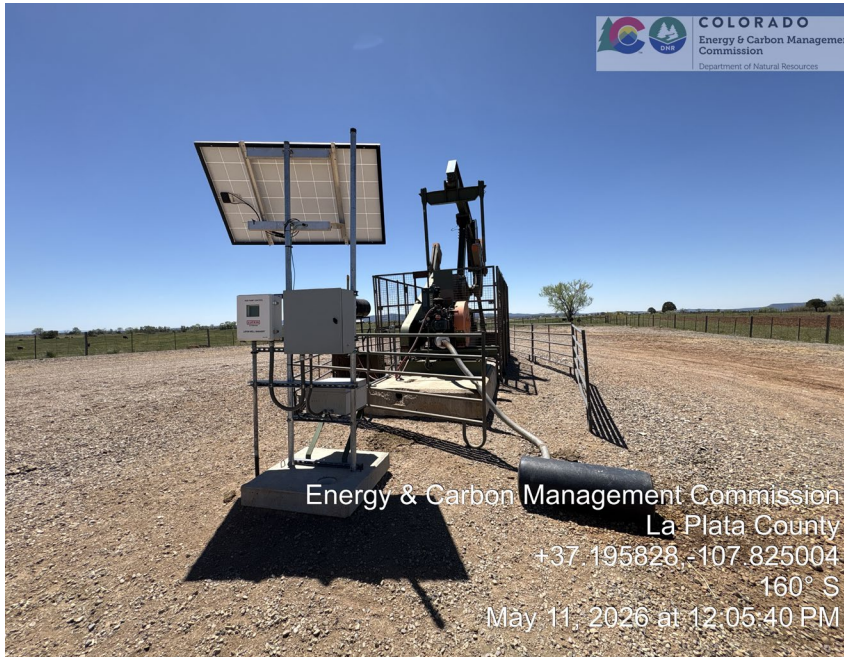
**9. Solar telemetry for well controls. Muffler for prime mover on gravel.**

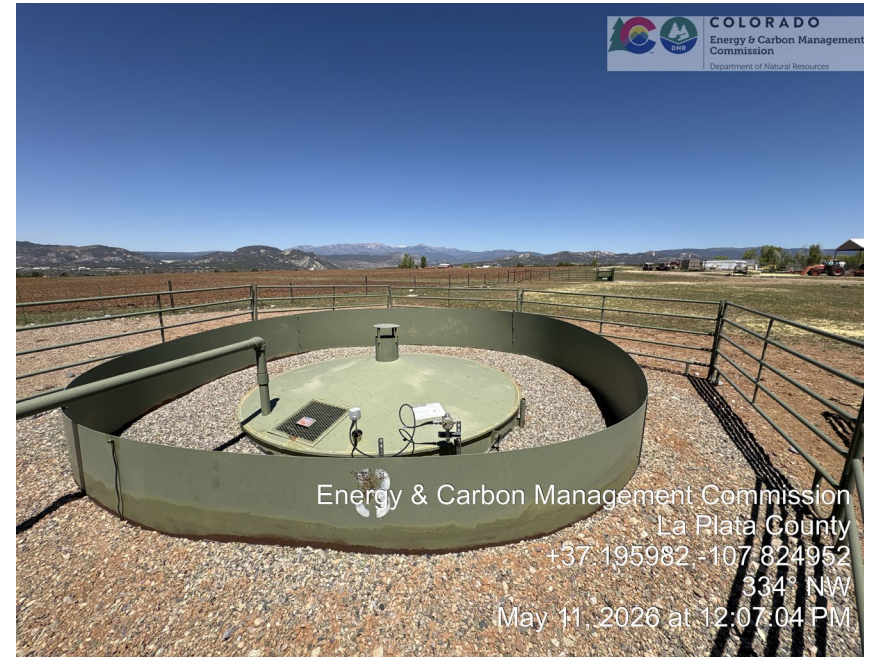
**10. Partially buried steel tank inside of containment. 95 bbl PBV, no contents, capacity or NFPA information observed. View looking NW.**

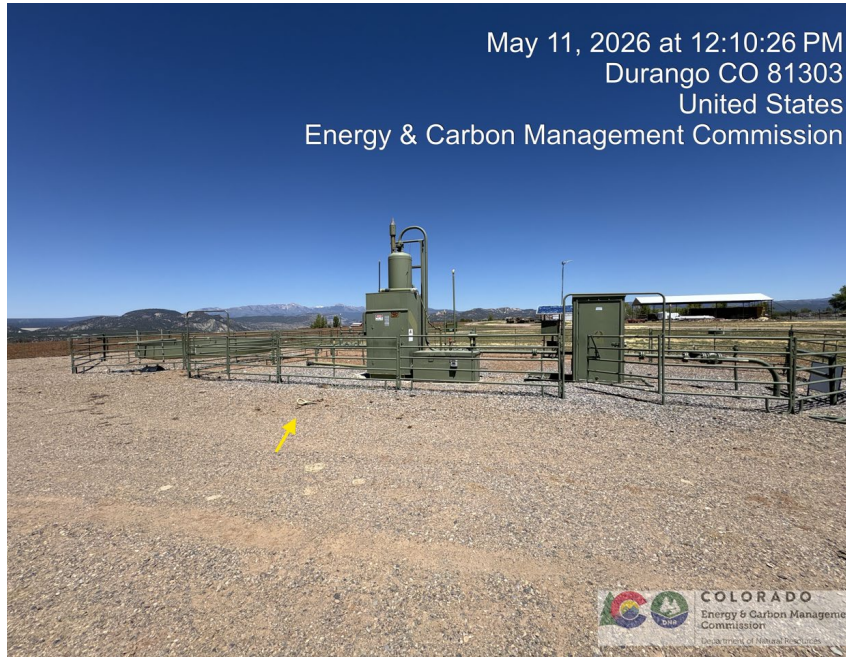
11. From left to right looking north: PBV tank, flowlines, vertical heated separator, production flowlines, meter run. Meter calibration card is inside meter run shed in plastic sleeve. Date is 7/14/25. Rig anchor lacks marker. View looking N.

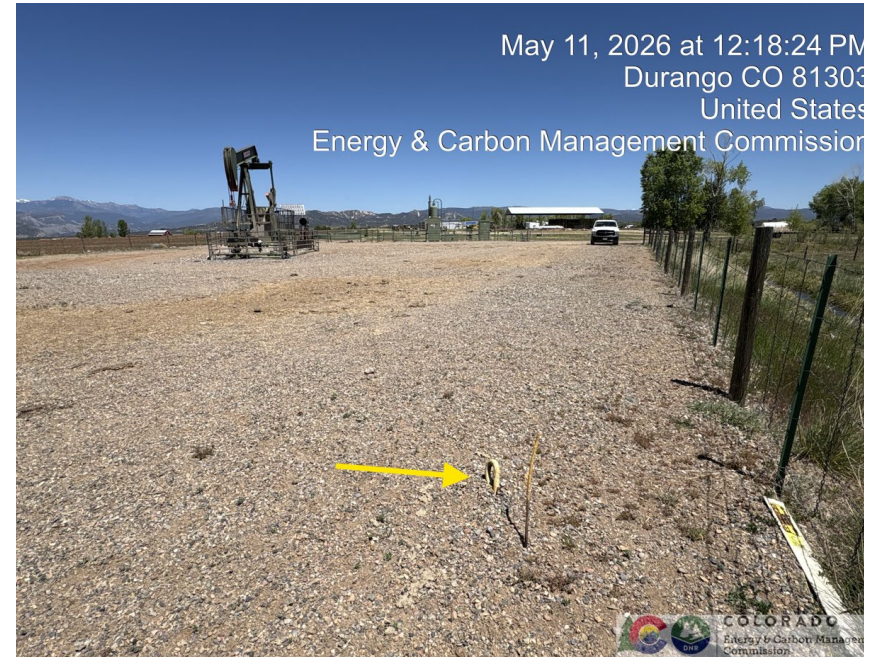
12. Pad overview. Rig anchor lacks proper marker. Only 18" cable stub. Irrigation ditch and active pasture on right of fence. View looking N along E edge of pad.

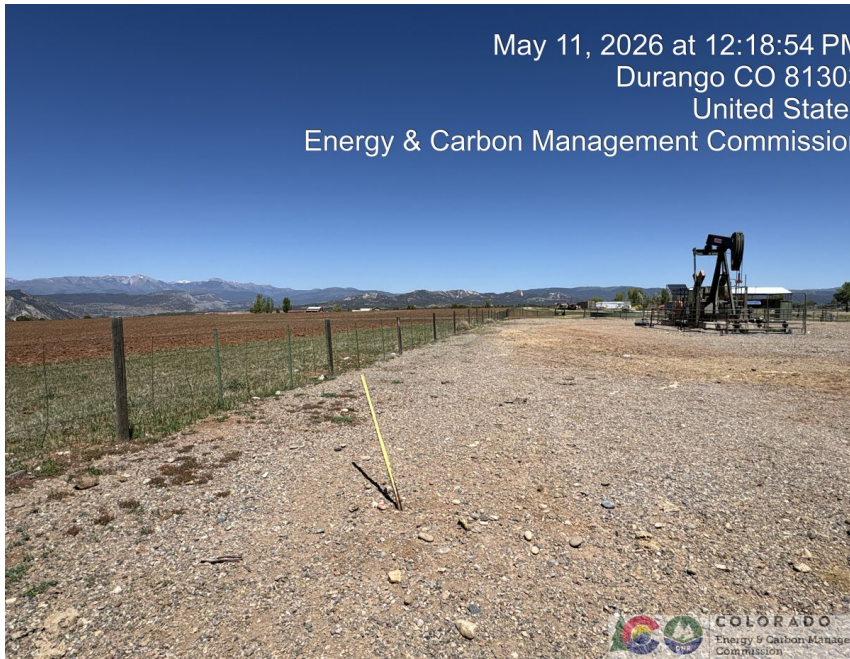
**13. Pad overview and tilled cropland outside of fence on left. Rig anchor is marked.**
