# Inspection Photos

Operator: TEP Rocky Mountain LLC #96850

Location ID: 335245

Inspection Doc: 719201131

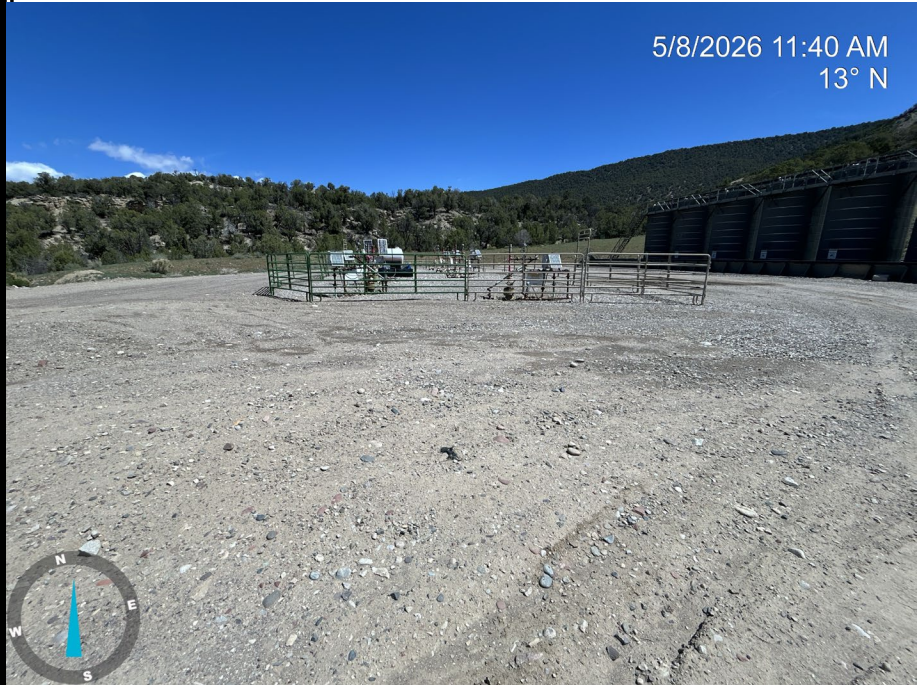
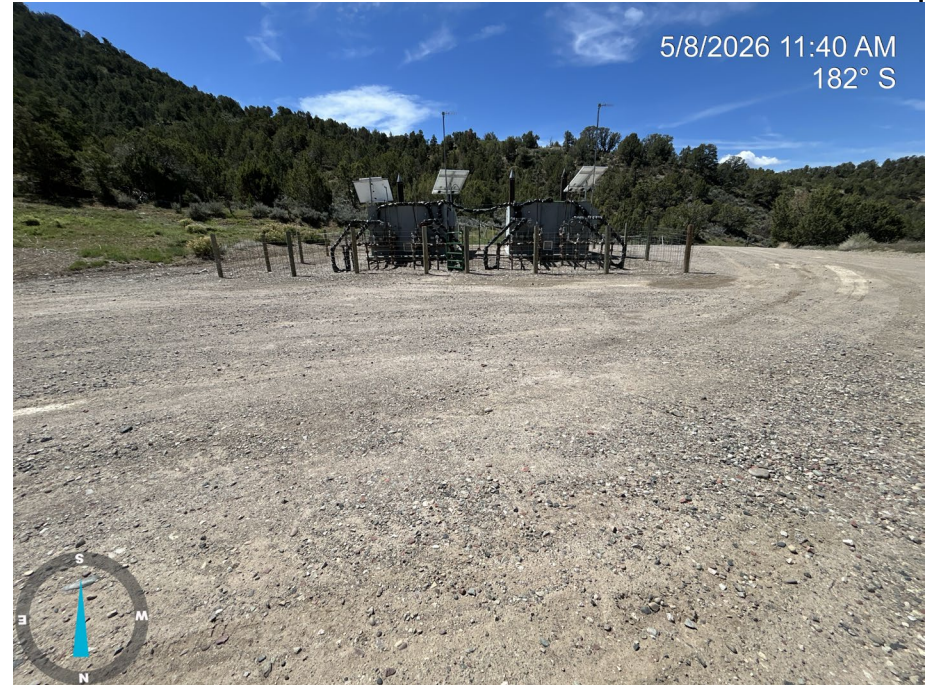
**Photo 1:** Photos showing an overview of the location looking north and south, respectively.

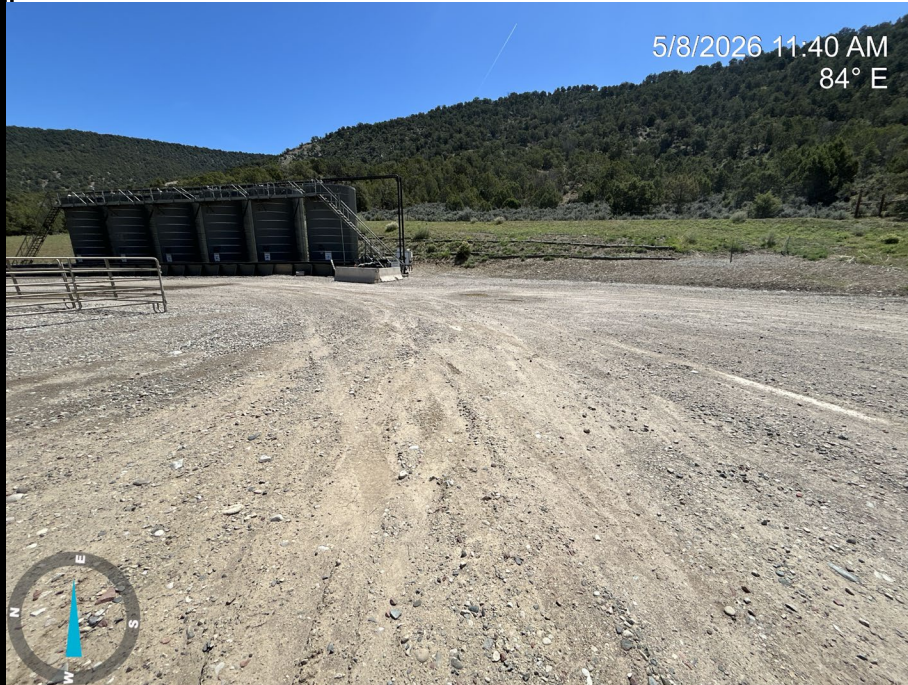
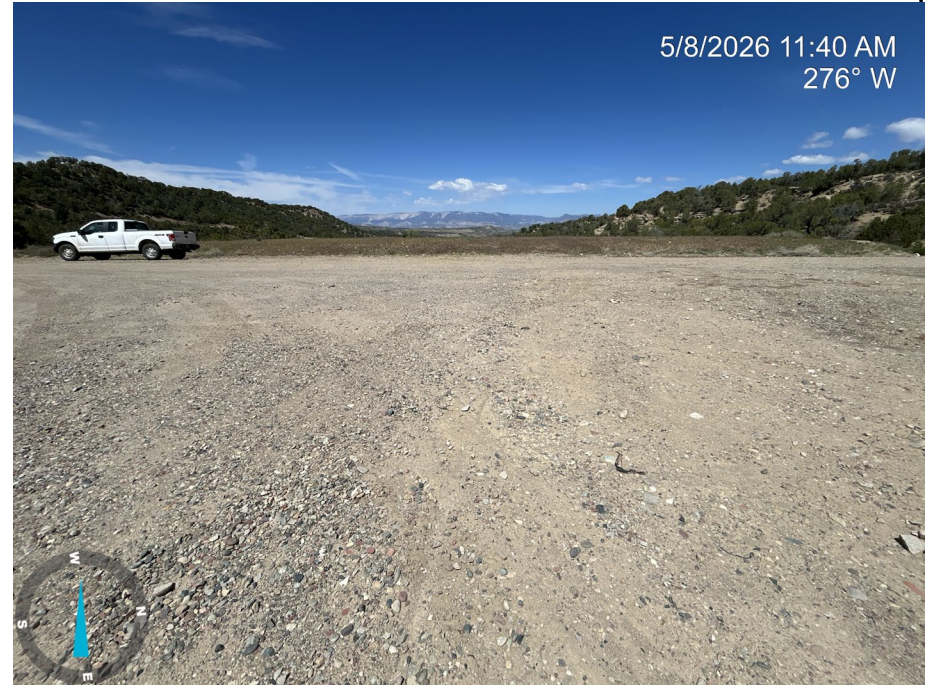
**Photo 2:** Photos showing an overview of the location looking east and west, respectively.

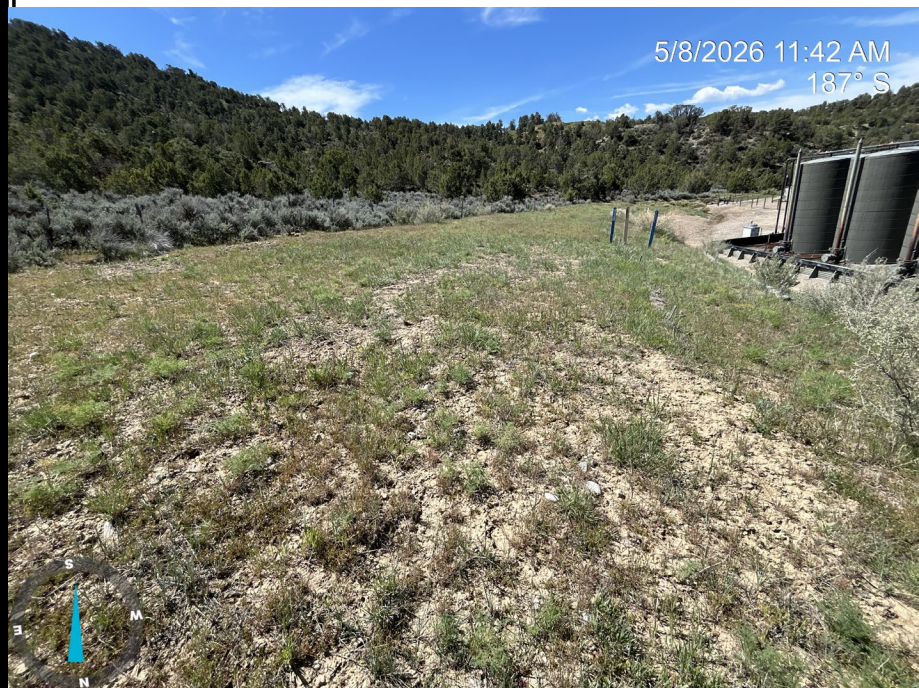
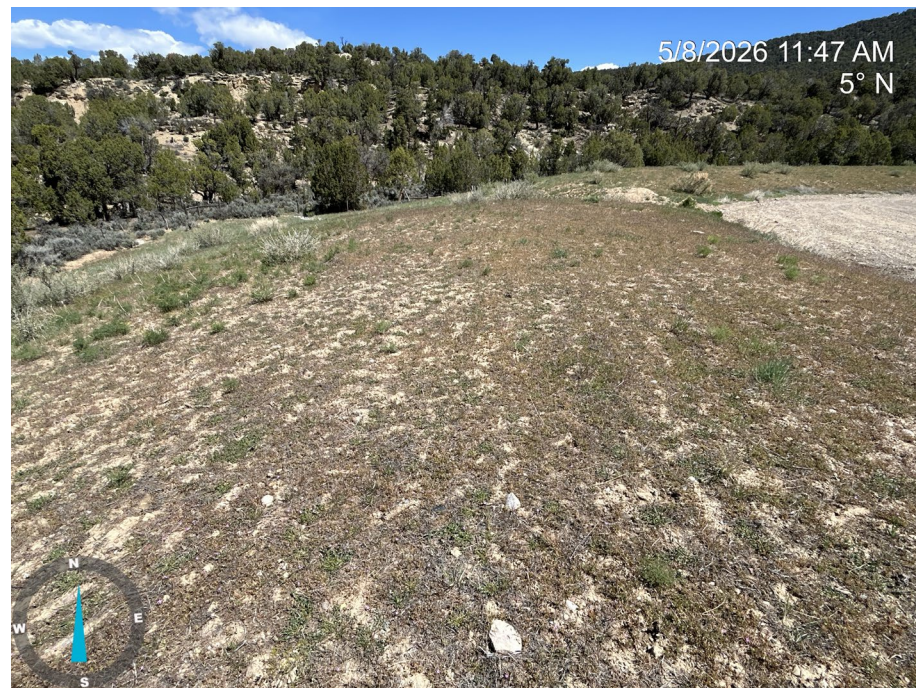
**Photo 3:** Photos showing an overview of the eastern and western interim areas, respectively. Redstem fillaree, a List C noxious weed, is dominant in some portions of the western interim area.

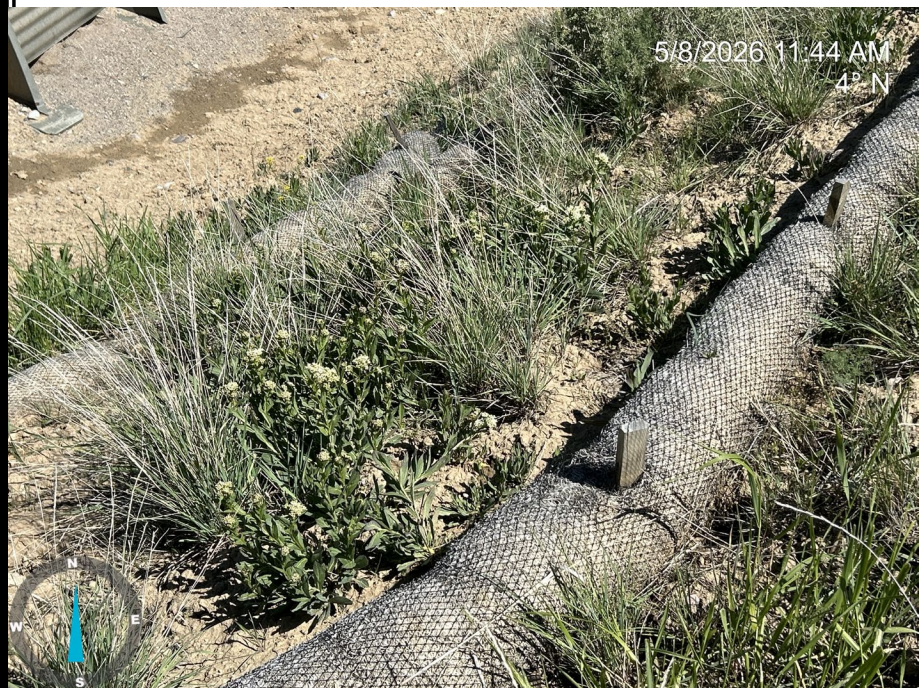
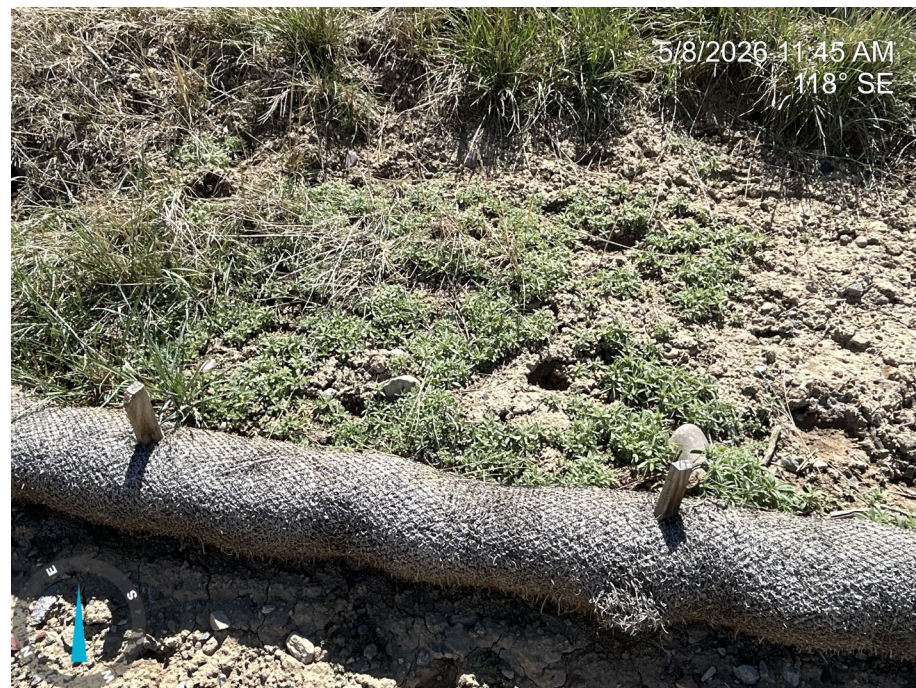
**Photo 4:** Photos showing examples of whitetop, a List B noxious weed, and kochia, an undesirable plant species, are present along wattles on the eastern cut slope. Weed management is required.

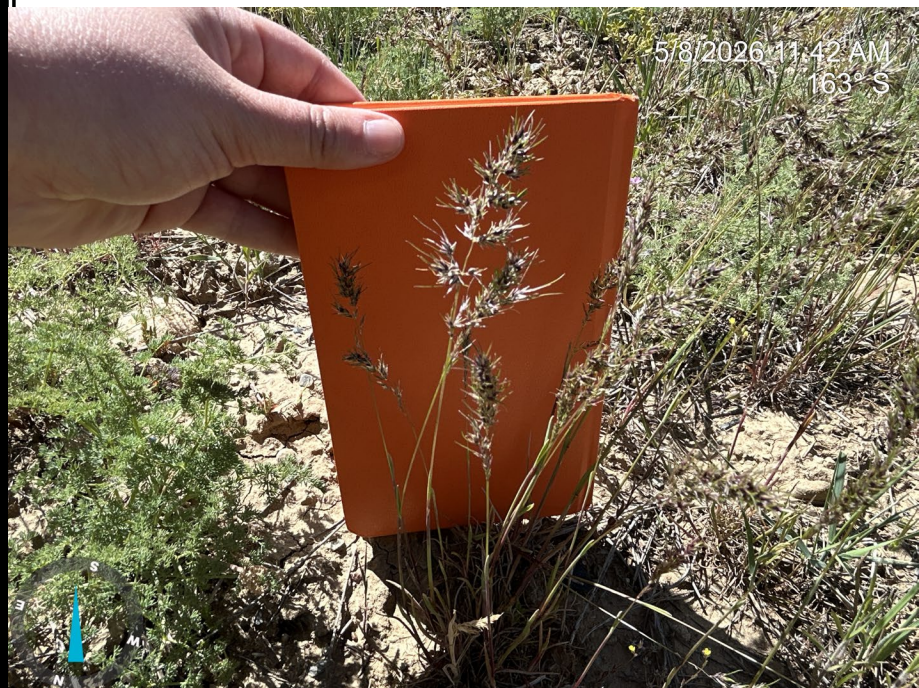
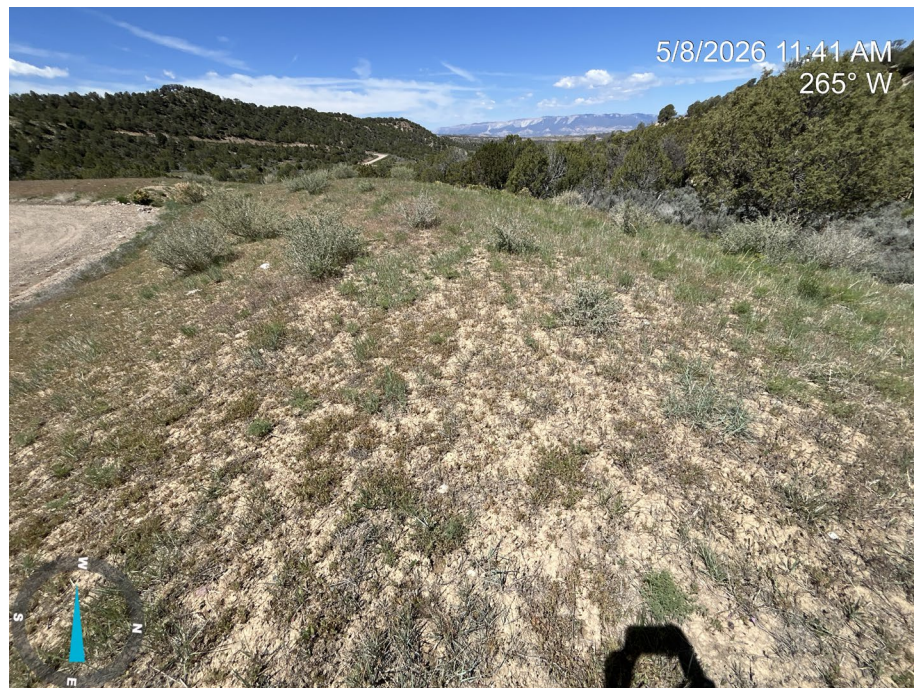
**Photo 5:** Photos showing additional examples of bulbous bluegrass and portions of the northern interim area that are dominated by noxious weeds and undesirable plant species. Weed management is required.

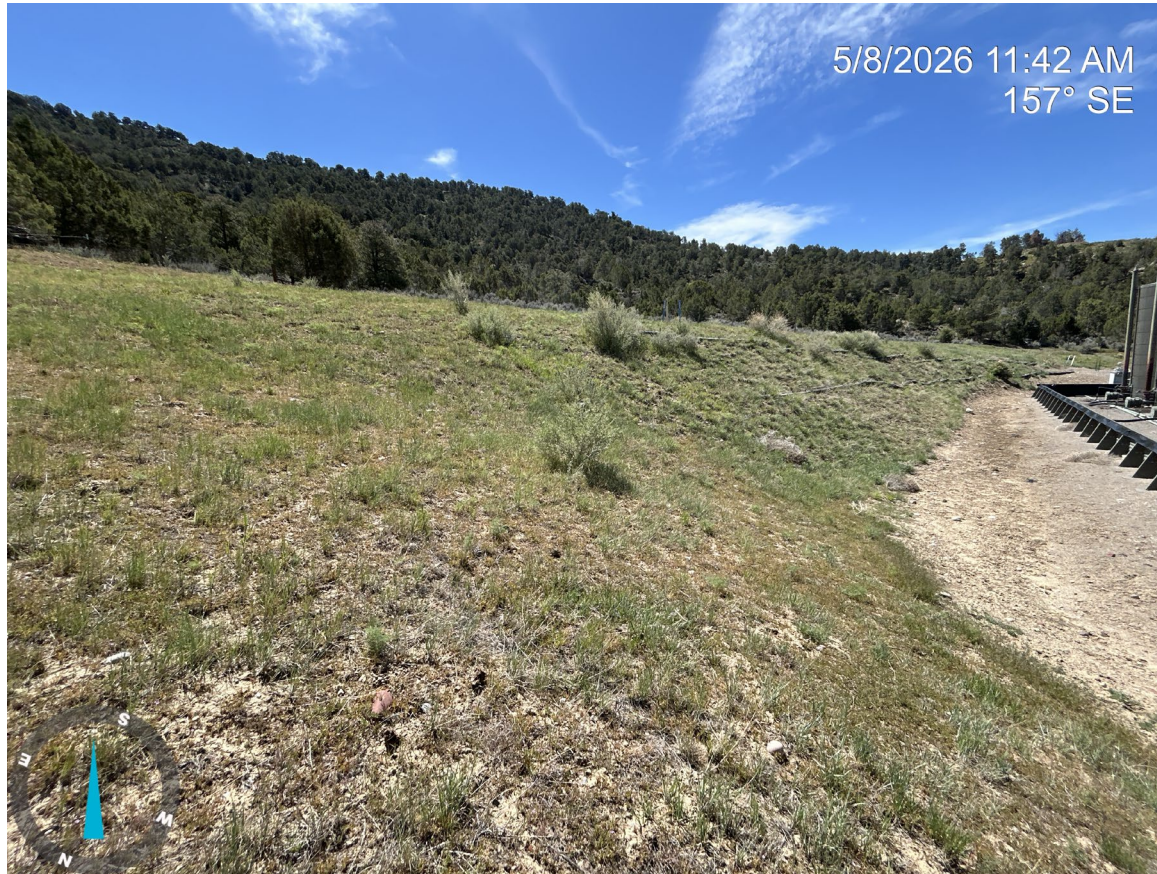
**Photo 6:** Photo showing eastern cut slopes are well vegetated. Overall, interim areas are progressing towards 1003 reclamation requirements.

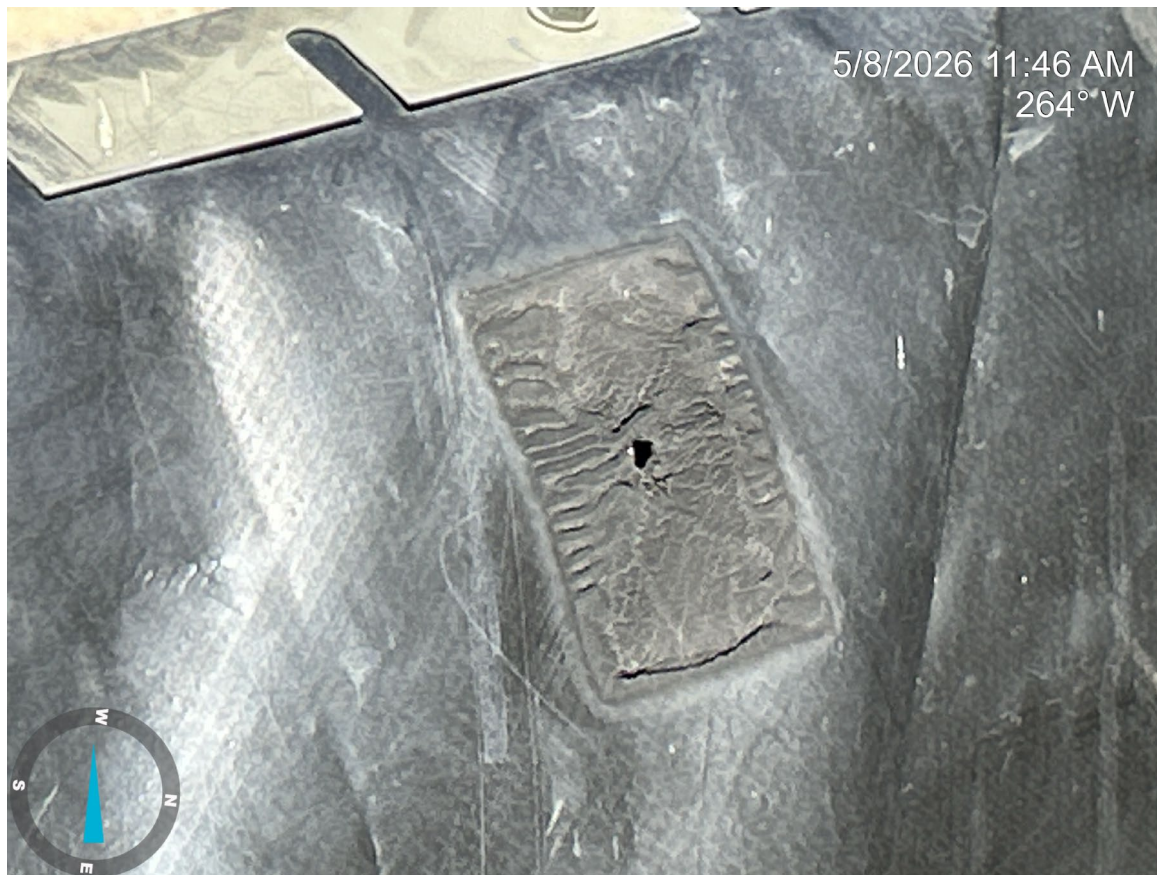
**Photo 7:** Photo showing a small hole is present in a patch at the tank's secondary containment black geotextile liner. Maintenance is required.

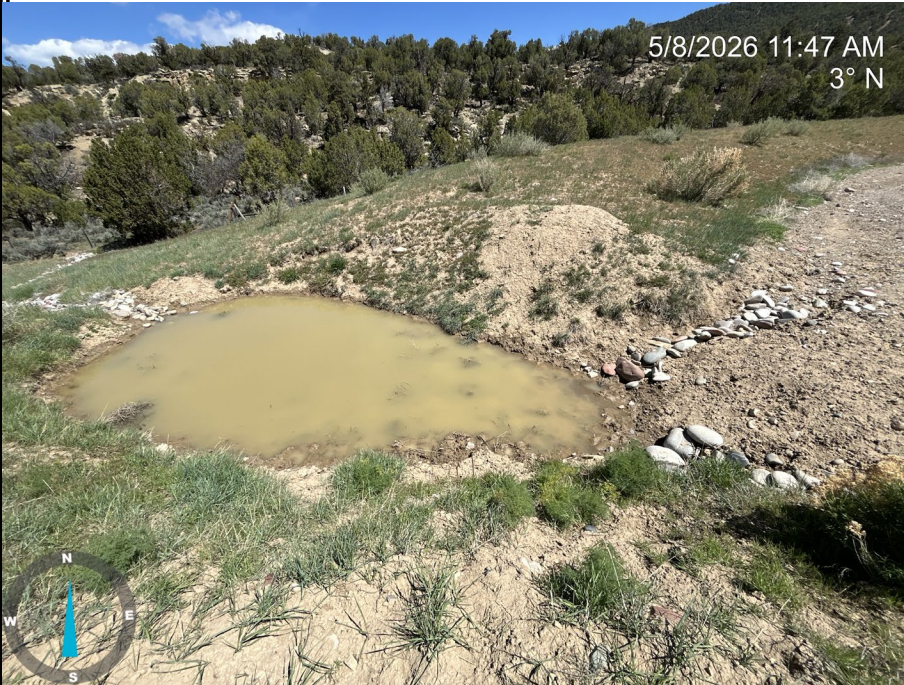
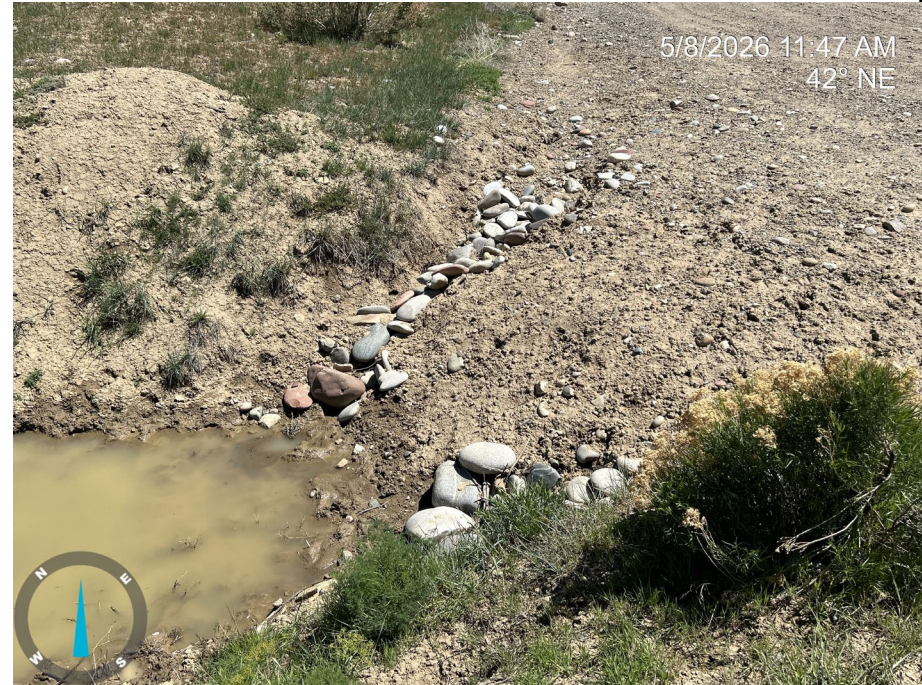
**Photo 8:** The northwestern sediment trap is in functioning condition at the time of inspection but appears to have reached capacity and may need maintenance soon.
