# INSPECTION PHOTOS

Well: BUSTER 13-1

INSPECTION DOC #: 716302344

Operator: EVERGREEN NATURAL RESOURCES LLC

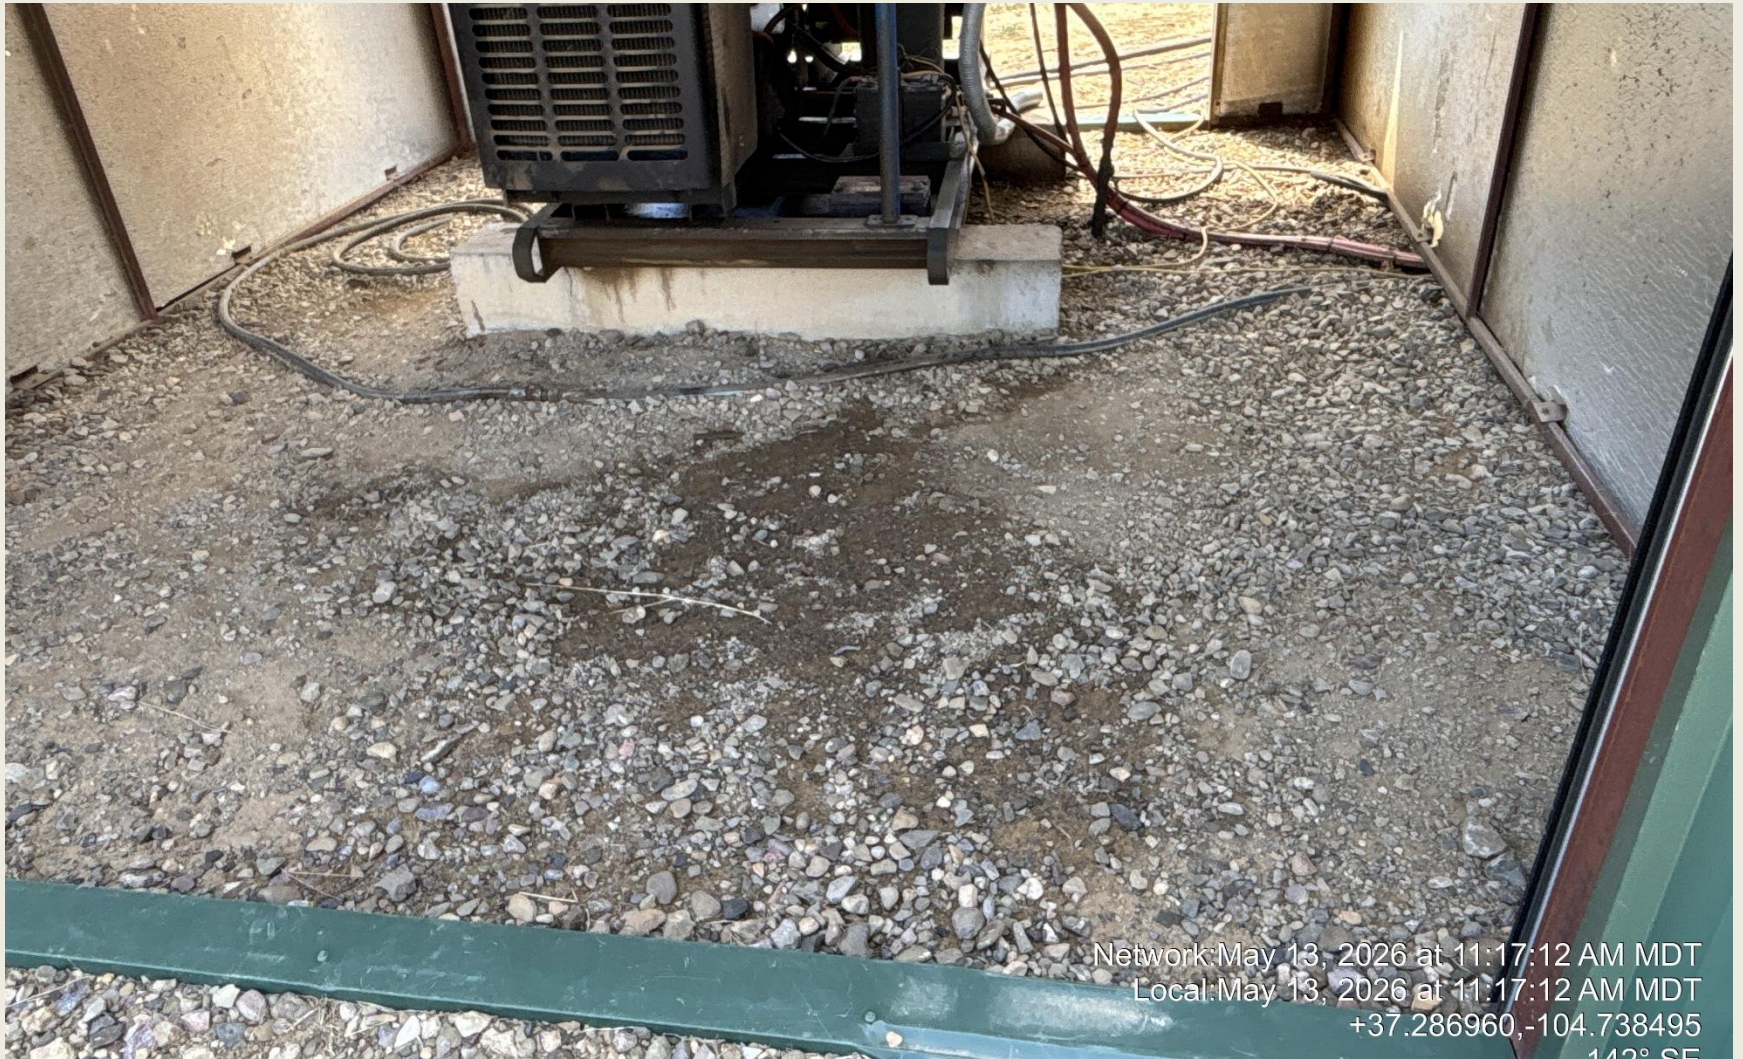
**PHOTO 5: AREA OF IMPACTED SOIL NEAR PRIME MOVER SKID. AT TIME OF INSPECTION THIS EQUIPMENT IS NOT IN OPERATION HOWEVER IT APPEARS TO HAVE SIGNIFICANT OIL LEAKS THAT SHOULD BE REPAIR PRIOR TO PUTTING EQUIPMENT BACK IN USE. Conduct maintenance on equipment, cleanup stained material and review self inspection processes. COMPLY WITH RULE 1002,(2).D CA DATE 6/13/2026.**

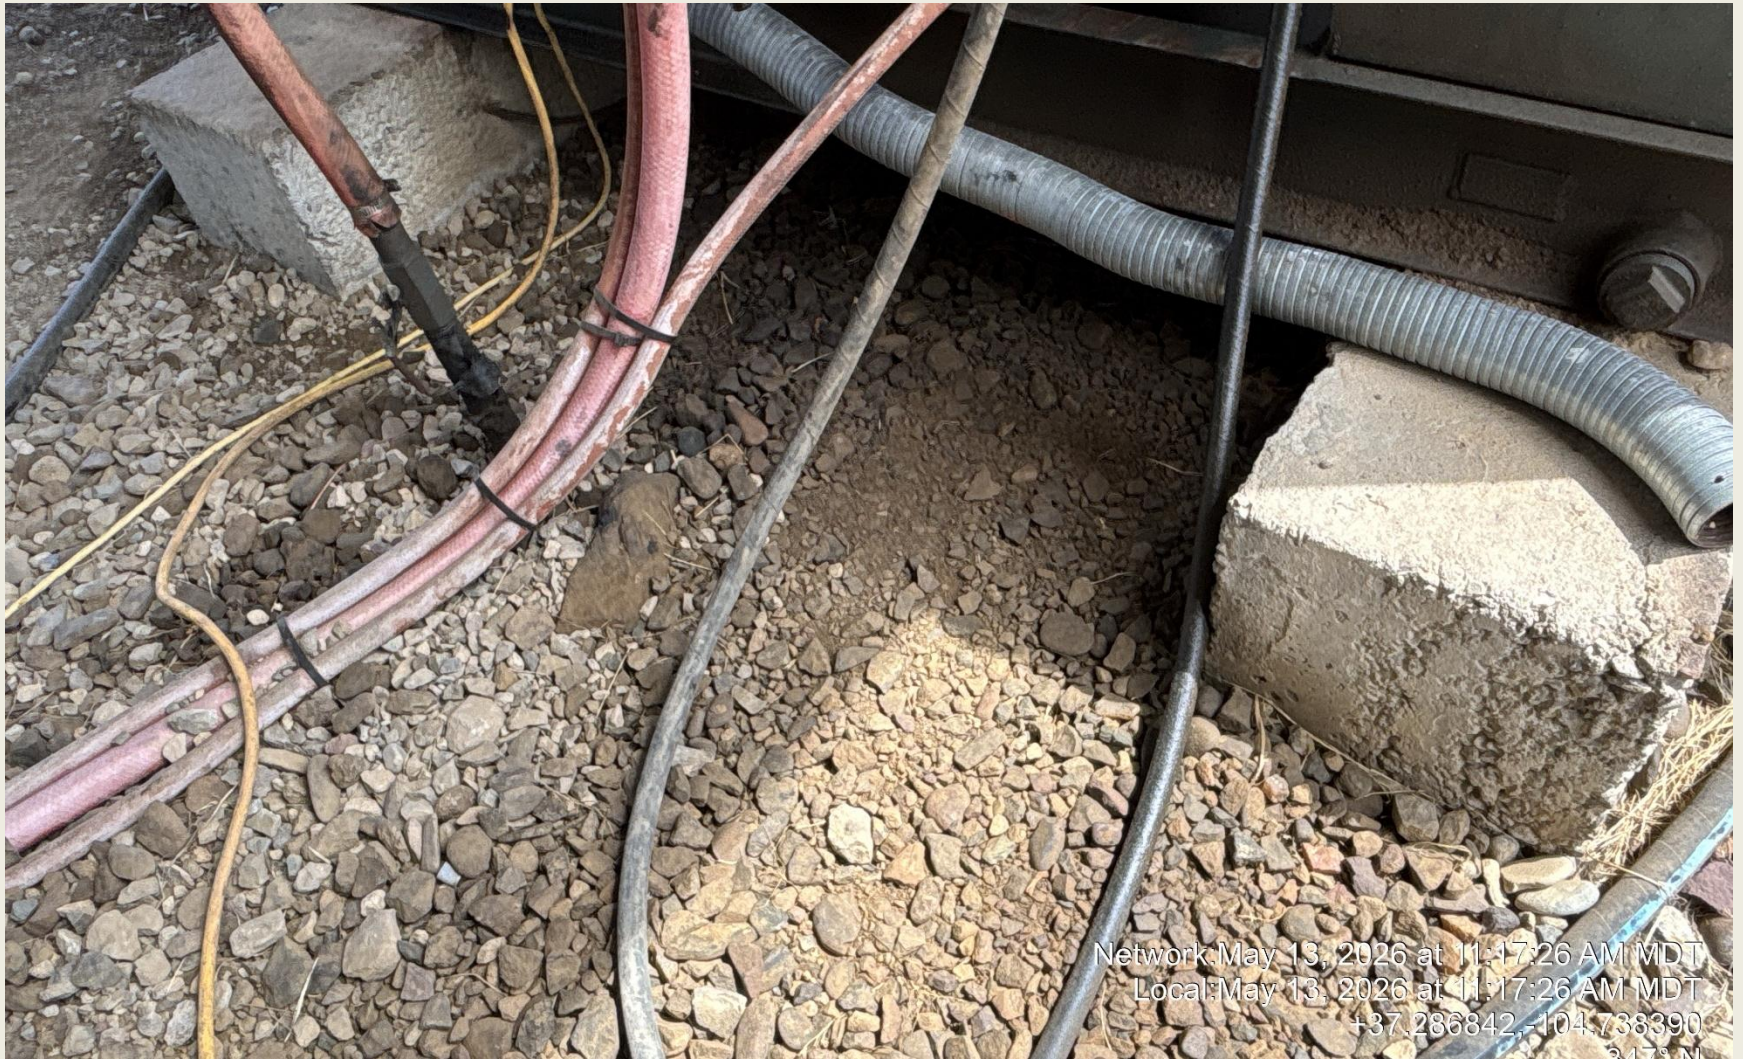
**PHOTO 6: AREA OF IMPACTED SOIL NEAR PRIME MOVER SKID. AT TIME OF INSPECTION THIS EQUIPMENT IS NOT IN OPERATION HOWEVER IT APPEARS TO HAVE SIGNIFICANT OIL LEAKS THAT SHOULD BE REPAIR PRIOR TO PUTTING EQUIPMENT BACK IN USE. Conduct maintenance on equipment, cleanup stained material and review self inspection processes. COMPLY WITH RULE 1002,(2).D CA DATE 6/13/2026.**

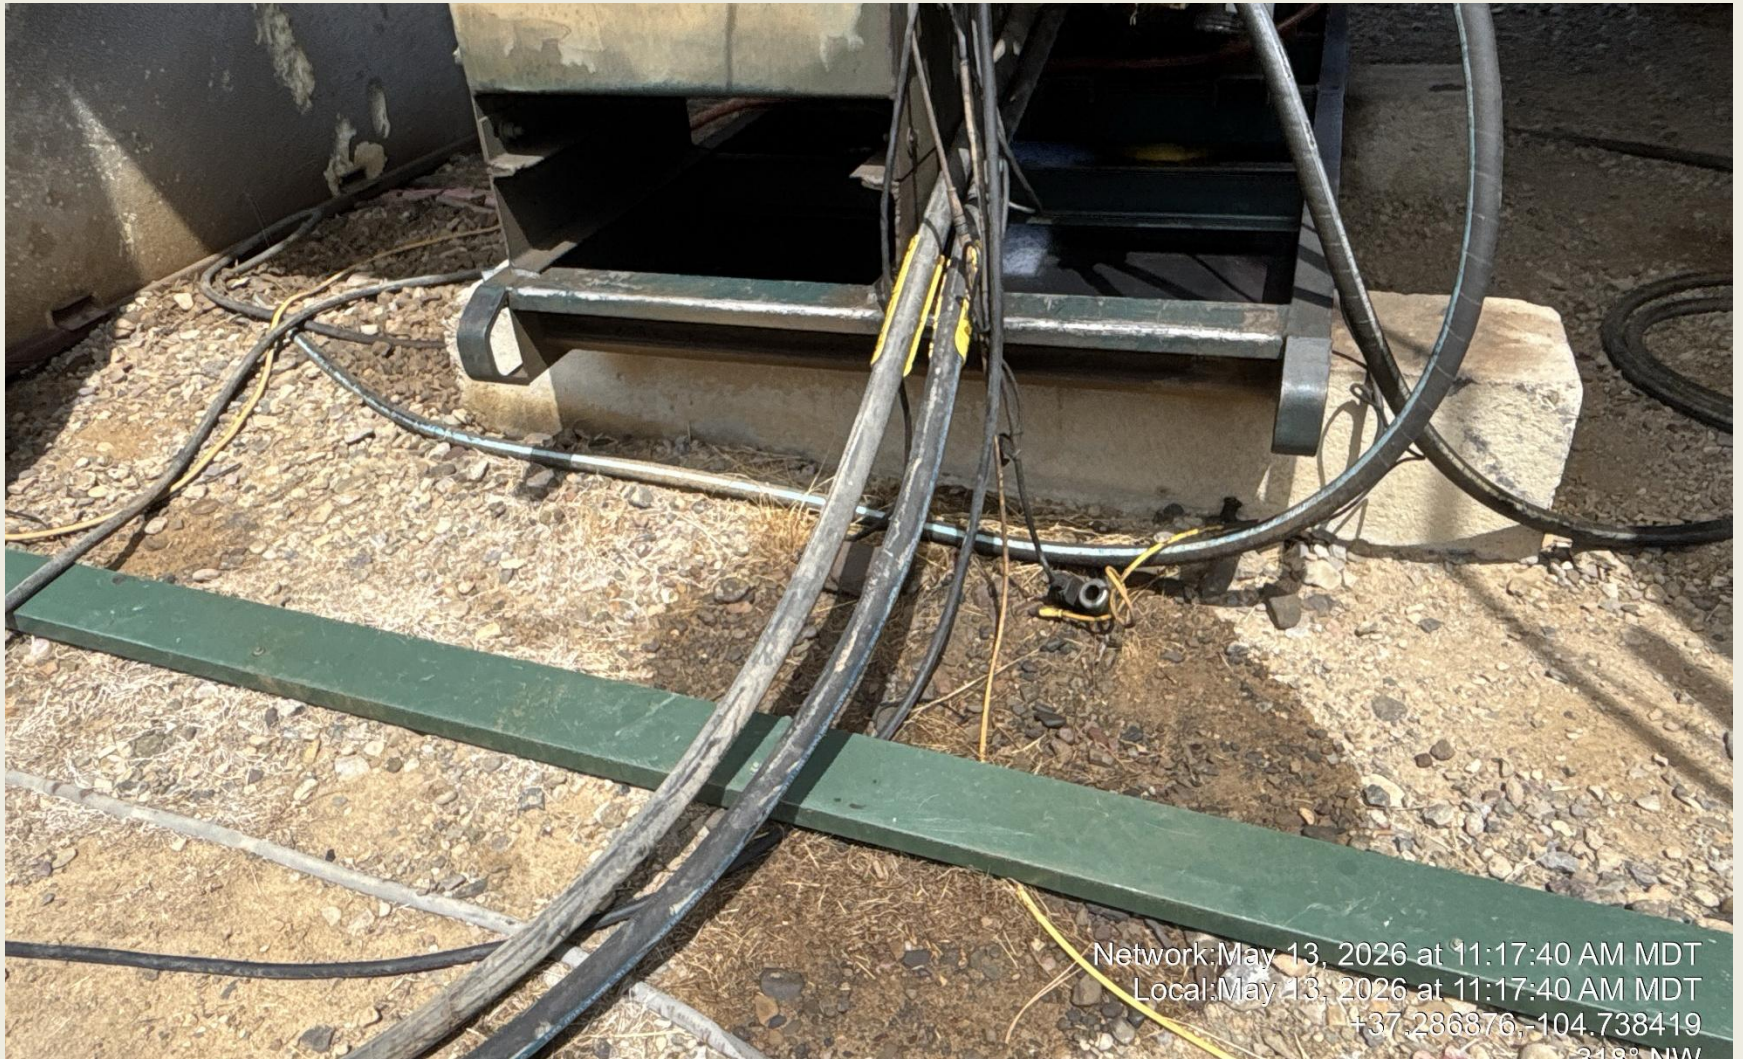
**PHOTO 7: AREA OF IMPACTED SOIL NEAR PRIME MOVER SKID. AT TIME OF INSPECTION THIS EQUIPMENT IS NOT IN OPERATION HOWEVER IT APPEARS TO HAVE SIGNIFICANT OIL LEAKS THAT SHOULD BE REPAIR PRIOR TO PUTTING EQUIPMENT BACK IN USE. Conduct maintenance on equipment, cleanup stained material and review self inspection processes. COMPLY WITH RULE 1002,.(2).D CA DATE 6/13/2026.**

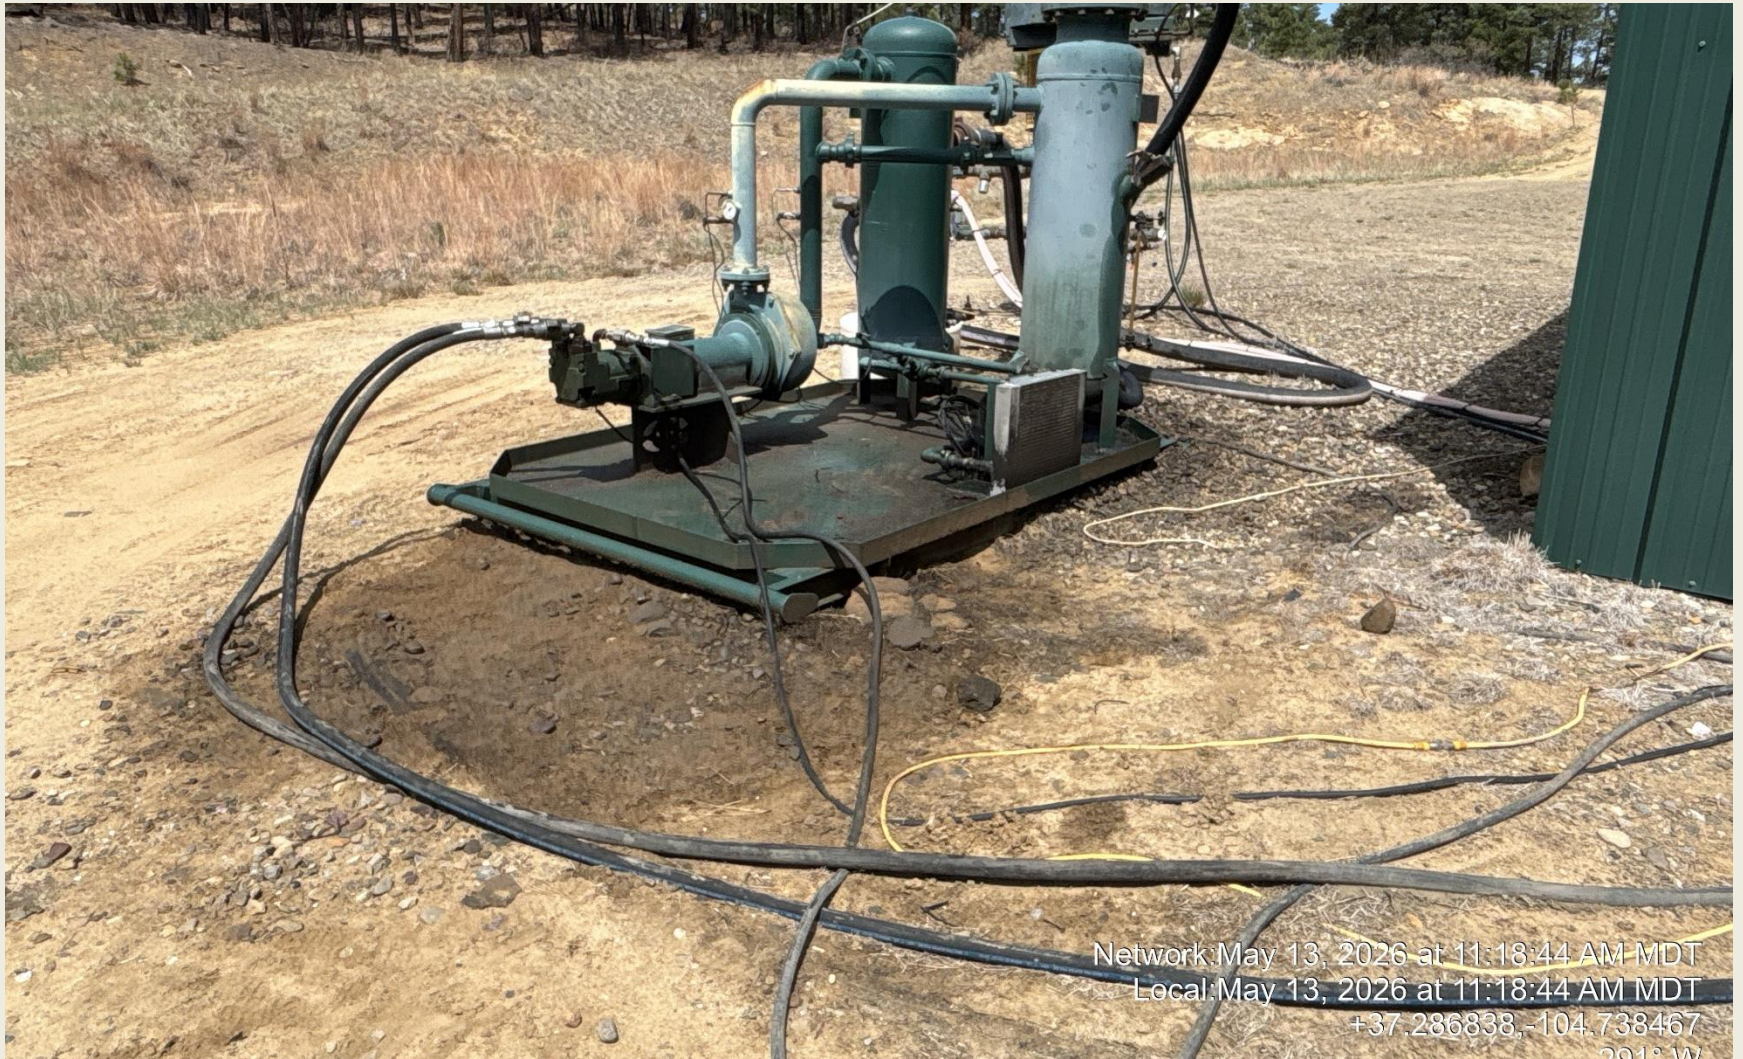
**PHOTO 8: AREA OF IMPACTED SOIL NEAR COMPRESSOR SKID. AT TIME OF INSPECTION THIS EQUIPMENT IS NOT IN OPERATION HOWEVER IT APPEARS TO HAVE SIGNIFICANT OIL LEAKS THAT SHOULD BE REPAIR PRIOR TO PUTTING EQUIPMENT BACK IN USE. Conduct maintenance on equipment, cleanup stained material and review self inspection processes. COMPLY WITH RULE 1002,.(2).D CA DATE 6/13/2026.**

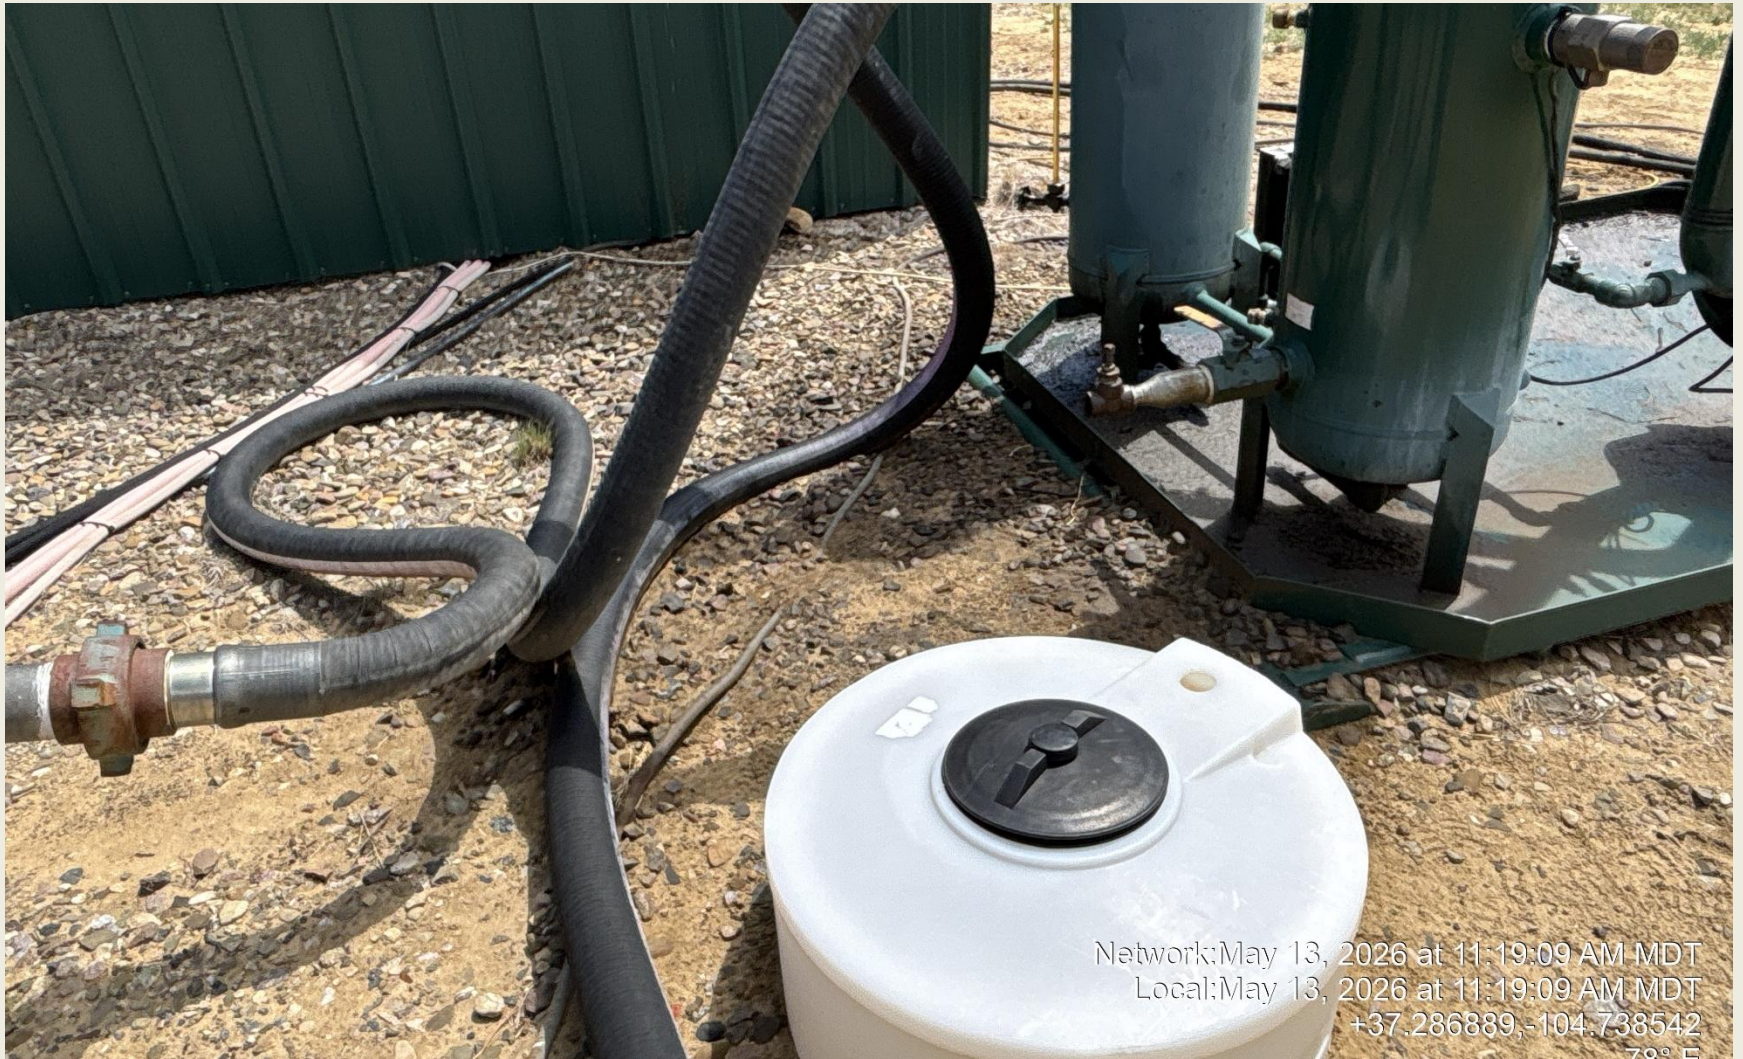
**PHOTO 9: AREA OF IMPACTED SOIL NEAR COMPRESSOR SKID. AT TIME OF INSPECTION THIS EQUIPMENT IS NOT IN OPERATION HOWEVER IT APPEARS TO HAVE SIGNIFICANT OIL LEAKS THAT SHOULD BE REPAIR PRIOR TO PUTTING EQUIPMENT BACK IN USE. Conduct maintenance on equipment, cleanup stained material and review self inspection processes. COMPLY WITH RULE 1002,.(2).D CA DATE 6/13/2026.**

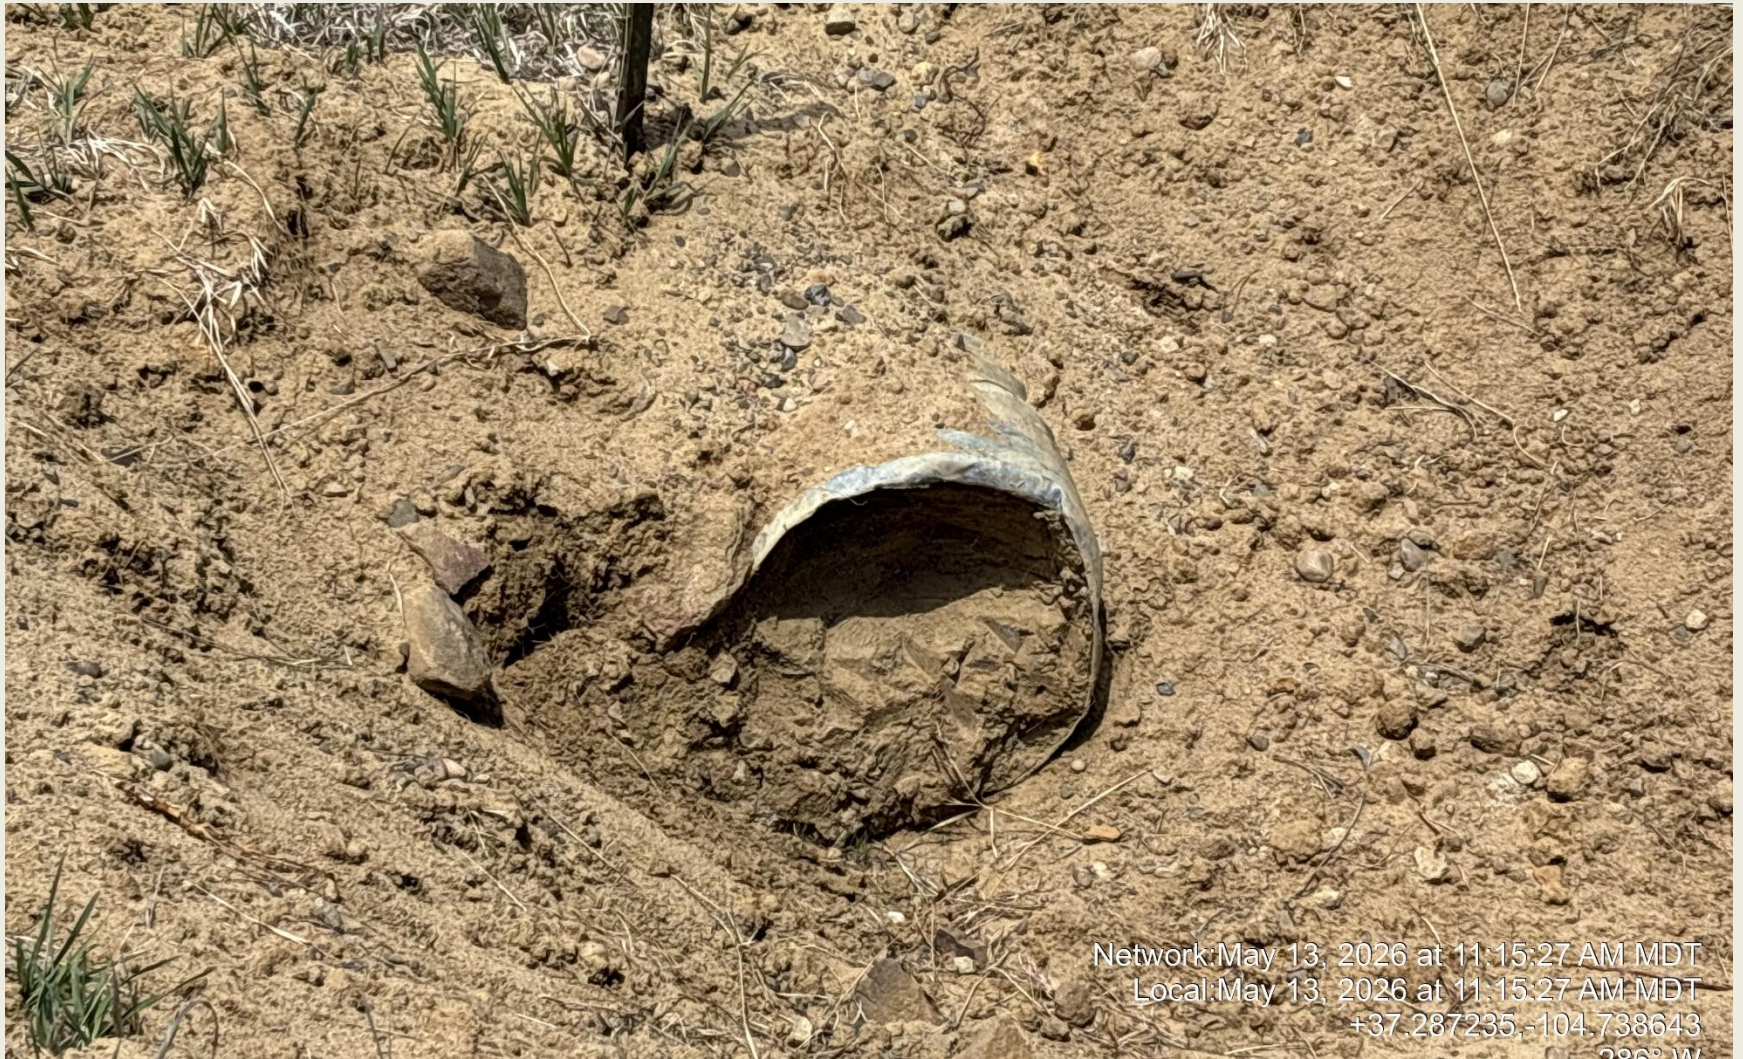
PHOTO 10: CULVER AT ENTRANCE OF LOCATION IS PLUGGED. **CLEAN CULVER PER RULE 1002. CA DATE 6/13/2026.**

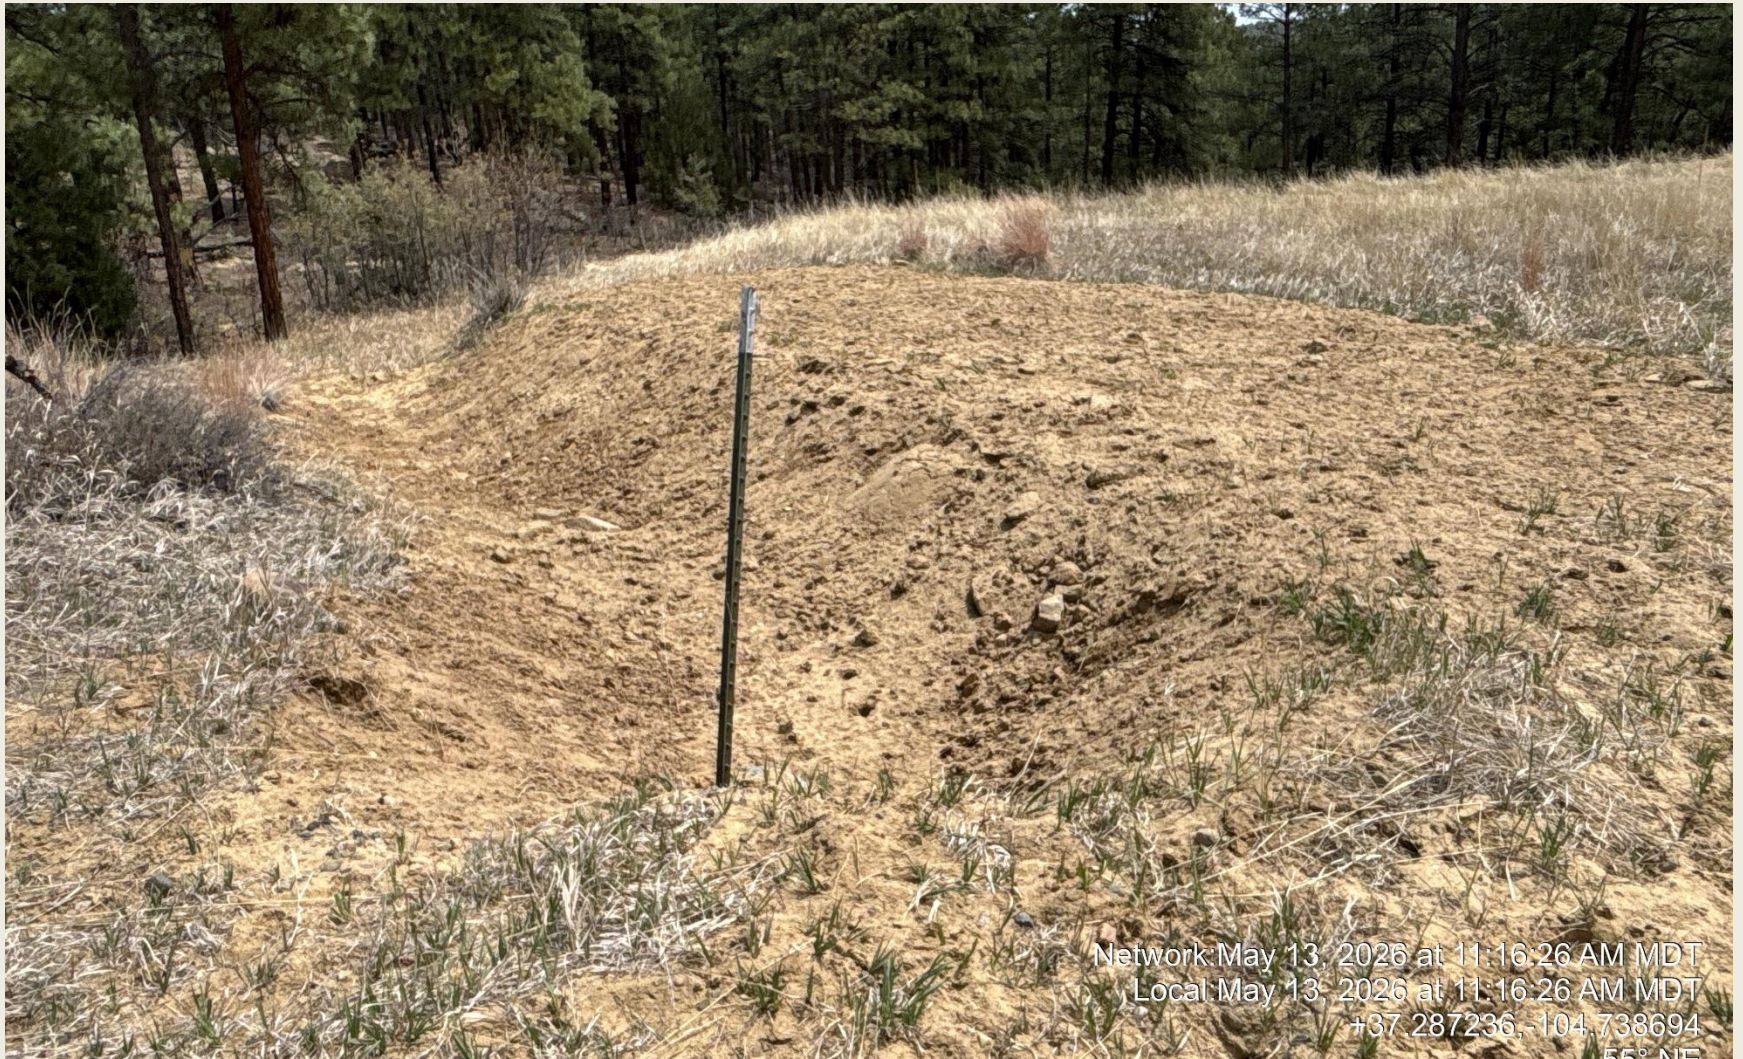
**PHOTO 11: RECENT RECLIMATION AREA DISTURBANCE DOES NOT APPEAR TO HAVE BEEN RESEEDED. SEED DISTURBED AREA PER RULE 1003. CA DATE 7/15/2026.**
