# Inspection Photos

Location Name: Simcoe McMahan 1

Location ID: 05-067-06952

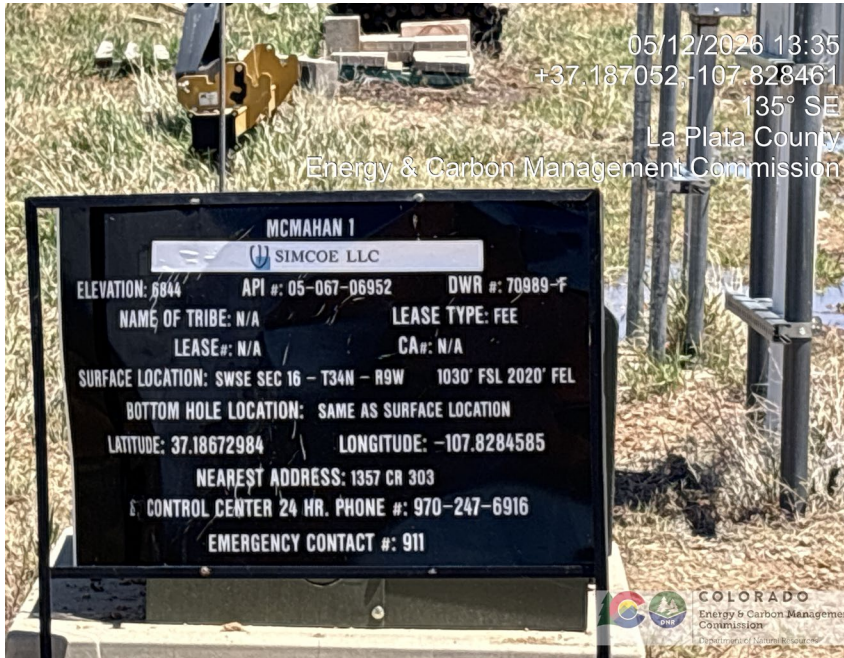
1. Well sign.

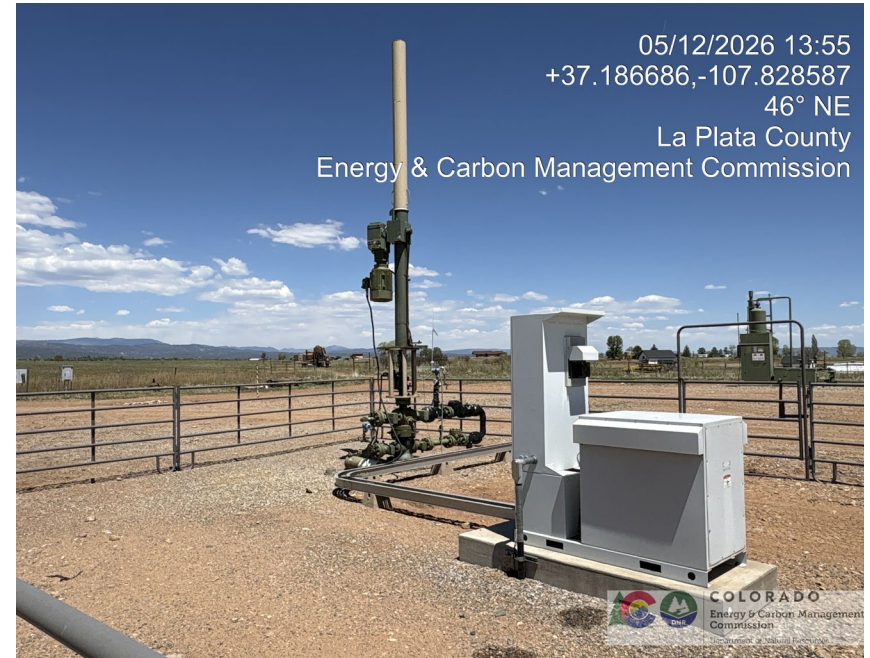
2. Wellhead, electric drive linear rod pump, electrical controls. Cattle panel fence.

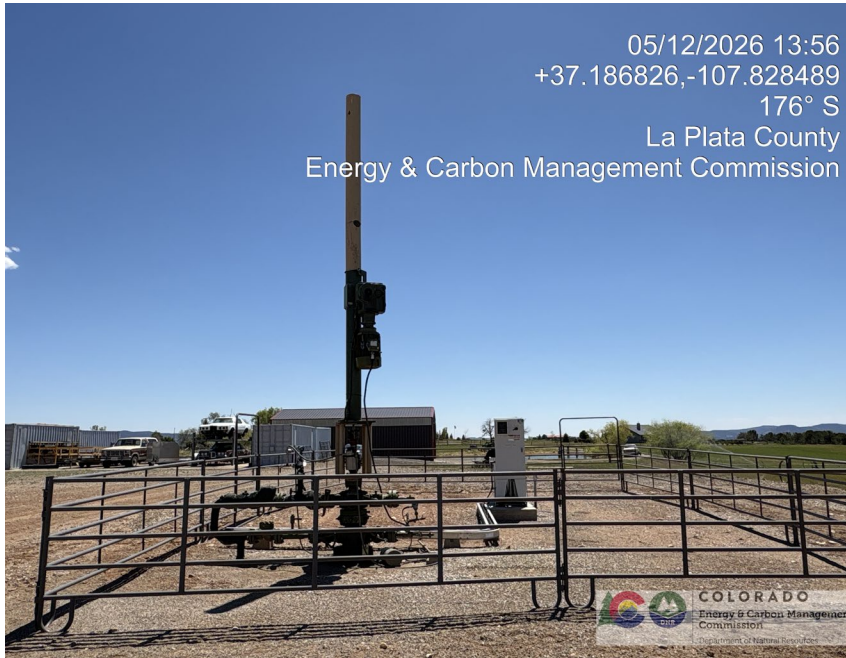
3. Wellhead and electric drive linear rod pumpjack.

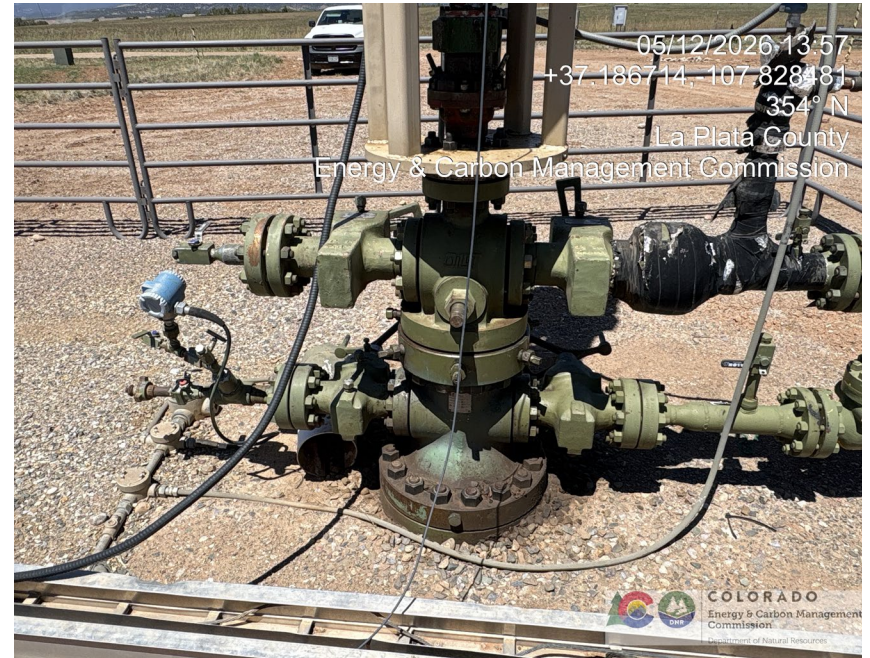
4. Close-up of wellhead and surrounding ground.

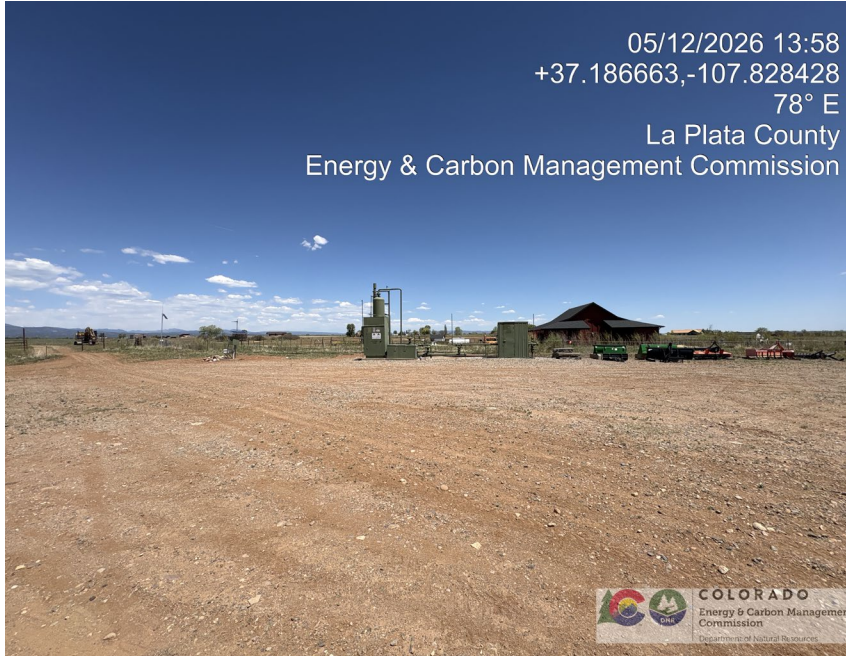
5. Overview of well pad and production equipment from position of wellhead looking east. Landowner tractor implements stored in neat row south of meter run on edge of pad.

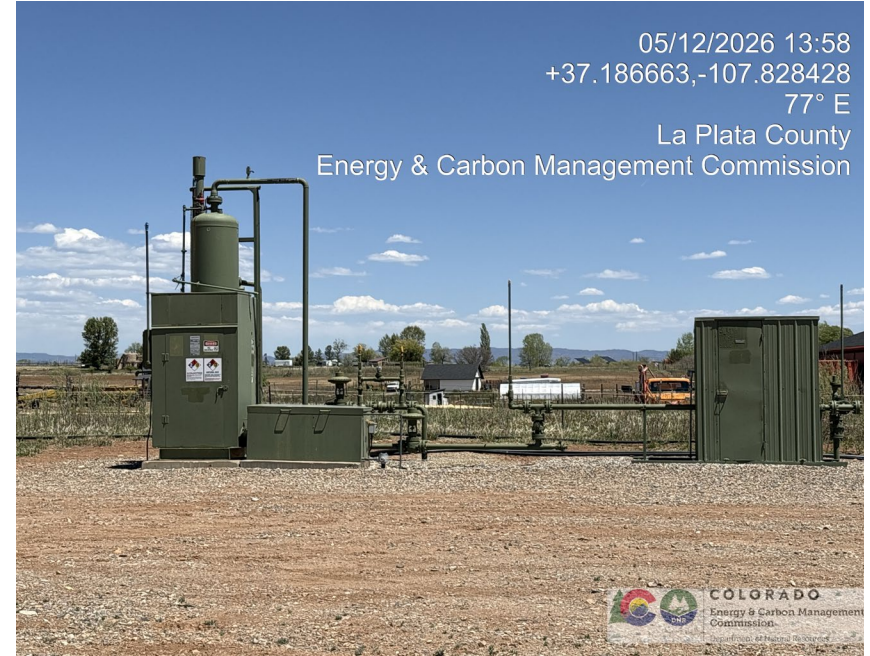
6. Vertical heated separator and meter run with 3 inch flow line.

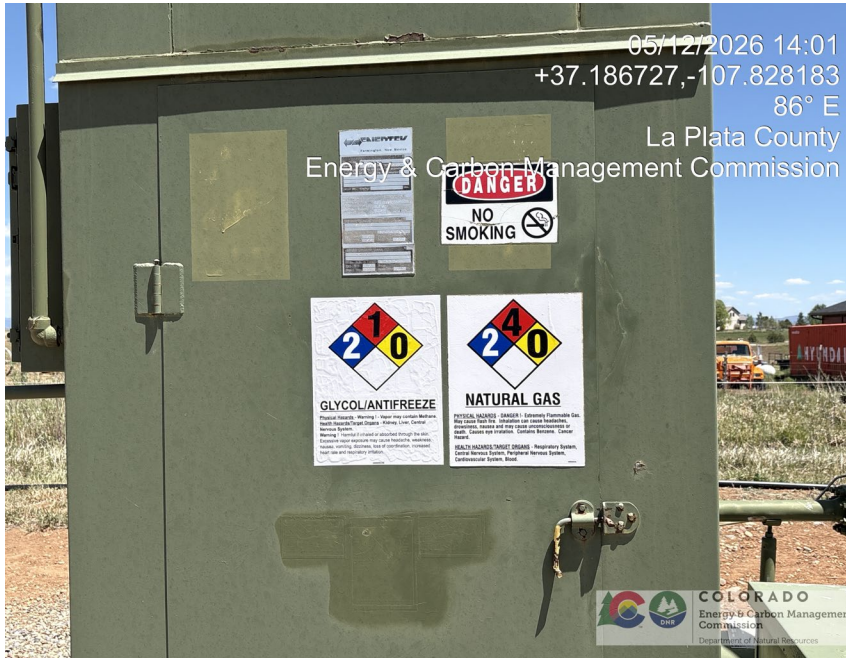
7. Labels on separator access hatch.

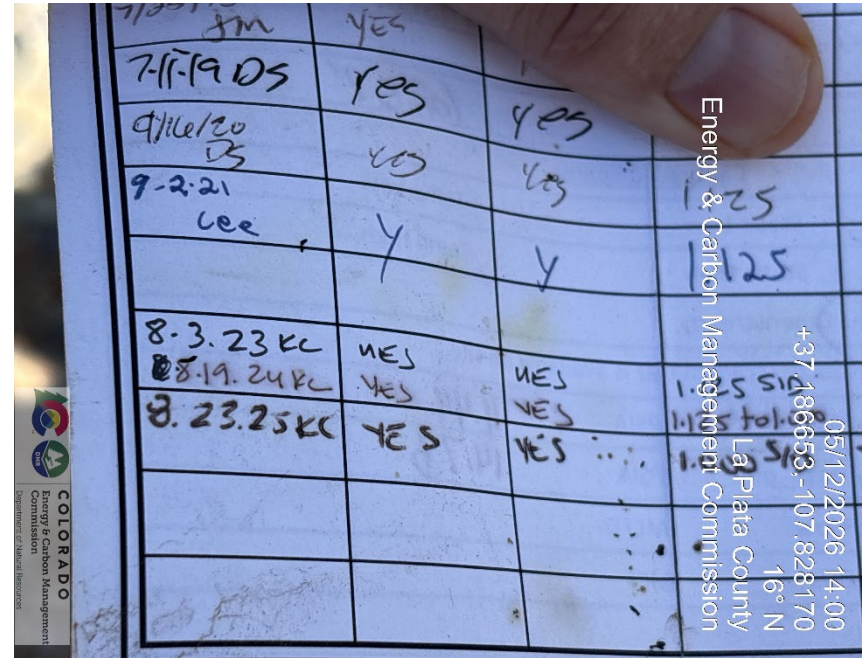
8. Meter calibration record. 8/23/2025.

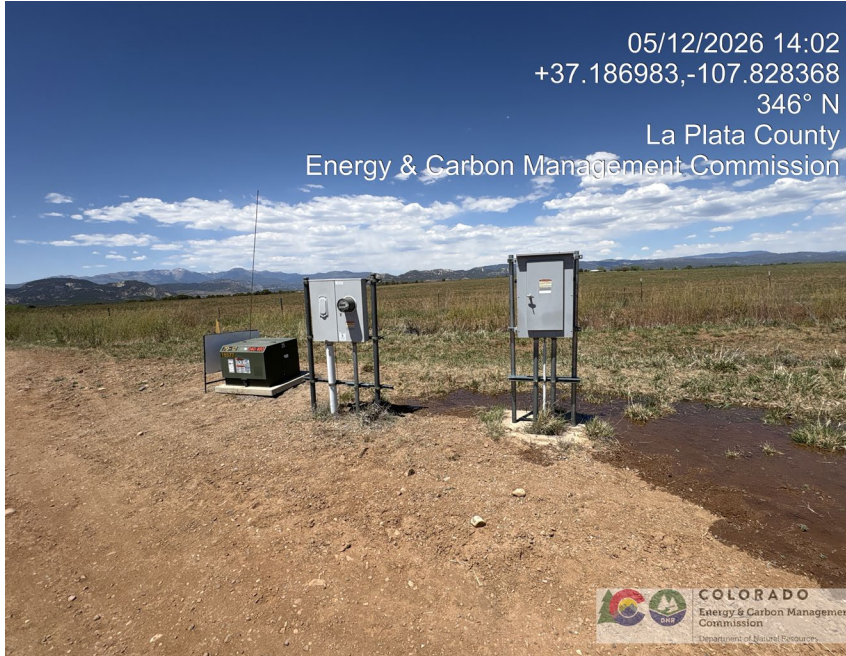
**9. Electrical service panels on north edge of pad. Area is wet from irrigation water from off location.**

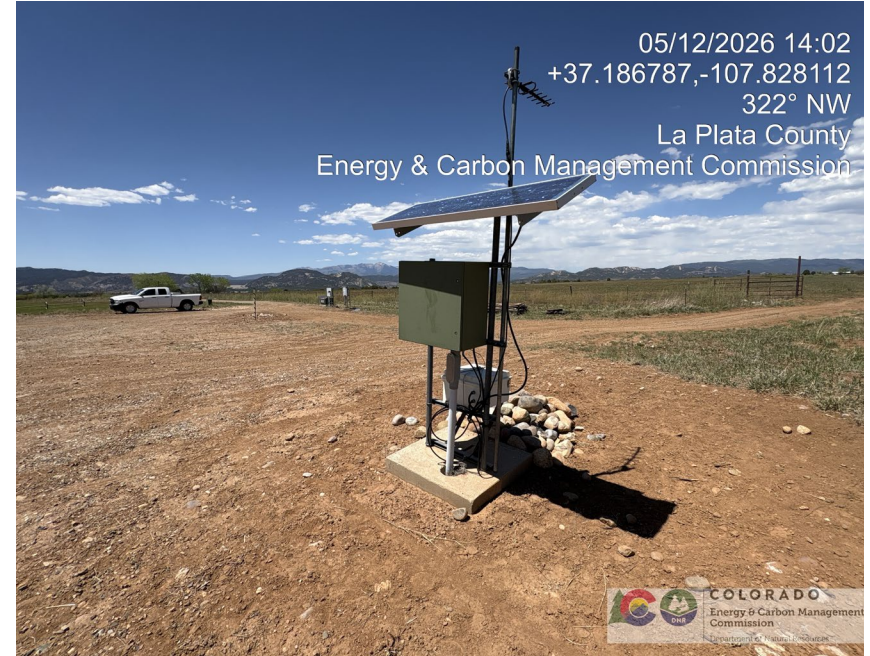
**10. Solar telemetry. Electrical service panels from photo 9 in distance.**
