Inspection Photos

Location Name: Simcoe – Simon Land and Cattle 15U-2R 2

Location ID: 05-067-08388

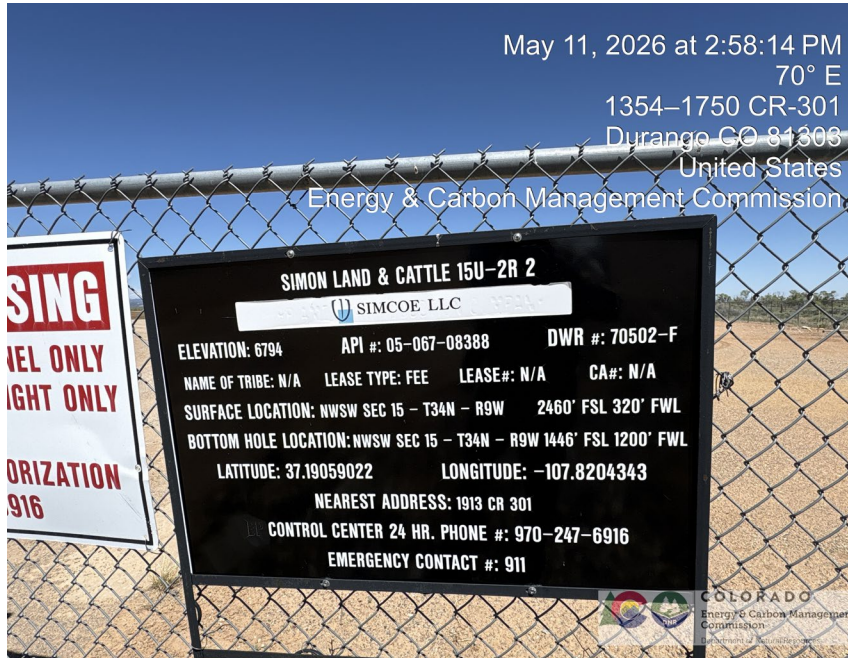
1. Sign for Simon Land and Cattle 15U-2R 2 well head on fence.

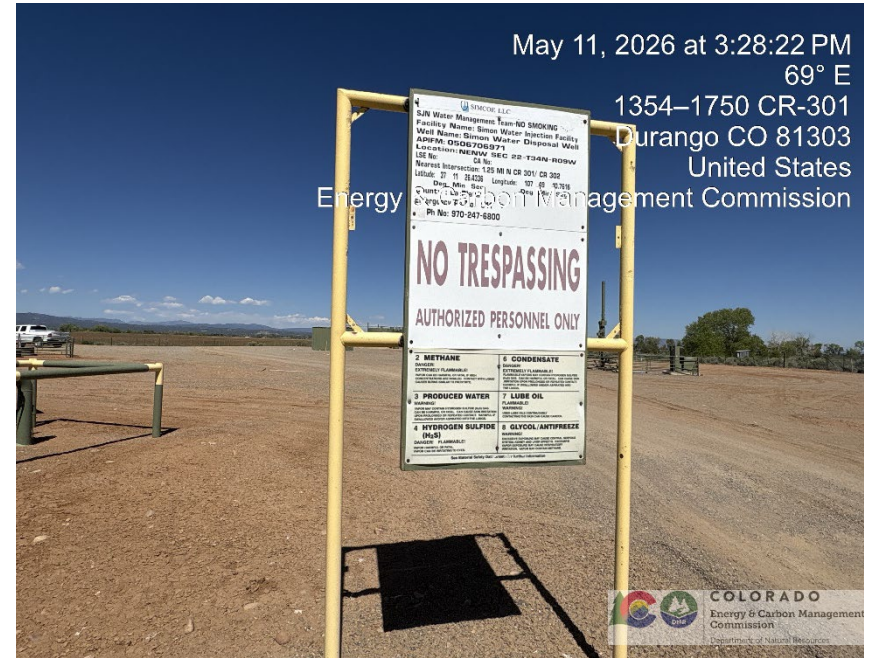
2. Sign for Simon Water Disposal Well #1 just inside front gate to location. Disposal well facilities not inspected.

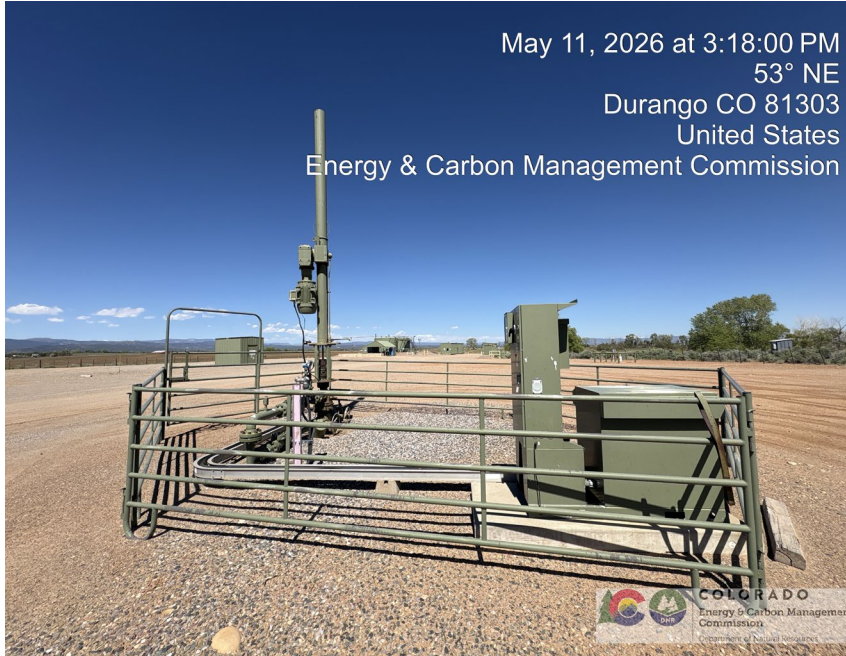
3. Electric drive linear rod pump on top of 15U-2R wellhead behind cattle panel. Pump was operating at time of inspection.

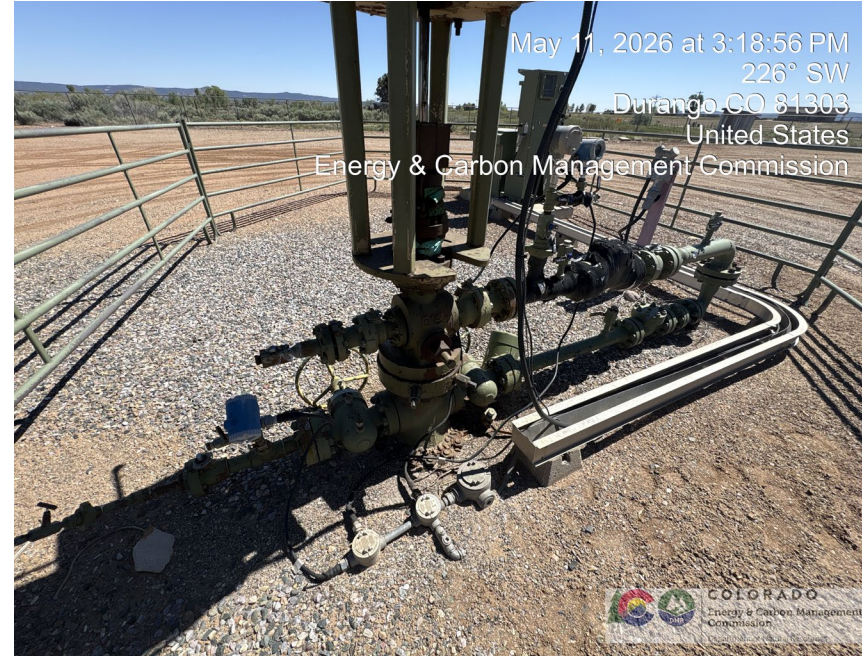
4. No stained soil observed at 15U-2R wellhead.

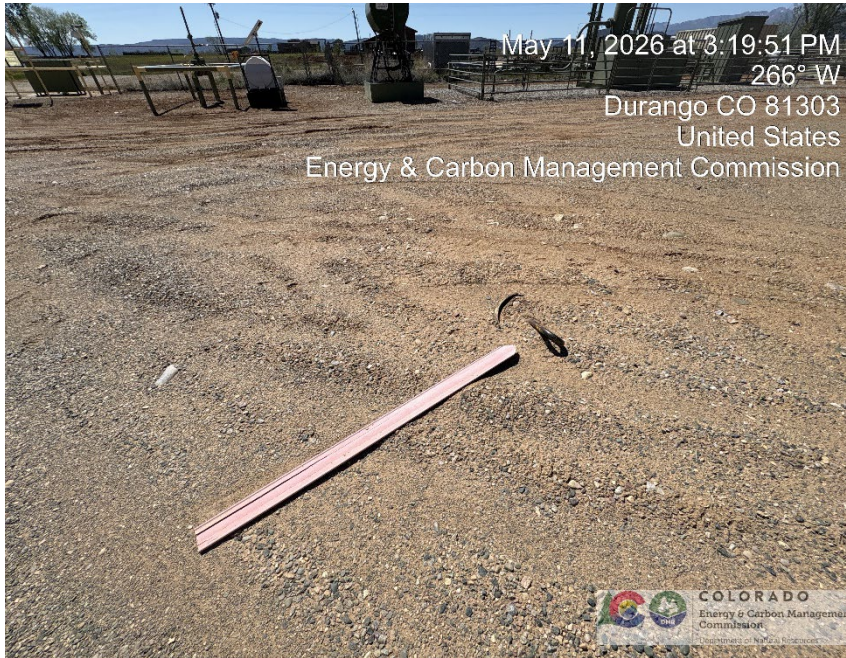
5. NW rig anchor with down anchor marker.

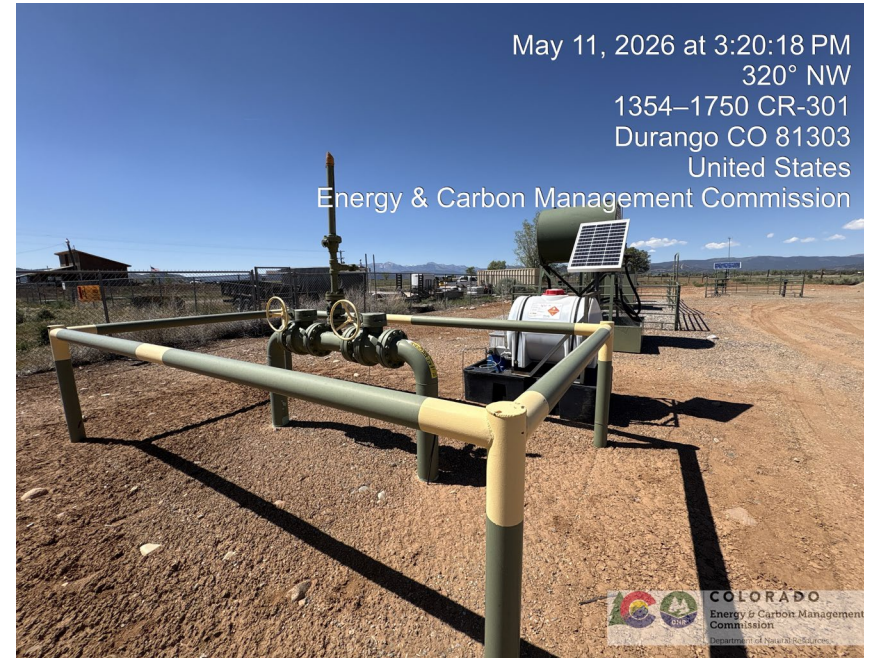
6. Valve on 6" pipeline for offsite gathering or produced water for injection well. Chemical treatment container on top of spill release with solar telemetry. Has manufacturer labelling.

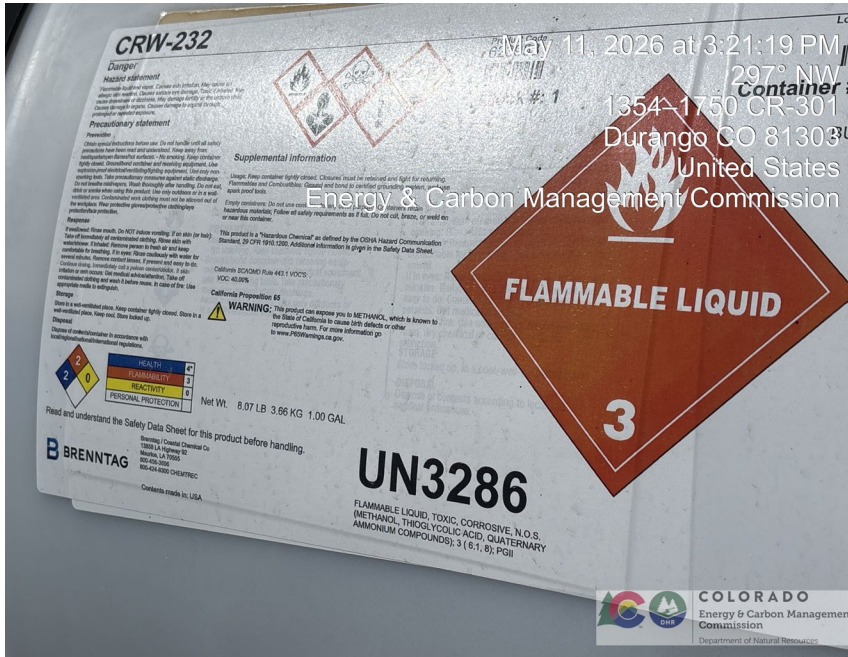
7. Manufacturer's labelling on chemical treatment container.

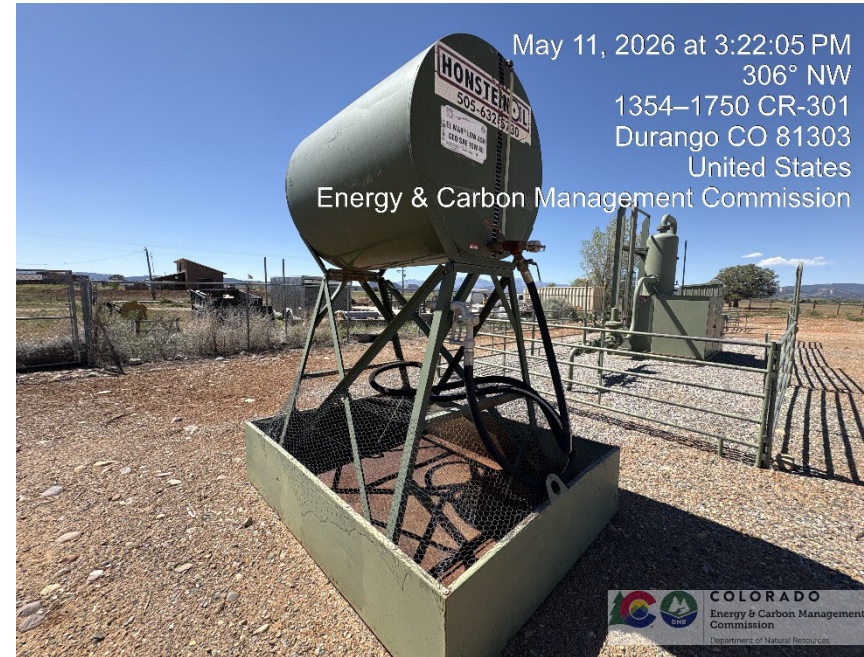
8. Unnecessary equipment. Appears to be 300 gal (est) lube oil tank with gravity fed unloading nozzle for filling smaller containers. Labeled "Honstein Oil. 505-632-5730. EL MAR LOW ASH GEO SAE 15W-40". Secondary containment has wildlife mesh (chicken wire) and is empty. Site glass indicates tank is empty. Not needed for gas well production equipment. Does not appear to be in use. Vertical heated separator in background.

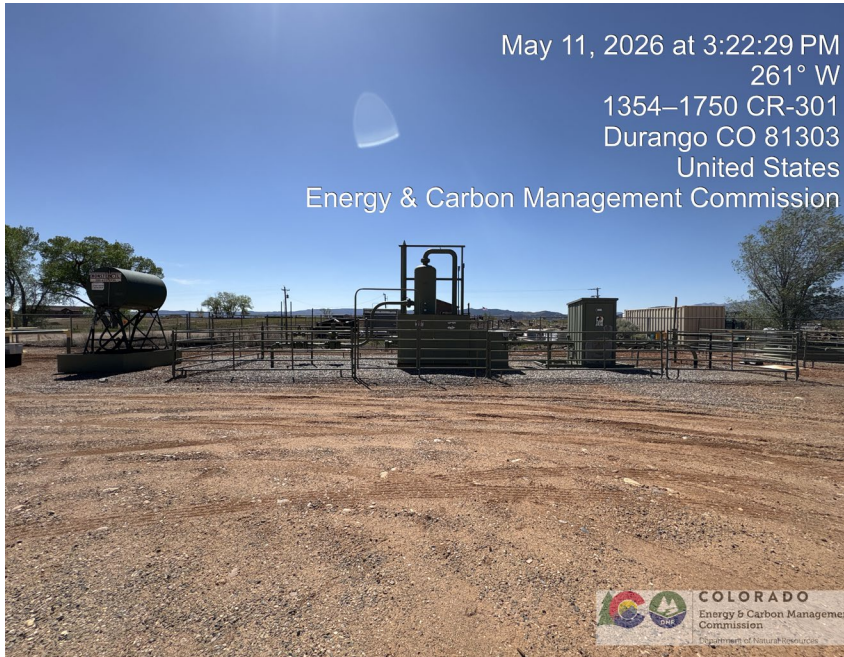
9. 15U-2R 2 production equipment behind cattle panel fence. Vertical heated separator and meter run. 4" production flowlines connecting equipment.

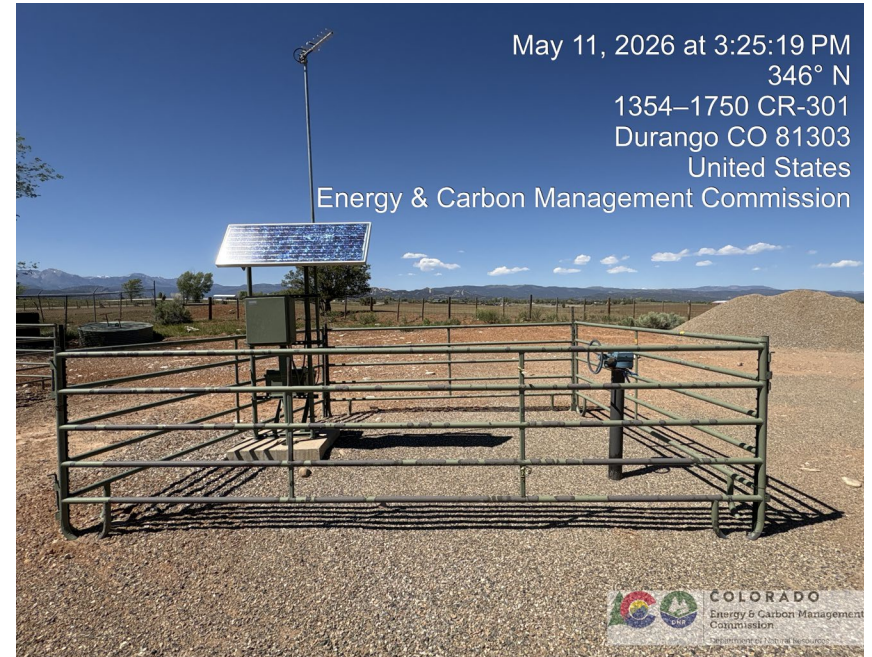
10. Solar telemetry and valve riser behind cattle panel.

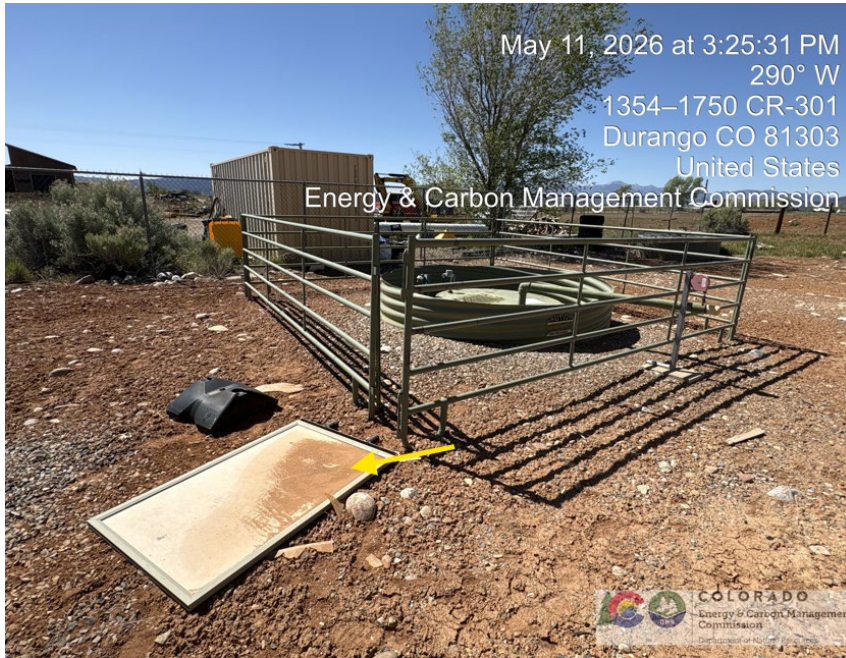
11. Steel PBV tank, volume unknown, not properly labeled/signed. Yellow arrow indicates sign that has fallen over, is not legible on face-down side. Located in NW corner of pad. Storage container and other equipment on other side of chain link fence presumably belong to surface owner not part of oil and gas operations.

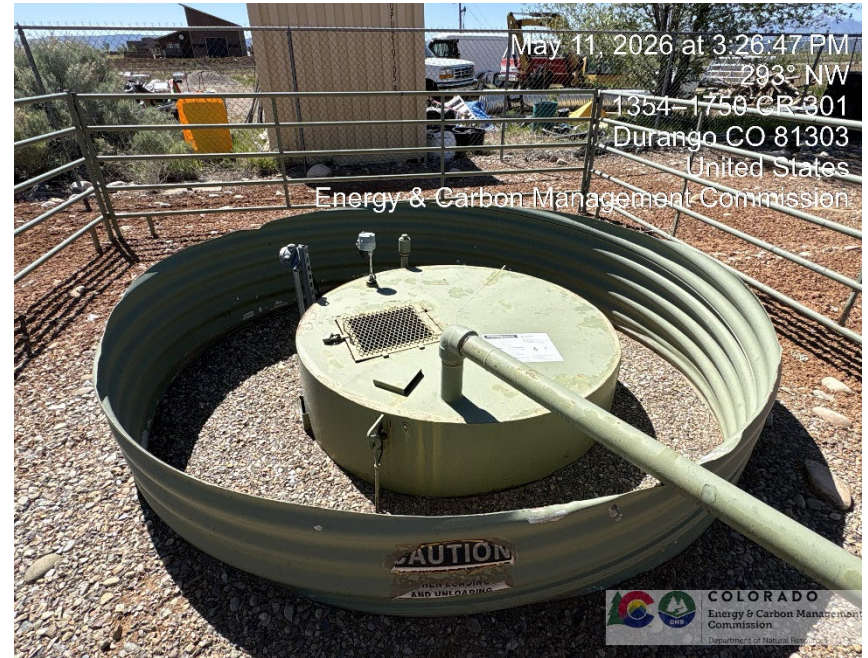
12. Additional photo showing unlabeled PBV produced water tank and secondary containment. Tank and secondary containment appear to be in adequate condition.

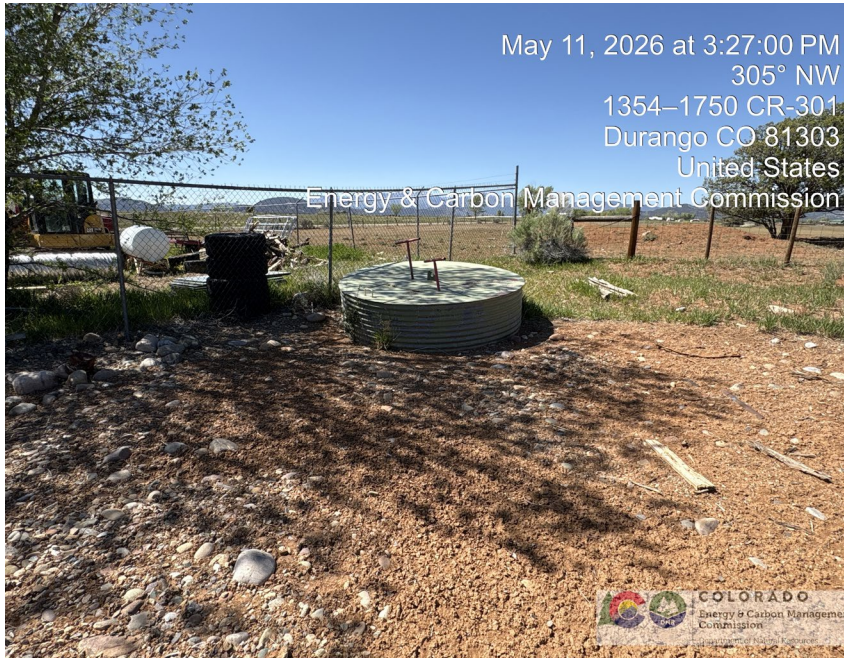
13. Underground flow line valve access box with T handle.

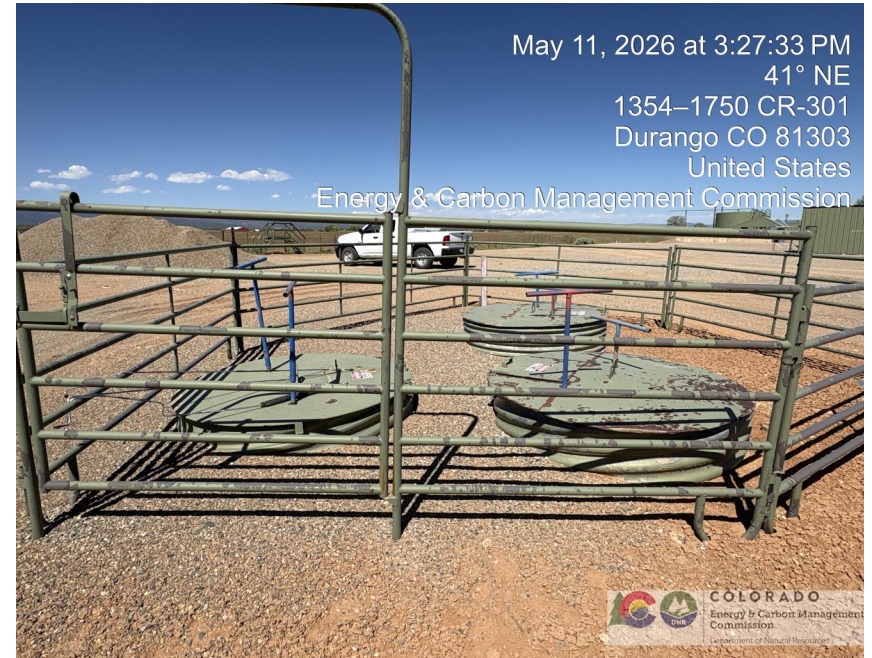
14. Three underground flow line valve access boxes with T handles.

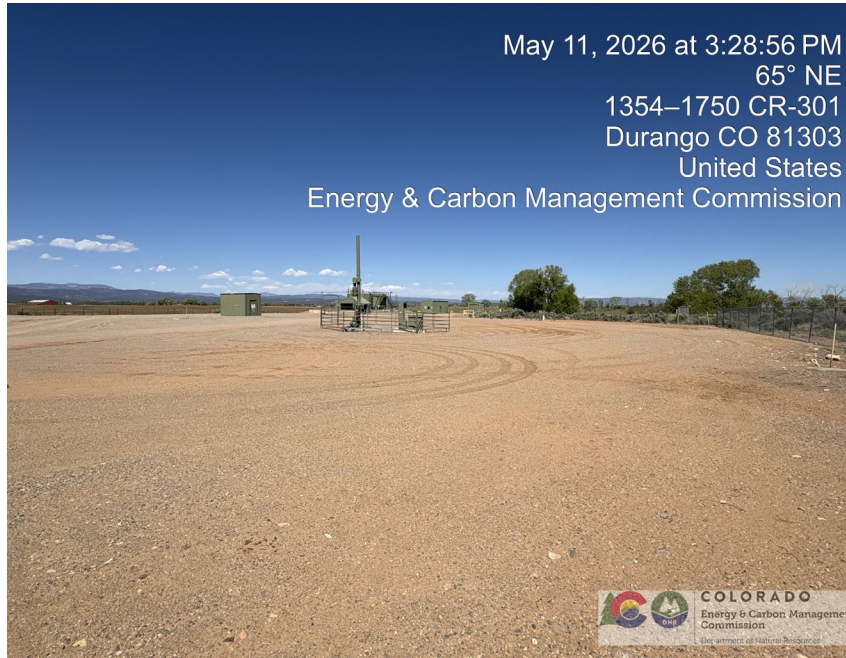
15. Location overview photo. 15E-2R 2 wellhead in middle of photo. Disposal well shelter to left. Disposal well equipment in background.

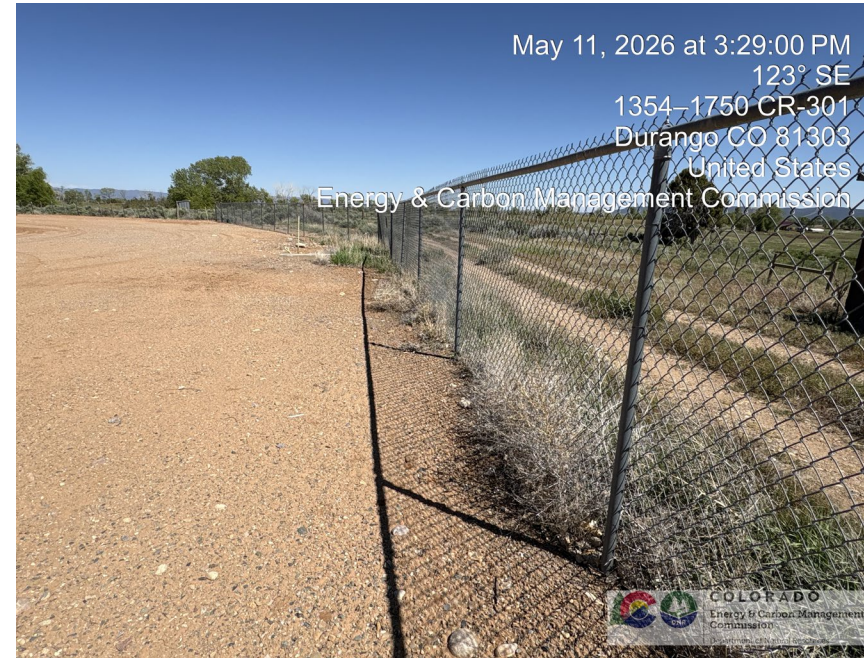
16. Location perimeter chain link fence on south side of location looking east.

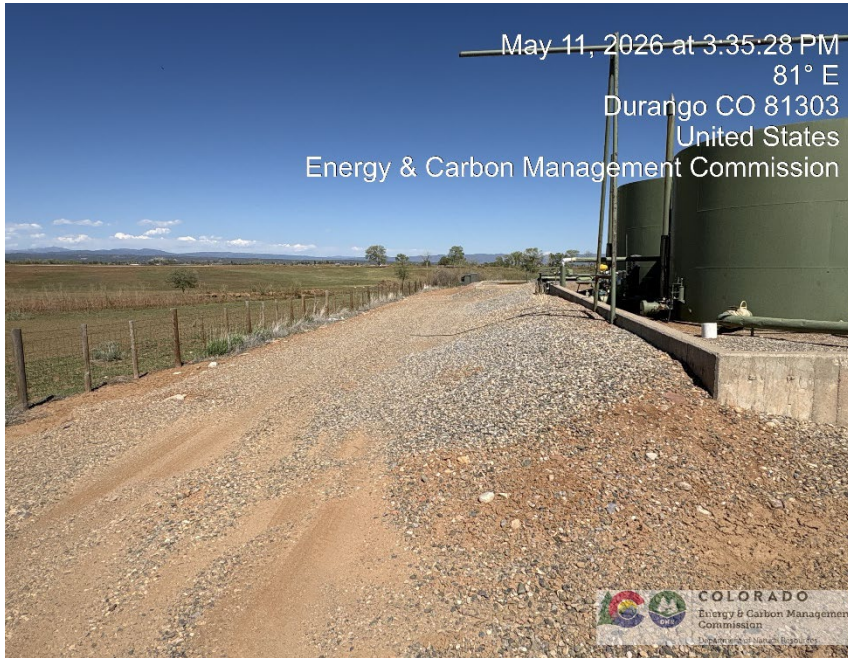
27. Pad margin along northern fence looking east. Tanks are associated with injection well facilities.
