# Site Specific Final Reclamation Completion Notice – Cropland Drone Imagery

## Permit Closure Report – Cropland

**Location ID:** 305880

**Location Name:** GEMINI B-65N64W/31CNW1/4

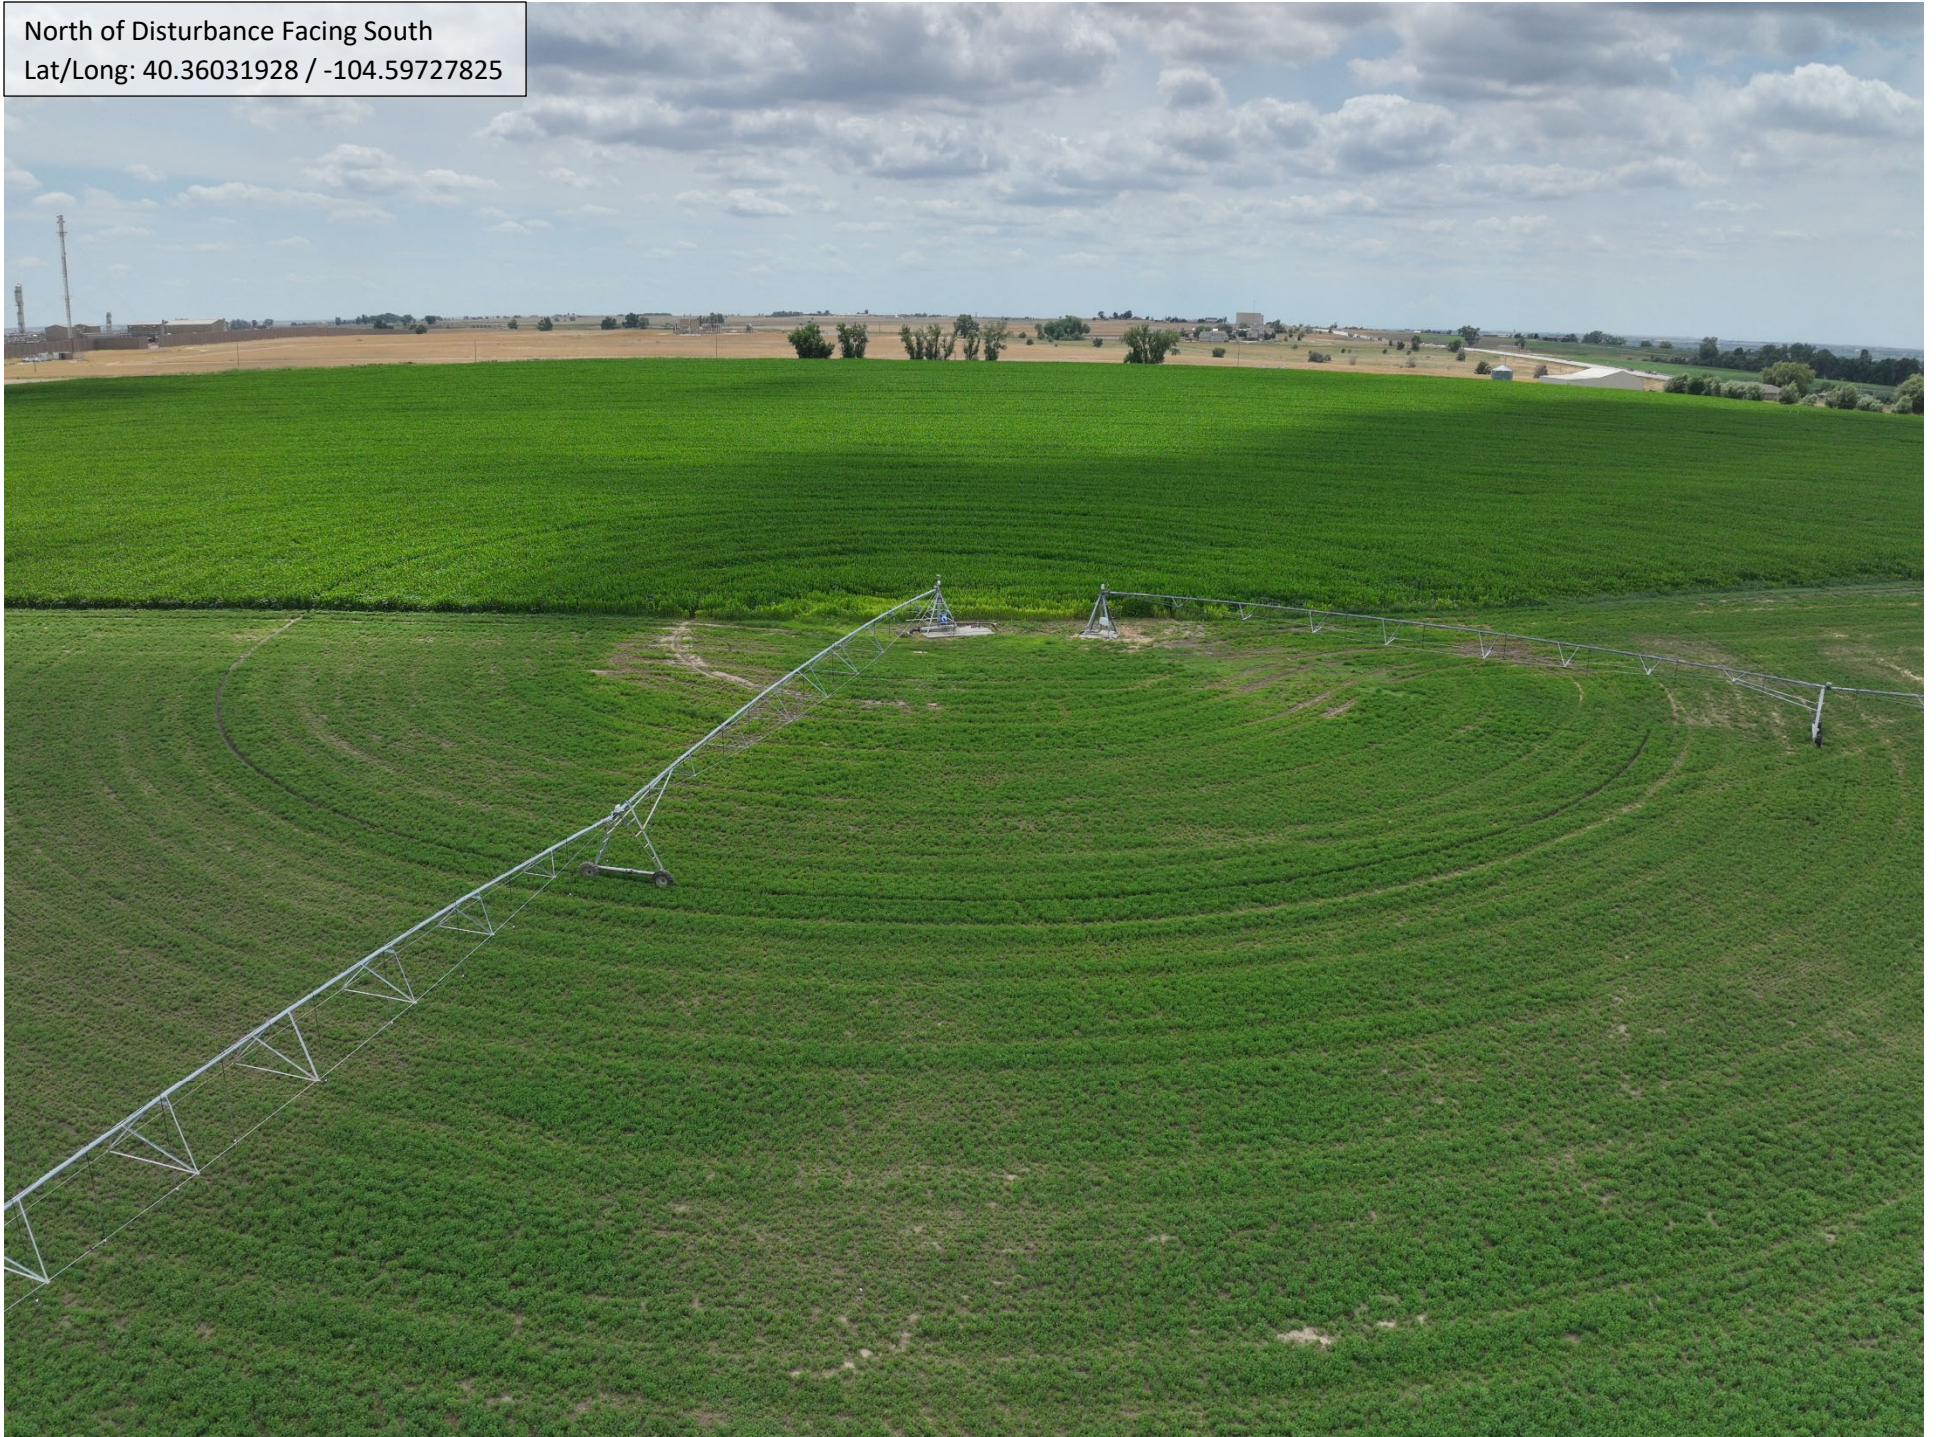
North of Disturbance Facing South  
Lat/Long: 40.36031928 / -104.59727825

Drone imagery confirms that no equipment was left on site at this location after reclamation activities occurred.

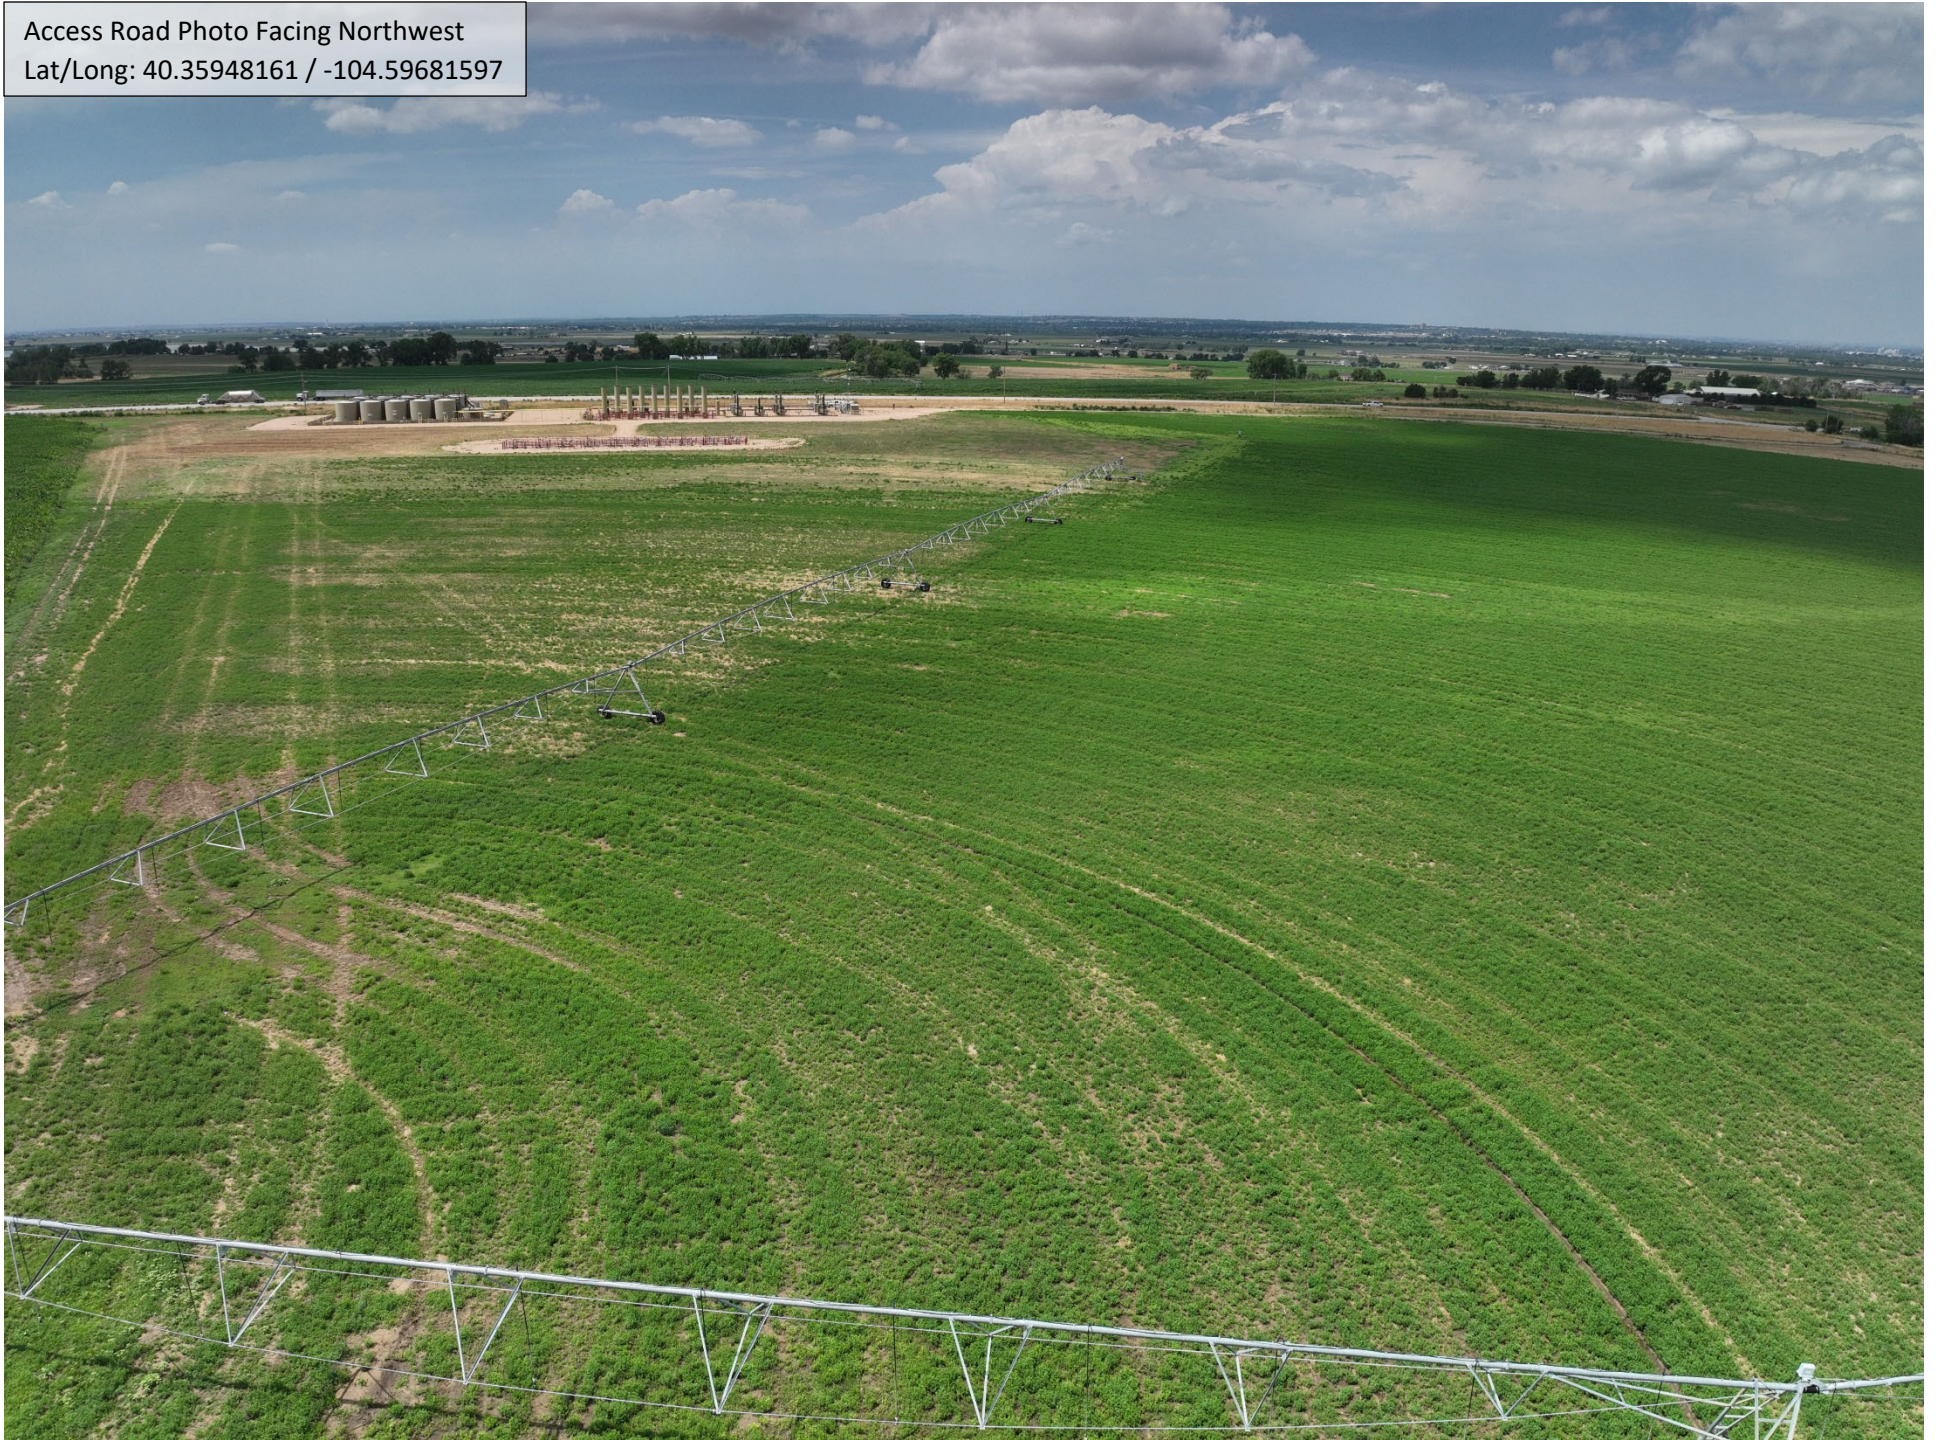
Access Road Photo Facing Northwest  
Lat/Long: 40.35948161 / -104.59681597

GEMINI B #31-19 was reclaimed and returned to the landowner for agricultural use in 2019. The wellhead was accessed from an unpaved access road that originated at an existing agricultural service road off of County Road 49. The access road was reclaimed and returned to agriculture in conjunction with the reclamation of the well location.
