# Site Specific Final Reclamation Completion Notice – Cropland Drone Imagery

## Permit Closure Report – Cropland

**Location ID:** 327982

**Location Name:** HAMILTON-65N65W/25NWSE

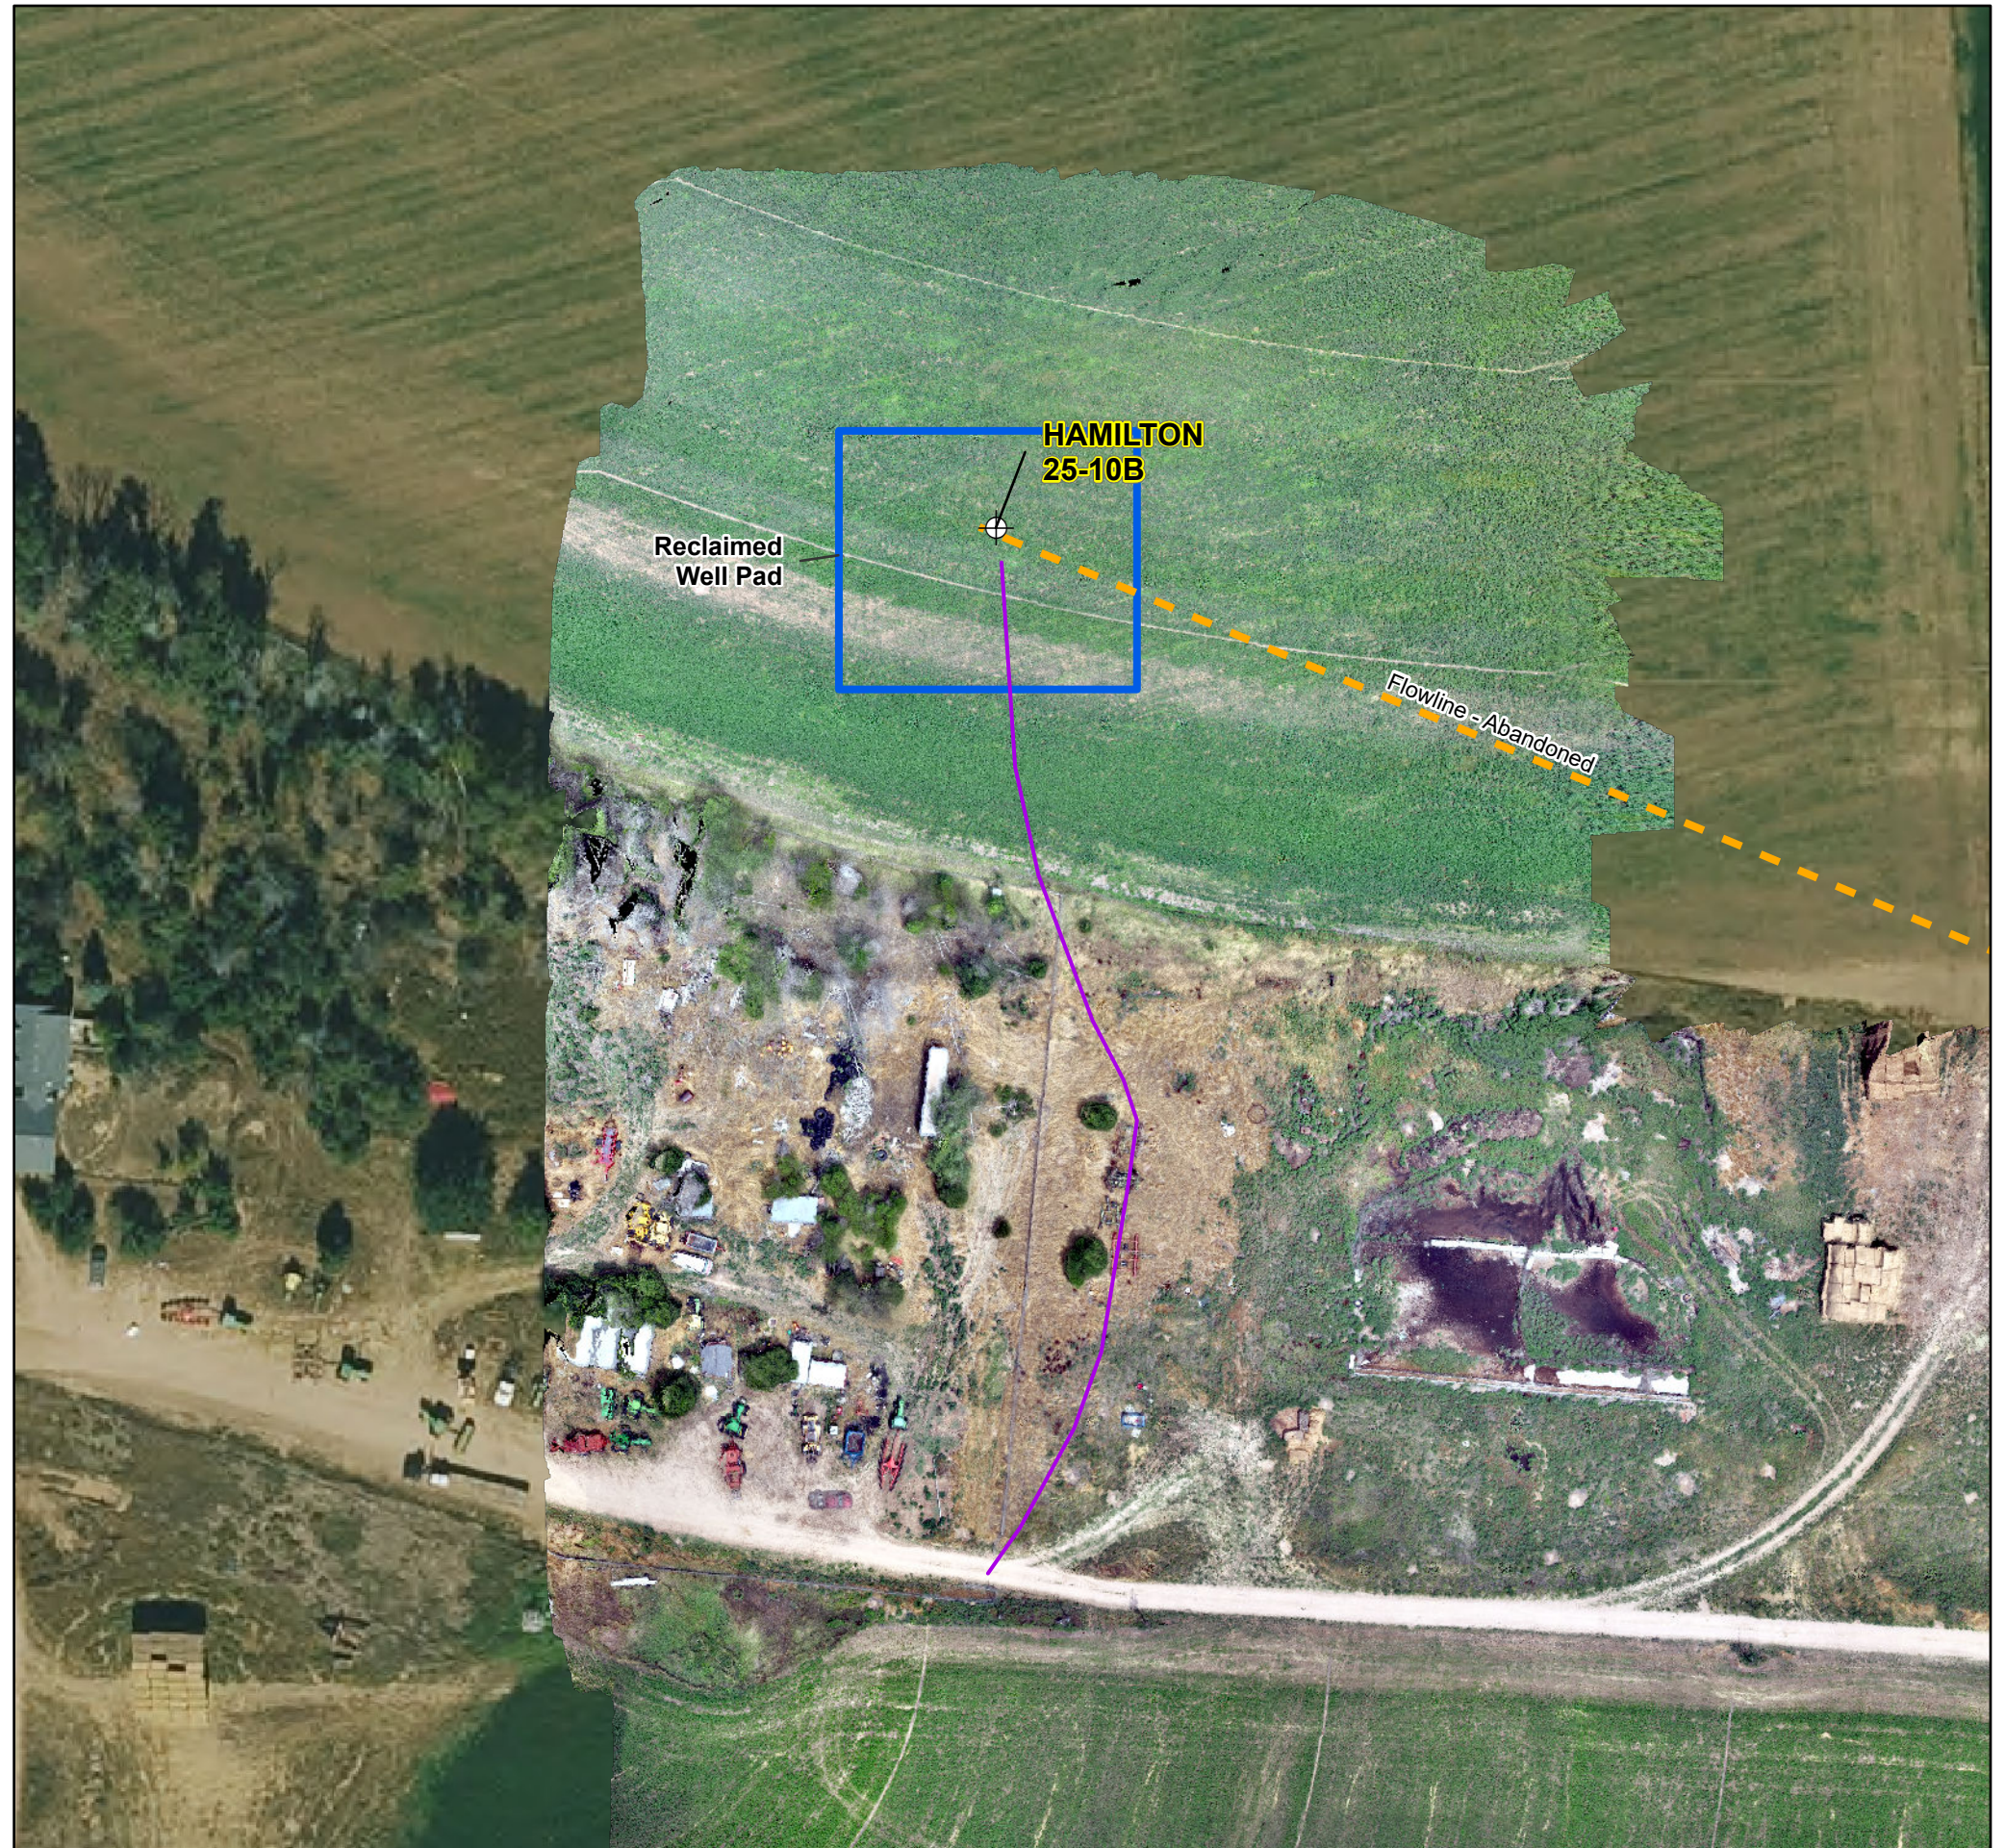
### Form 4 Final Reclamation - Post Plugging Overview

Drone imagery confirms that no equipment was left on site at this location after reclamation activities occurred.
