# Inspection Photos

Operator: Chevron USA Inc #16700

Location ID: 315050

Inspection Doc: 719201157

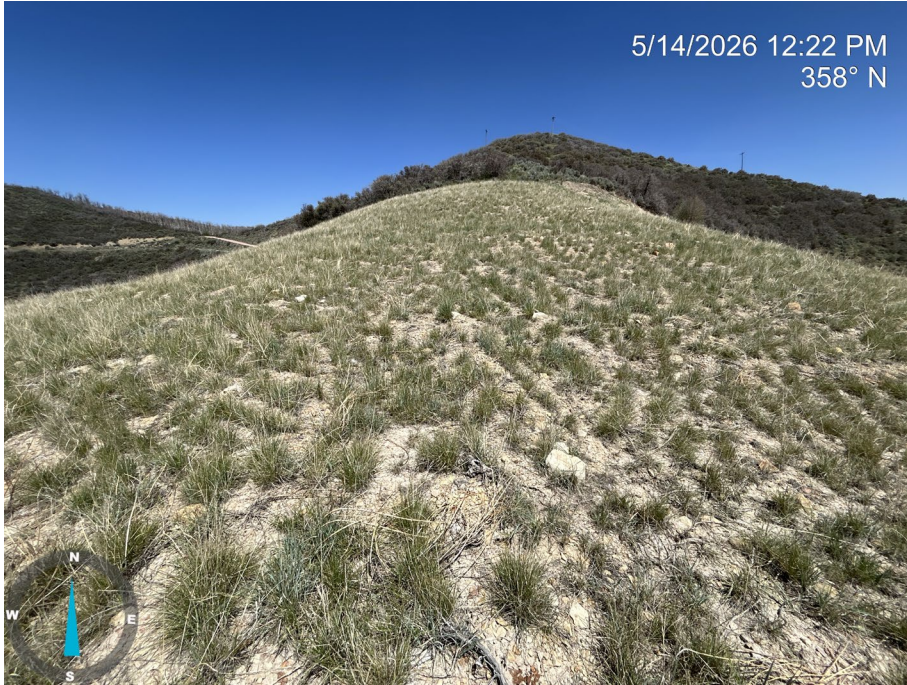
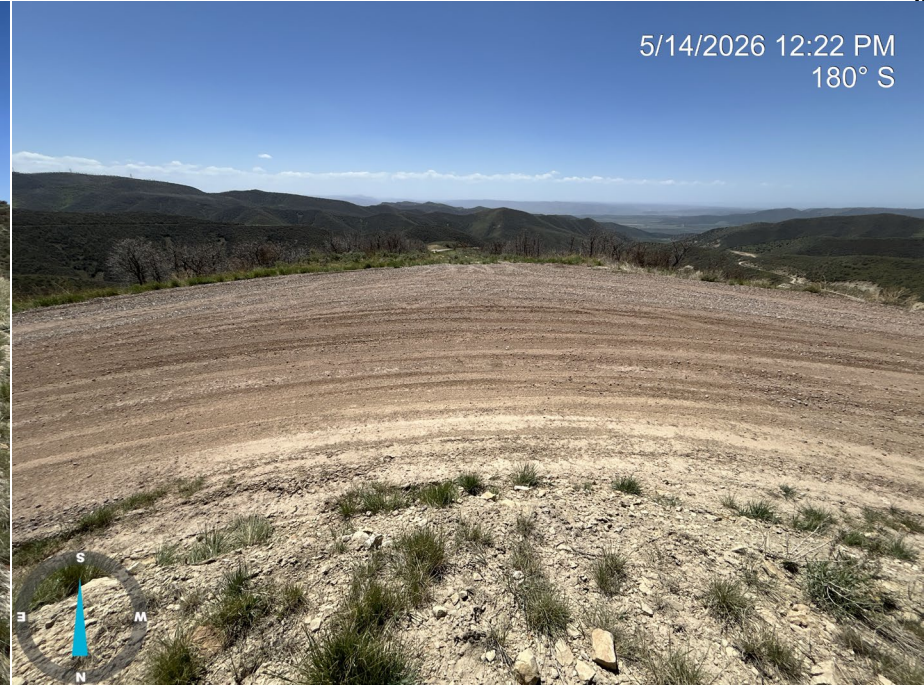
**Photo 1:** Photo left looking north at the location from the toe of the reclaim. Photo right looking south at the access road that runs along the toe of the location.

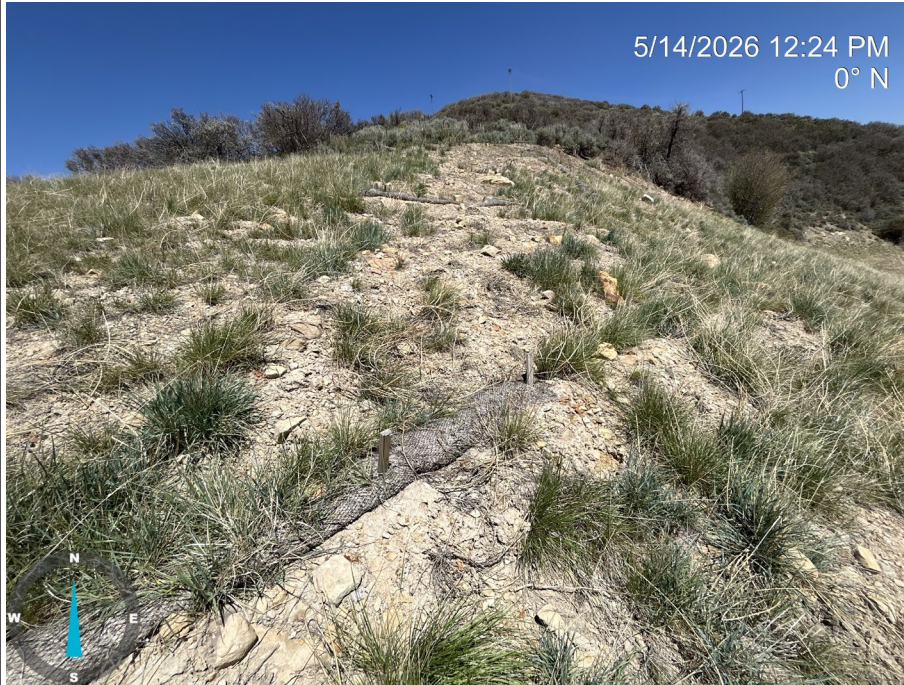
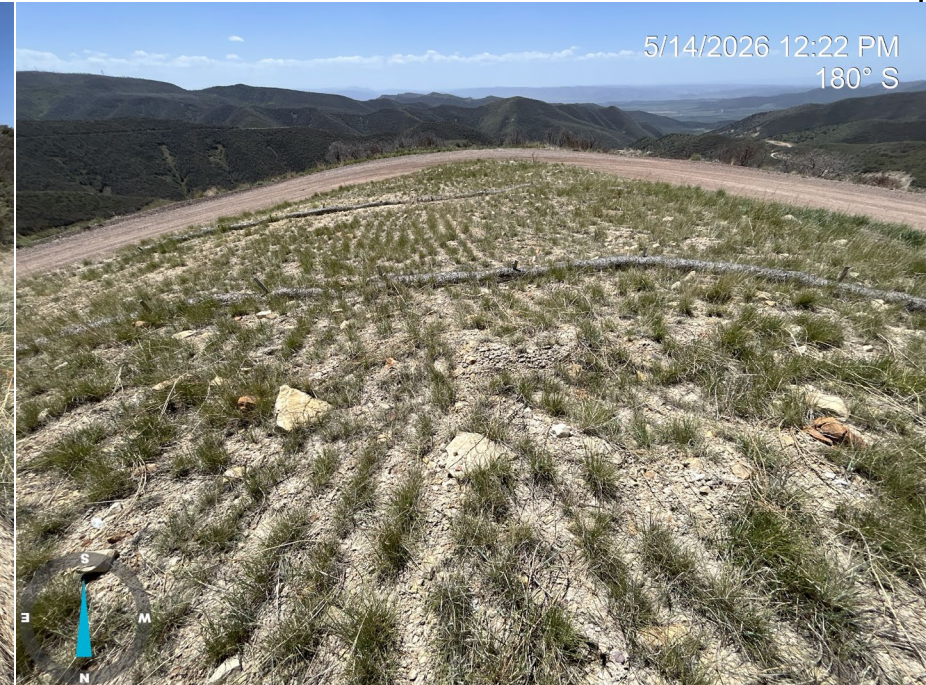
**Photo 2:** Photos showing an overview of the location looking north and south, respectively.

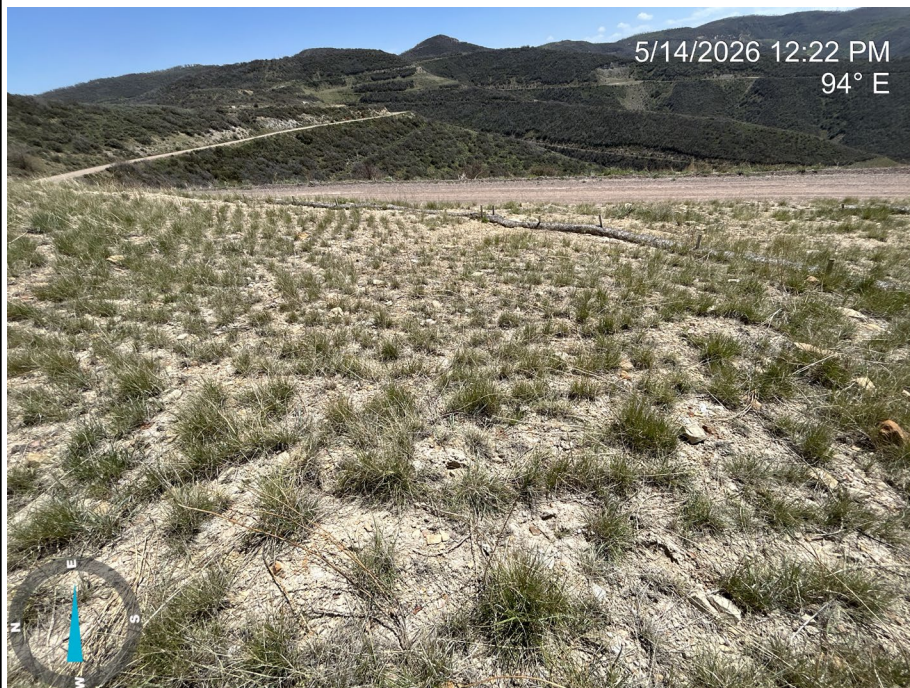
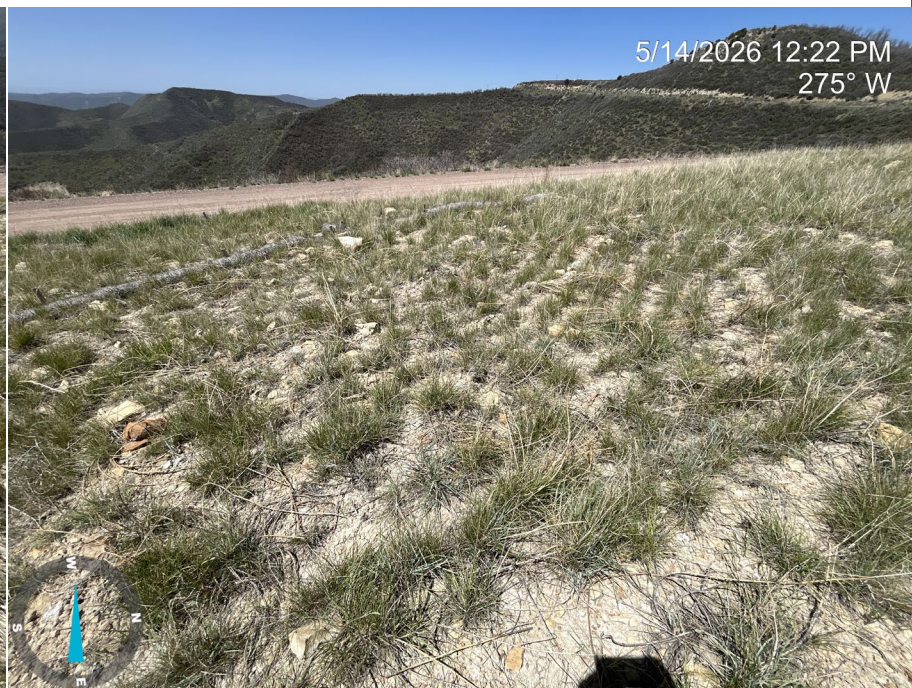
**Photo 3:** Photos showing an overview of the location looking east and west, respectively.

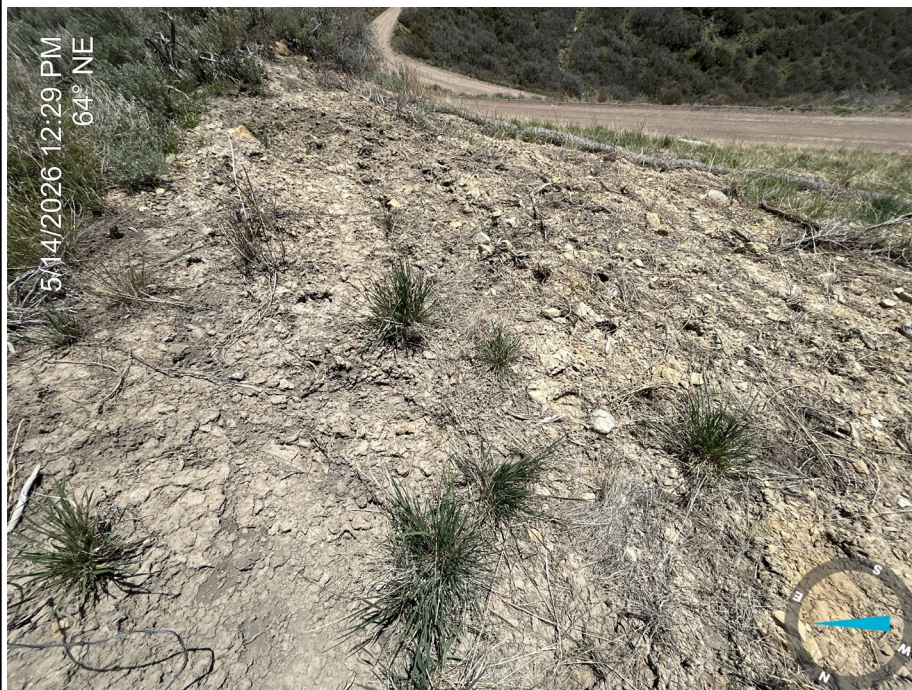
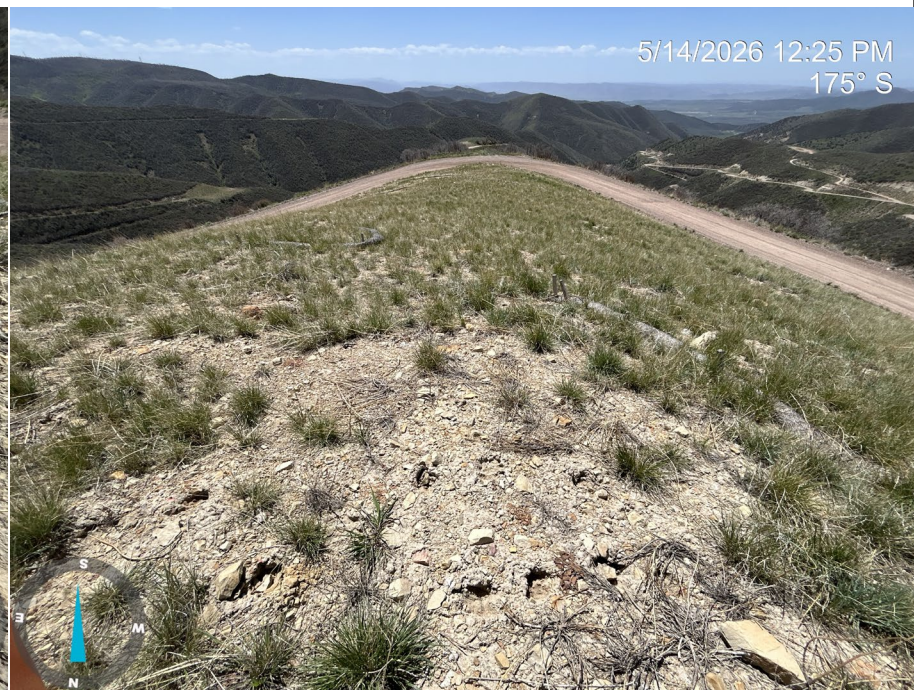
**Photo 4:** Photos showing that desirable, perennial vegetation on some portions of the location have not yet reached uniformity.

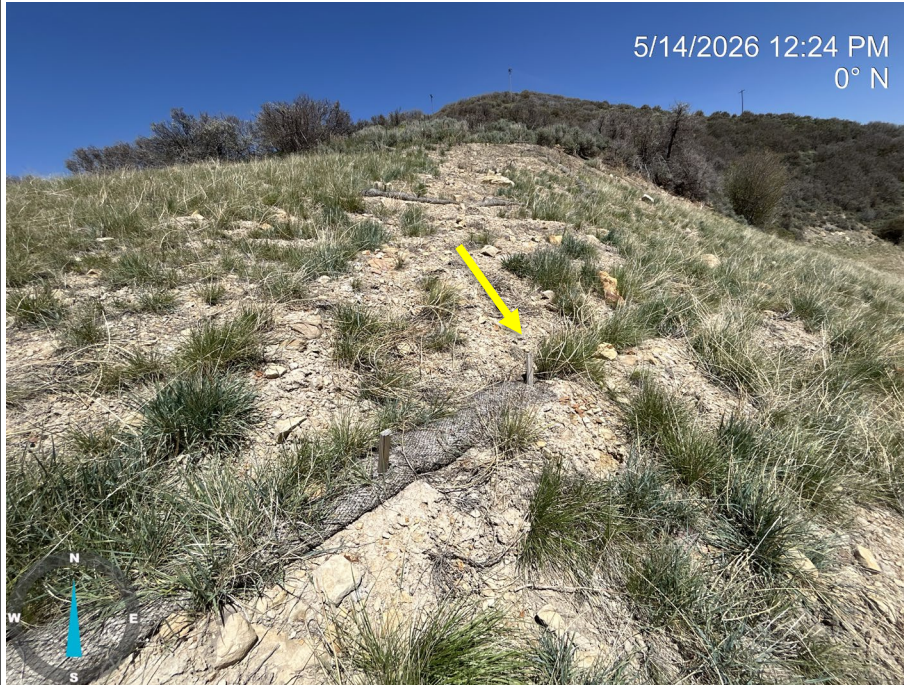
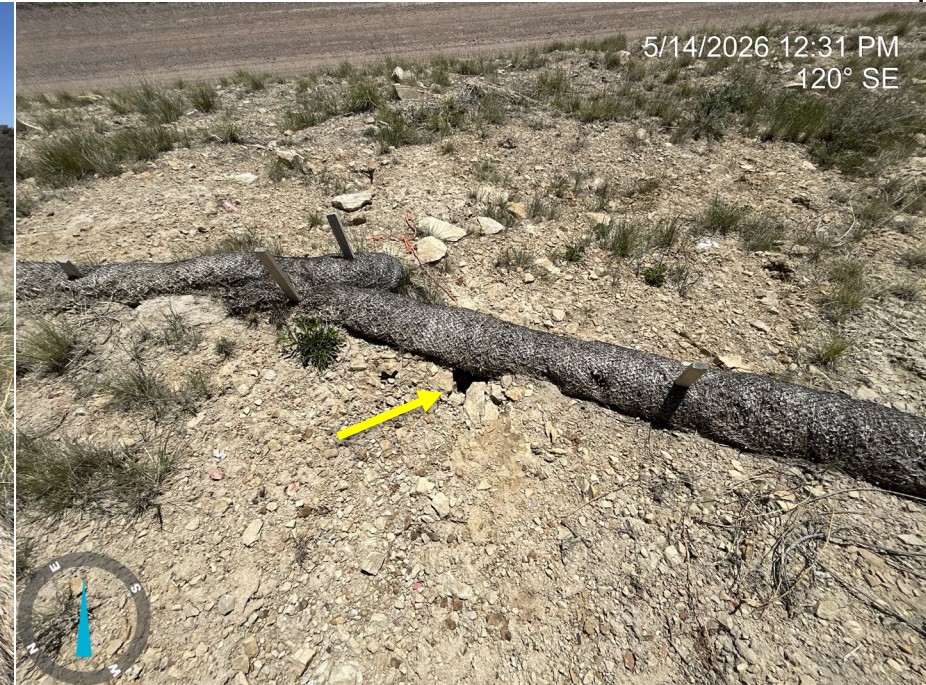
**Photo 5:** Photos showing some stormwater controls need maintenance (yellow arrows); some wattles are overtopped with sediment and some have erosion/soil piping occurring underneath.

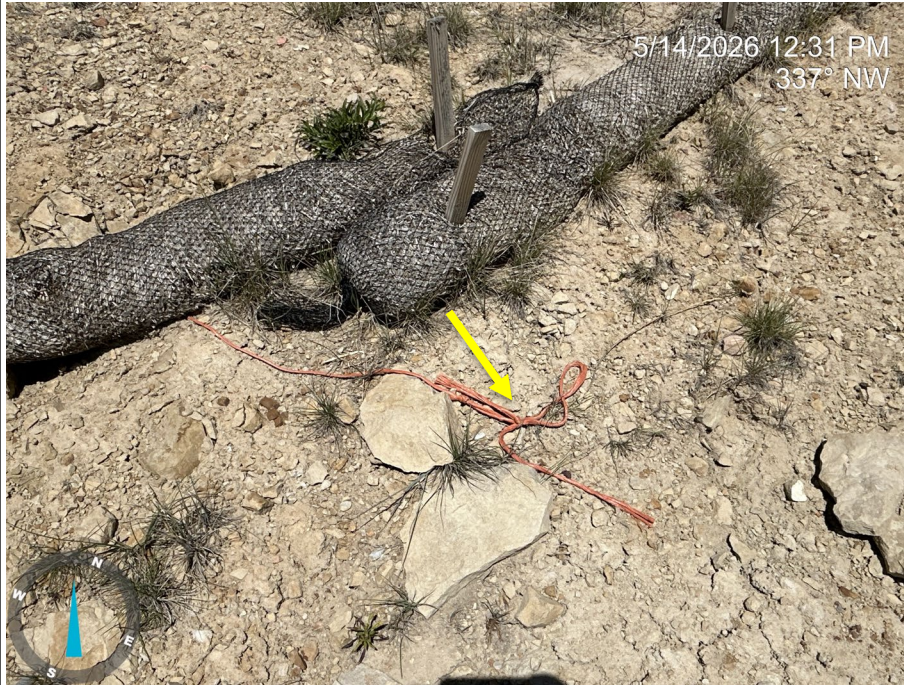
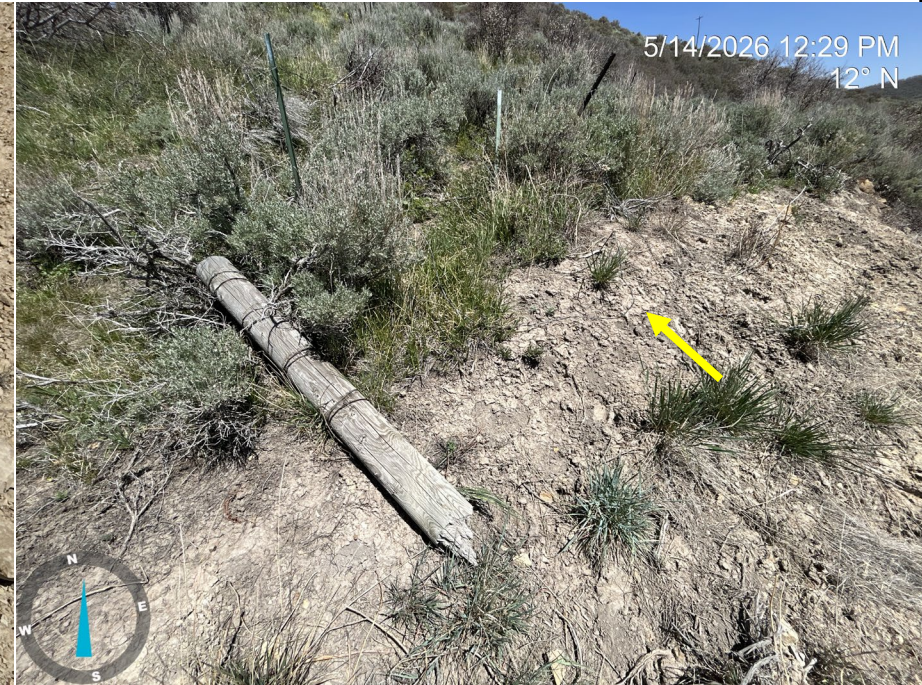
**Photo 6:** Photos showing examples of twine trash that is scattered throughout and downed fencing and barbed wire on the northern portion of the location.

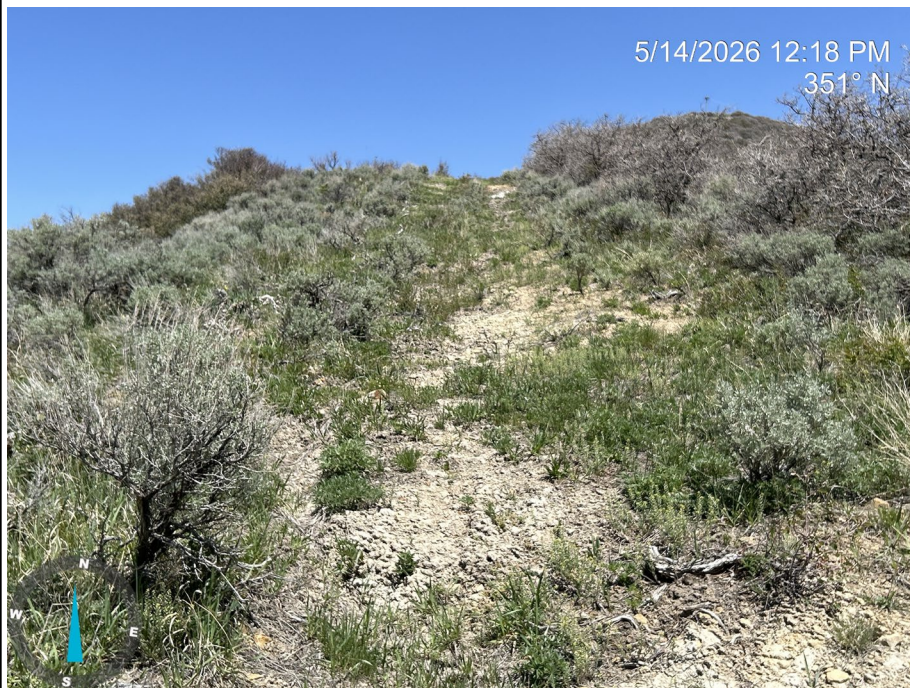
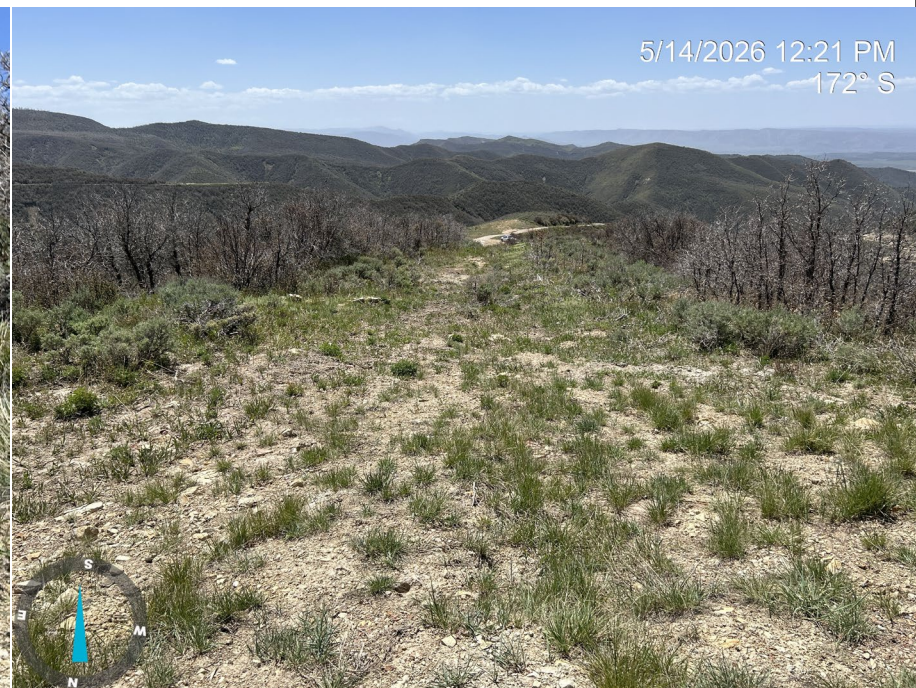
**Photo 7:** Photos showing the reclaimed utility line ROW located directly south of the location.

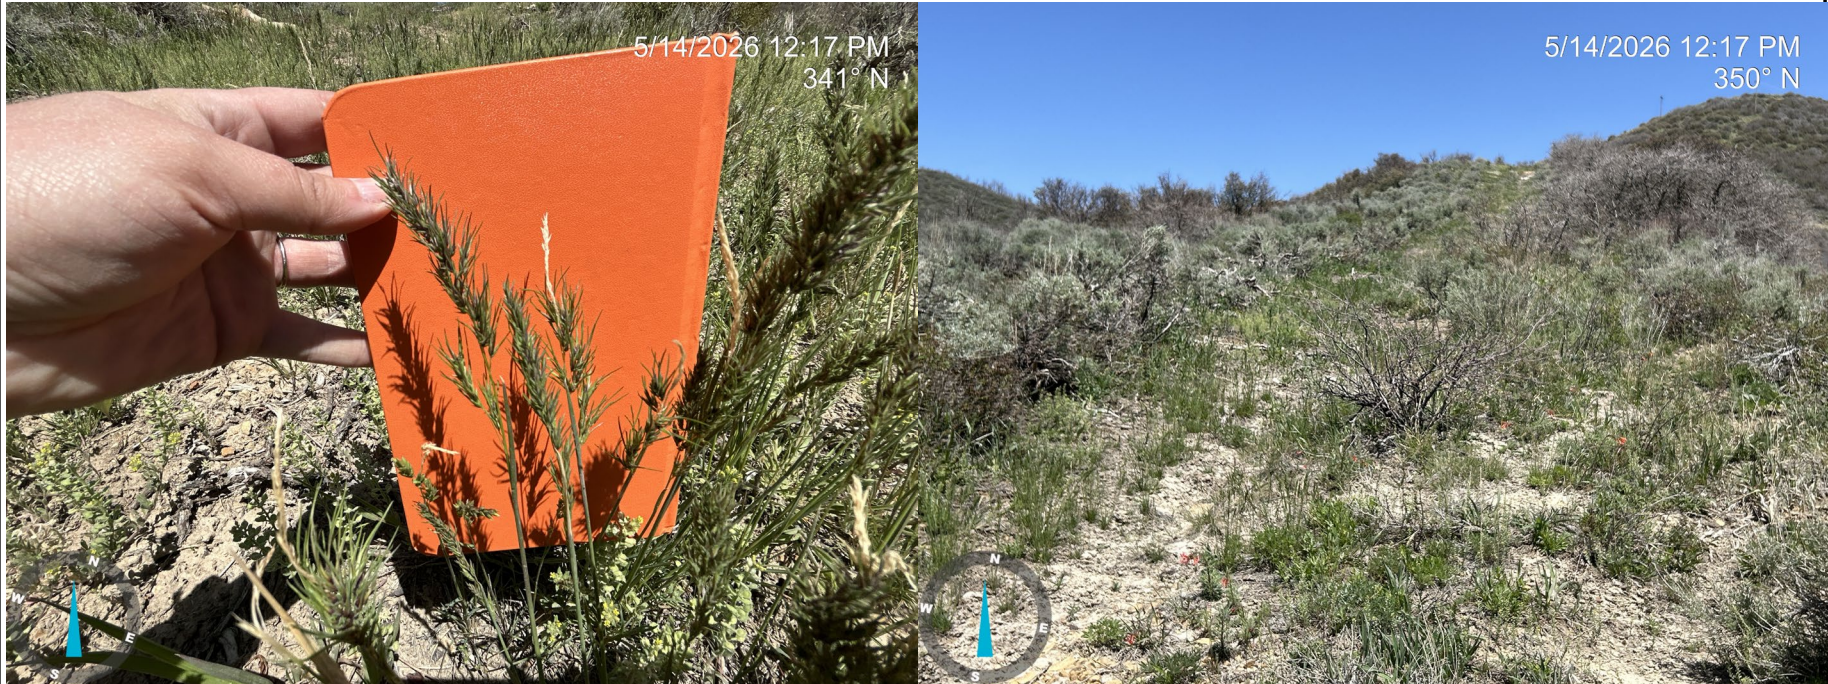
**Photo 8:** Photos showing tertiary amounts of bulbous bluegrass and a weedy mustard (*Alyssum* sp.), both undesirable plant species, that is present at the intersection of the utility ROW and County Road 9. Weed control is not required at this time; however, ongoing weed maintenance and monitoring is necessary until the location receives a passing final reclamation inspection.
