Inspection Photos
Location Name: Mill Iron 1-11
API: 05-125-06316

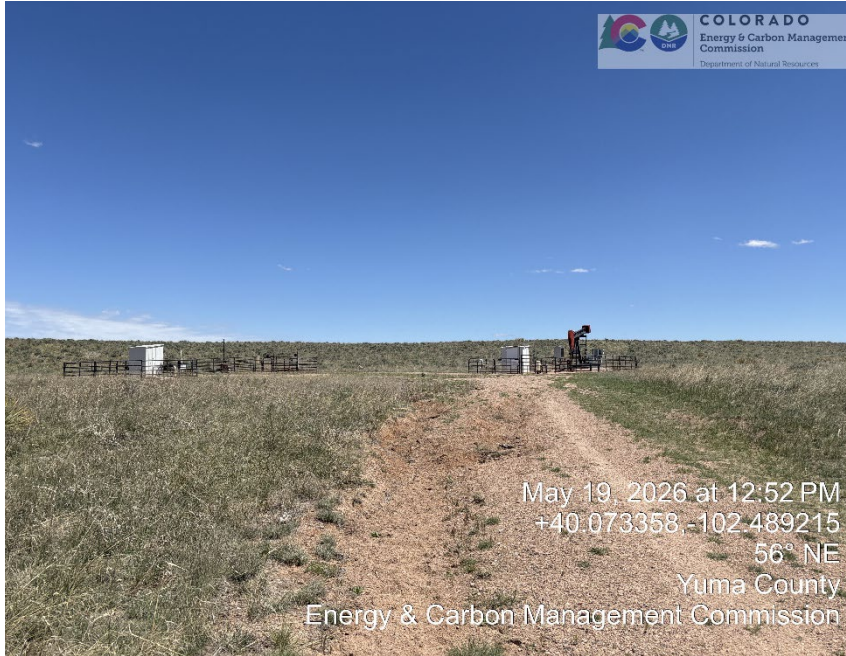
Location and Erosion

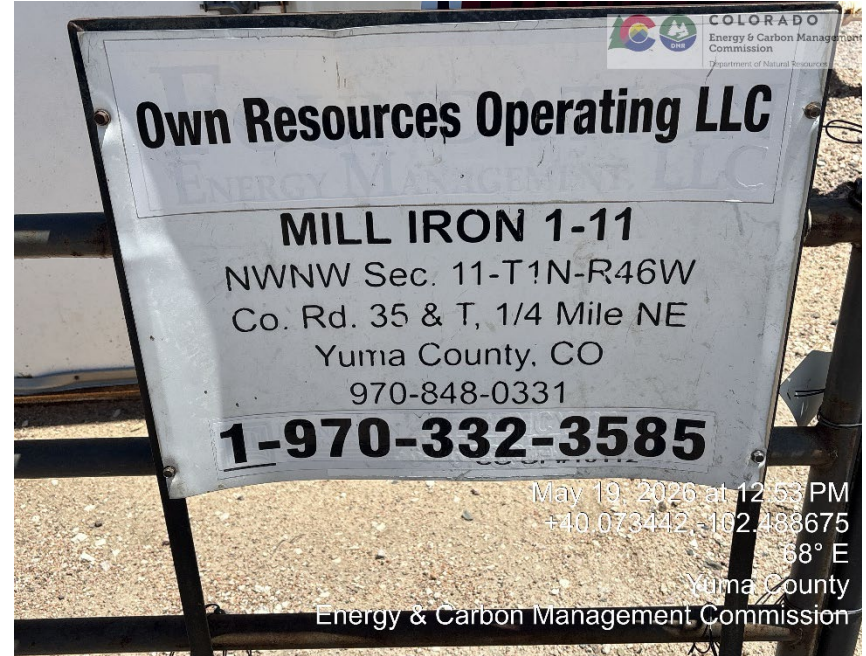
Lease sign

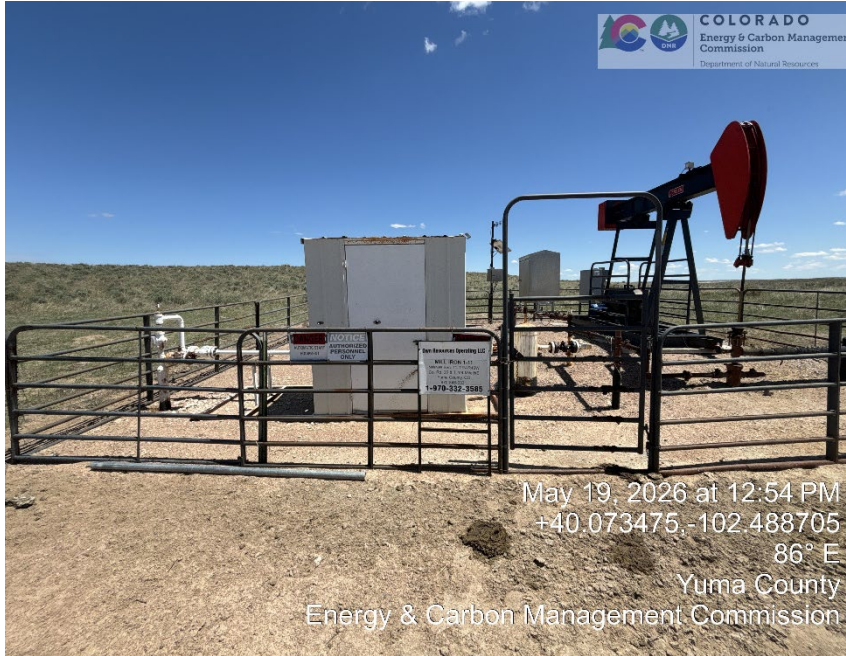
Meter run and Wellhead

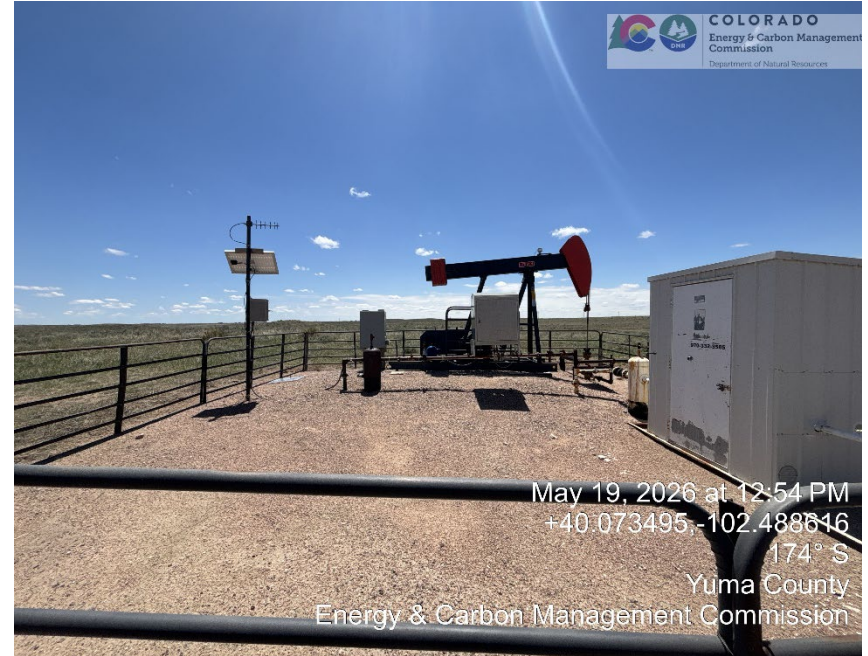
Meter run and PU

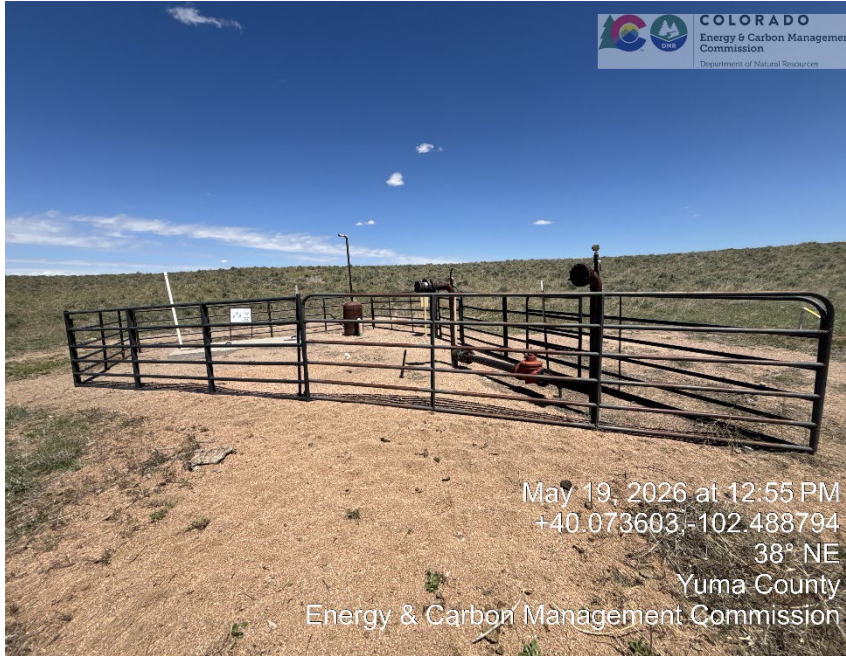
Buried tank and Unmarked risers

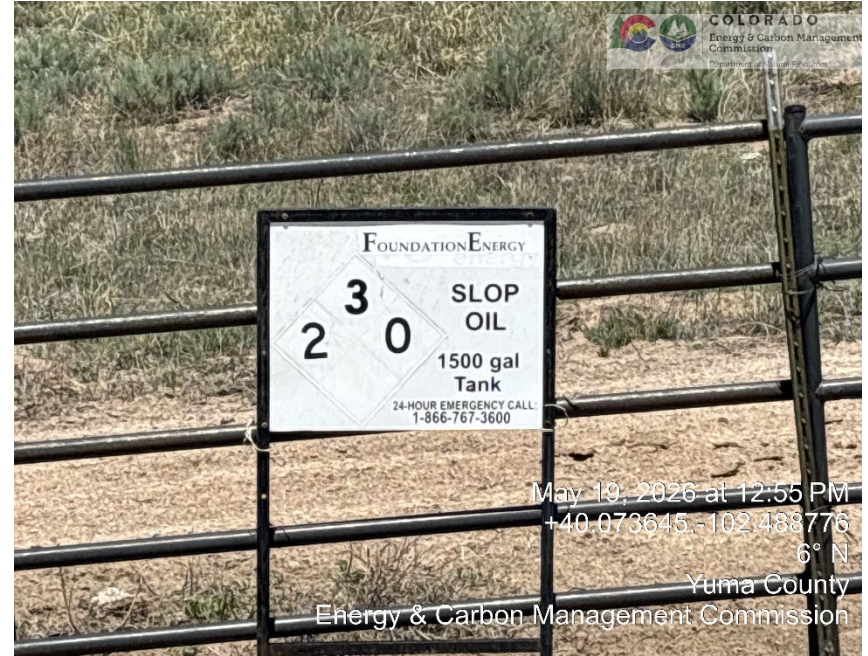
Tank sign

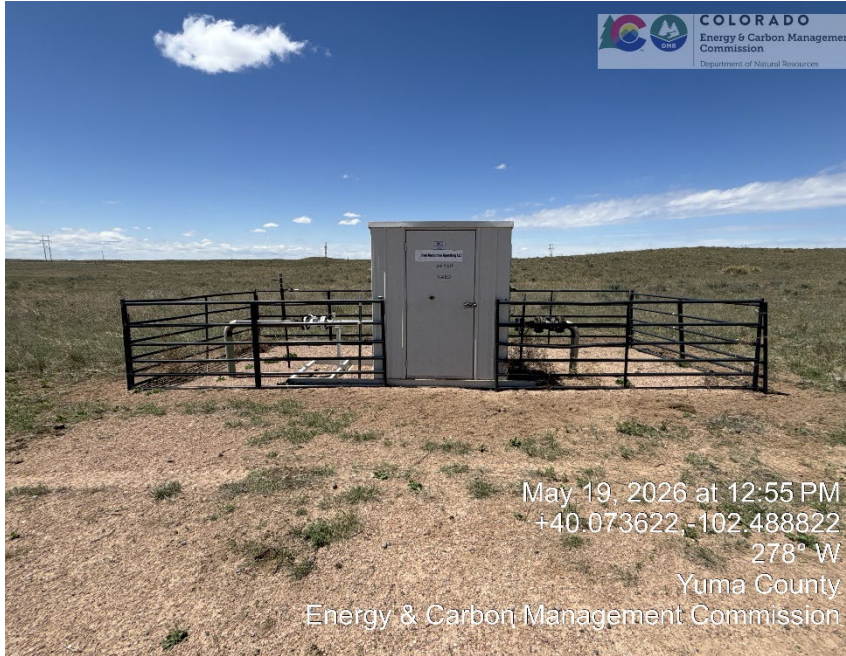
Meter shed

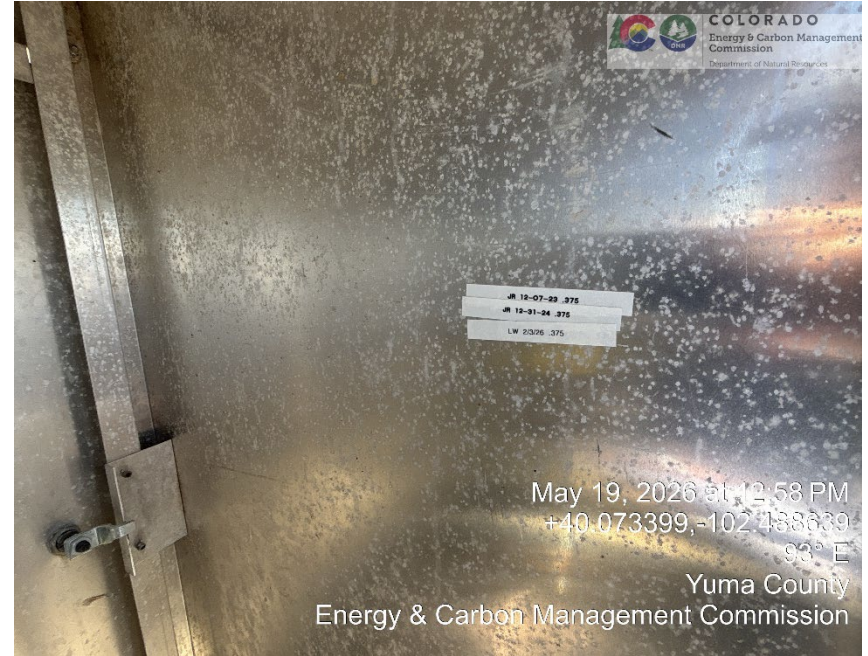
Calibration stickers
