ECMC Inspection Photos - KP Kauffman
Location ID 450409 – Lanson Farms Battery
Date 05/20/2026

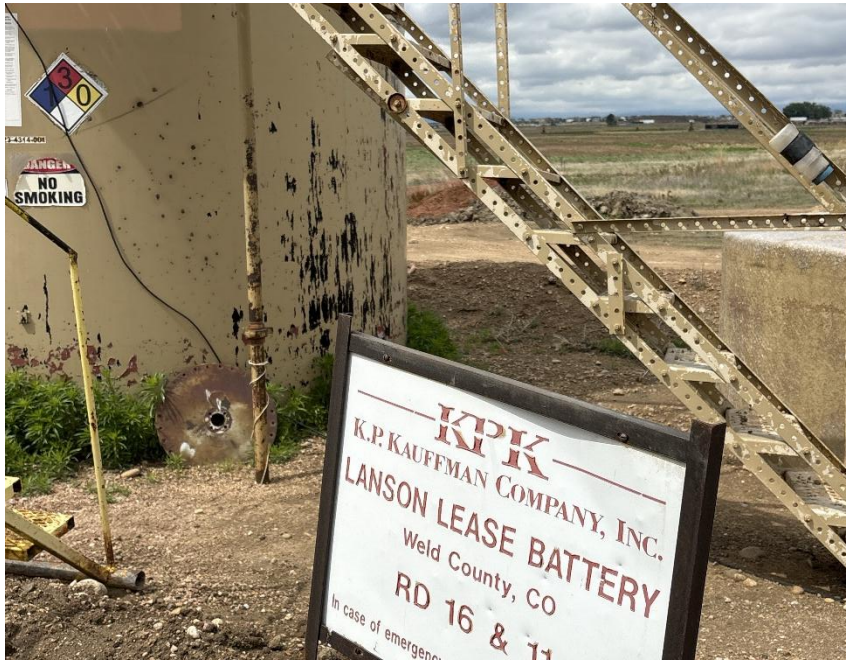
KPK Lanson Farms Battery and signage.

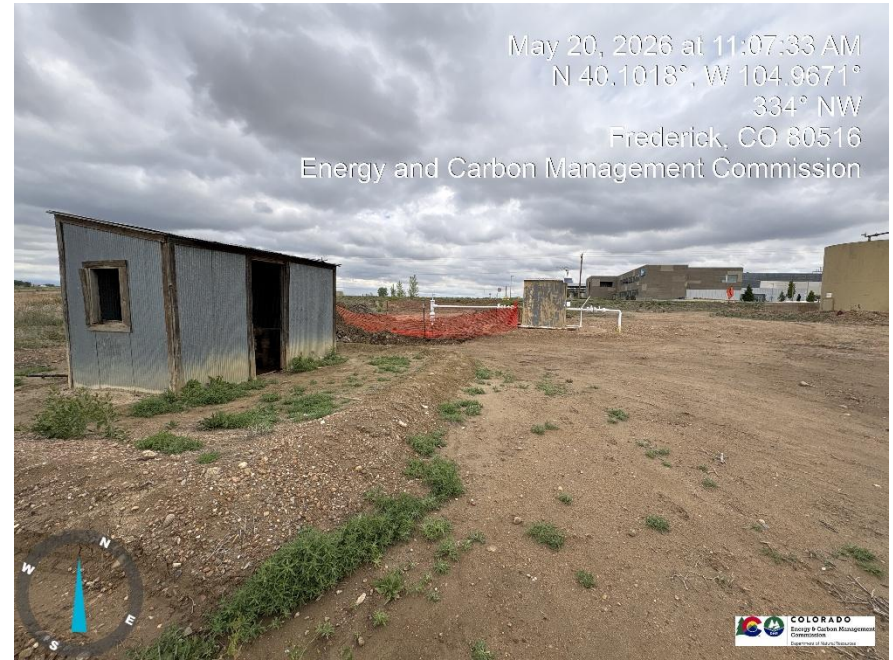
View from location looking north toward fenced excavation at the Western Midstream gas meter run. The KPK outbuilding houses a flowline manifold.

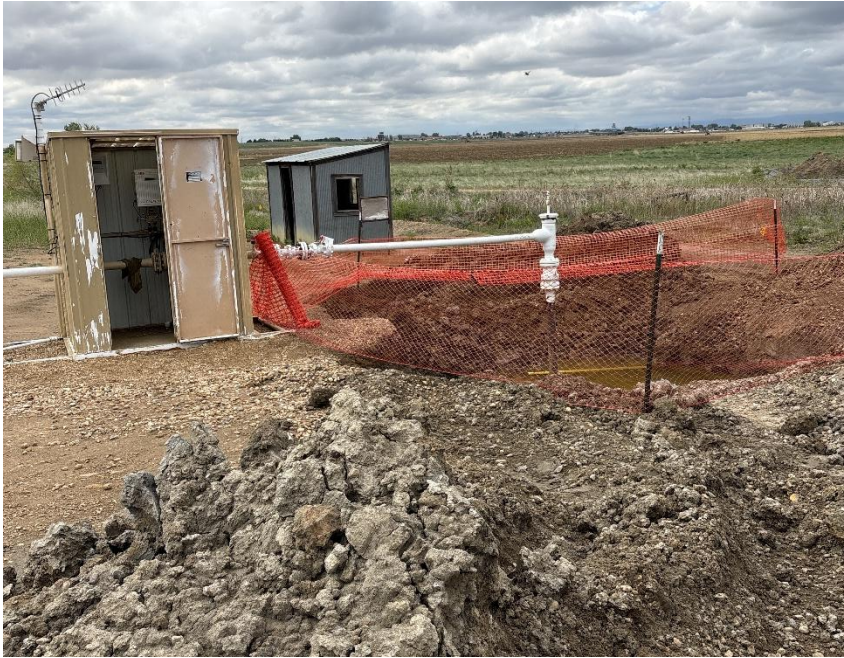
View from location looking south at fenced excavation on the west side of the Western Midstream gas meter run. The KPK outbuilding houses a flowline manifold.

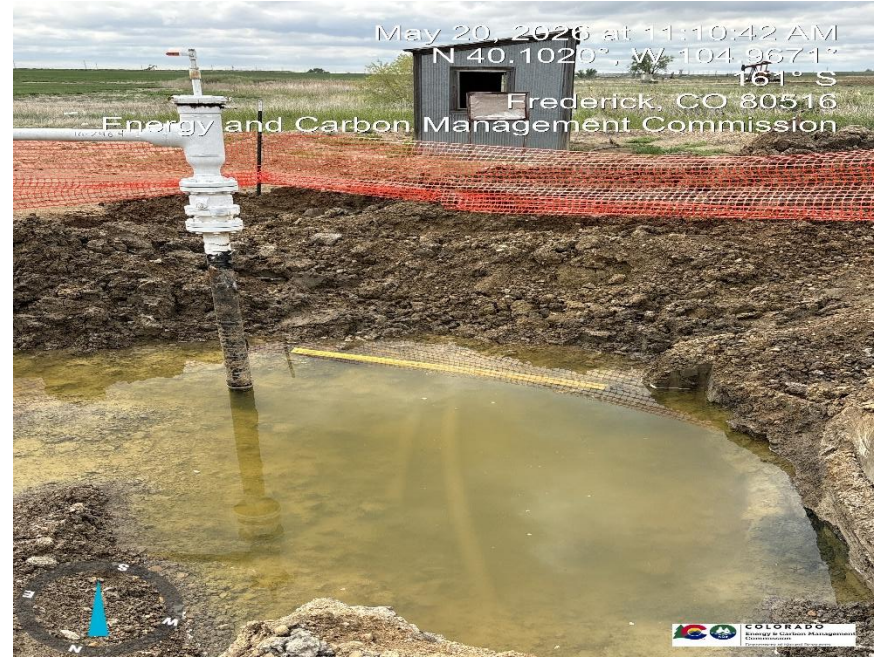
Closer view of (2) 3" fiberglass flowlines operated by KPK exposed in excavation; standing ground water in excavation.

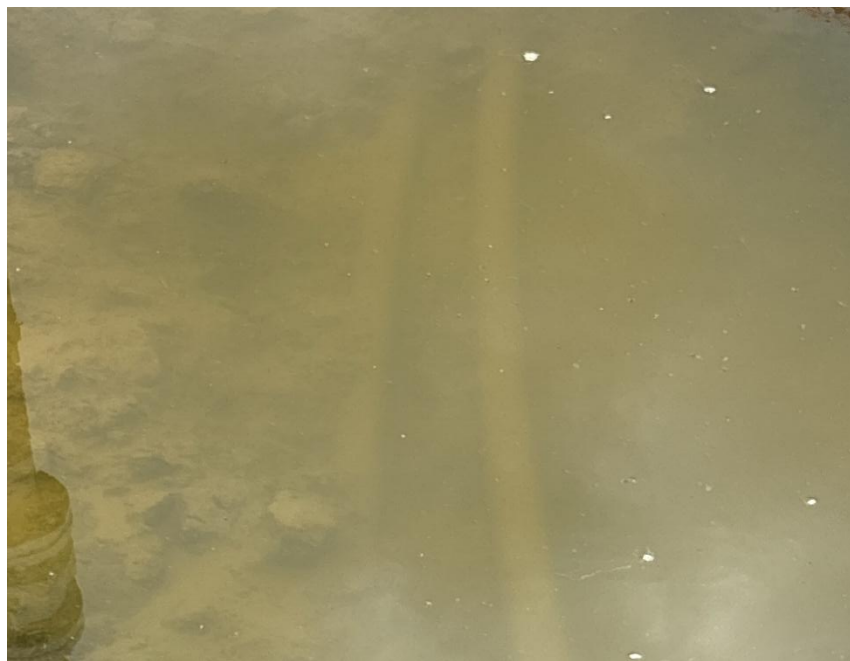
Close up view of (2) KPK 3" fiberglass flowlines unearthed in the excavation. Standing groundwater in excavation makes it difficult to see the flowlines in any detail.

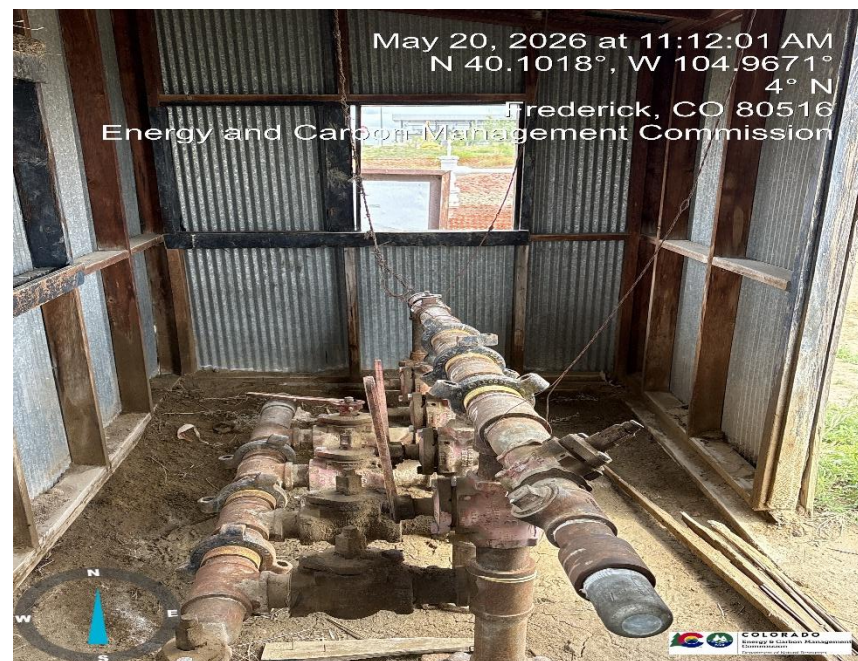
Photo of KPK Lanson Farms flowline manifold in outbuilding.
