Inspection Photos

Location Name: Simcoe – Linder A 1
Location ID: API 05-067-07419

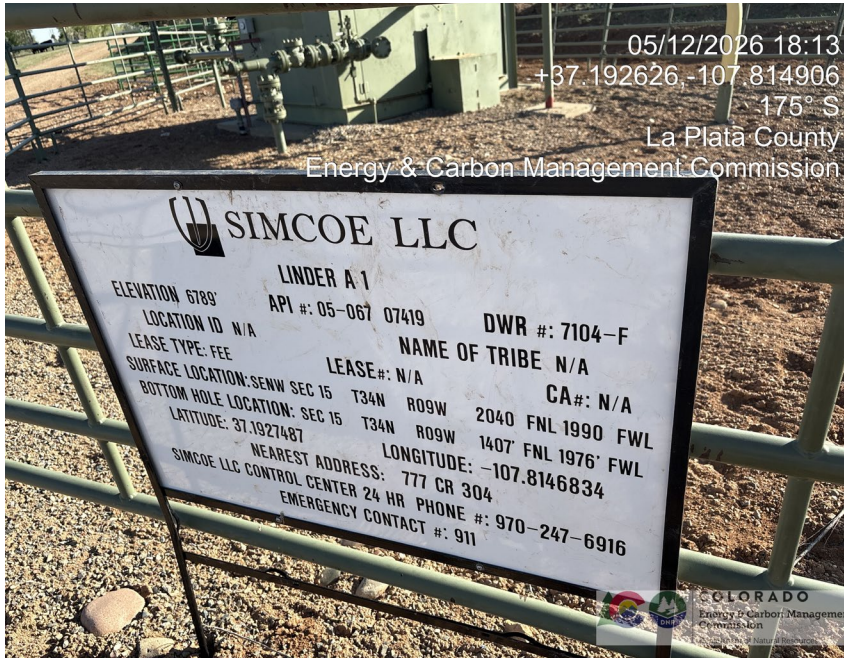
1. Well Sign.

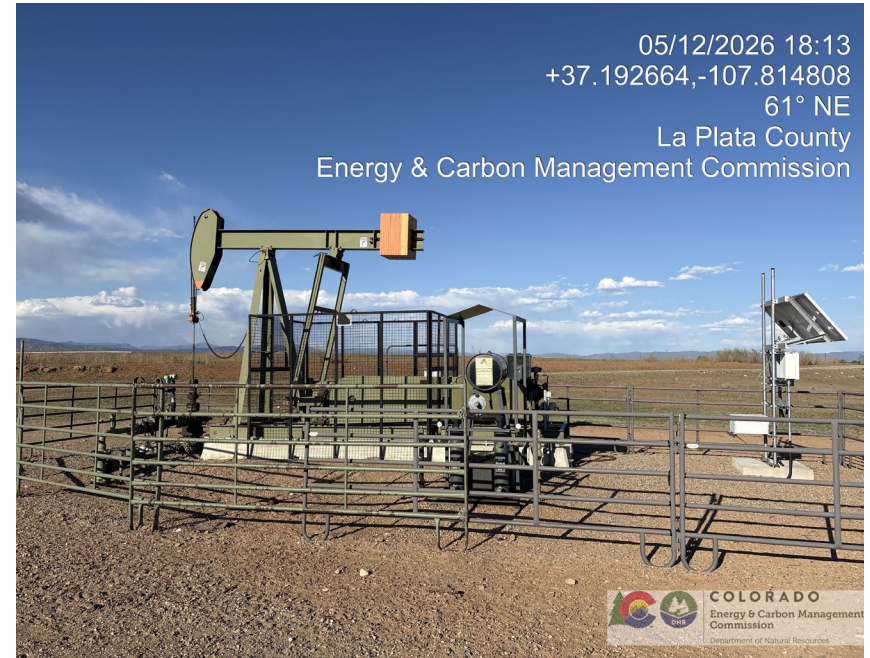
2. Wellhead, pump jack and solar telemetry behind steel cattle panel fence. There is also a black steel mesh cage around the drive portion of the pump jack.

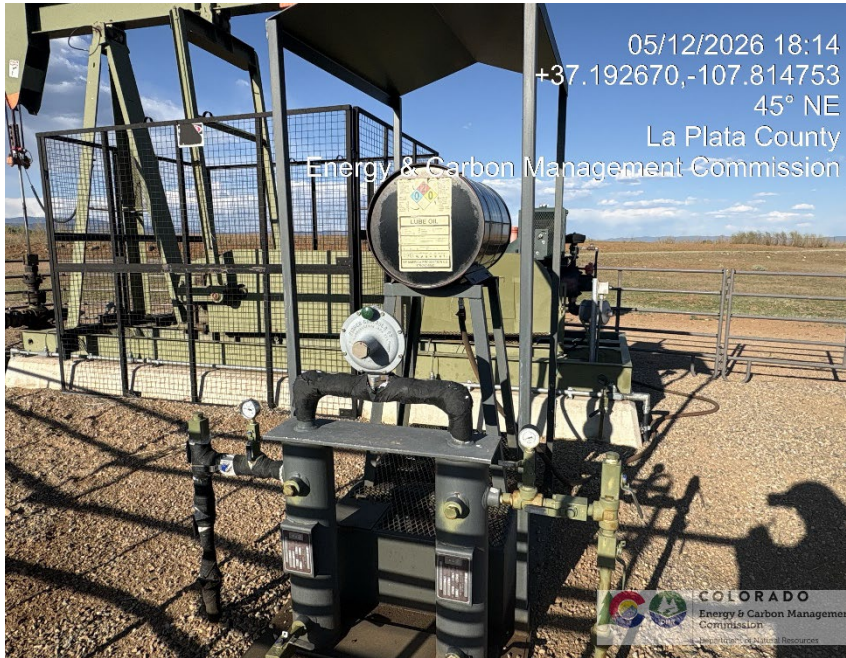
3. Lube oil container over spill prevention next to valve riser.

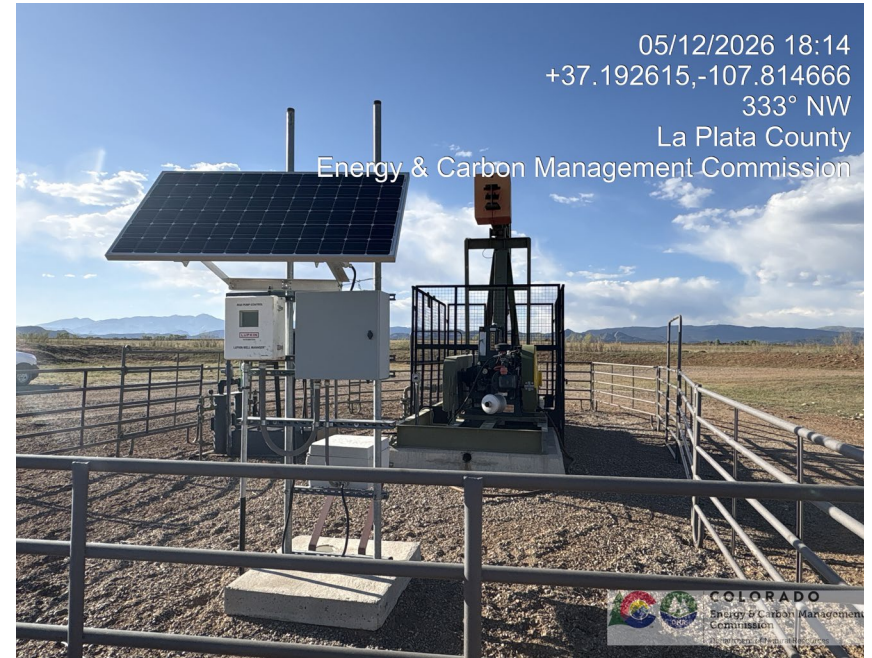
4. Solar telemetry.

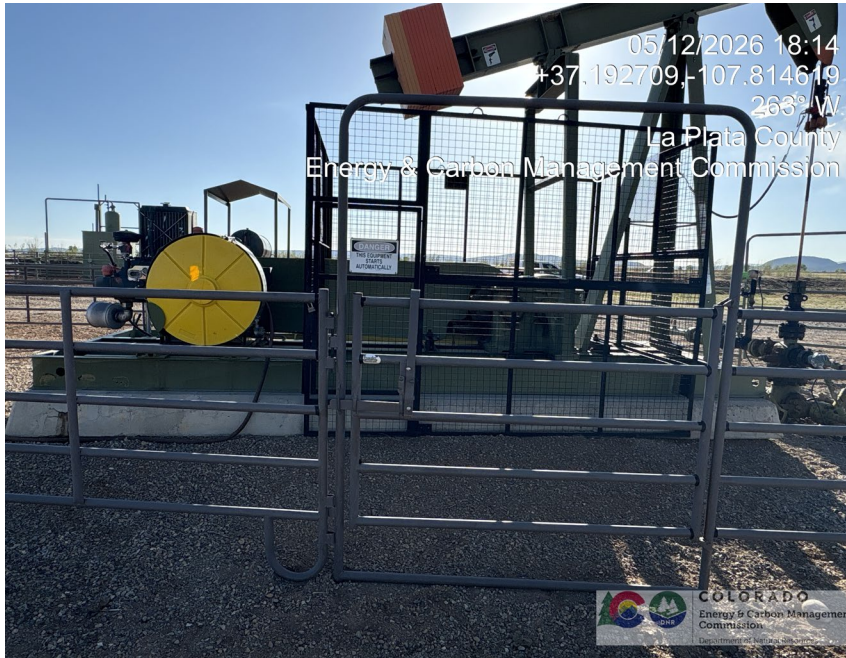
5. Well gas prime mover, pump jack, and wellhead.

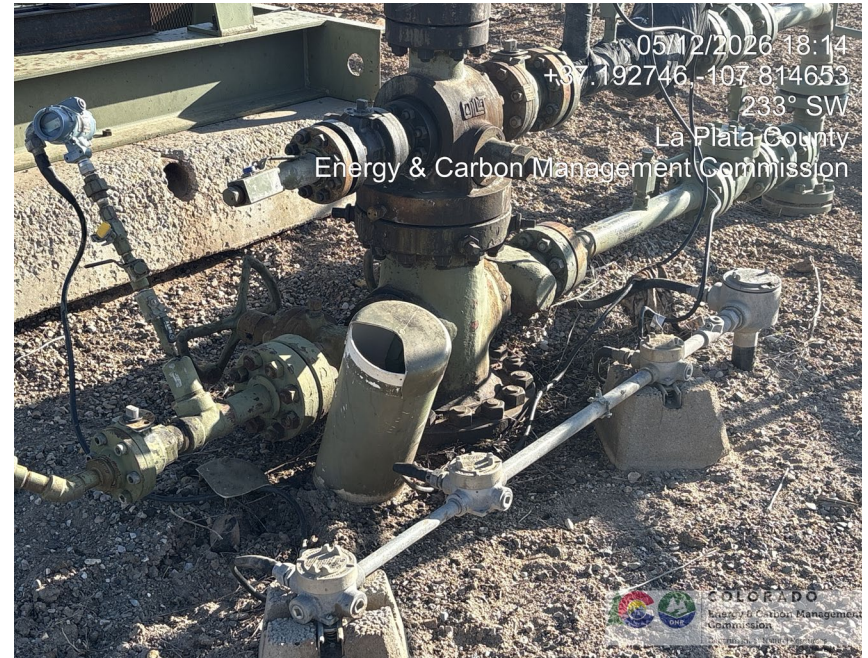
6. Wellhead.

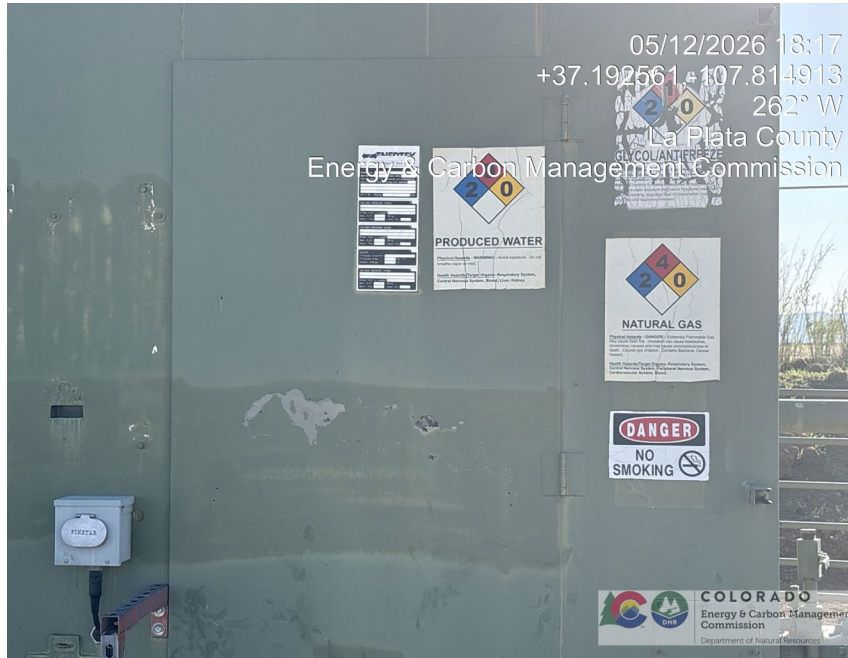
9. Vertical heated separator NFPA labels.

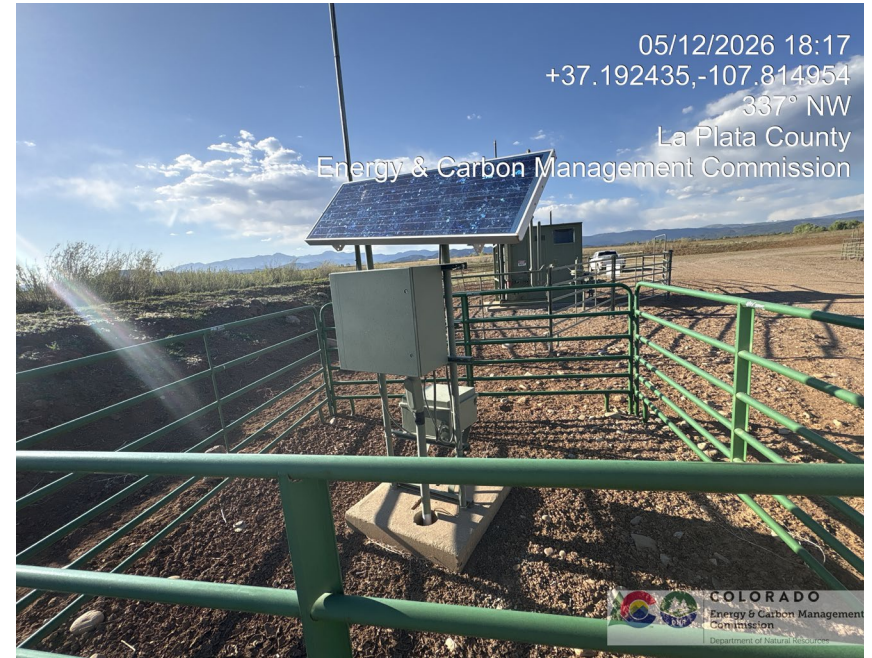
10. Solar telemetry for production equipment.
