Inspection/Audit Photos

Location Name: QB ENERGY OPERATING LLC CHEVRON 44-5D (PARACHUTE CREEK 8)

Location ID: 335766

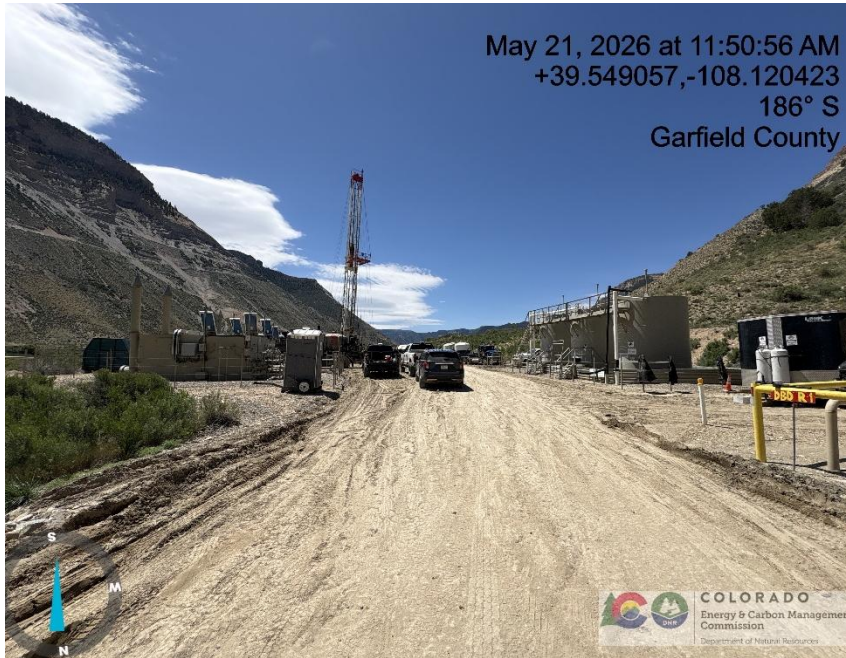
Photo # 1275 From entrance to location

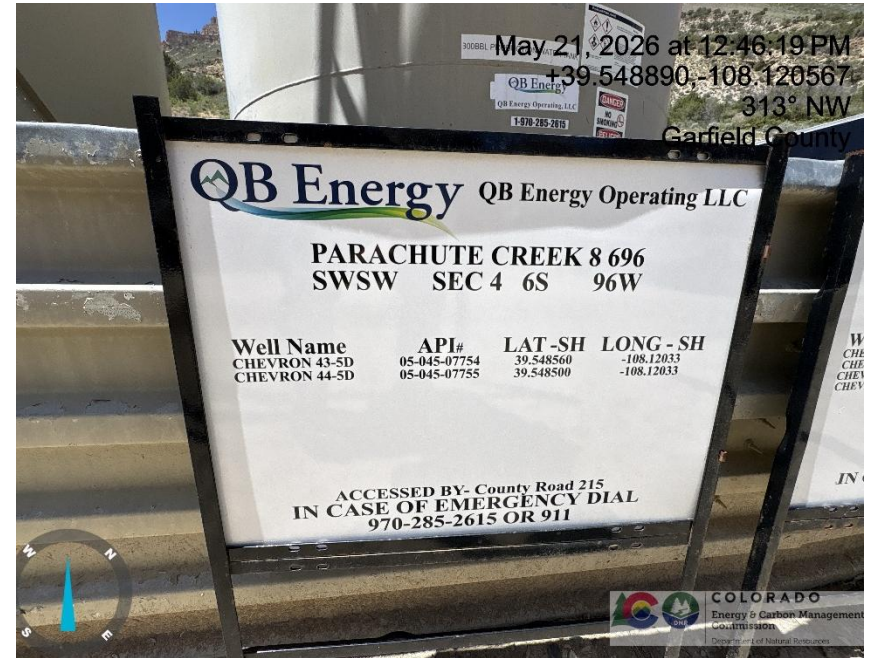
Photo # 1276 Battery sign

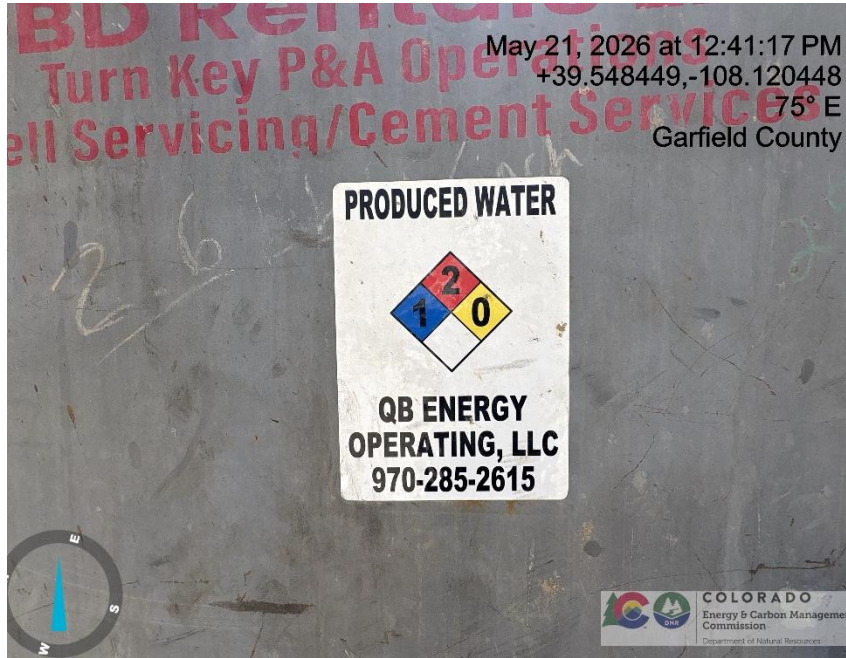
Photo # 1293 Label on rig tank lacks capacity

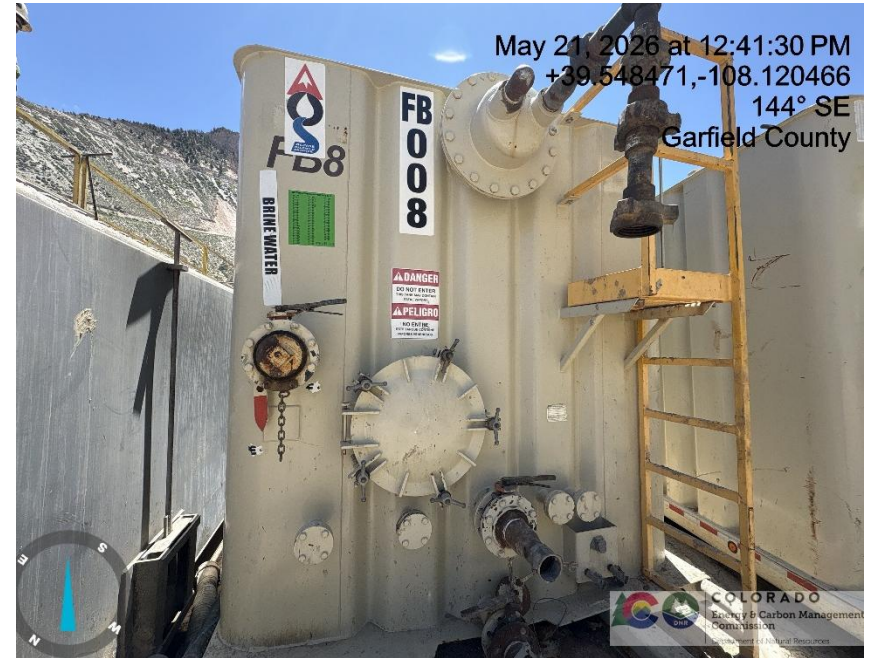
Photo # 1294 Frac tank lacks required labeling

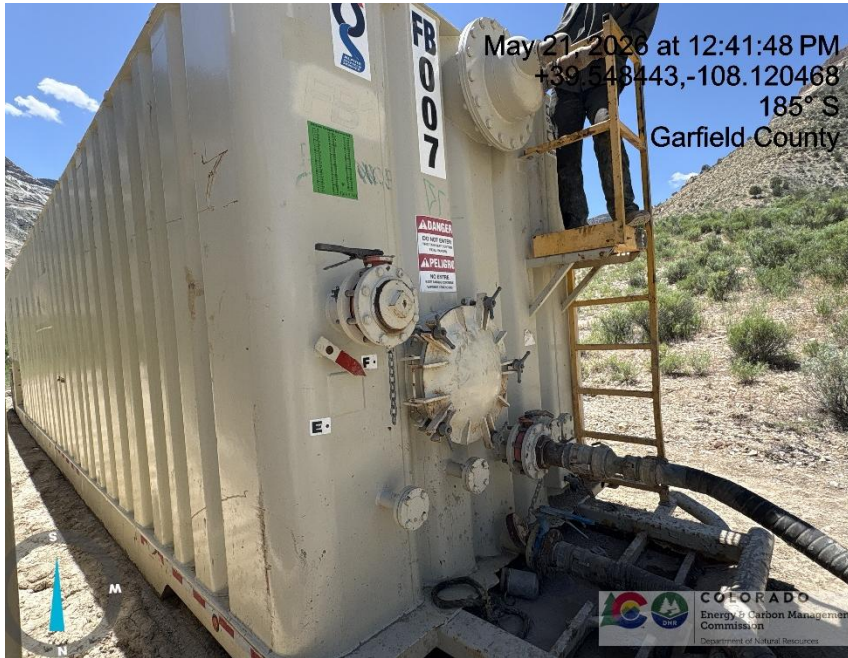
Photo # 1295 Frac tank lacks required labeling
