Inspection Photos

Operator: Wesco Operating Inc #95520

Location ID: 312877

Inspection Doc: 719201175

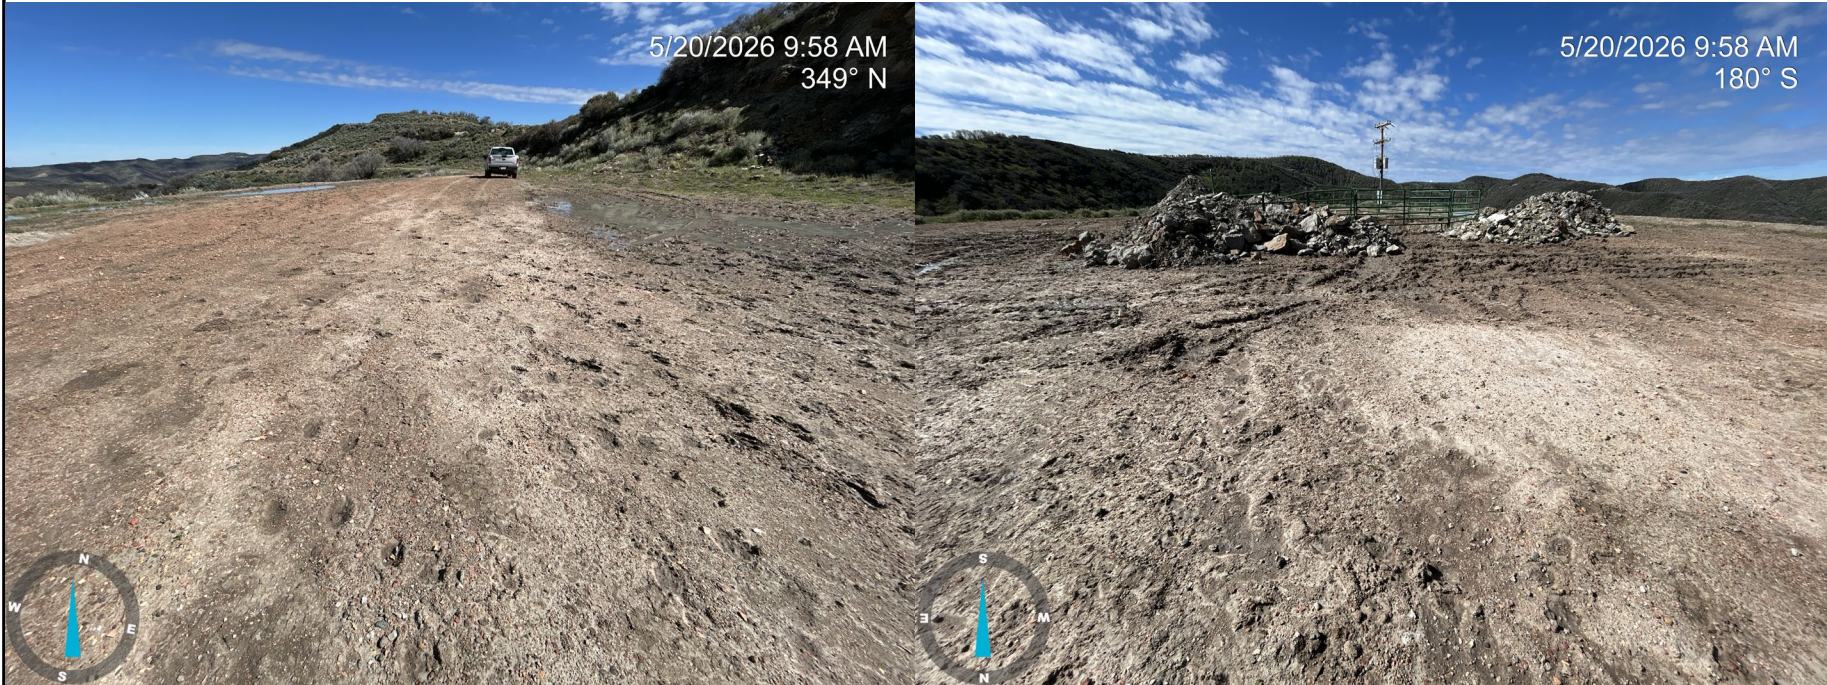
Photo 1: Photos showing an overview of the location looking north and south, respectively. Ongoing soil sampling efforts are occurring at the location.

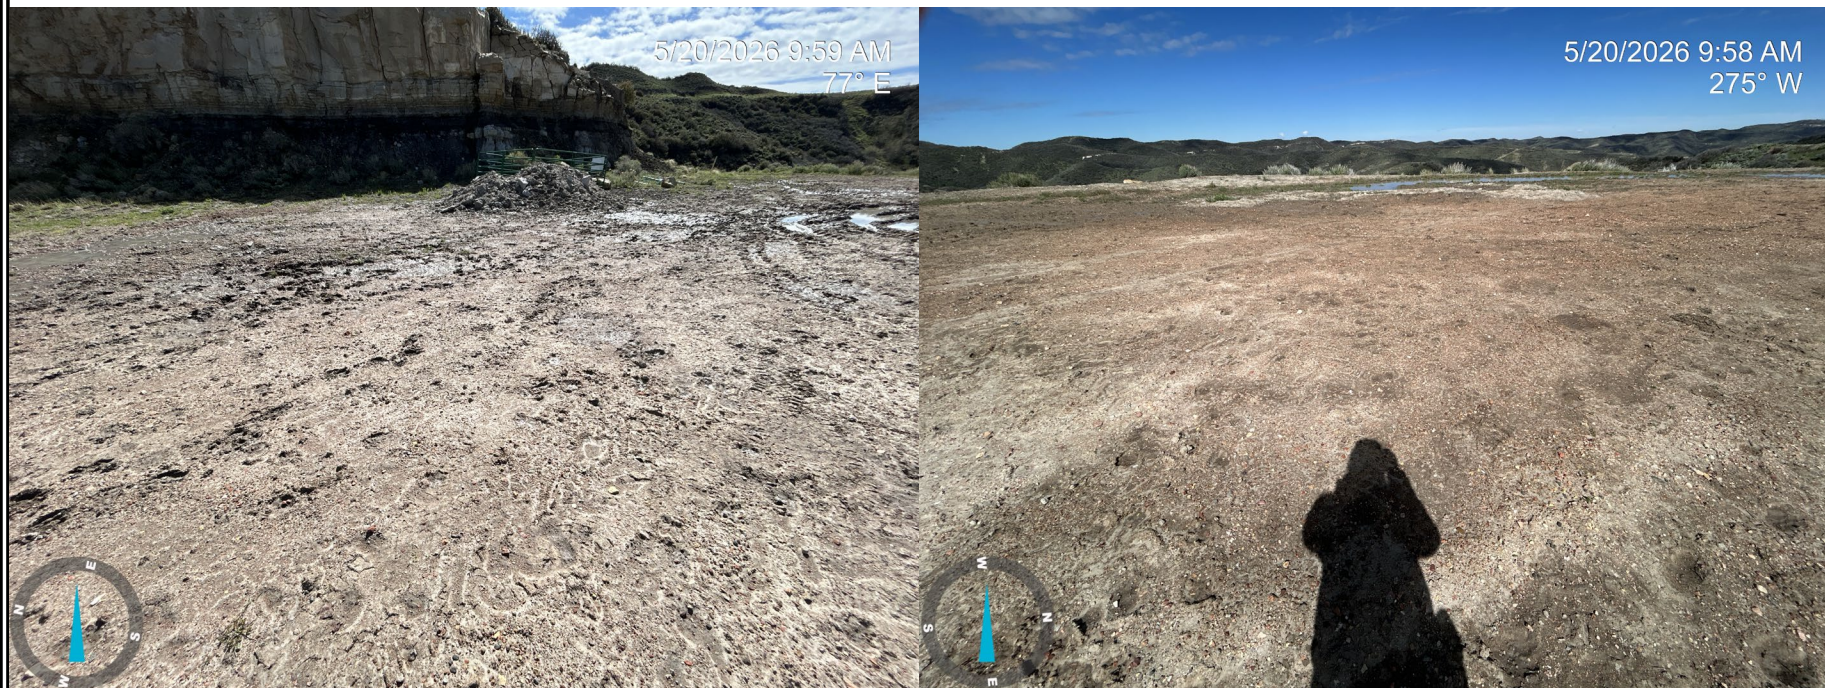
Photo 2: Photos showing an overview of the location looking east and west, respectively. Ongoing soil sampling efforts are occurring at the location.

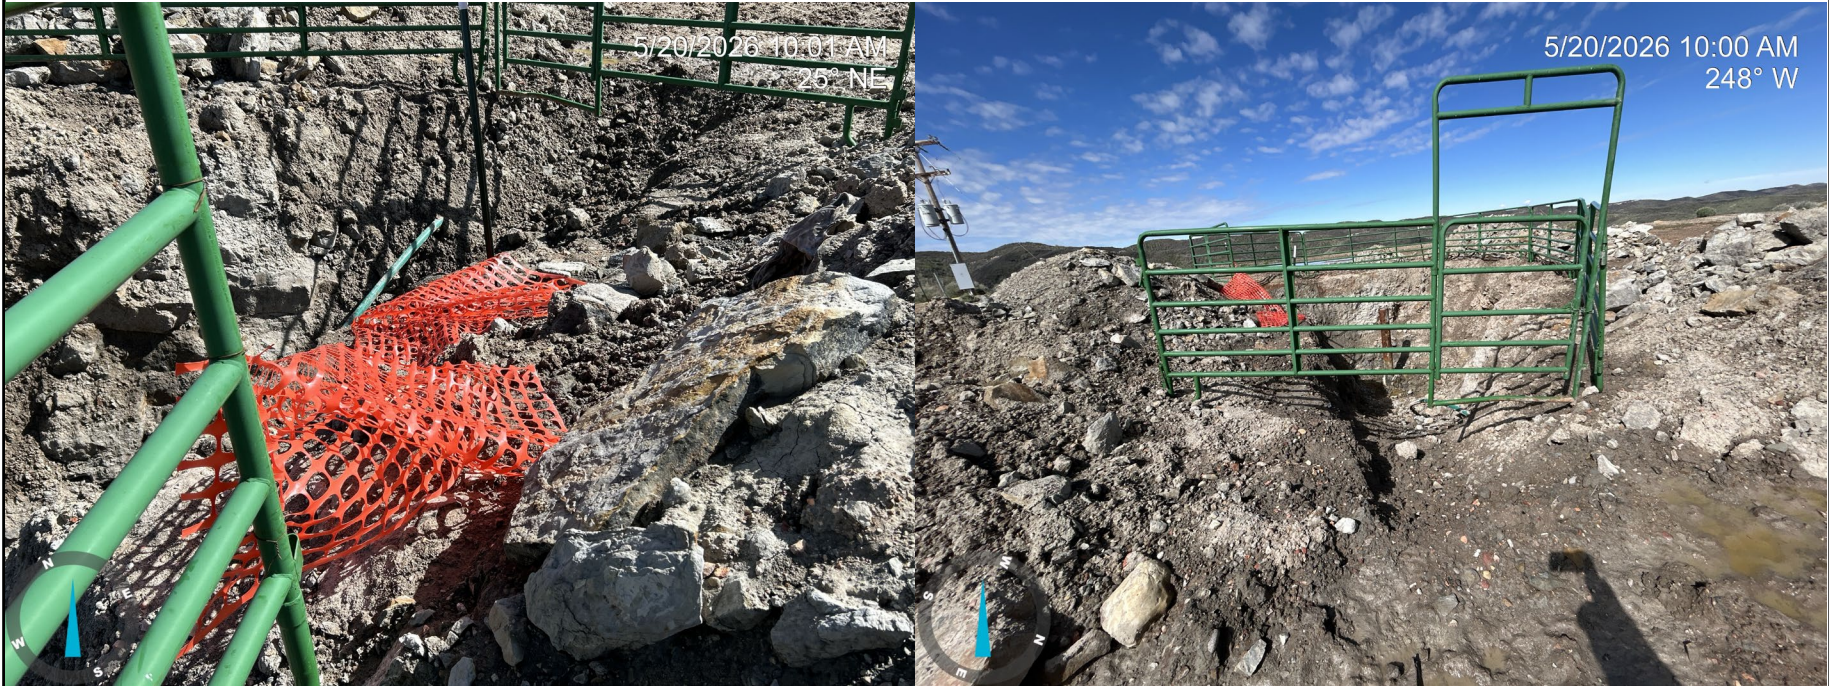
Photo 3: Photos showing orange plastic fencing around a portion of the open excavation is in disrepair and requires maintenance.

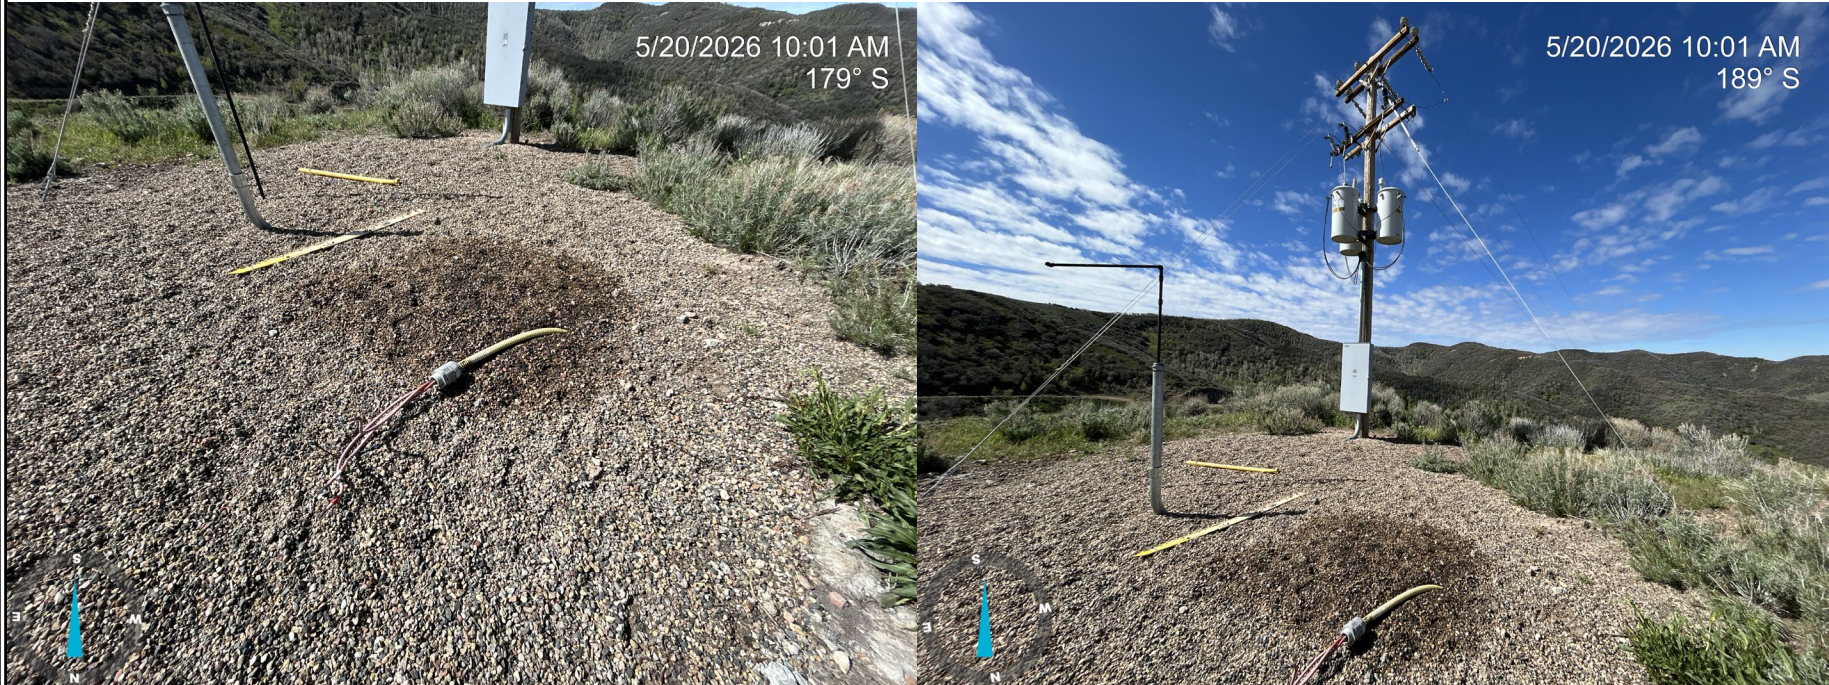
Photo 4: Photos showing stained soils at the southern portion of the location near utility equipment. Cleaning/removal of stained soils is required.

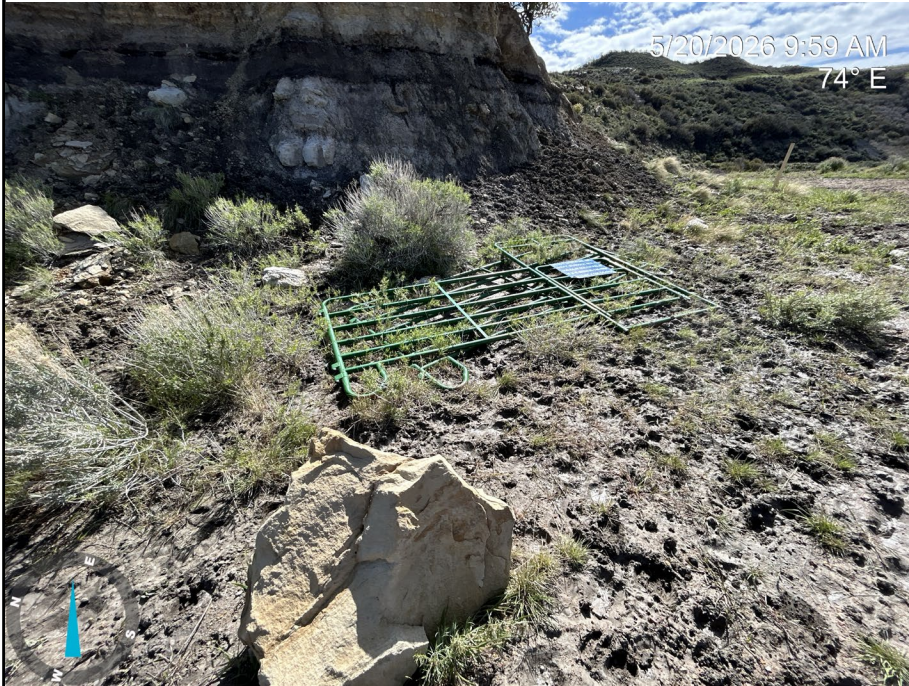
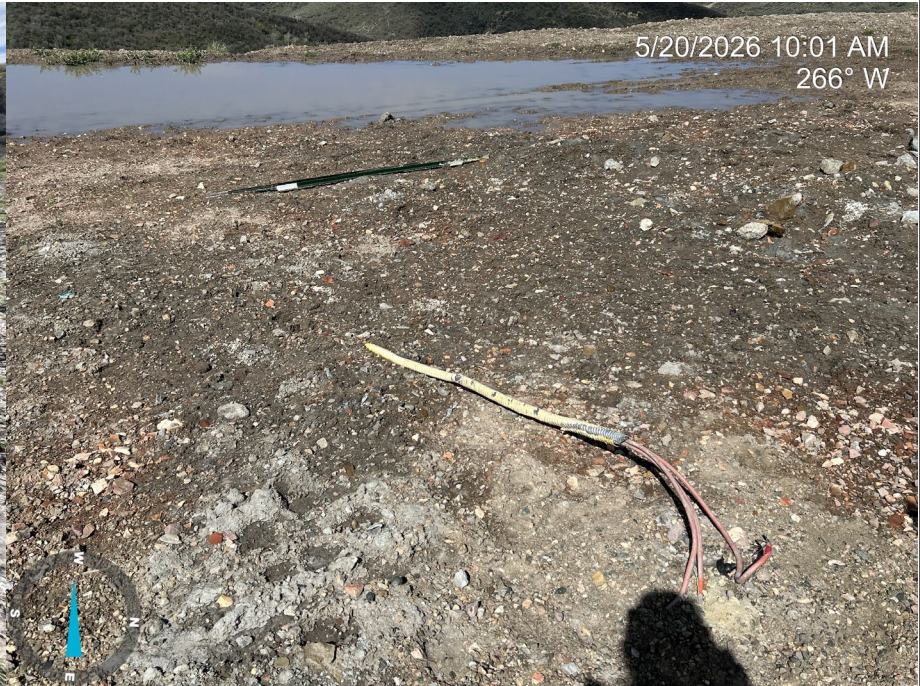
Photo 5: Photos showing examples of unused equipment/supplies that is scattered throughout the location and requires removal.

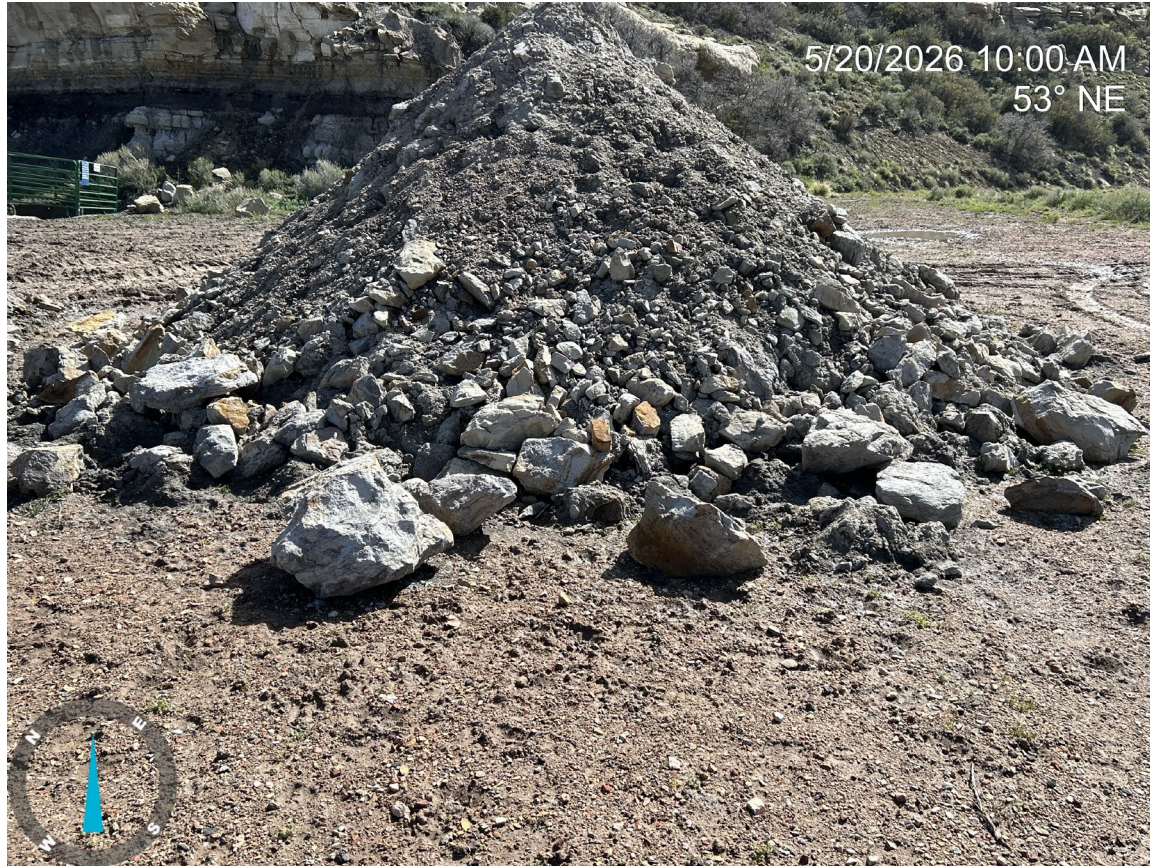
Photo 6: Photos showing an example of a soil stockpile; multiple stockpiles are present at the location. Stormwater BMP's are missing or insufficient; comply with Rule 1002.f.

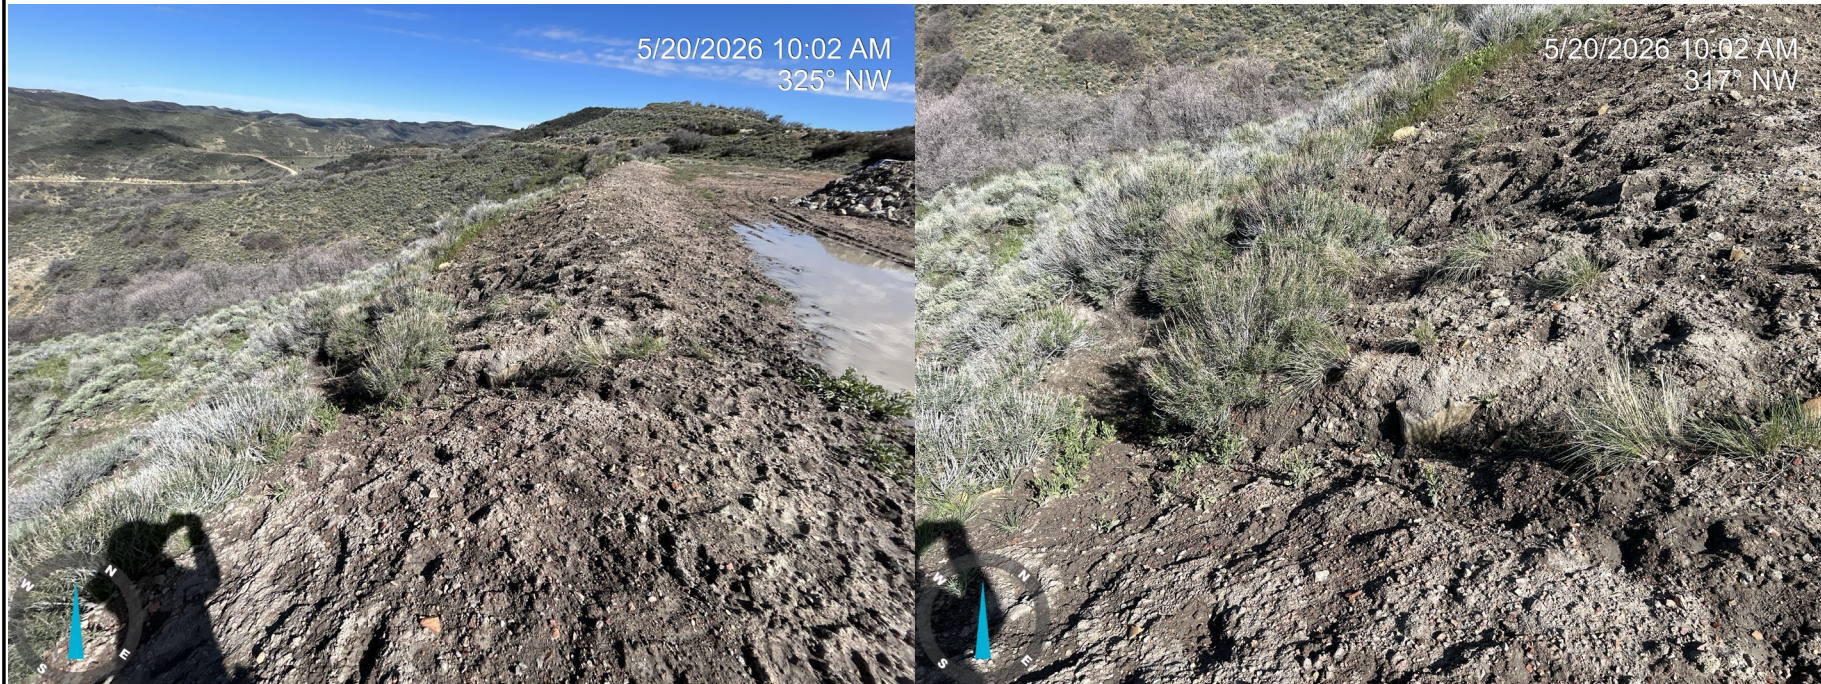
Photo 7: Photos showing examples of rilling and erosion that is occurring on the western edge of the pad; stormwater BMP's appear missing or insufficient. Stormwater BMP's are required until the location achieves final reclamation pursuant to 1004 series Rules.

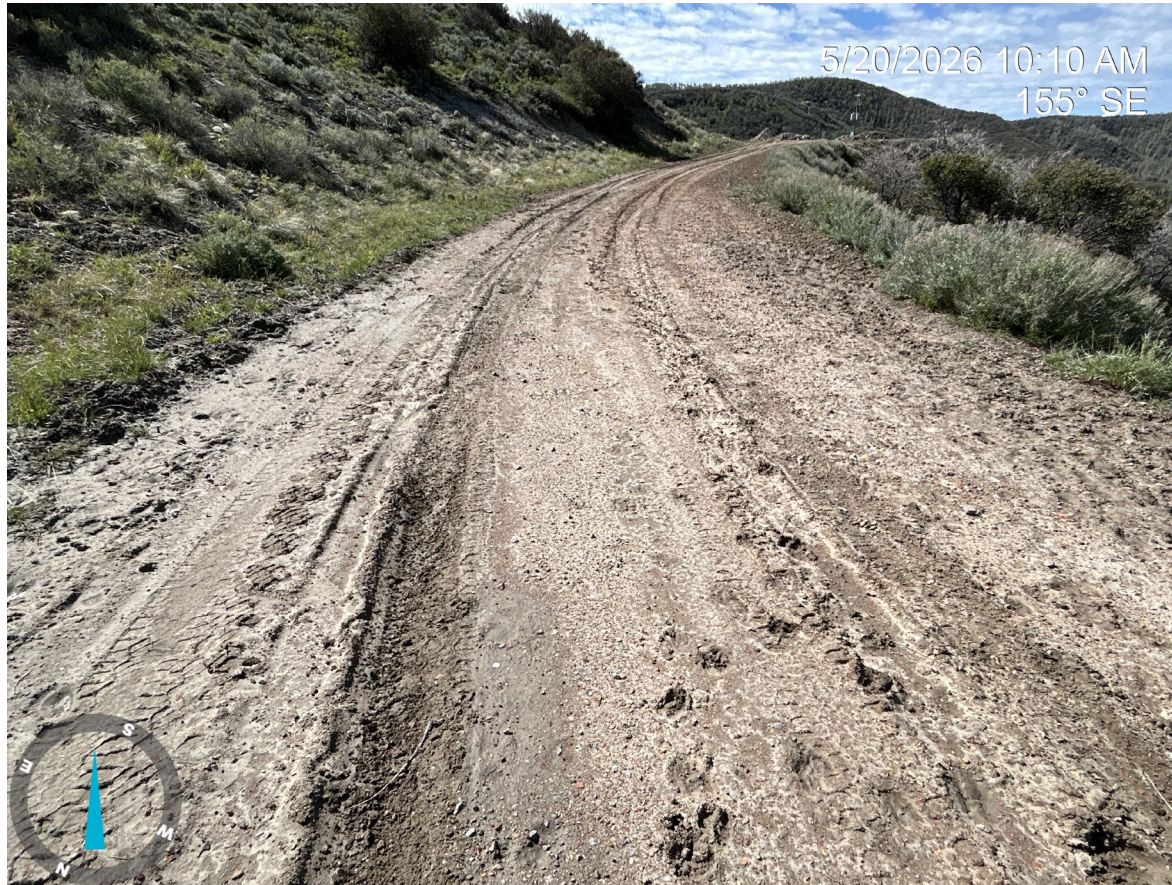
Photo 8: Photo showing an overview of the access road leading to the location.

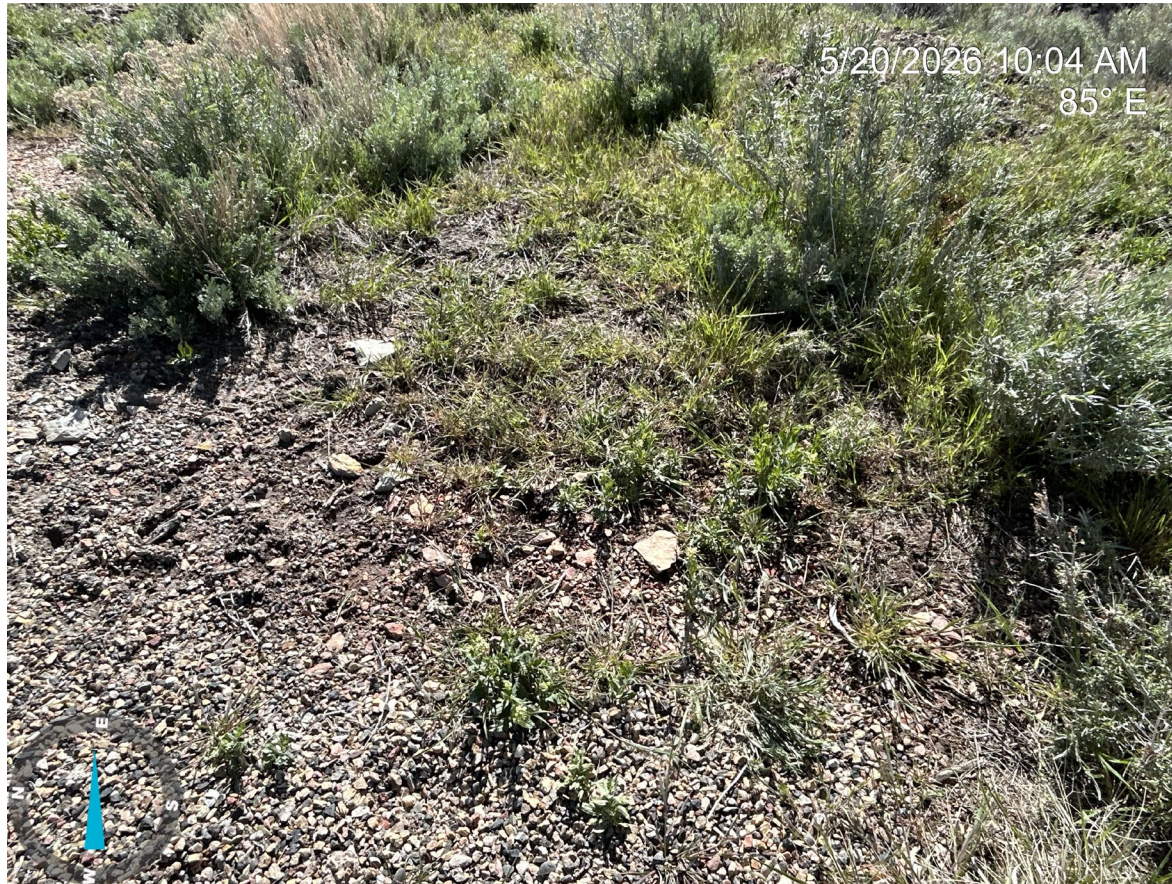
Photo 9: Photo showing hoary cress and cheatgrass is present in tertiary amounts around the edges of the pad.

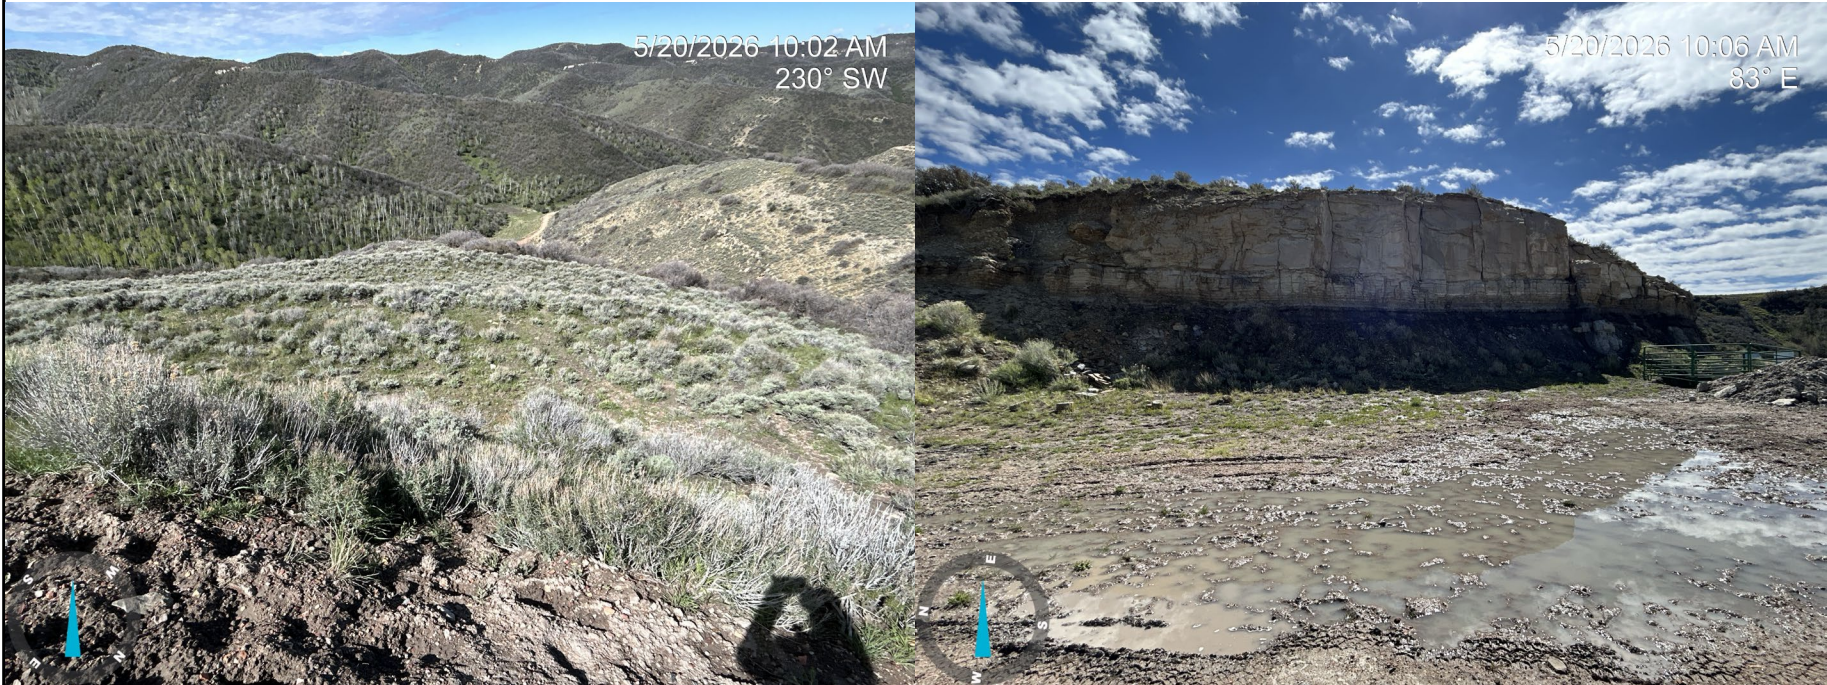
Photo 10: Photos showing an overview of the western/southern interim area and the eastern cut slopes at the location. Vegetation is well established and no issues were observed.
