# Inspection Photos

Operator: Wesco Operating Inc #95520

Location ID: 312864

Inspection Doc: 719201180

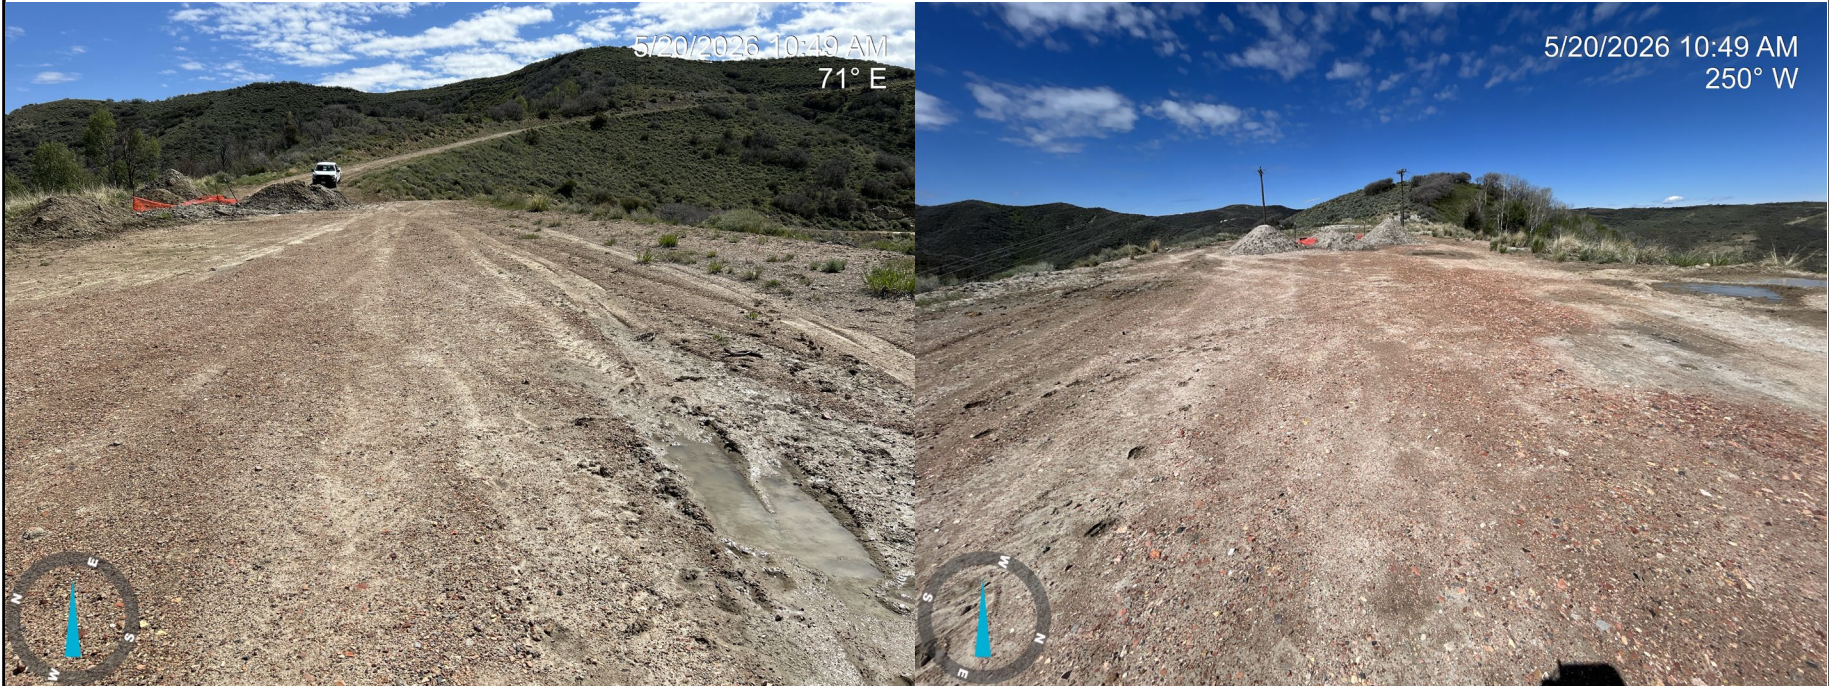
**Photo 1:** Photos showing an overview of the location looking east and west, respectively.

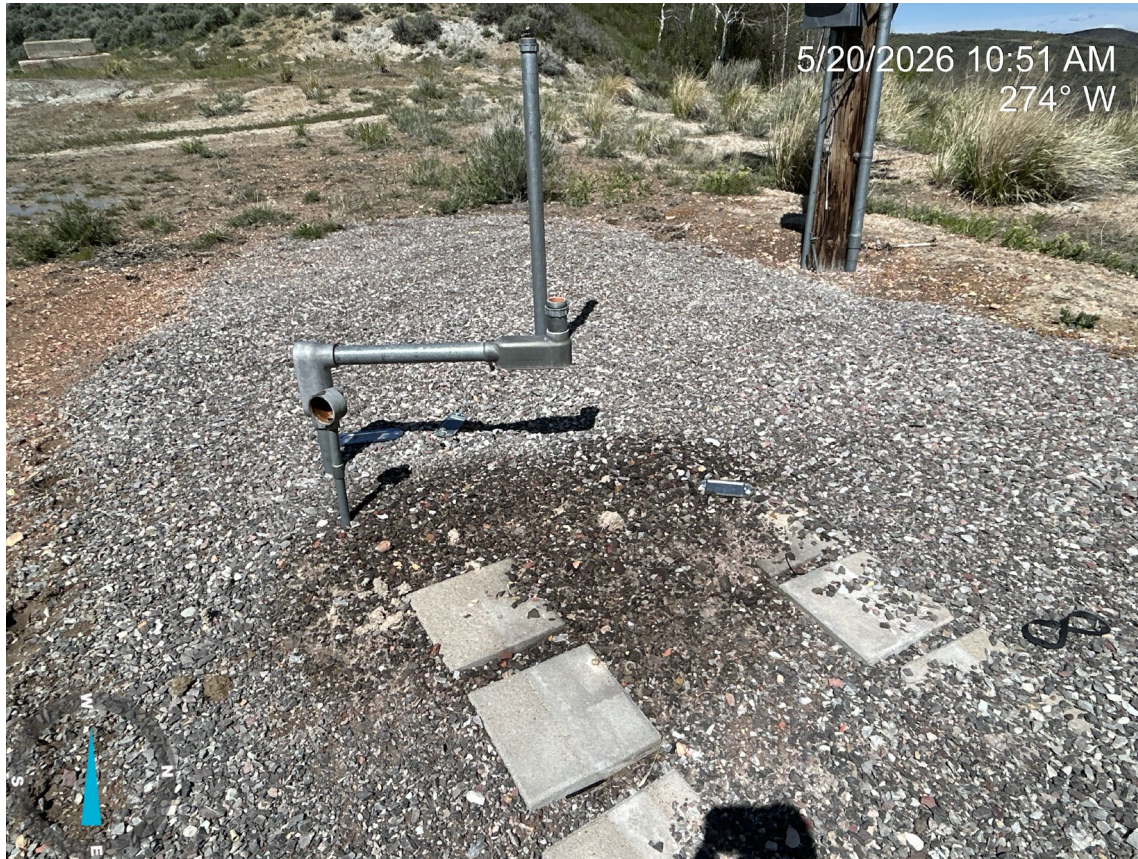
**Photo 2:** Stained soils appear to be present on the northwestern portion of the location near utility equipment; cleaning/removal of stained soils is required.

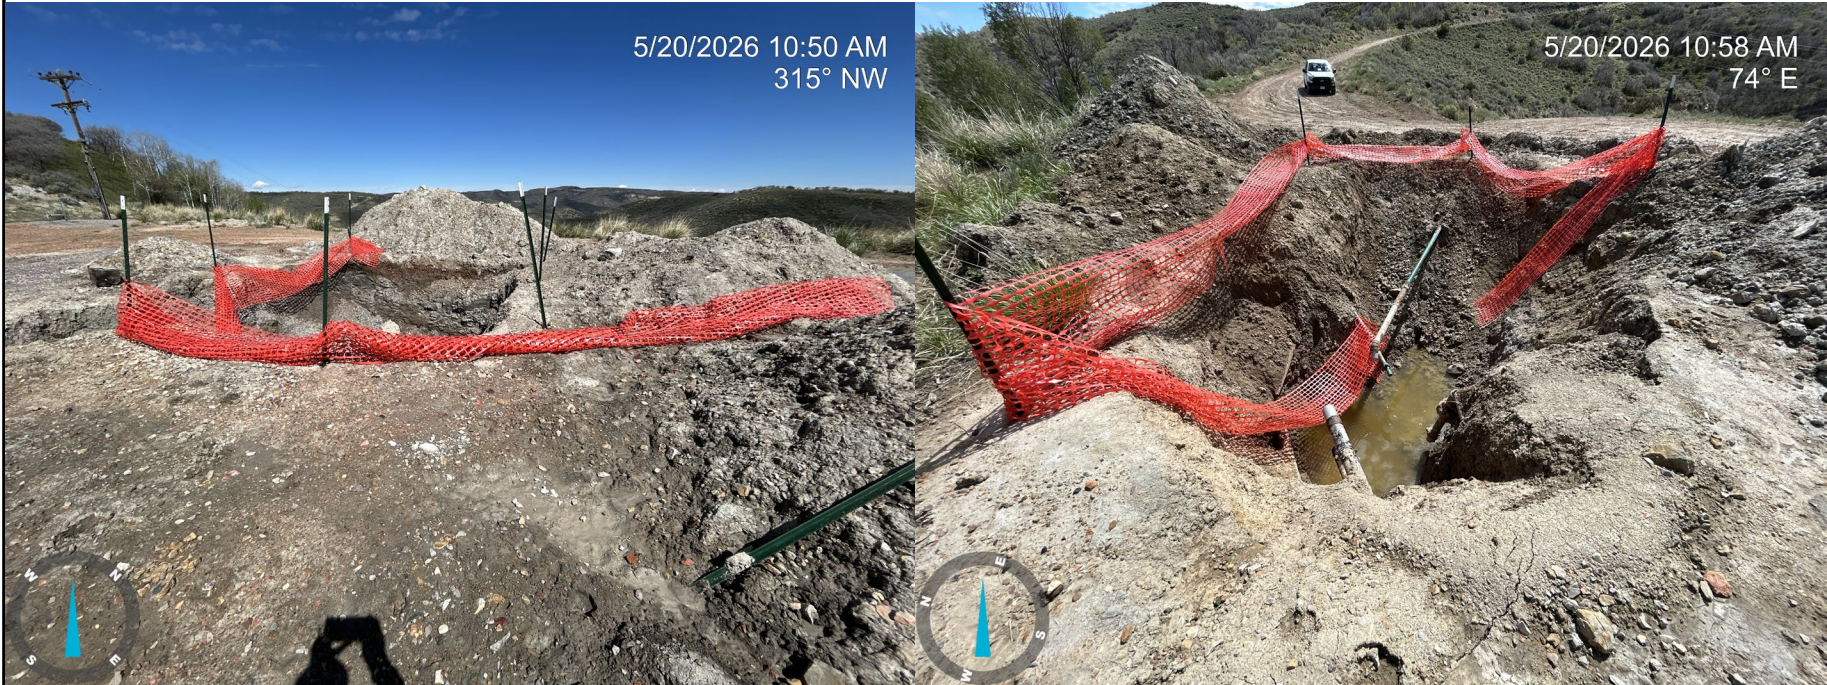
**Photo 3:** Orange plastic fencing around open excavations is down/in disrepair. Maintenance is required to prevent access.

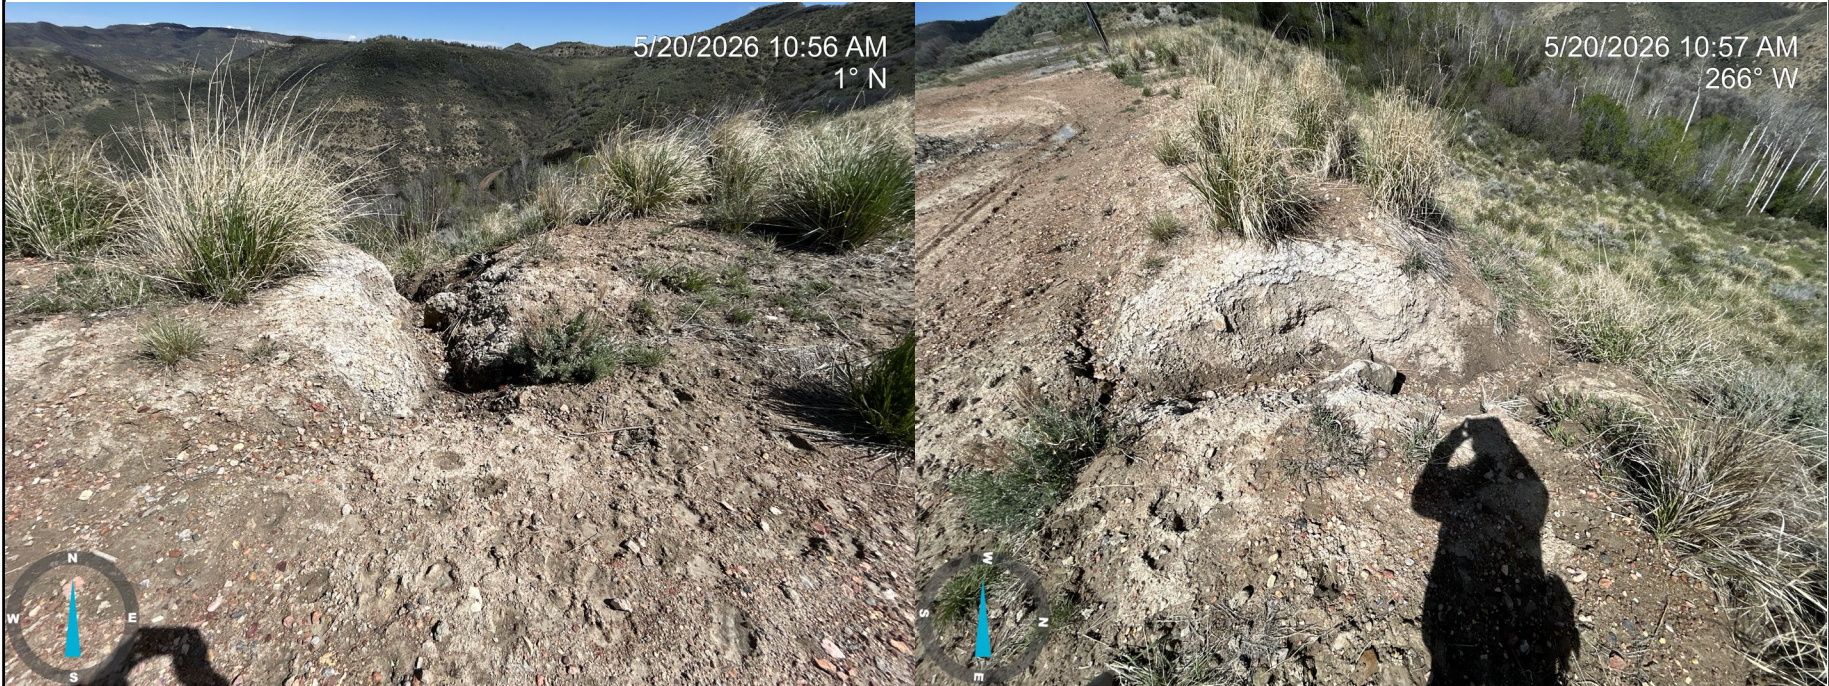
**Photo 4:** Photos showing erosion and rilling is occurring on the northern edge of the pad; implementation or maintenance of stormwater BMP's is required until the location receives a passing final reclamation inspection.

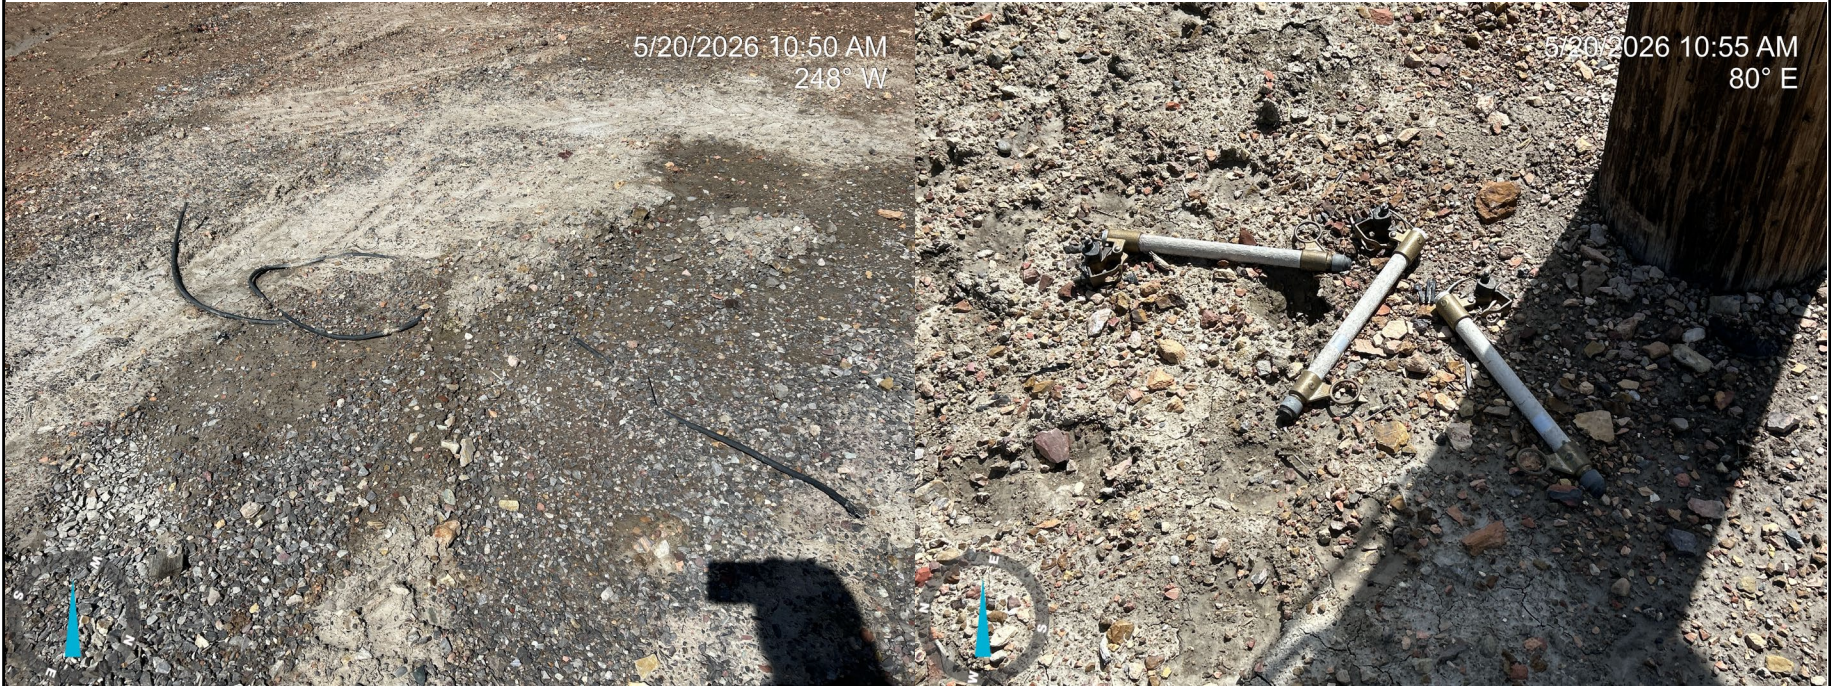
**Photo 5:** Photos showing trash/debris that is scattered throughout the location and requires removal.

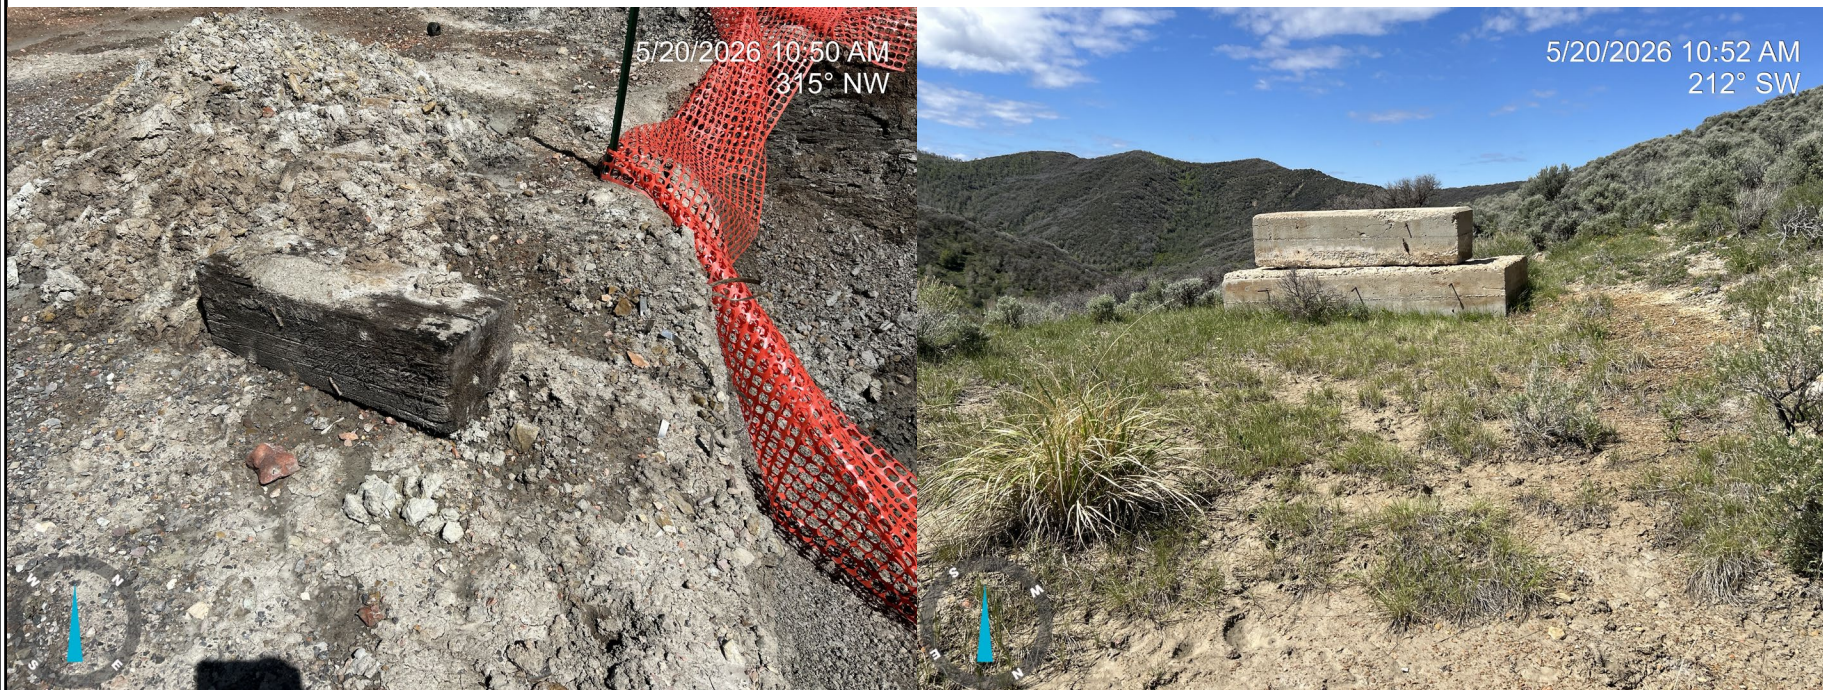
**Photo 6:** Photos showing trash/debris that is scattered throughout the location and requires removal.

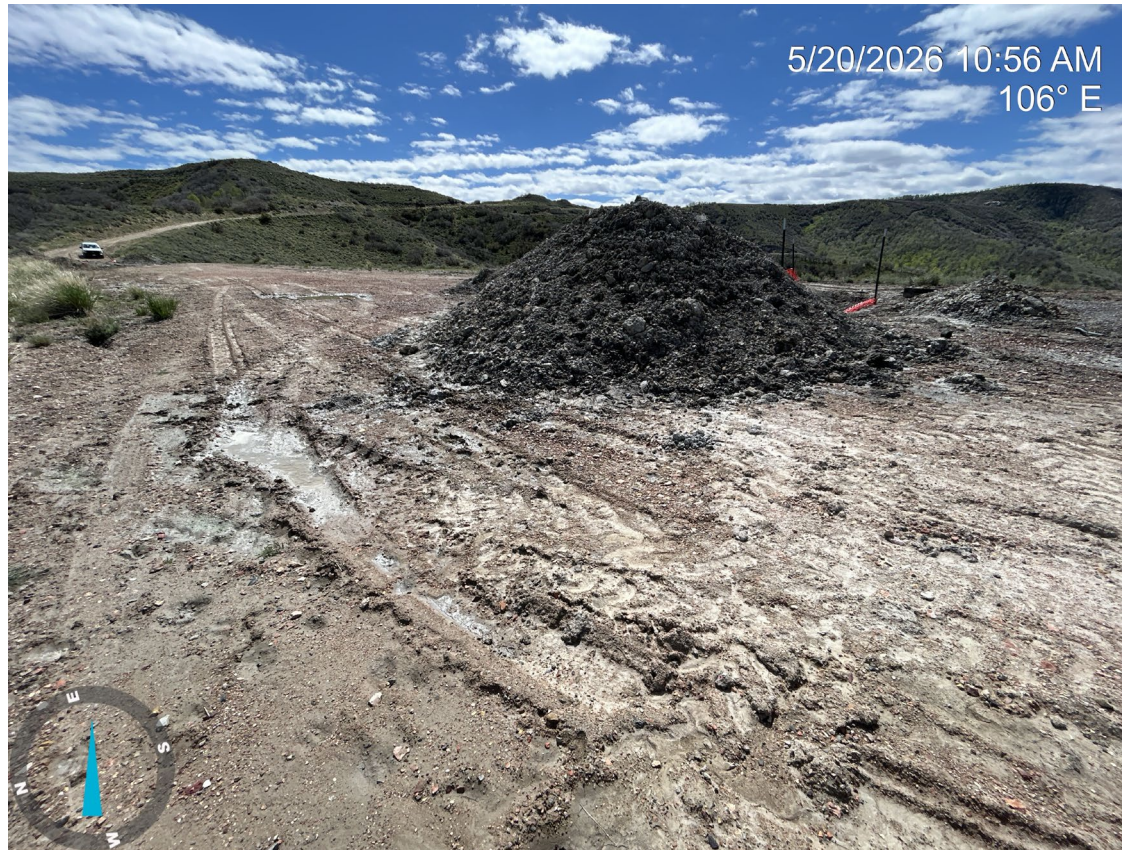
**Photo 7:** Soil stockpiles at the location appear to be missing stormwater BMP's; implementation and/or maintenance of stormwater BMP's on soil stockpiles is required.

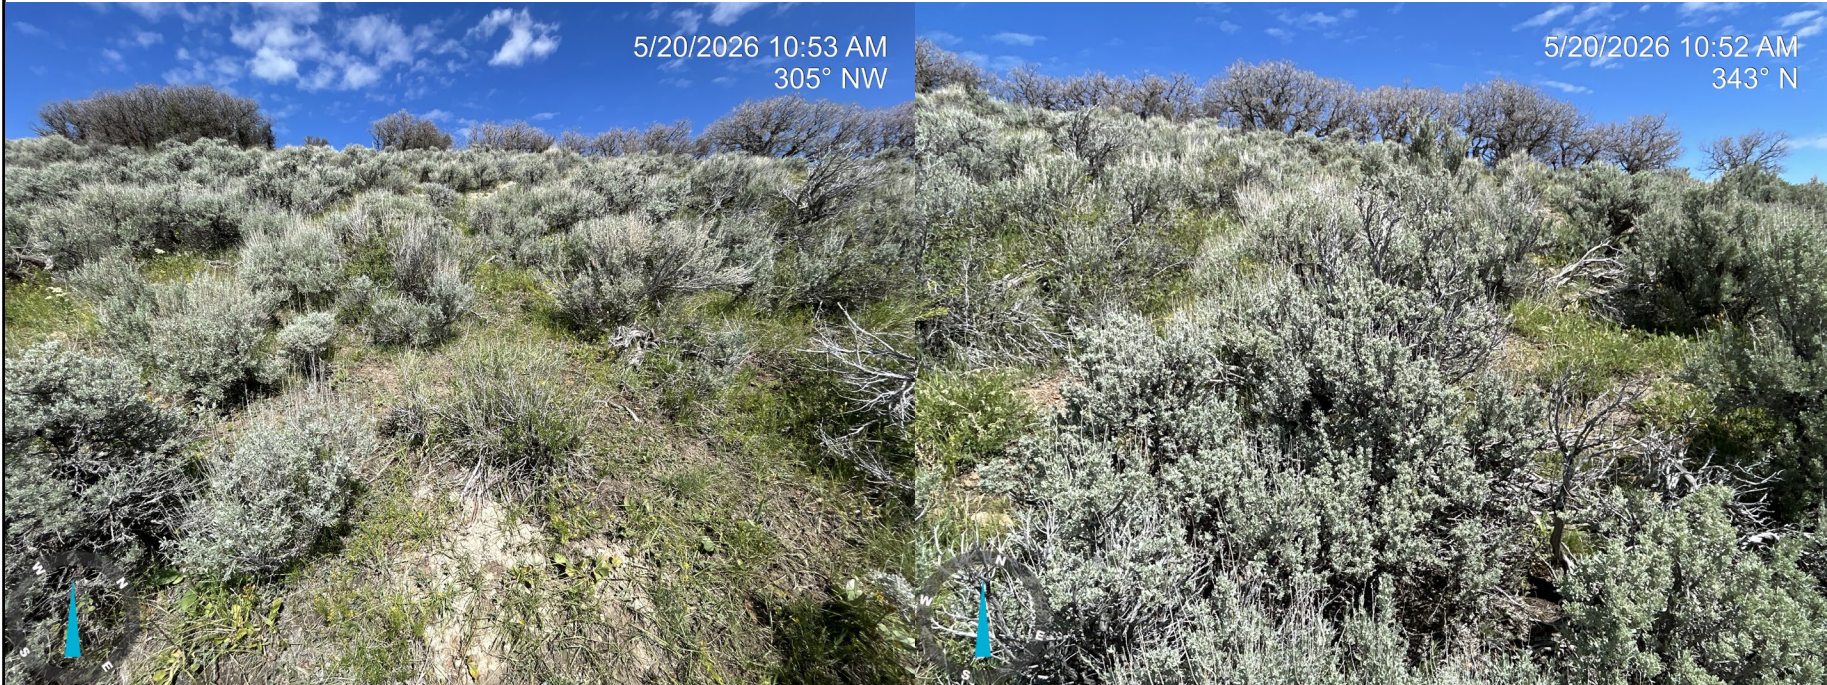
**Photo 8:** Photos showing the nearby reference area, directly west of the location. The reference area is primarily composed of big sagebrush, with secondary amounts of scrub oak.

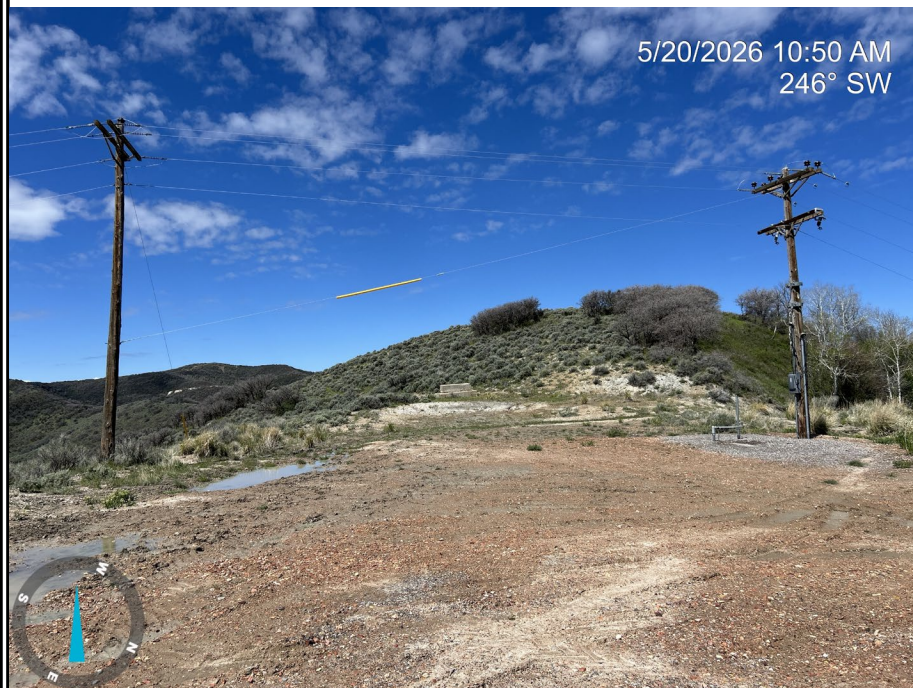
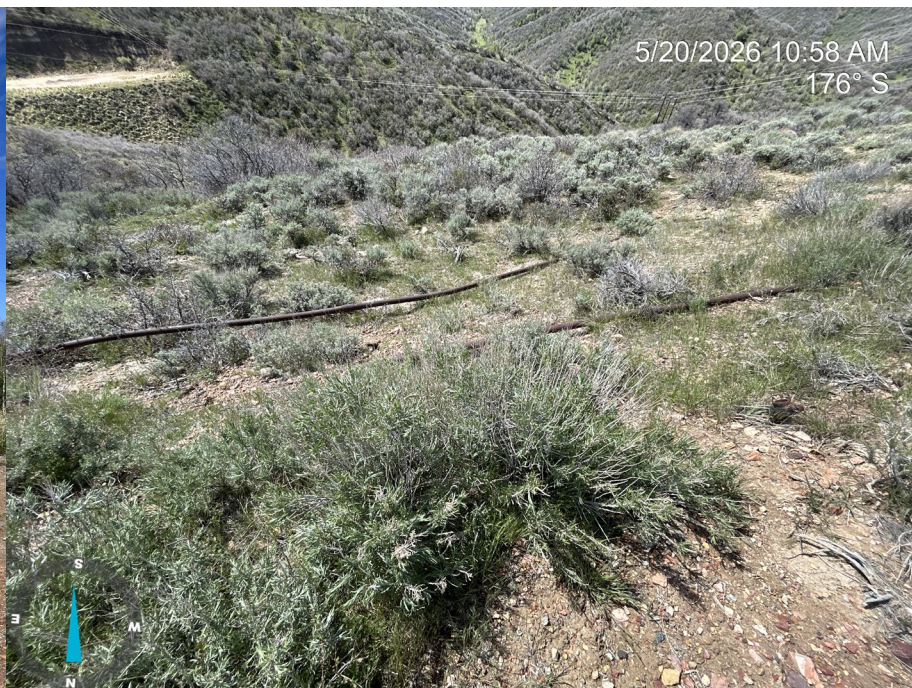
**Photo 9:** Photos showing surface equipment such as utility line and above-ground flowlines that require removal before the location receives a passing final reclamation inspection.
