Inspection Photos

Location Name: Linder Gas Unit: Linder A 2; Linder A 4.

Location ID: #333463. API (A 2) 05-067-08970; (A 4) 05-067-09270

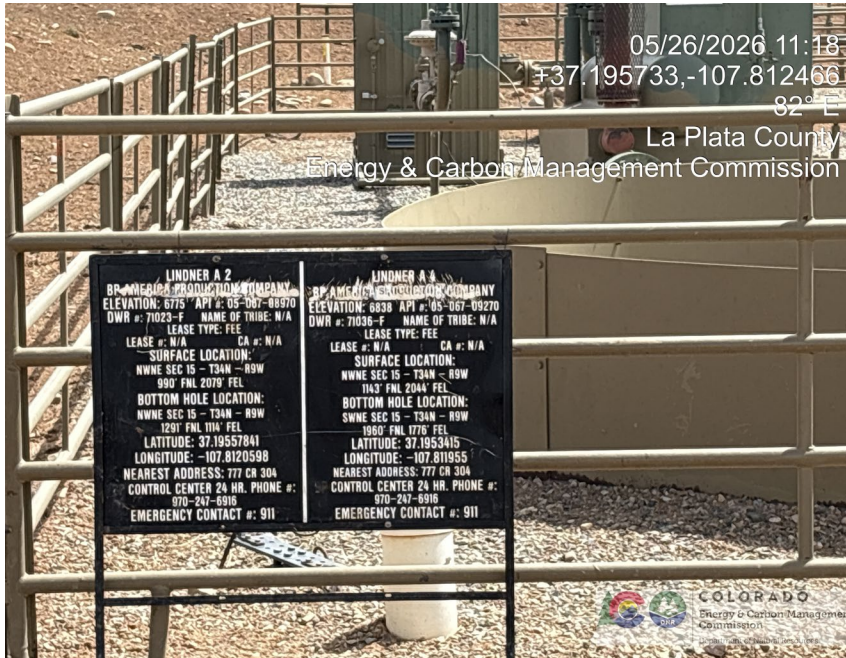
1. Well sign for both wells. Decal of current operator name has peeled off.

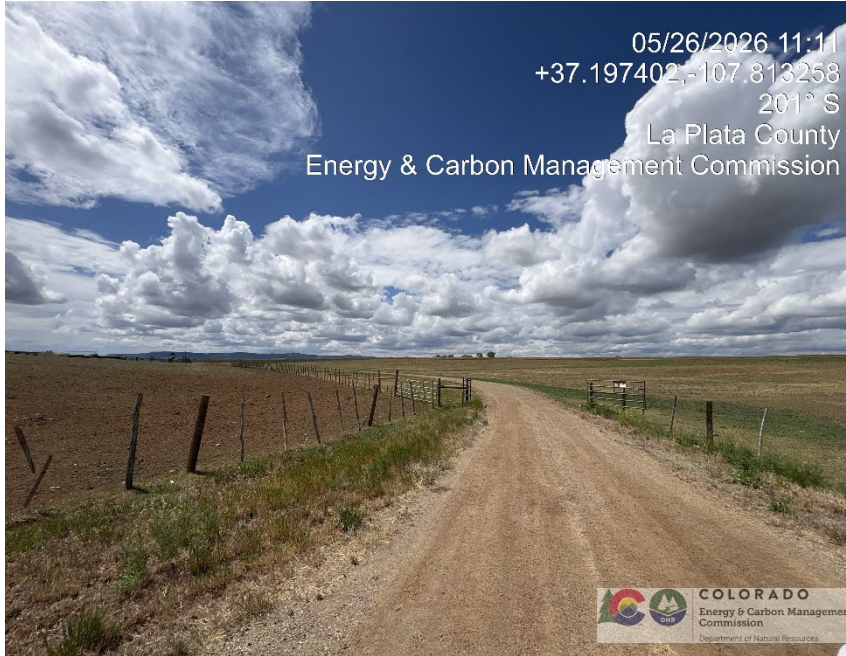
3. Access road to location from gate by county road.

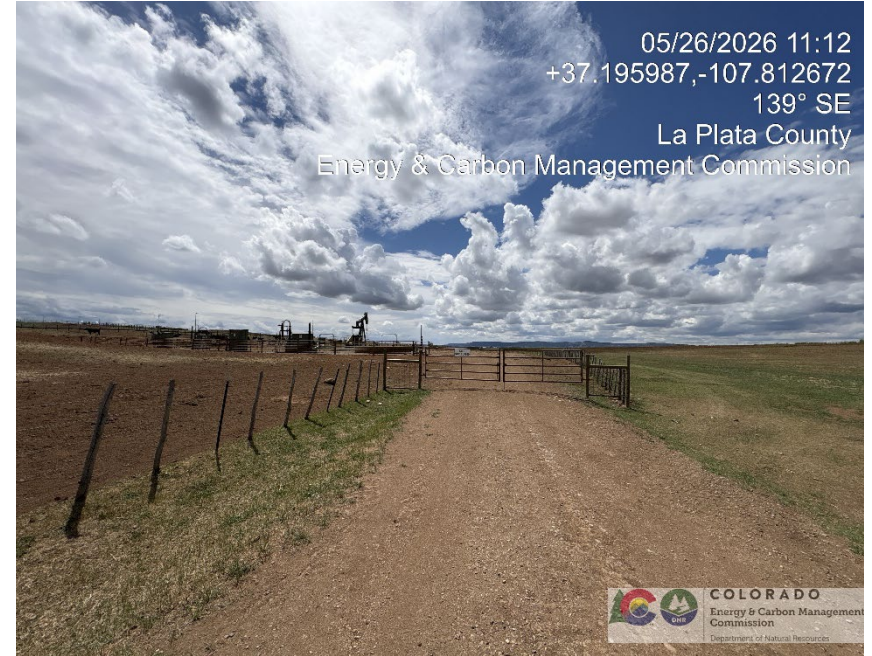
4. Location from access gate at pad entrance.

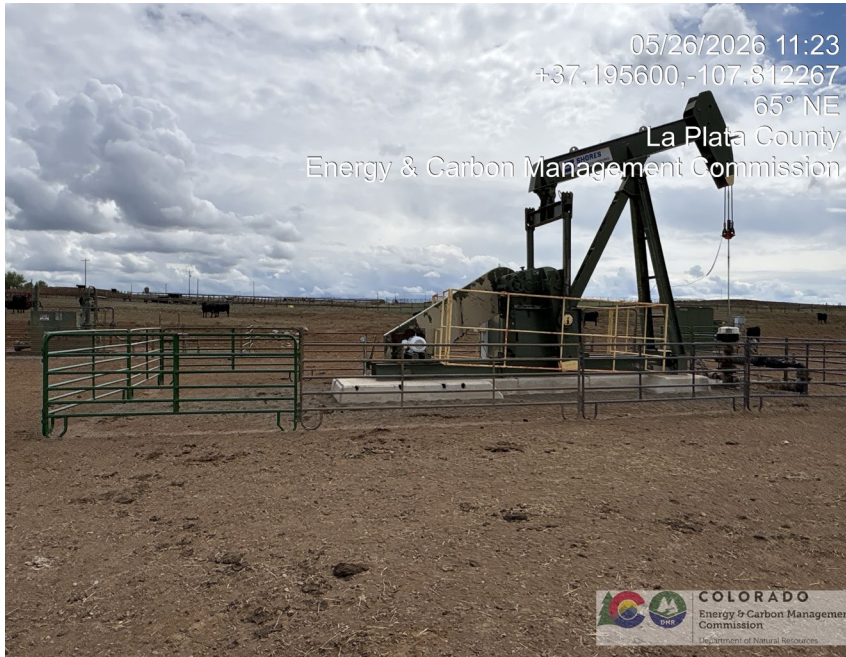
5. Linder A2 well, pumpjack, and electric prime mover behind cattle panel fence. Well does not have any identification to distinguish from A4.

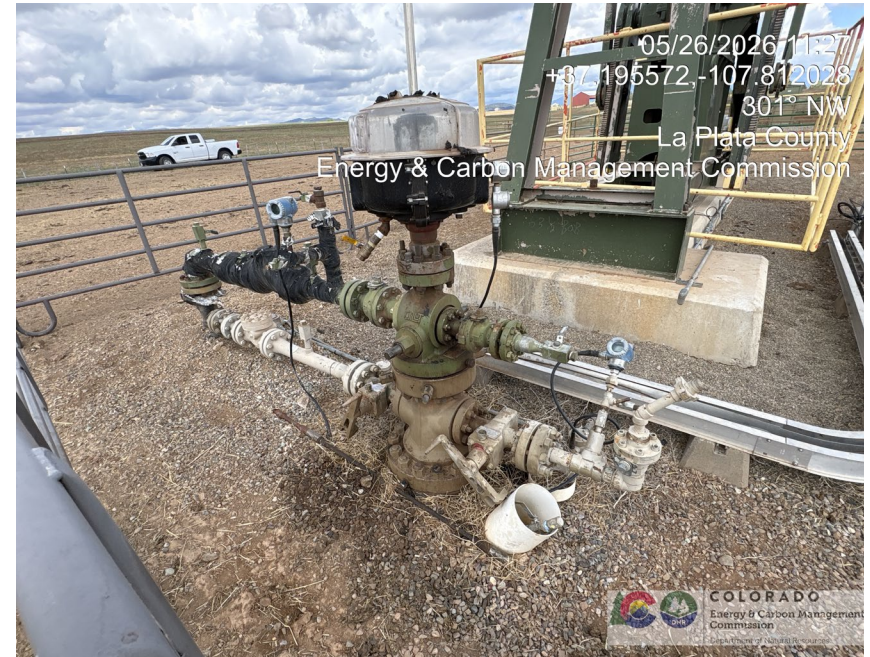
6. A2 Wellhead. Vegetative debris (hay) is accumulating beneath the wellhead. There is de minimis staining in the gravel beneath the wellhead.

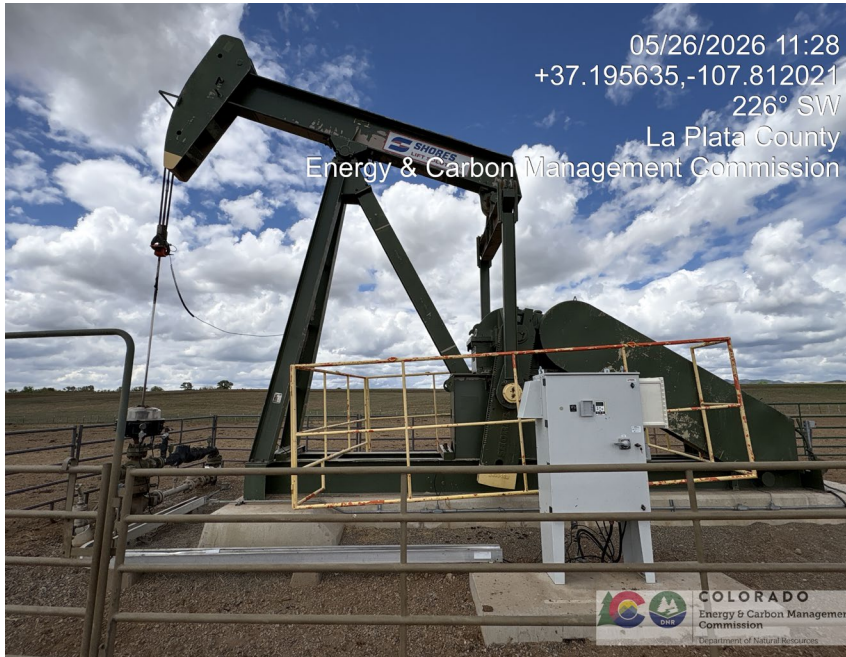
7. A2 Pumpjack.

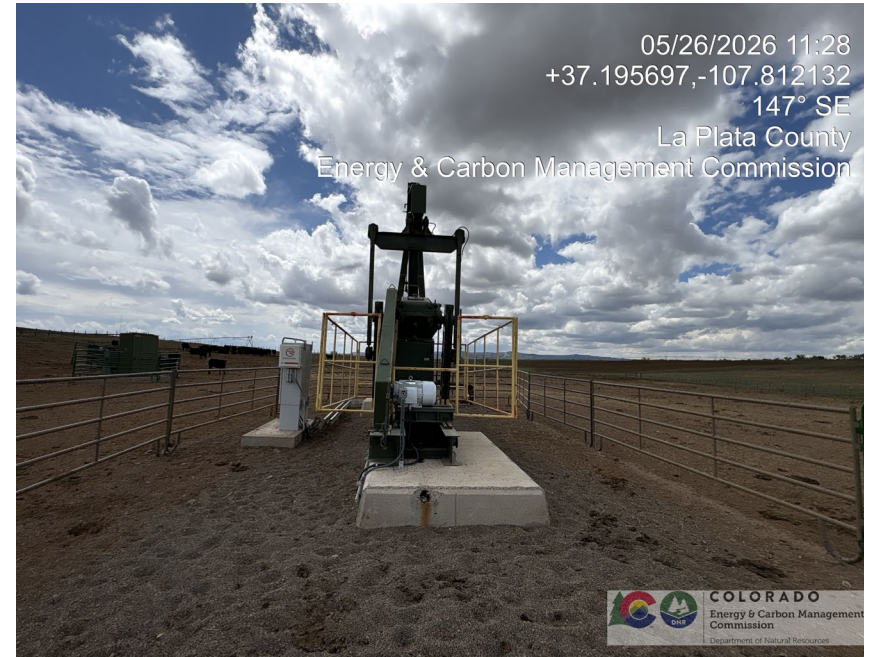
8. A2 Pumpjack.

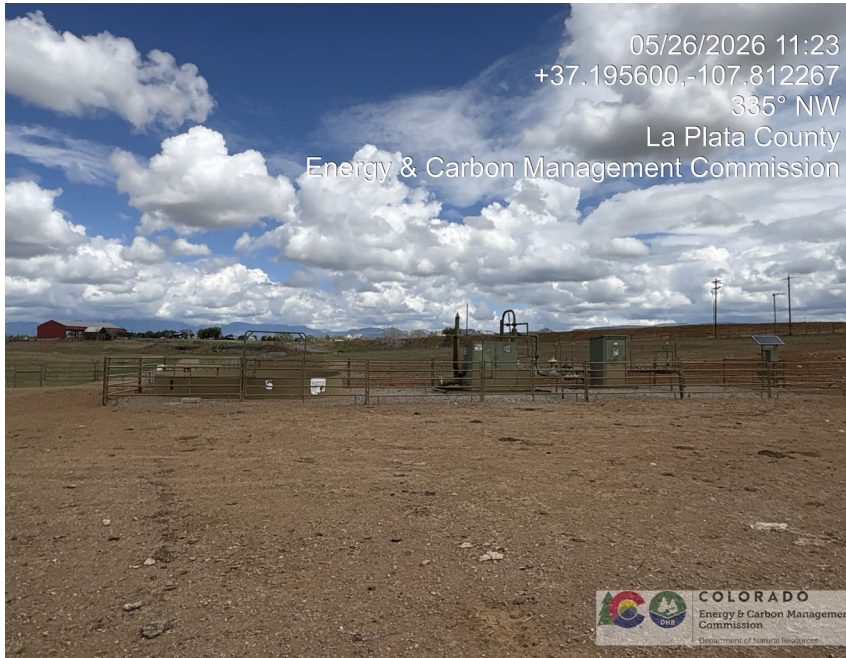
9. Linder A2 production equipment behind cattle panel fence. From left to right: 95 BBL produced water/natural gas PBV tank, horizontal heated separator, meter run, and solar telemetry. Various flow lines, mostly 3" diameter.

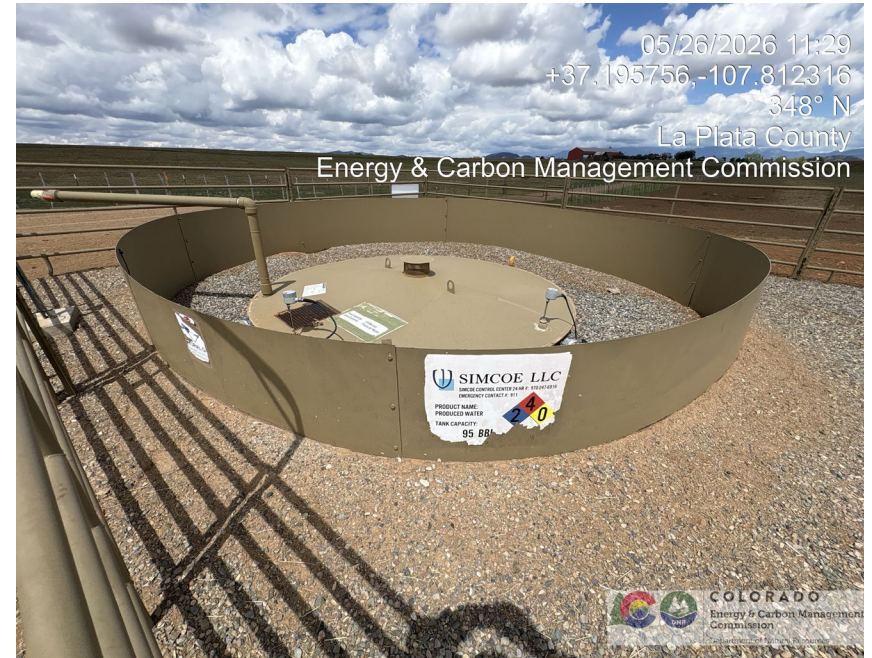
10. Linder A2 95 BBL produced water tank. Tank label is peeling.

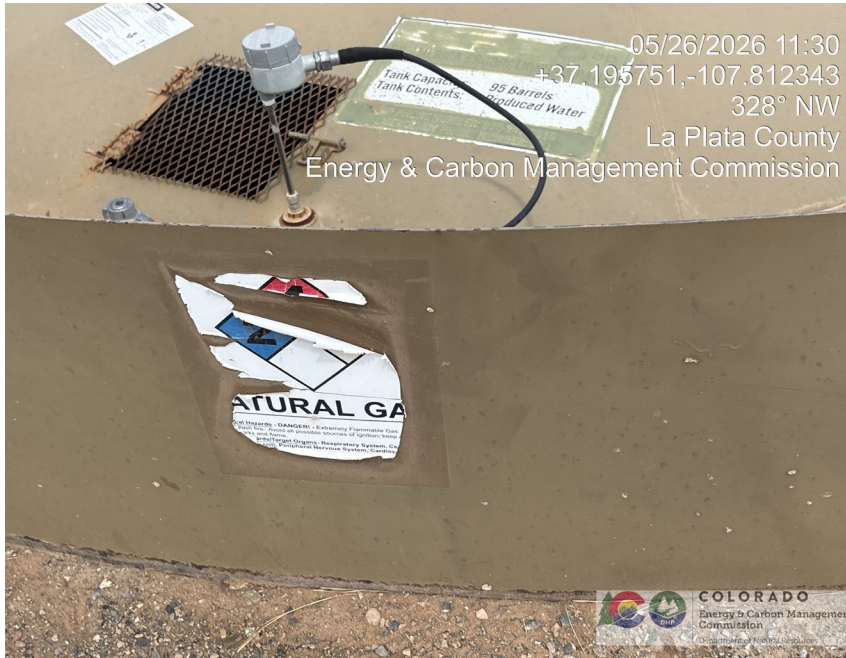
11. NFPA diamond on tank not legible.

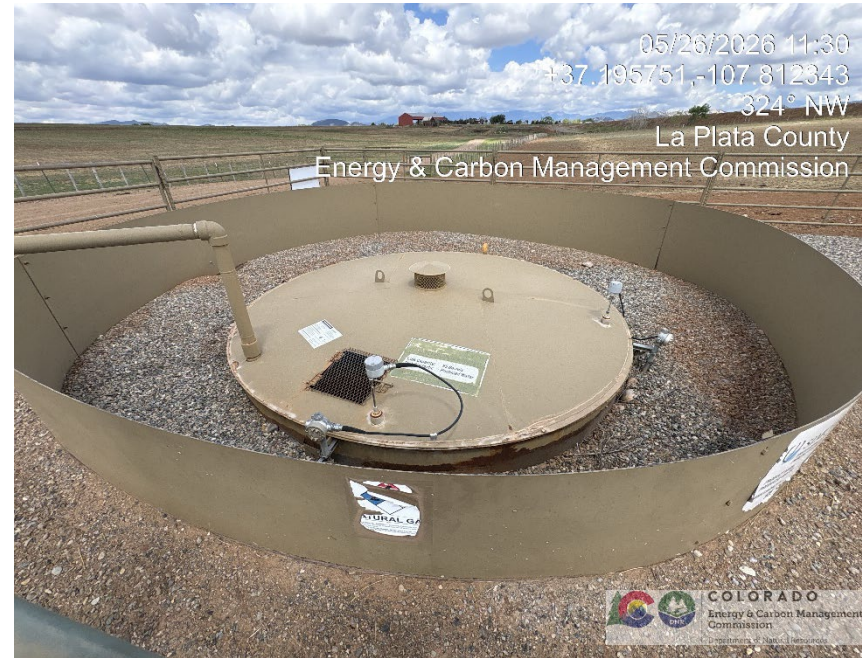
12. 95 BBL tank and secondary containment.

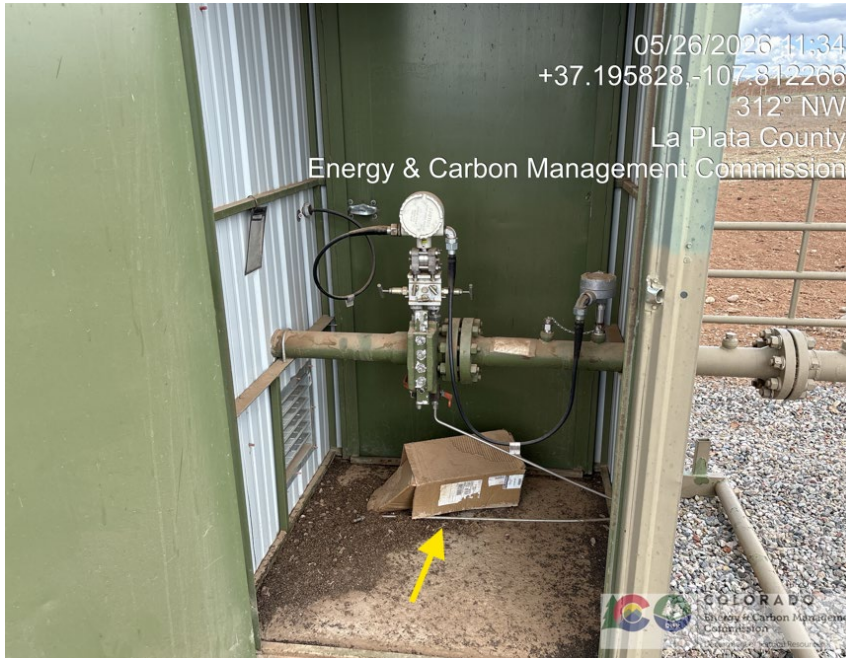
15. Inside A2 meter run shed. On 1/4" vent line is disconnected (yellow arrow). Gas could vent inside enclosure. Cardboard trash on floor.

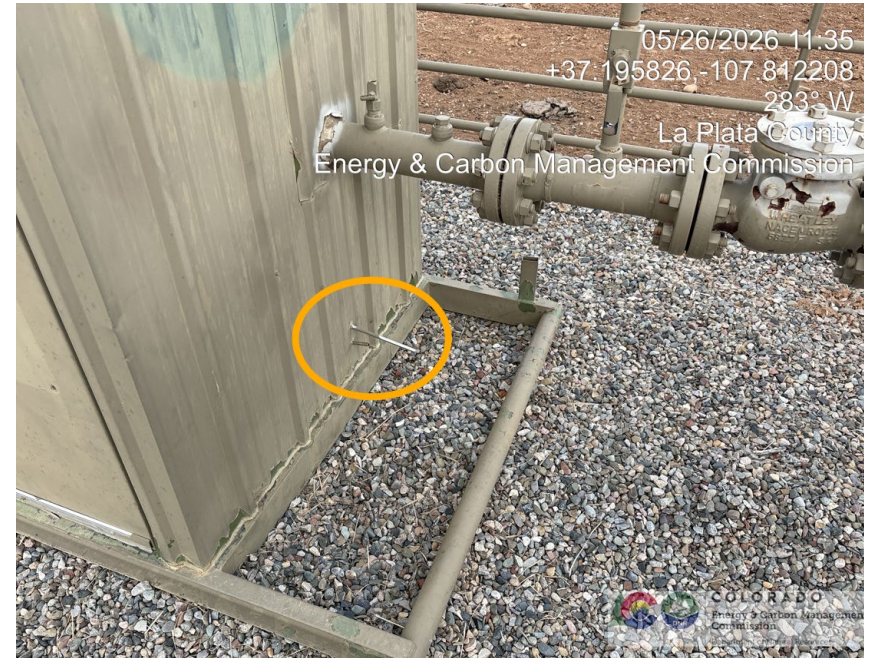
16. 1/4" stainless vent tubing sticking out of meter run shed.

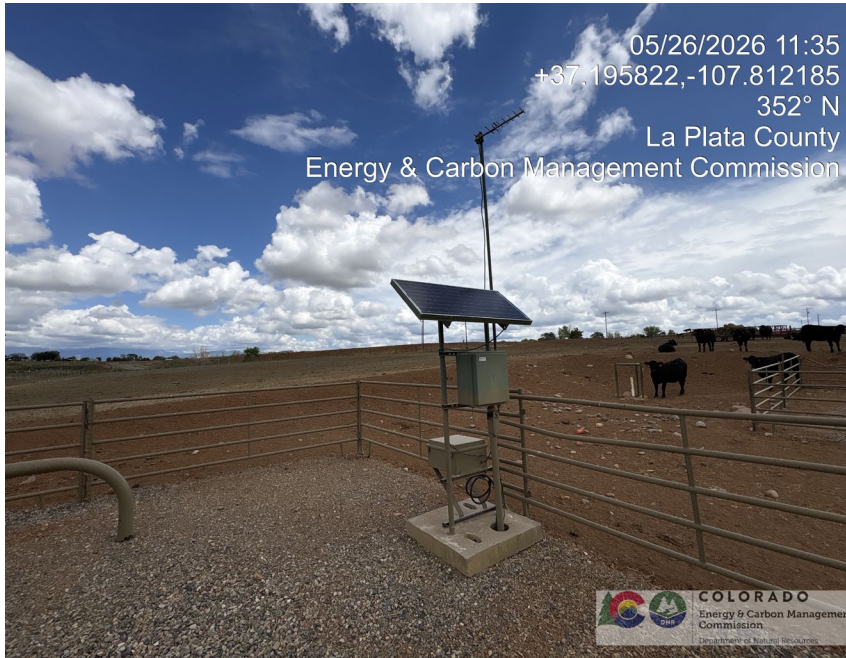
17. Solar telemetry for Linder A2.

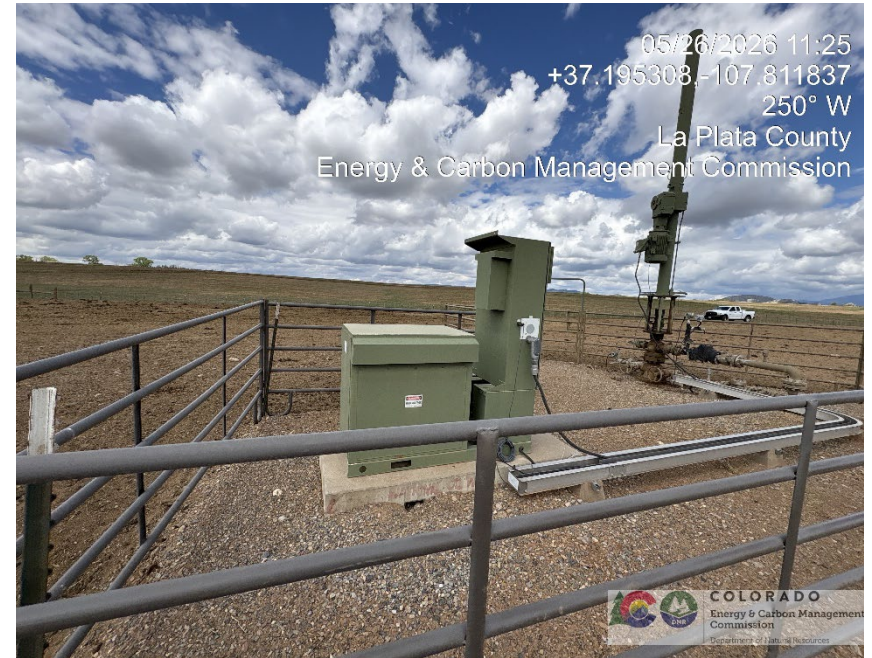
18. Linder A4 linear rod pump with electric prime mover and electrical controls behind cattle panel fence.

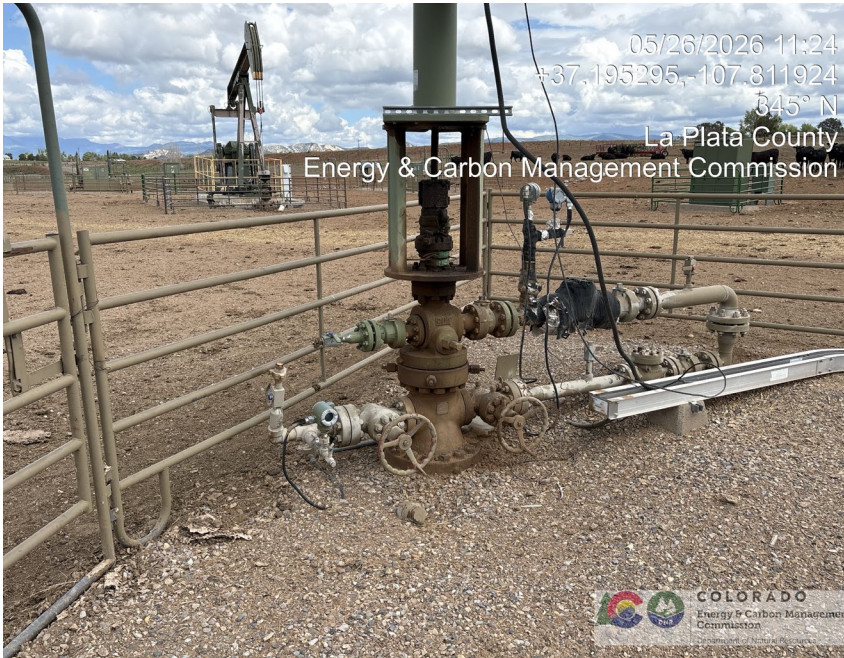
19. Linder A4 wellhead closeup.

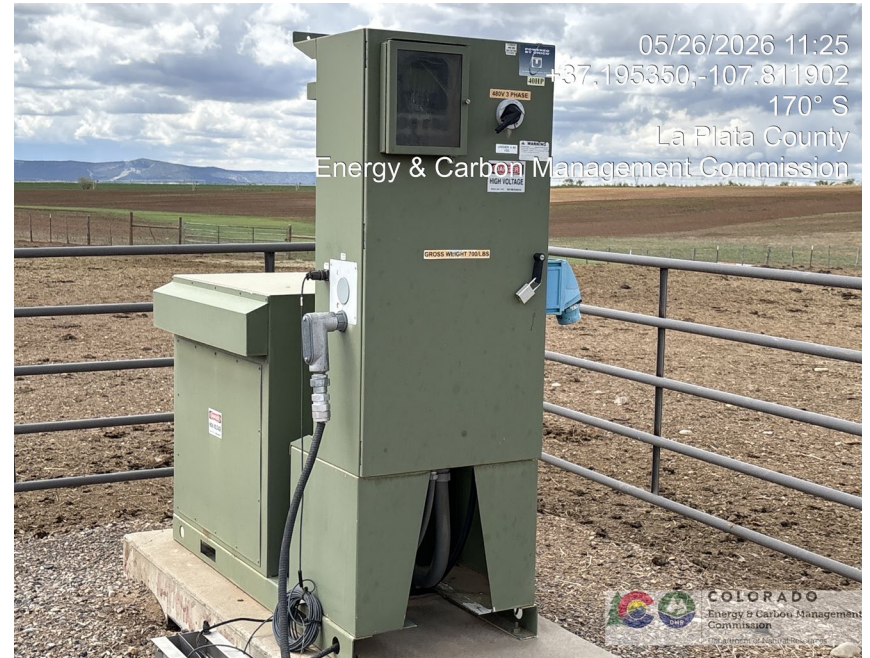
20. Linder A4 electric controls.

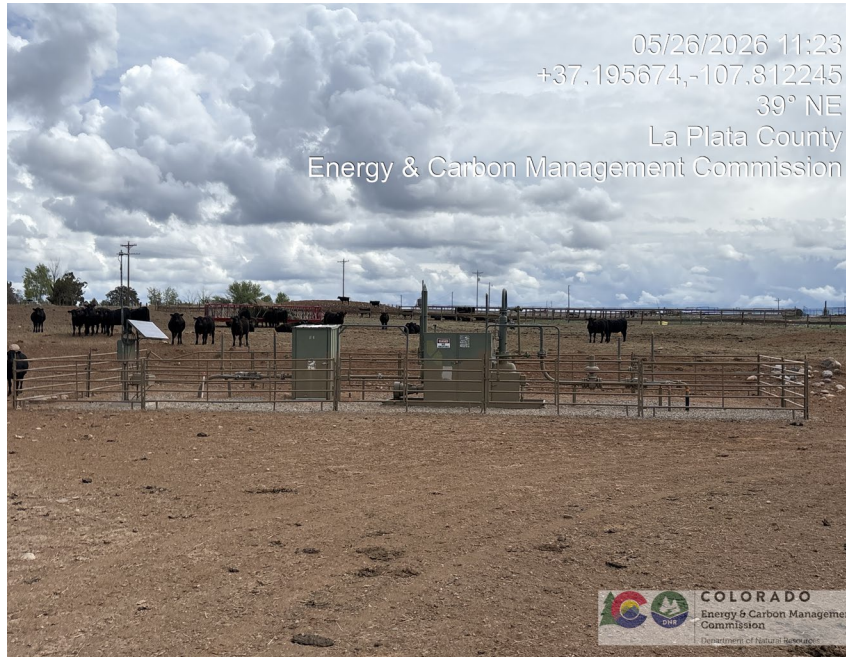
21. Linder A4 production equipment. L-R: Solar telemetry, meter run, horizontal heated separator and flow line.

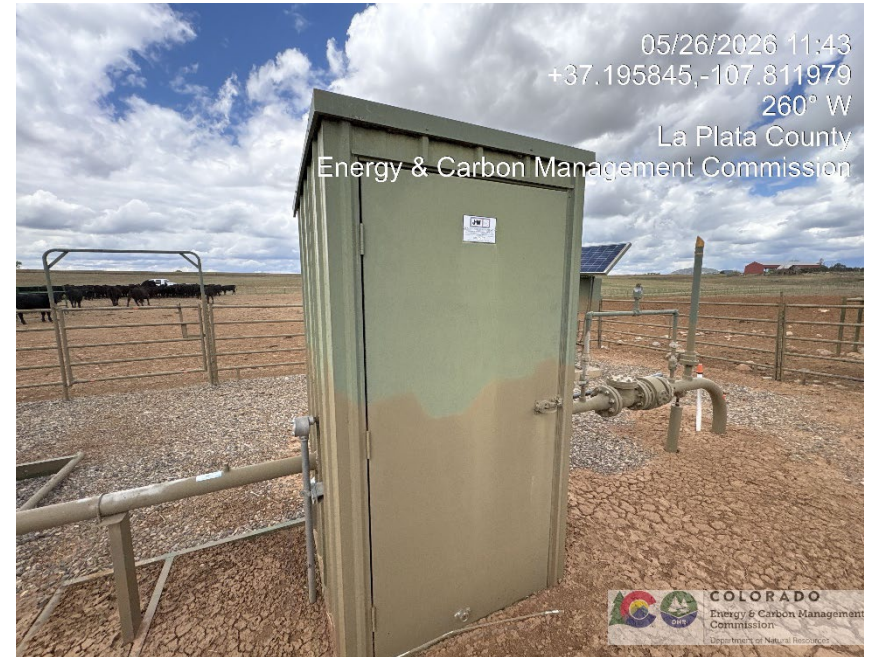
22. A4 meter shed.

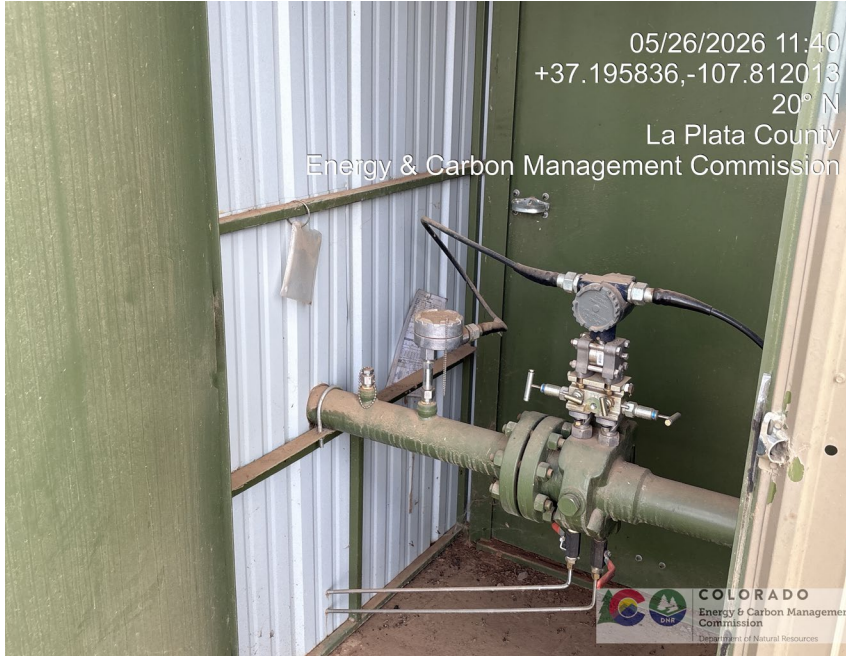
23. Meter run for A4. Both ¼" stainless vent tubes connected to ball valves in this meter shed.

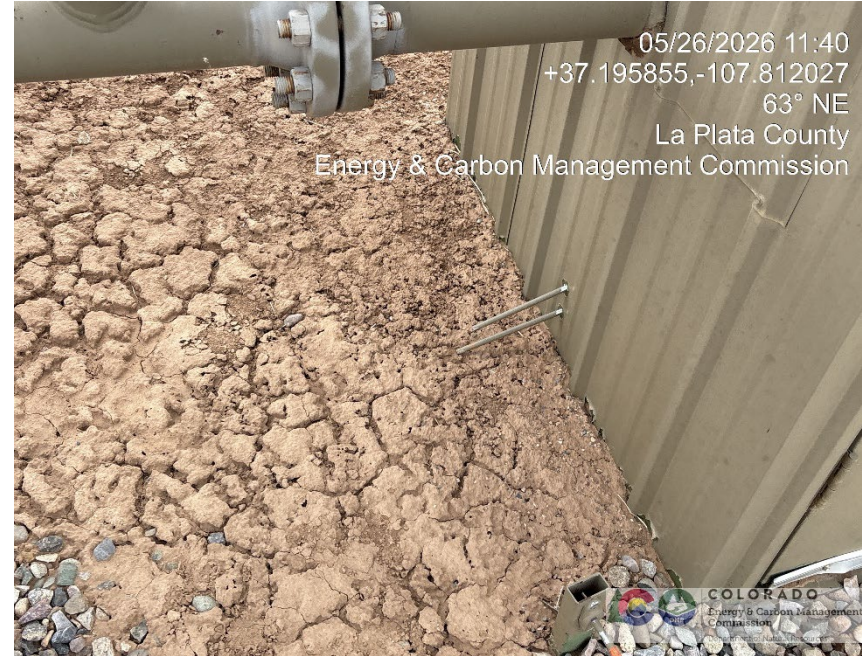
24. ¼" stainless tubes vent tubes on A4 meter shed.

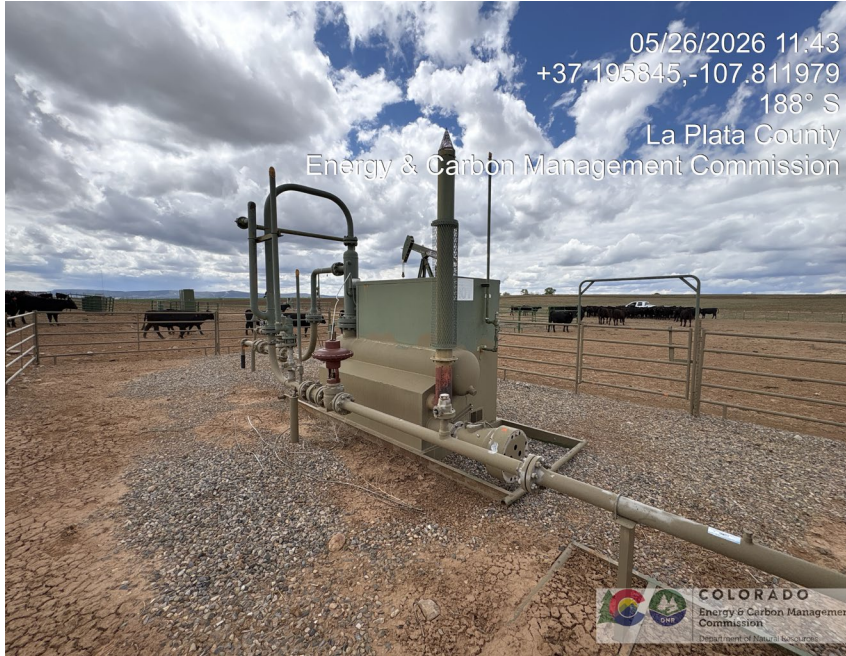
25. Linder A4 horizontal heated separator.

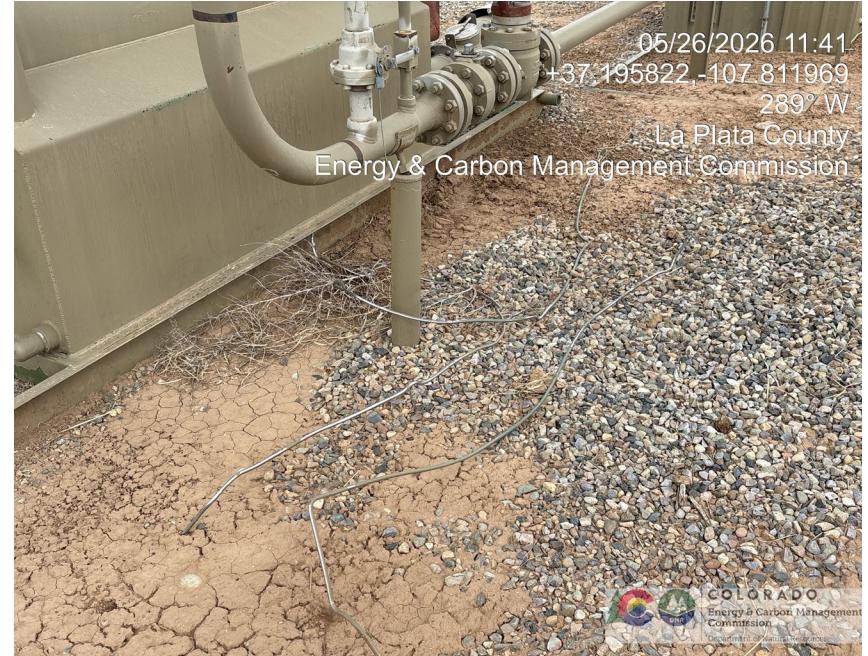
26. Stainless tubing on ground not in use.

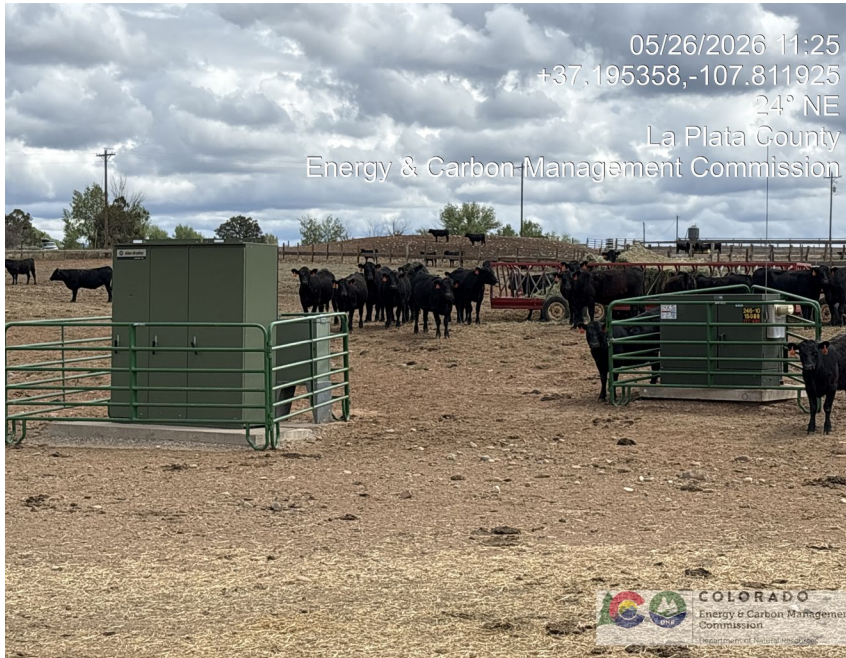
27. Electrical control panel and electric service behind individual cattle panel fence.

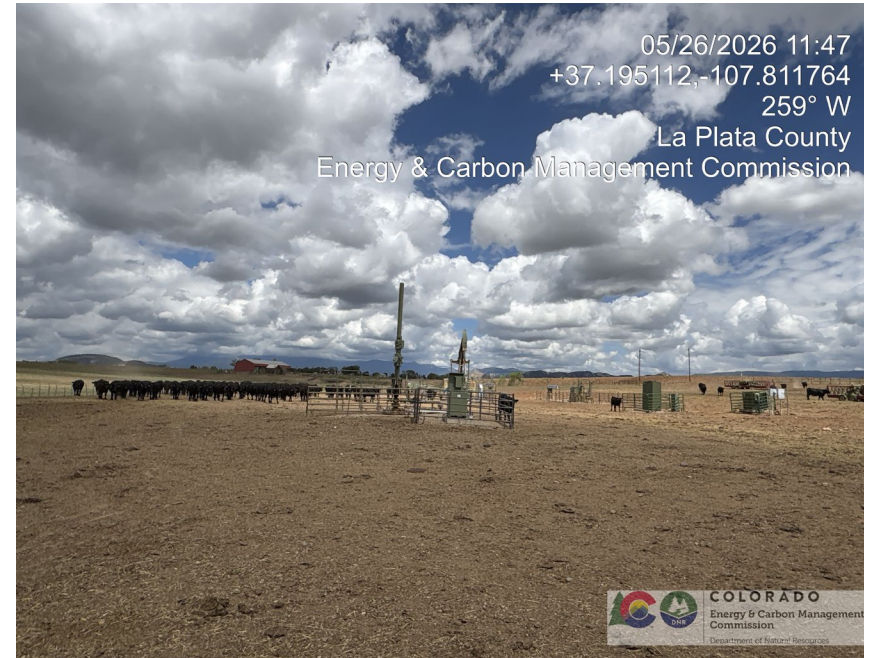
28. Well site overview from southeast corner looking west.
