From: Shad Brown
Sent: Thursday, May 28, 2026 6:49 AM
To: Tammy Jones; Cheryl Weston; Francisco Enriquez Quintana; Clint Calvert; Freddy Proctor; Jennifer Street; Priscilla Shorty
Subject: RE: ARGENTA 34-10 31-1 - INC - 714003597(Email #4)
Attachments: 267253.png; 267261.png; 267252.png

Well Name:	ARGENTA 34-10 31-1	Location:	Sec: 31	Twn: 034N	Rng: 0
API Number:	05.067.08199	Footage:	2483 FSL 2406 FEL		
Operator:	Hilcorp Energy Company	Area/Run/MSO:	01	0101	Francisco Quintan
Meter #:		Pipeline:			
INC Number:	714003597	Agency:	ECMC	Inspector:	Corey M
Type of INC:	Written	Photos Required:	Yes	Due Date:	
Issue of Concern:	<p>Comment: Inspection doc #714002169 observed Musk thistle at the location access point and req by 5/28/2025. It was observed in this inspection that treatment efforts were unsuccessful, musk thistle in various patches throughout the location access road and at the access road access point. Original CA has been addressed. Original CA and date remains applicable. No CA date is being provided as this location is not in compliance for the same Rule.</p> <p>Corrective Action Comply with rule 1003.f.</p> <p>Comment: A vegetation transect was completed during the previo

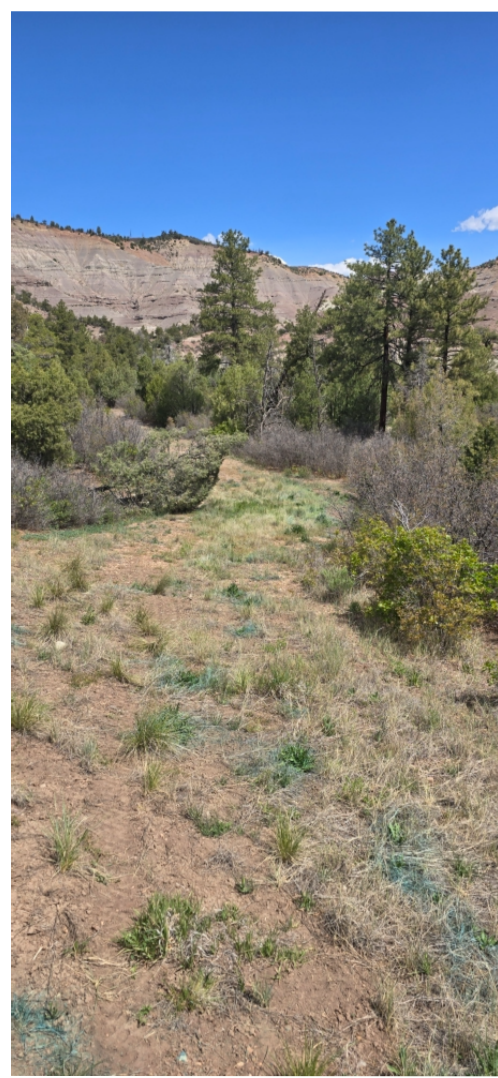
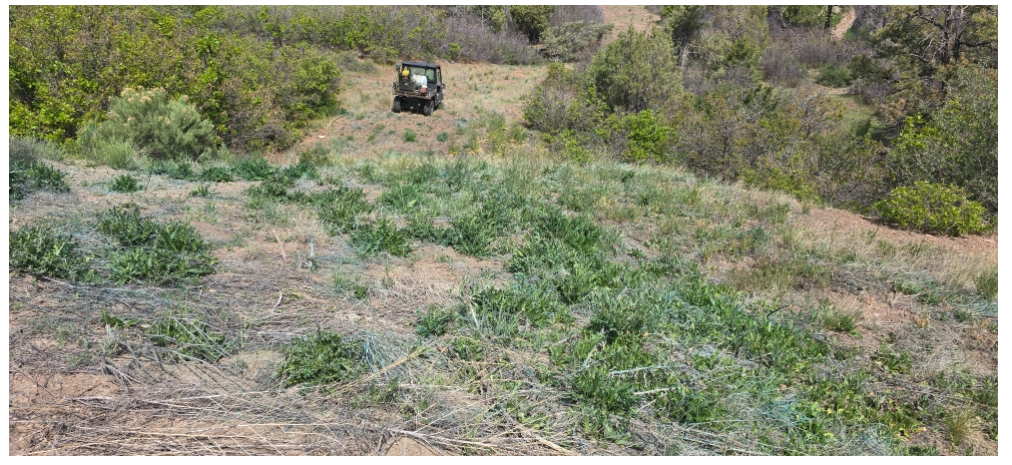
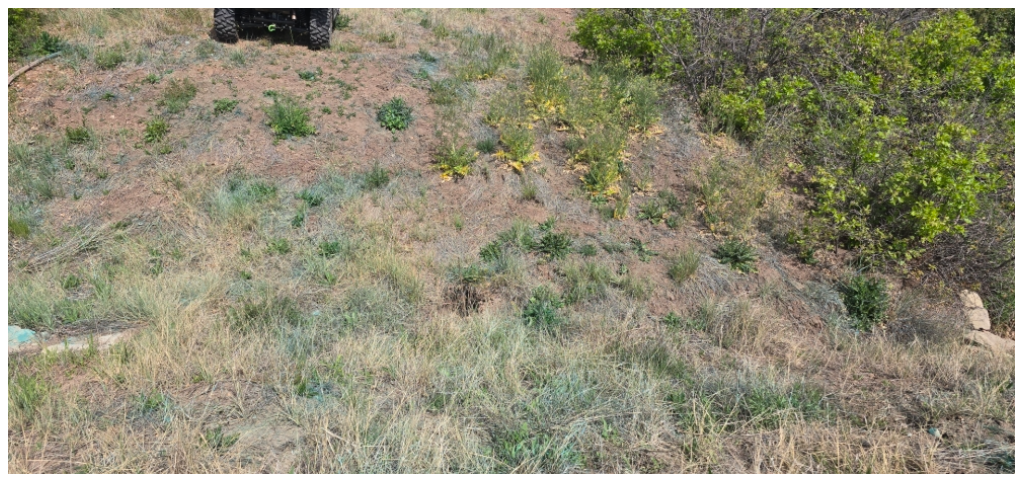
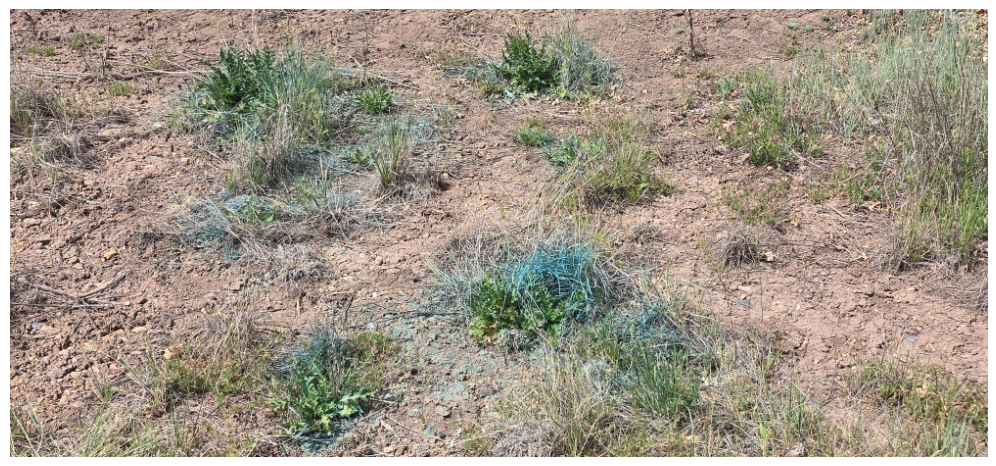
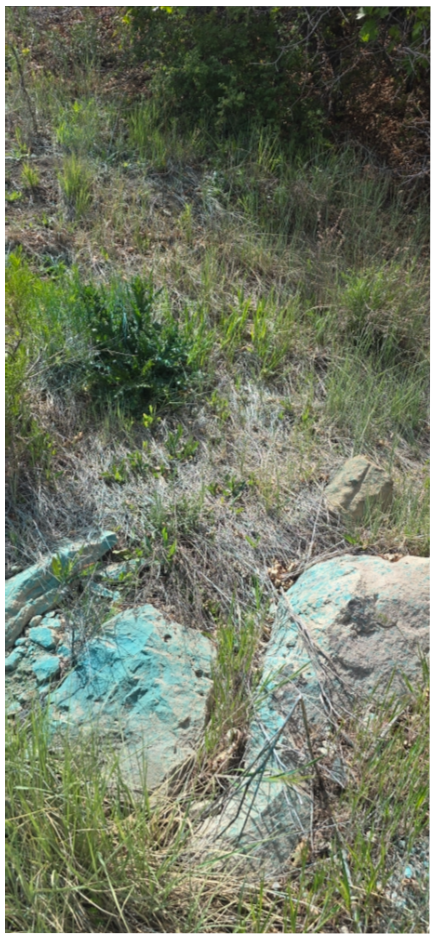
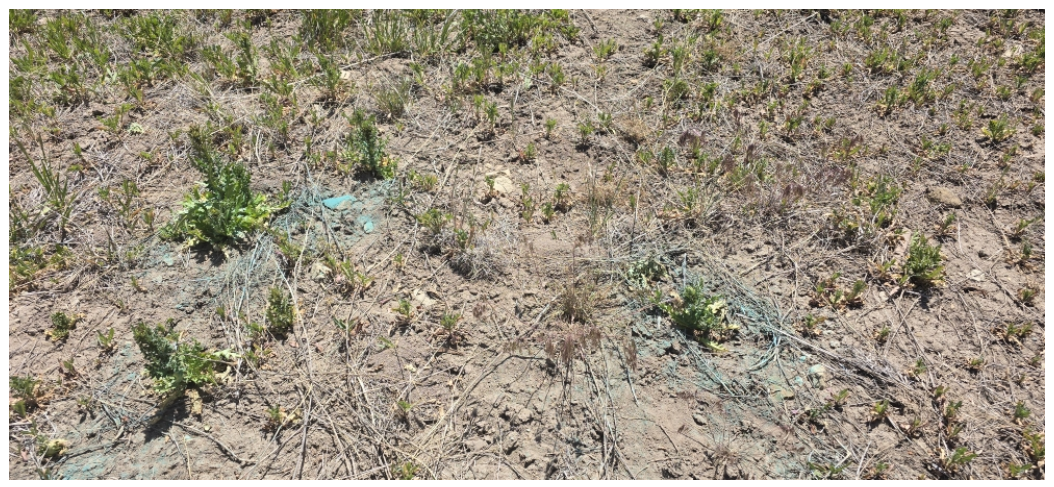
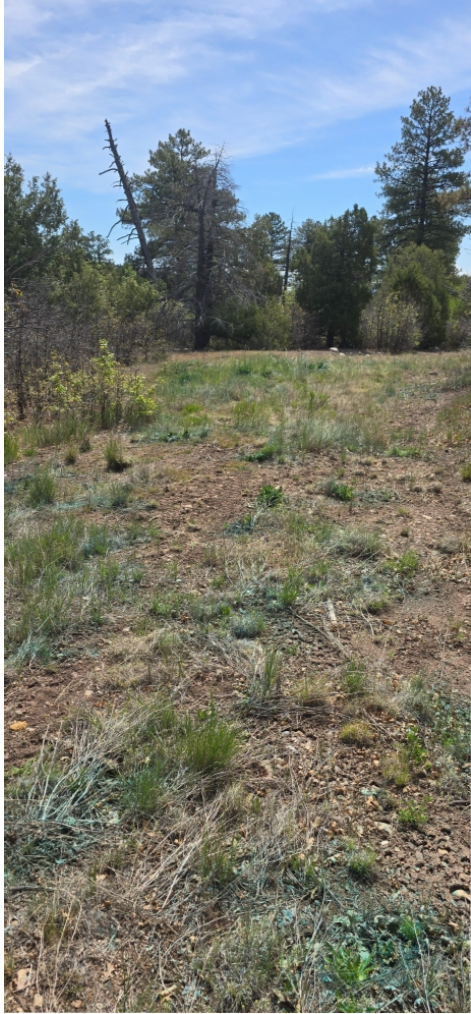
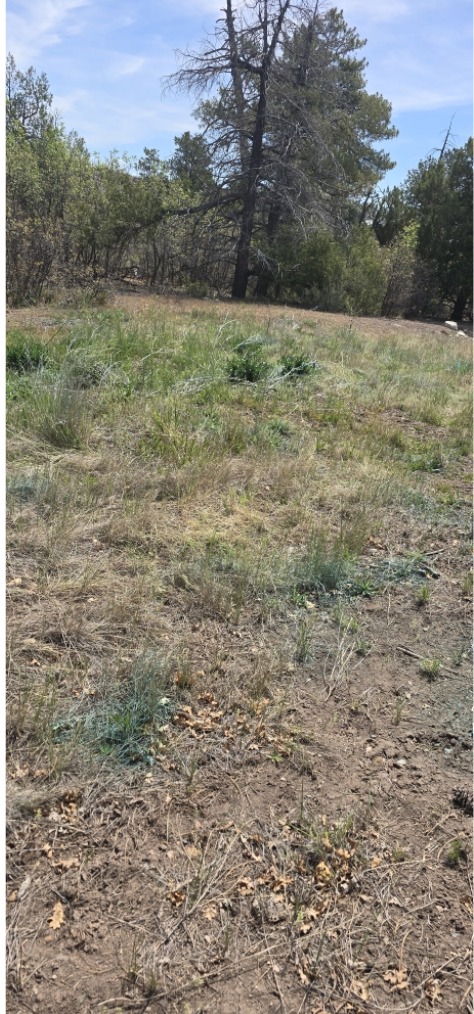
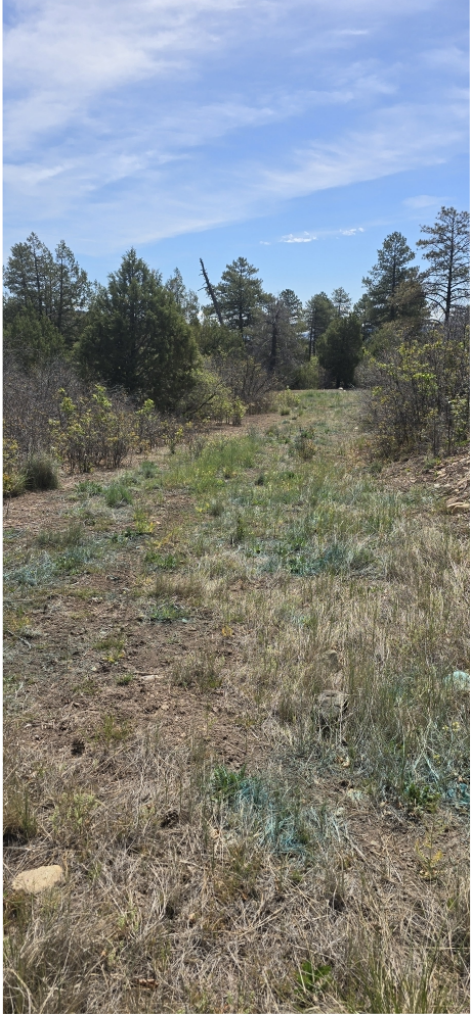
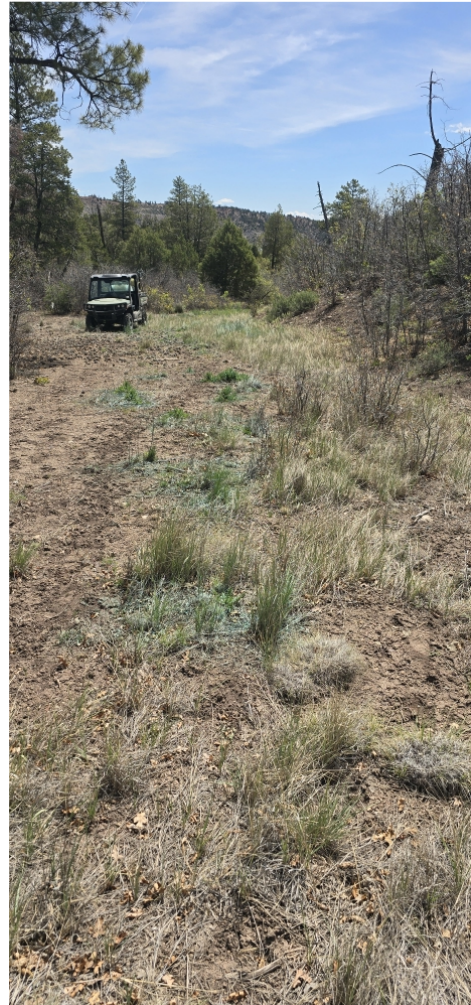
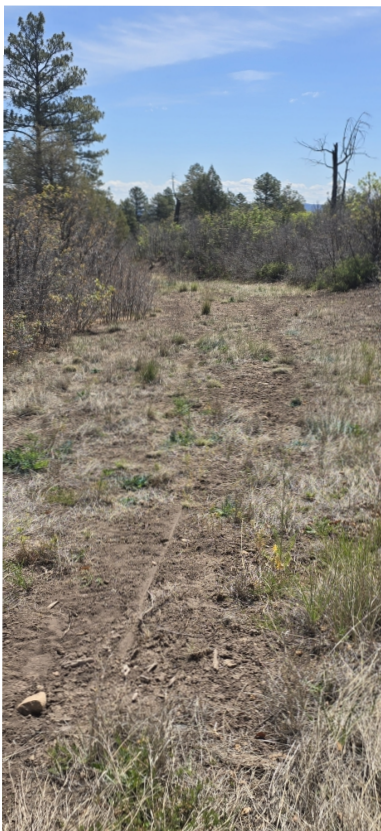
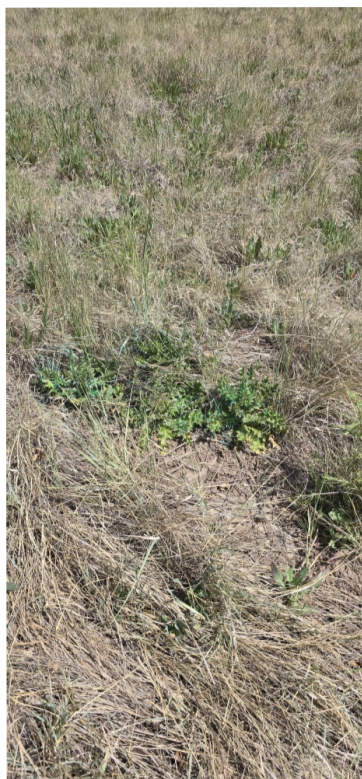
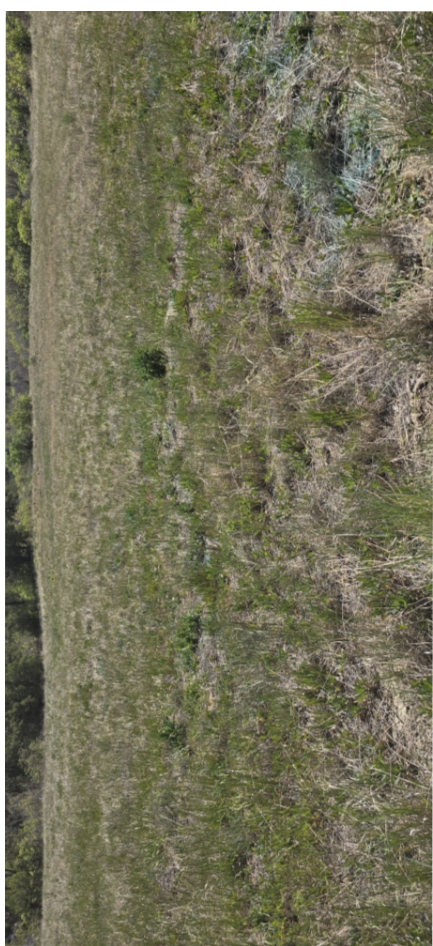
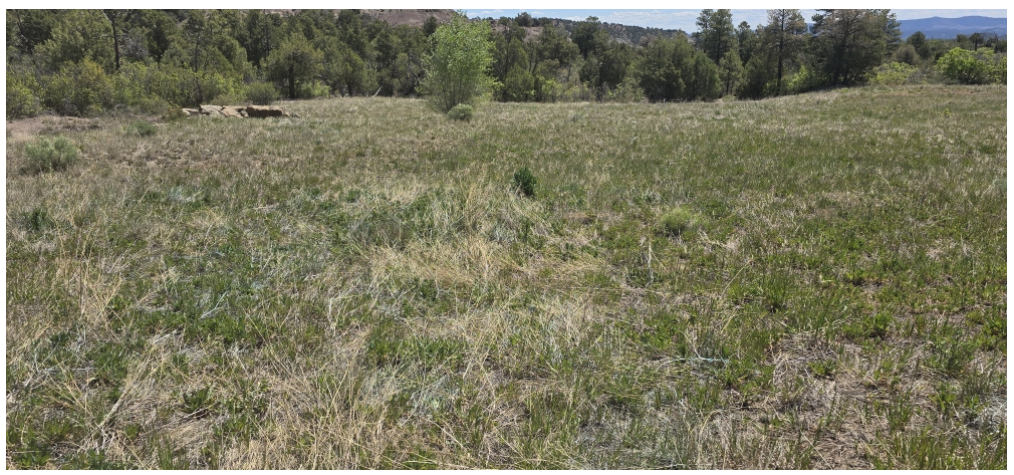
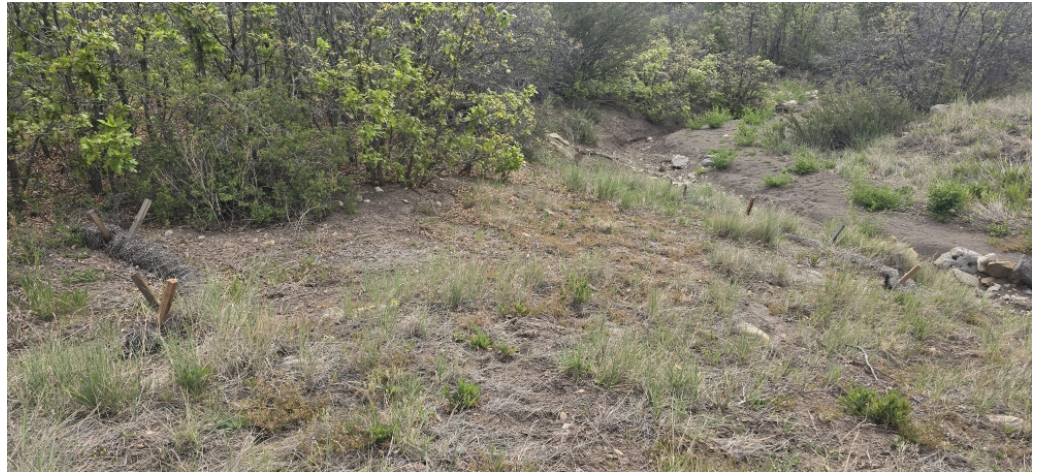
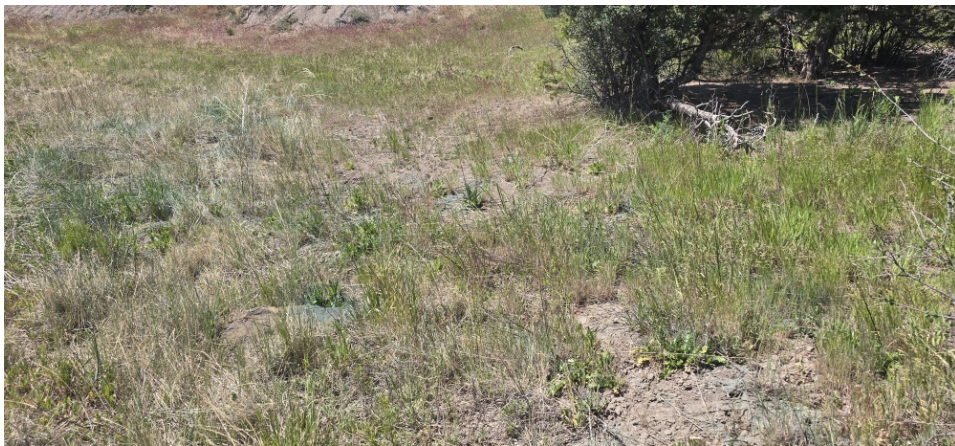
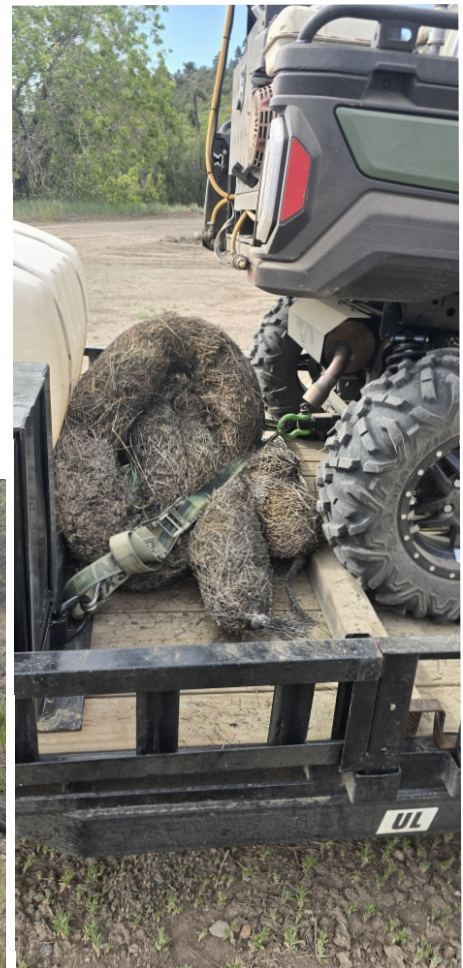
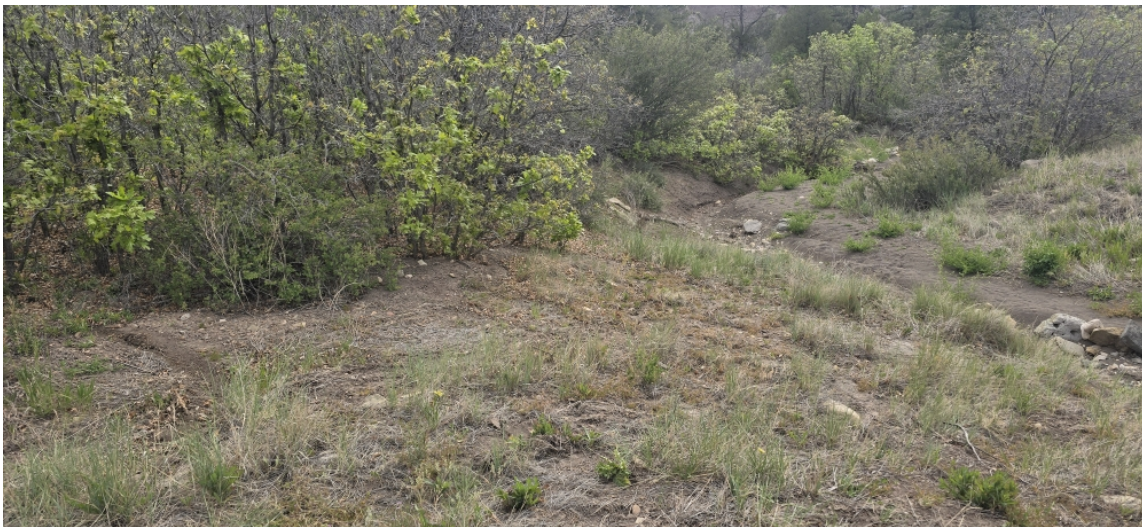
Resolved Photos:

Corrective Action: Stormwater wattles require removal before location can pass final reclamation. Submit, attached to a Form 4 Sundry to Area Reclamation Specialist Corey McDonough, date stamped photographs showing removal of the wattles.

Removed and properly disposed of wattles.
