Inspection Photos

API: 061-06480

Operator: MURFIN DRILLING COMPANY INC

Inspection Date: 5/26/2026

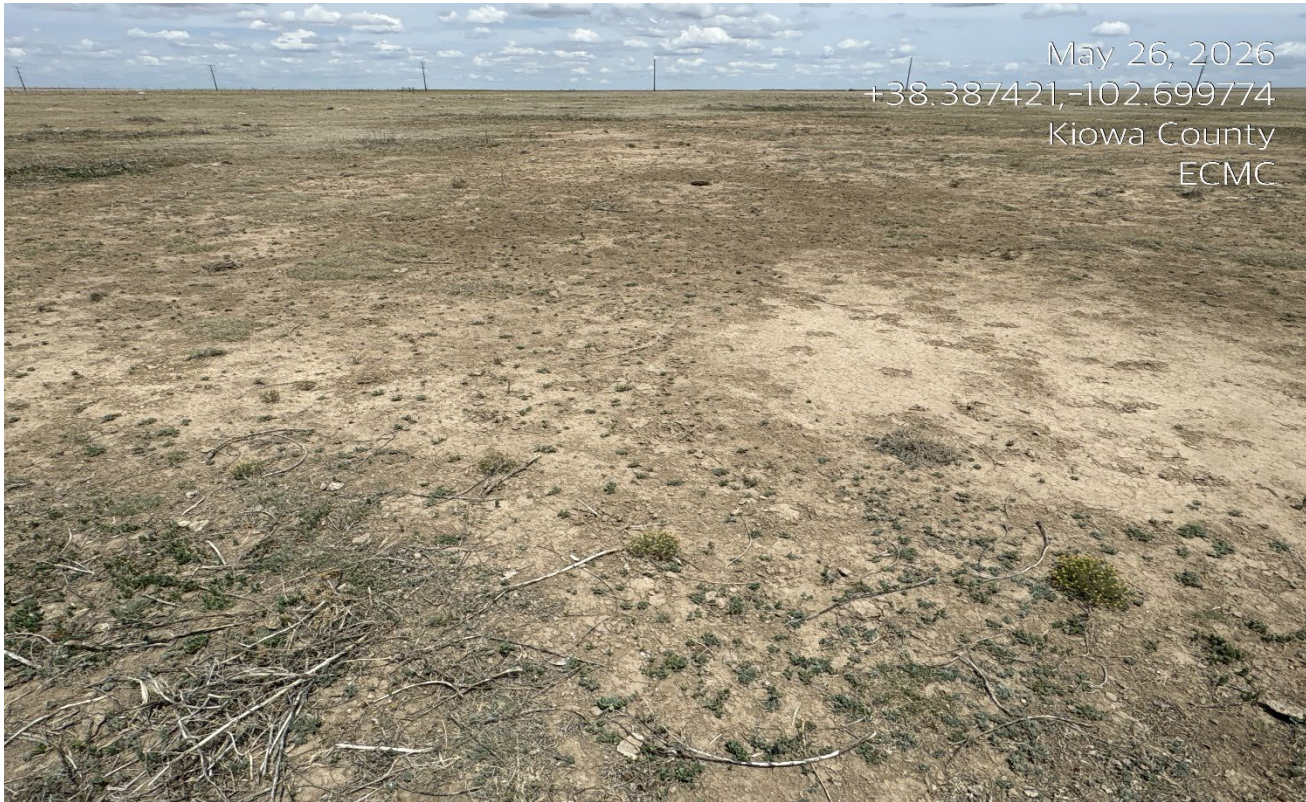
Photo 1. Center of the location facing north. This area is bare of vegetation and has not been reclaimed.

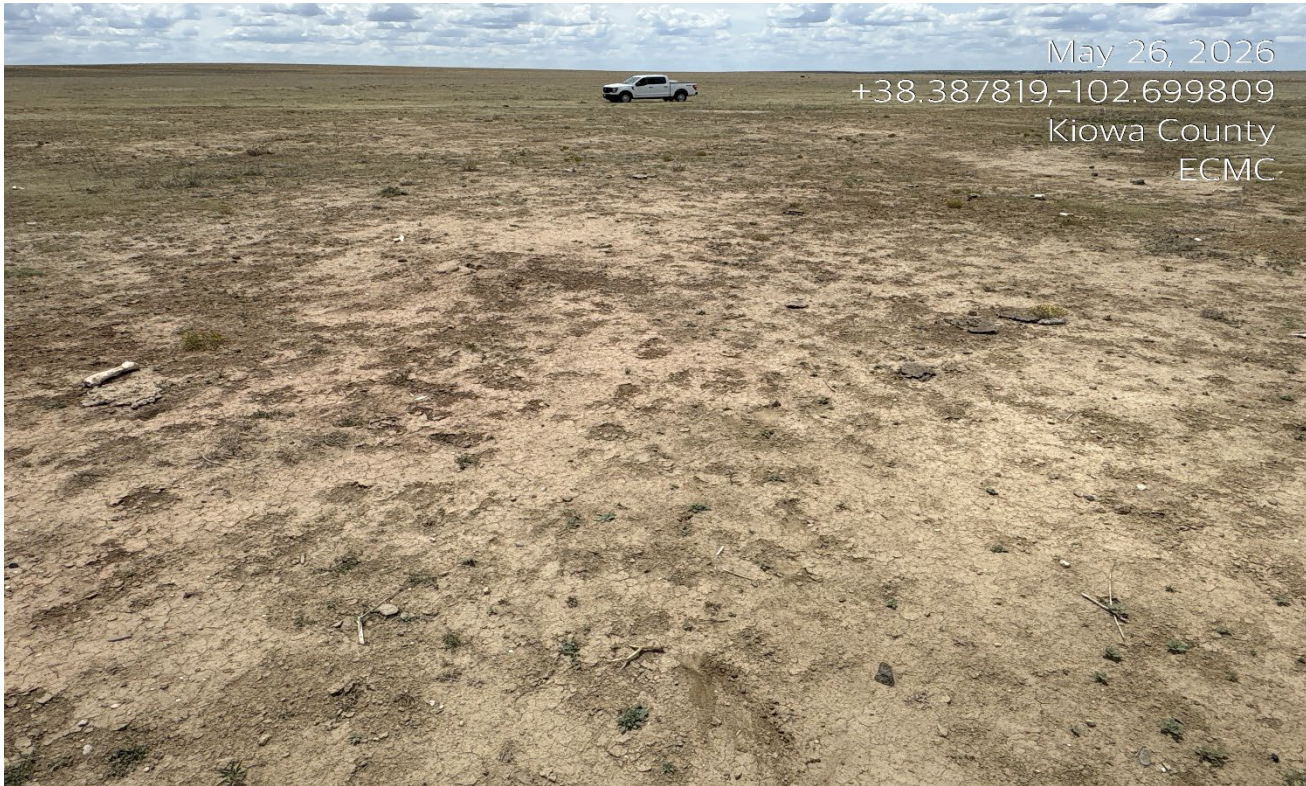
Photo 2. Center of the location facing south. This area is bare of vegetation and has not been reclaimed.

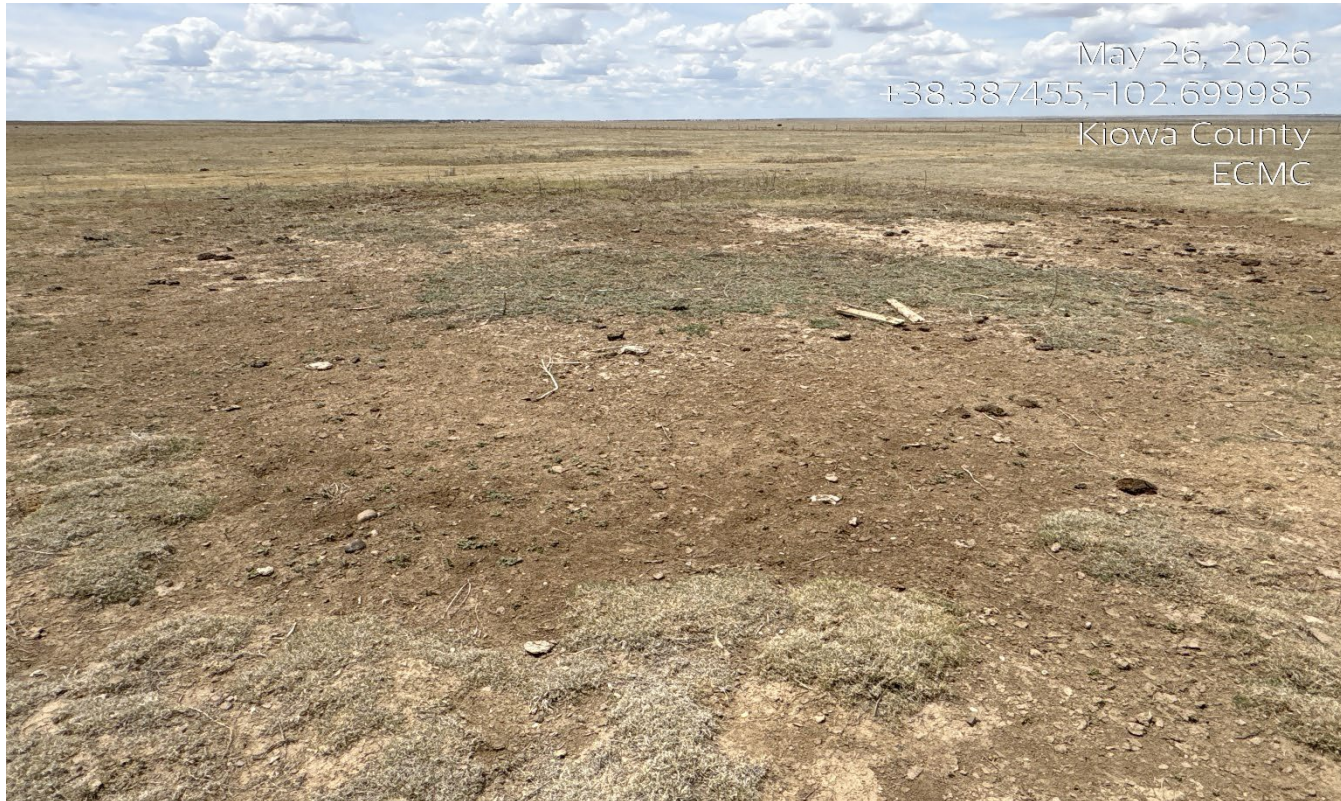
Photo 3. Facing southwest at the location. This area is bare of vegetation and has not been reclaimed.

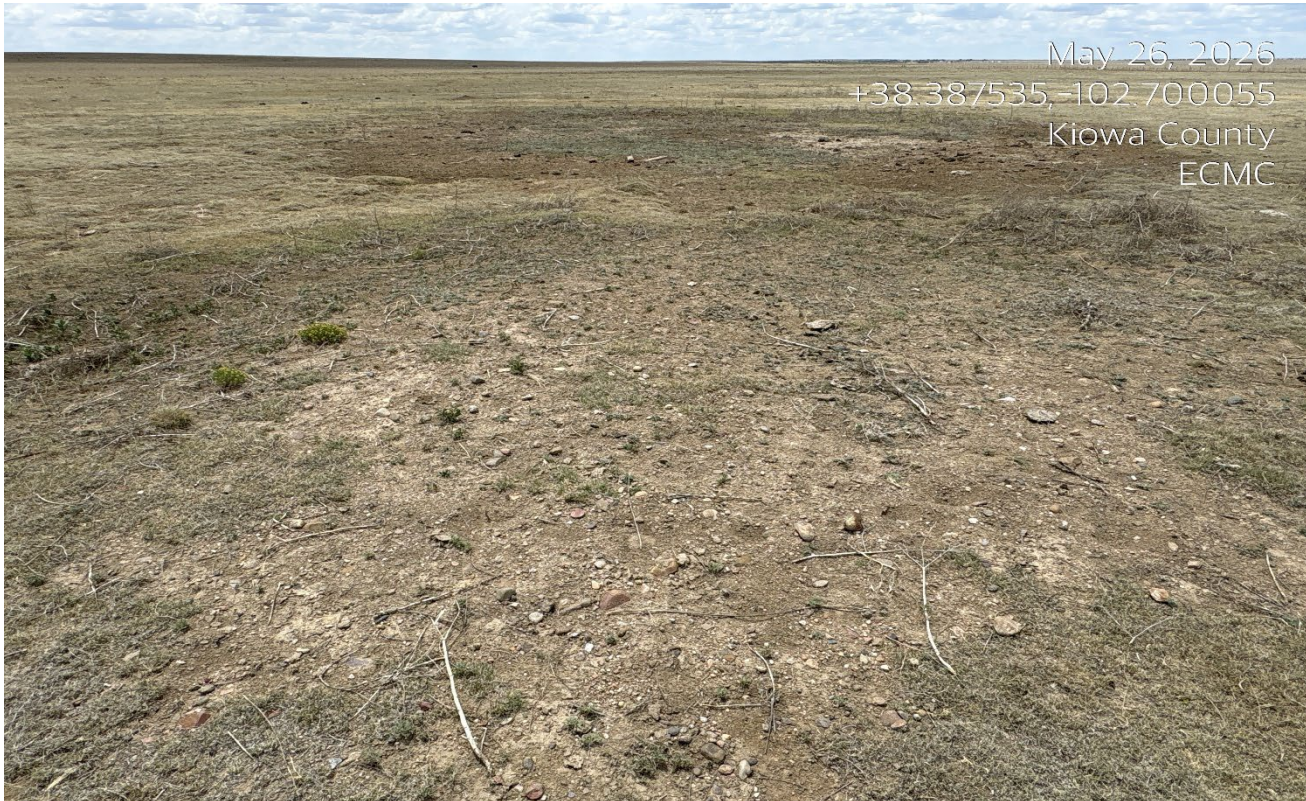
Photo 4. West side of the location facing south. This area is bare of vegetation and has not been reclaimed.

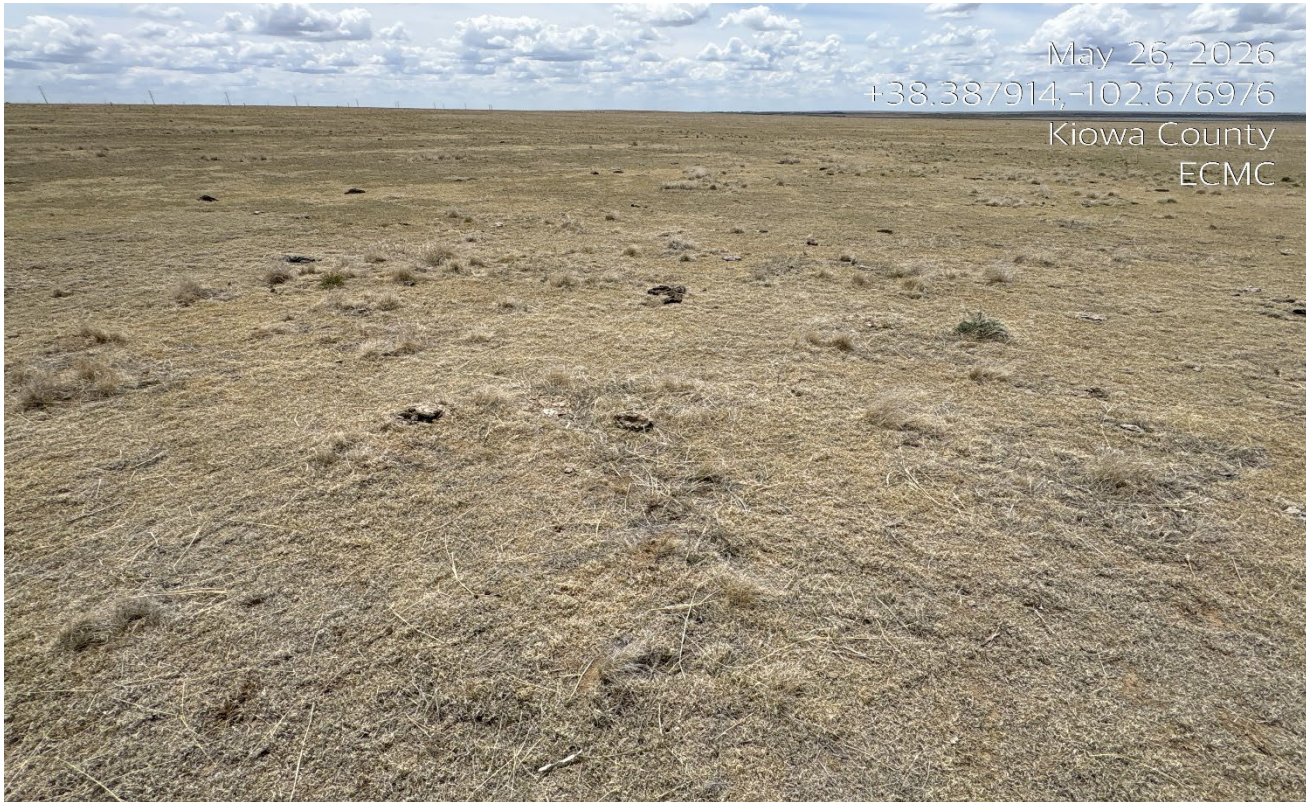
Photo 5. Facing toward the surrounding undisturbed reference area.
