# Inspection Photos

API: 061-06590

Operator: OXY USA INC

Inspection Date: 5/26/2026

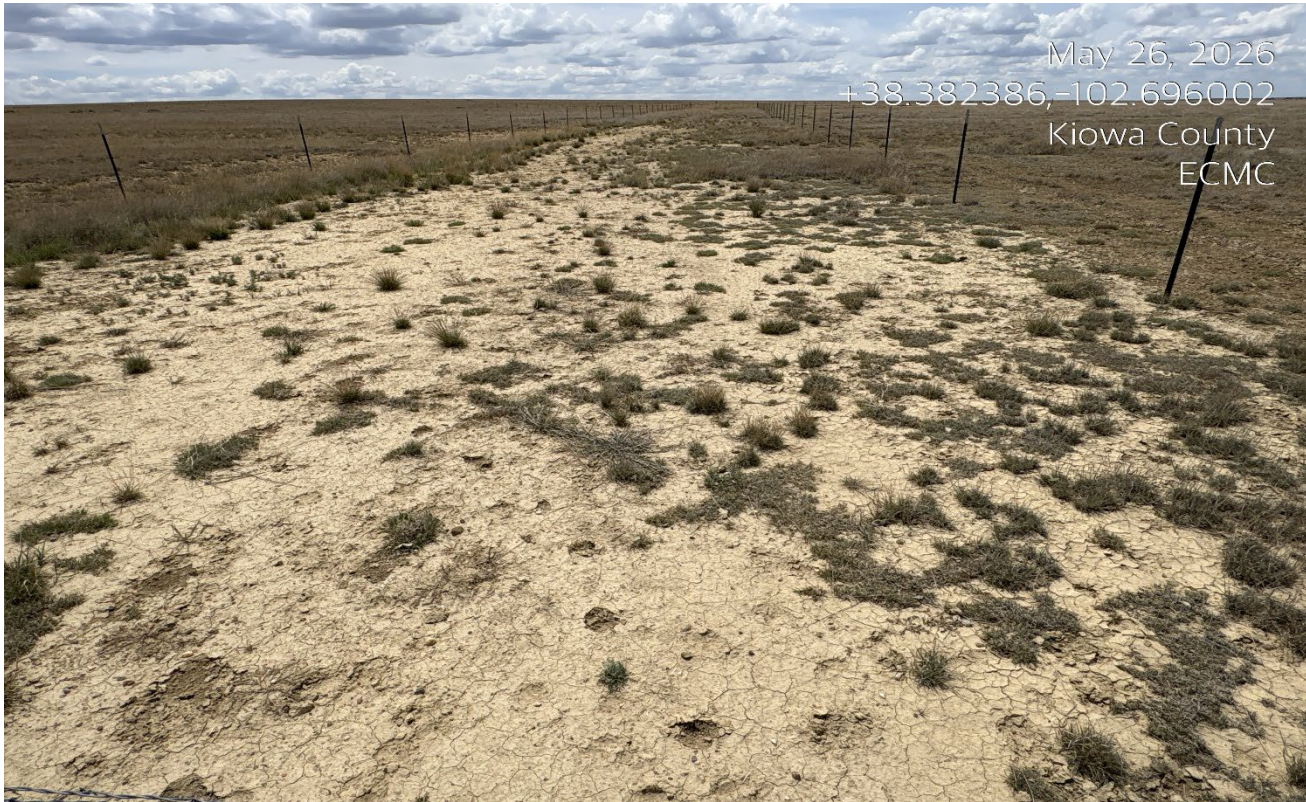
**Photo 1.** Facing south along the former access road. This area is fenced and vegetation is sparse in areas.

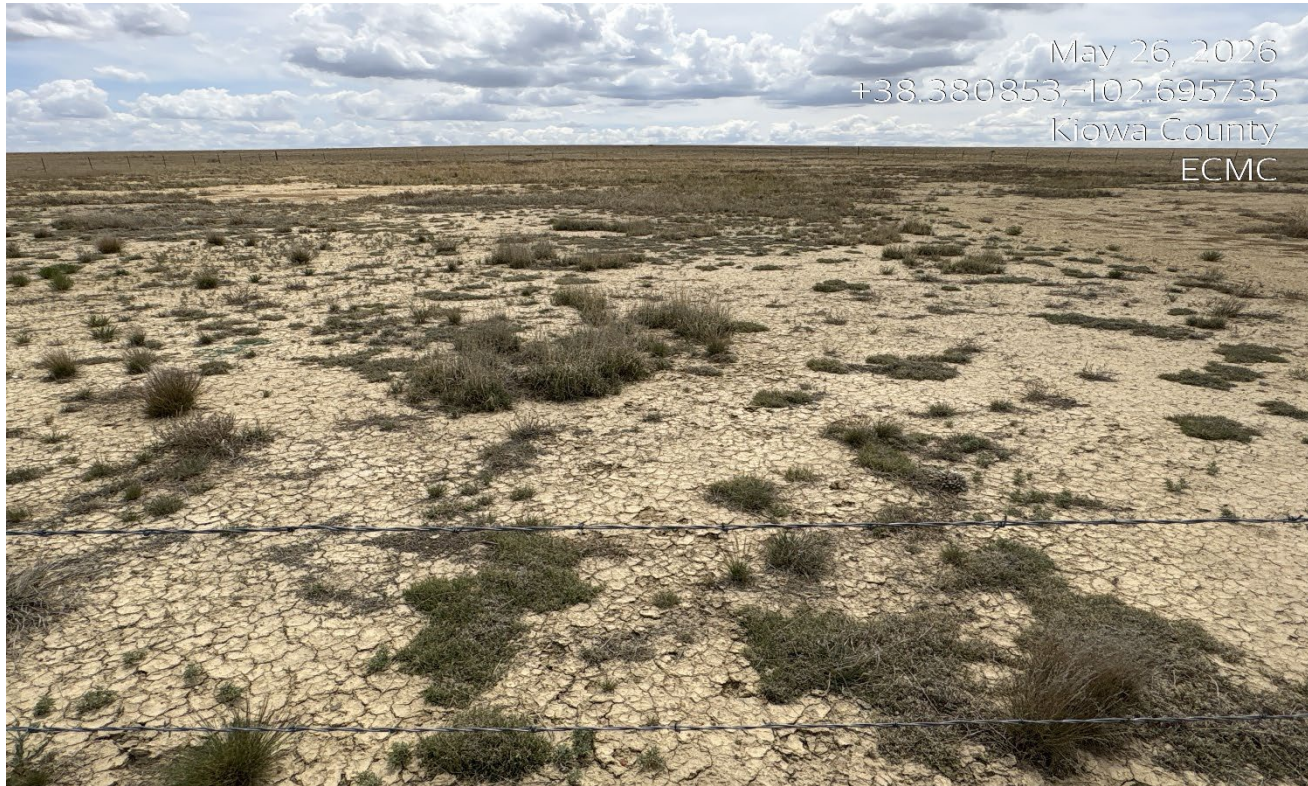
**Photo 2.** Facing southeast toward the location.

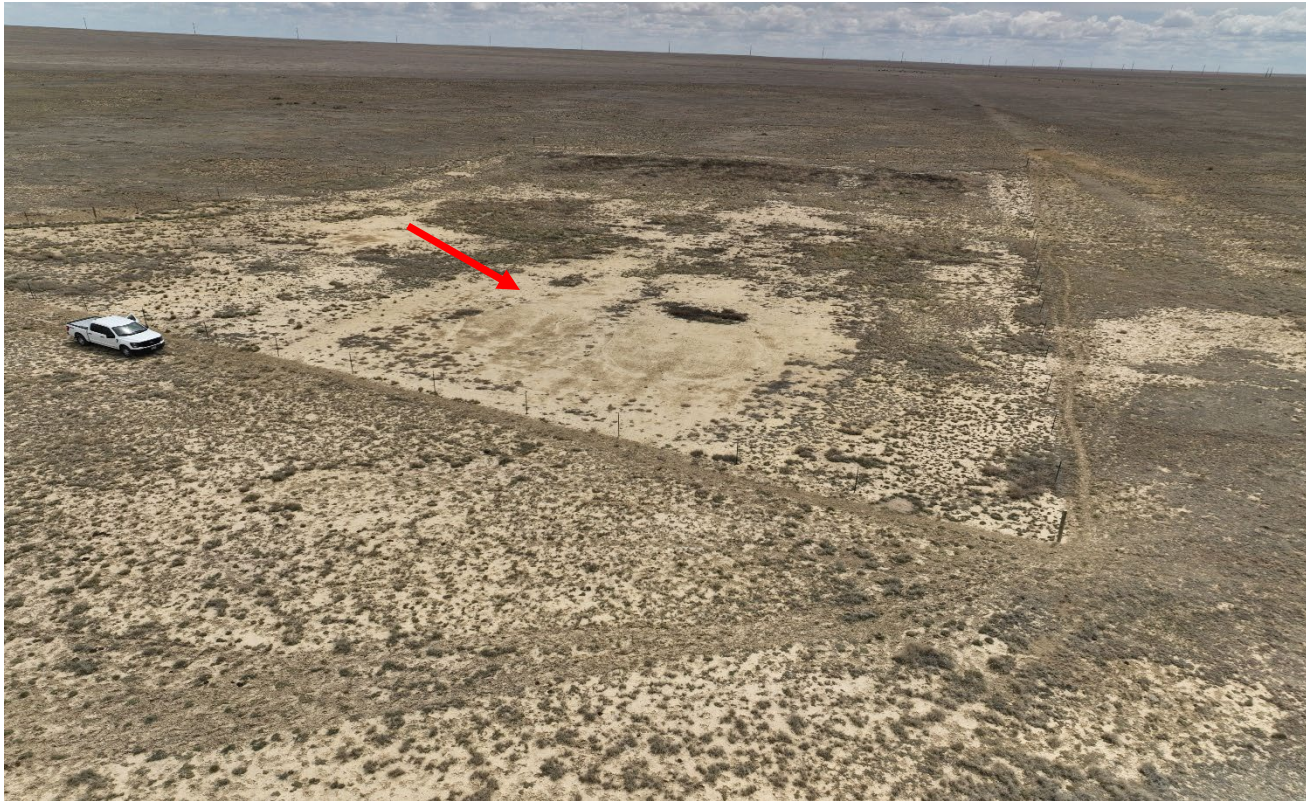
**Photo 3.** Drone aerial photo facing southeast toward the location. The area at red arrow has not established vegetation.

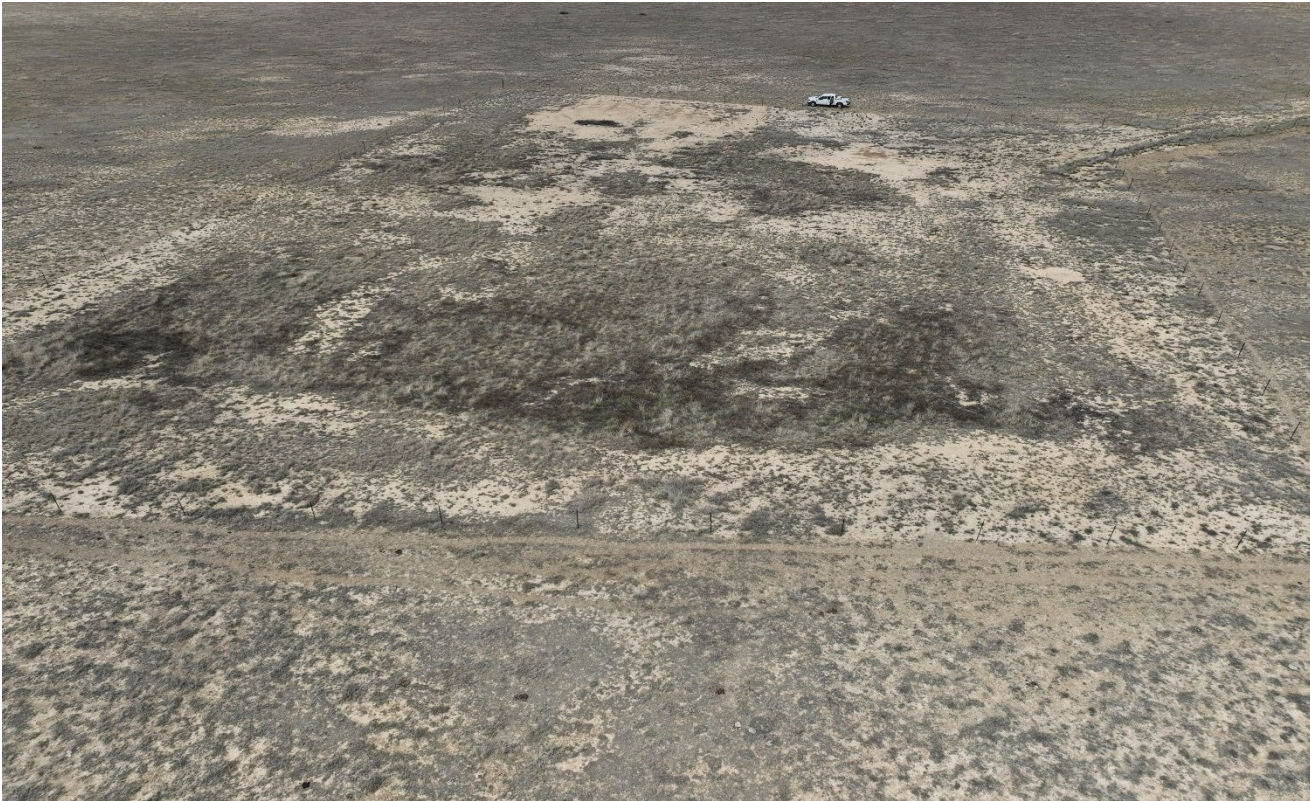
**Photo 4.** Drone aerial photo facing northwest toward the location.

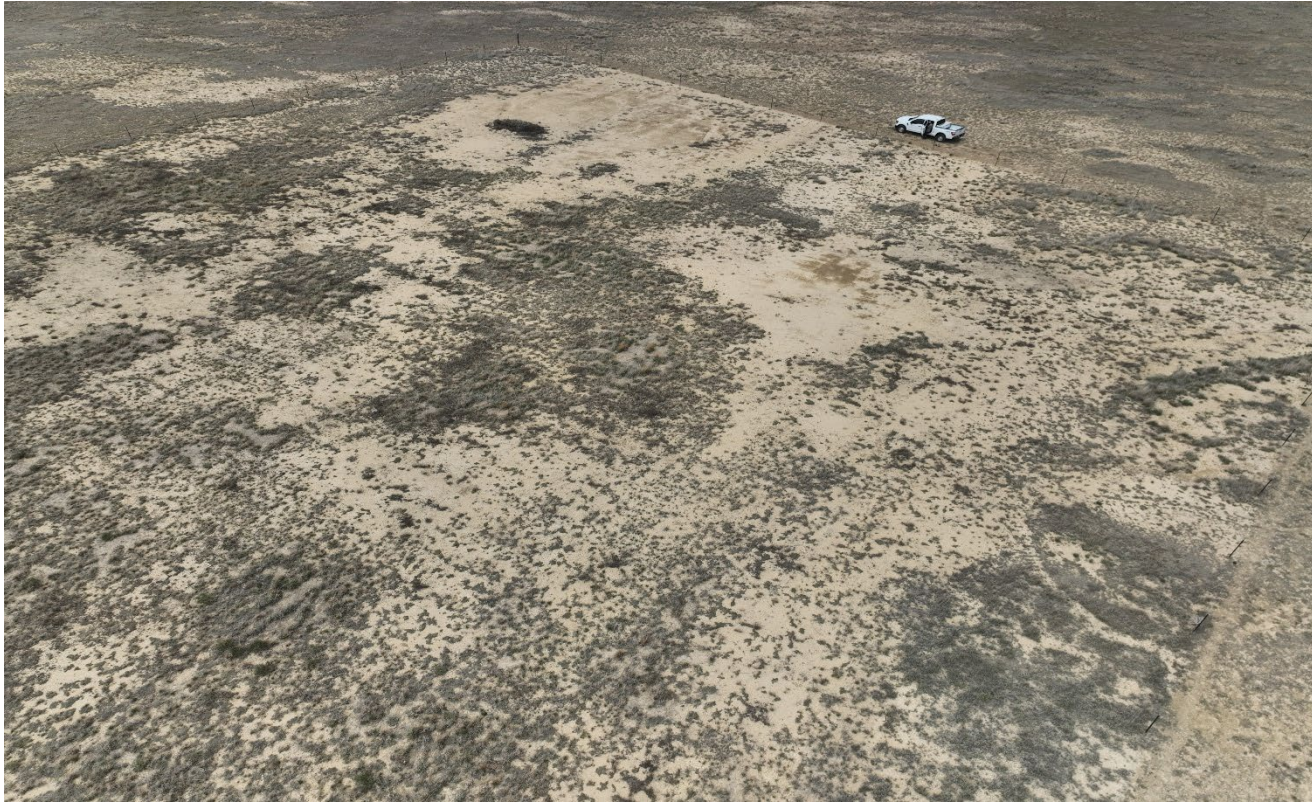
**Photo 5.** Facing northwest overlooking the location.

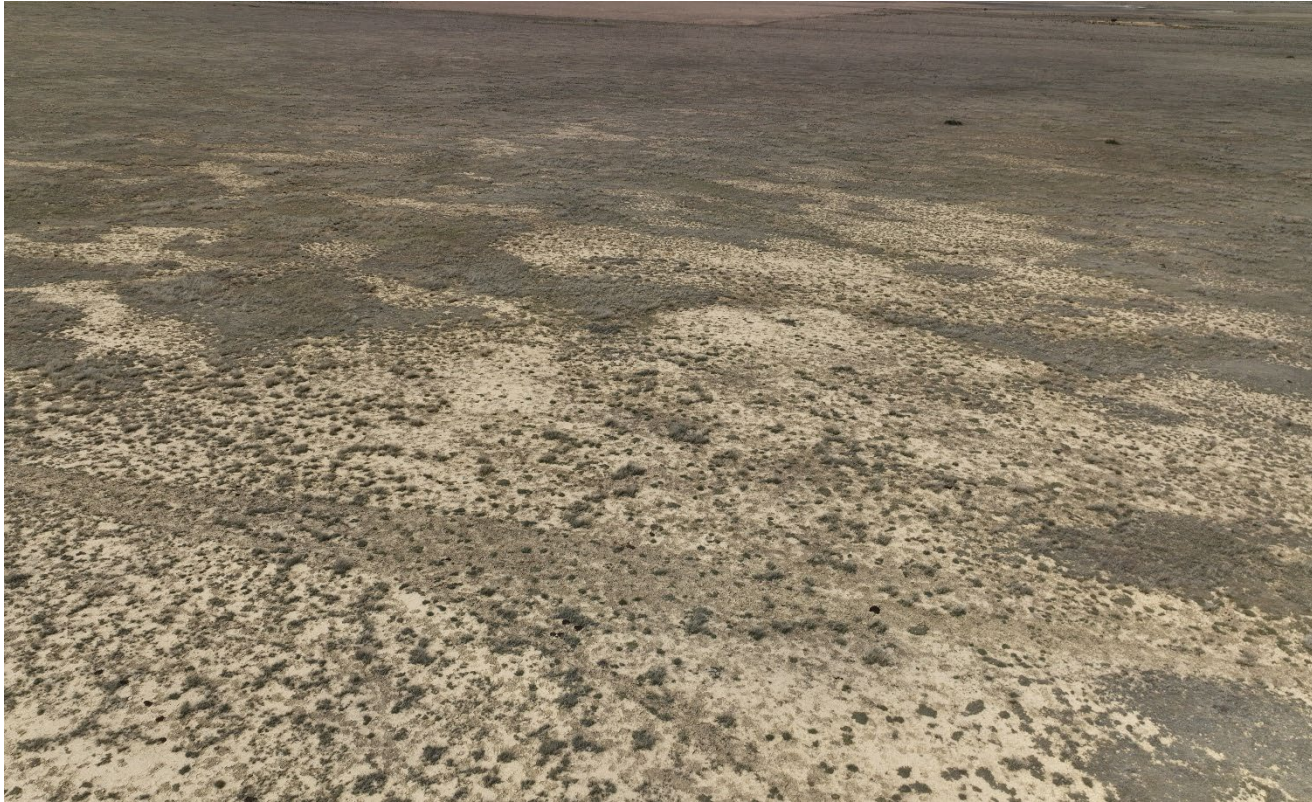
**Photo 6.** Facing toward the surrounding undisturbed reference area. There are areas in the reference area with sparse vegetation.
