# Inspection Photos

API: 011-06155

Operator: THOMAS L SPRING LLC

Inspection Date: 5/26/2026

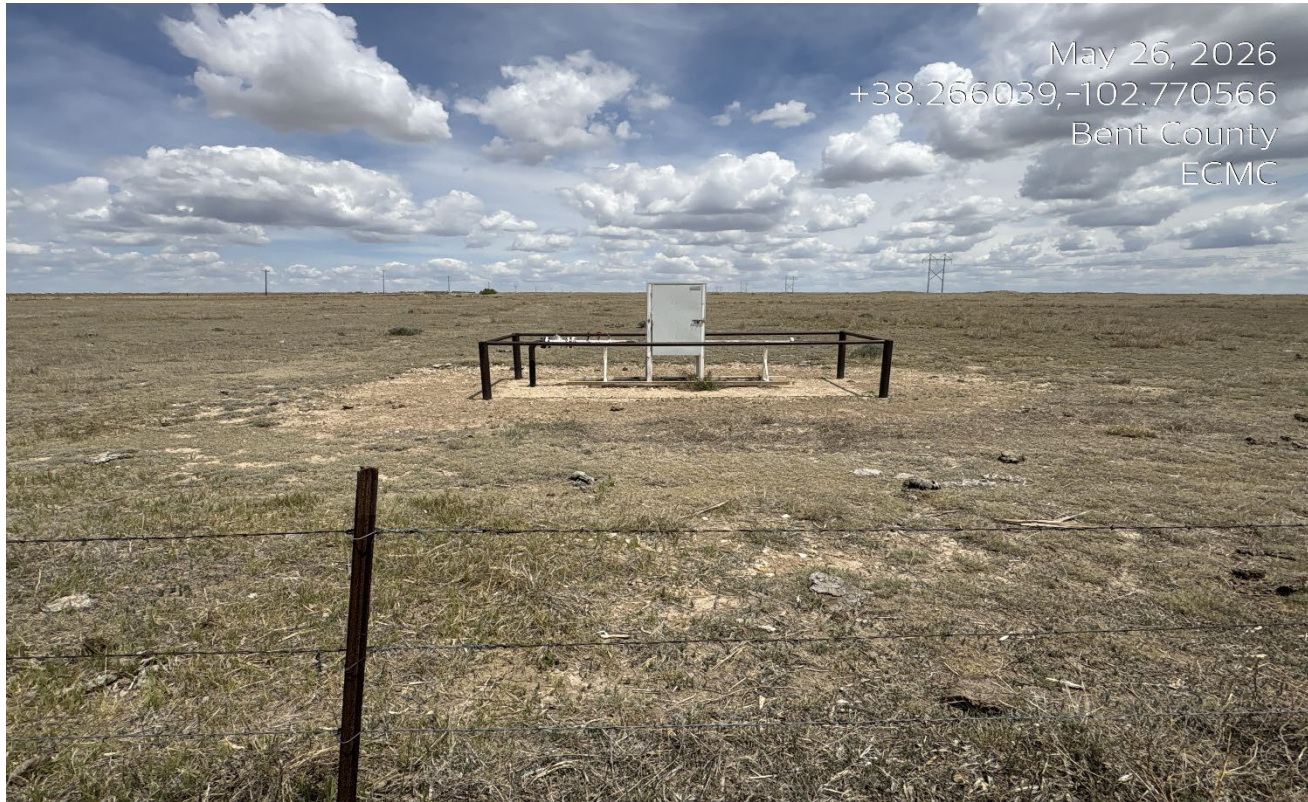
**Photo 1.** The meter flowline riser located along the access road has not been removed.

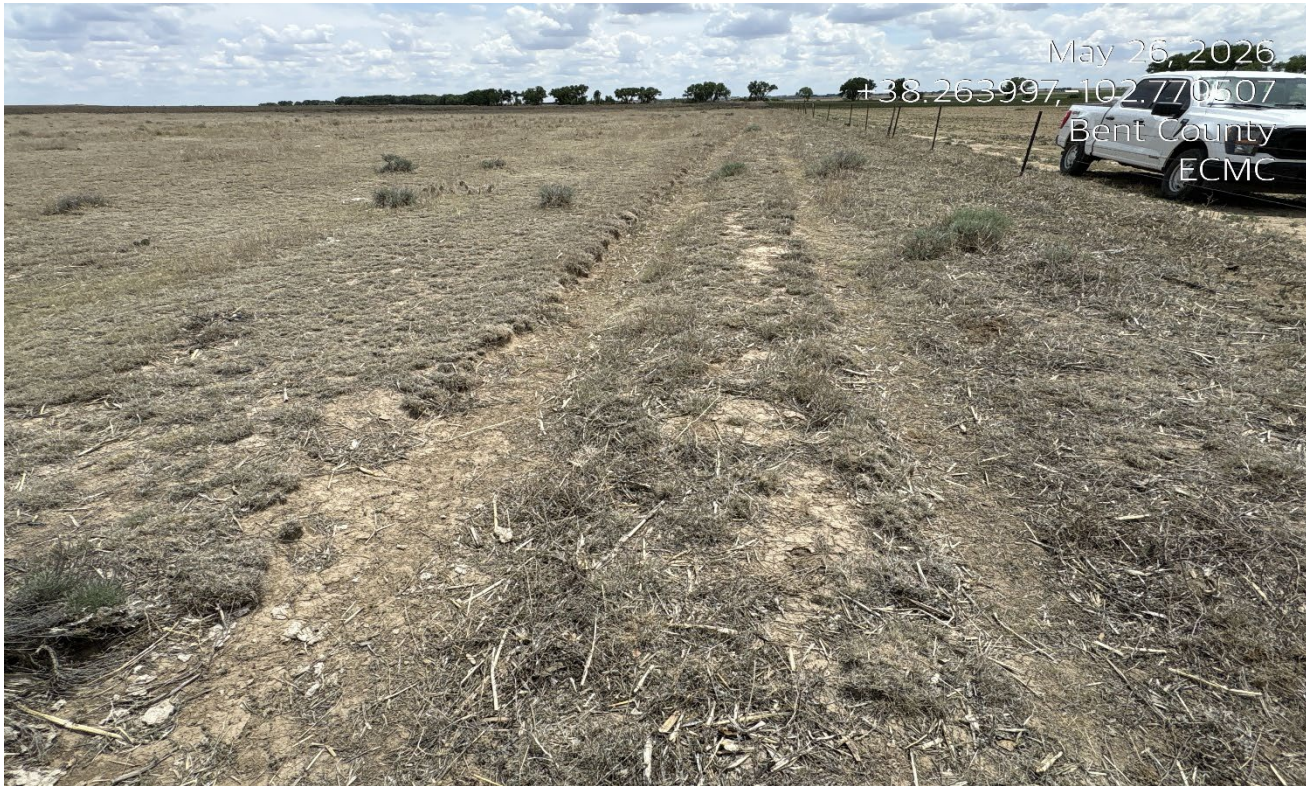
**Photo 2.** Facing north along the two track road. The vehicle ruts need to be filled in with soil for proper contouring.

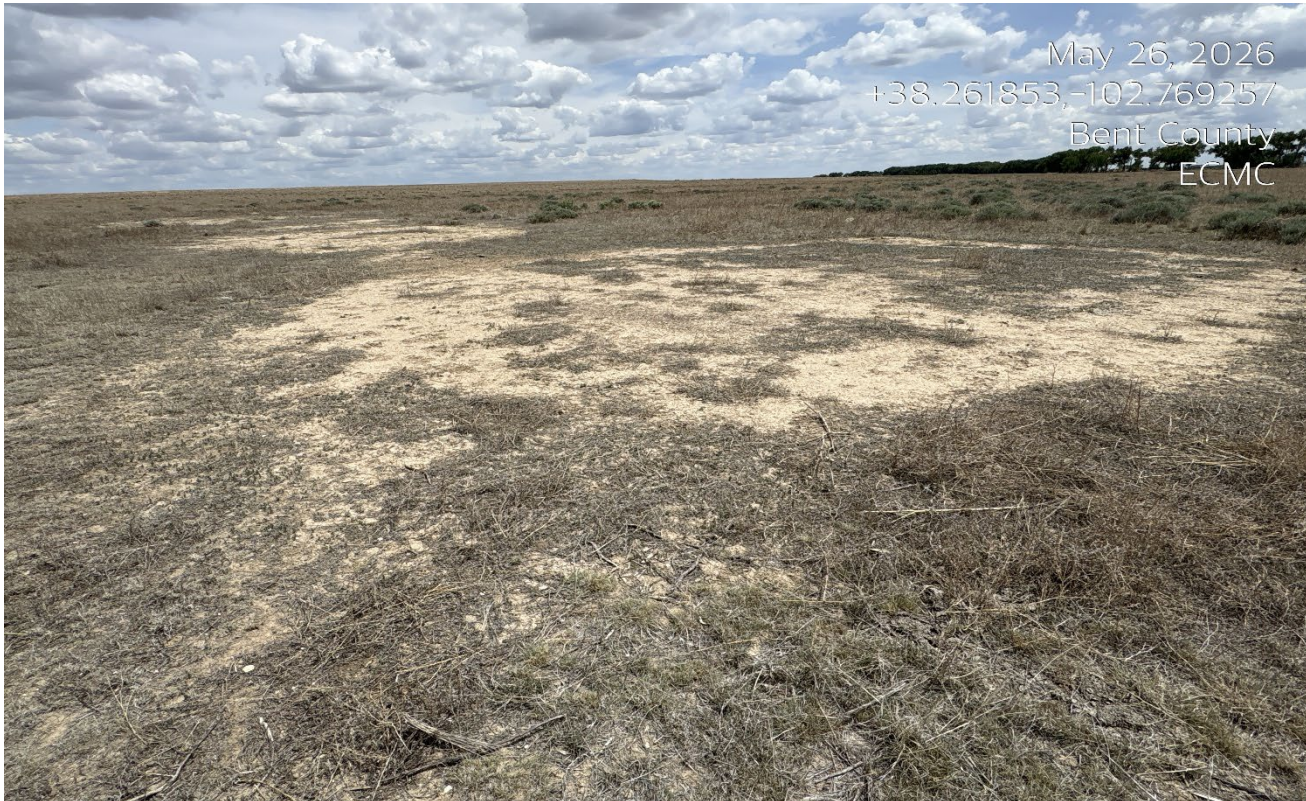
**Photo 3.** Facing southeast toward the location. The location has not been reclaimed and there are areas bare of vegetation.

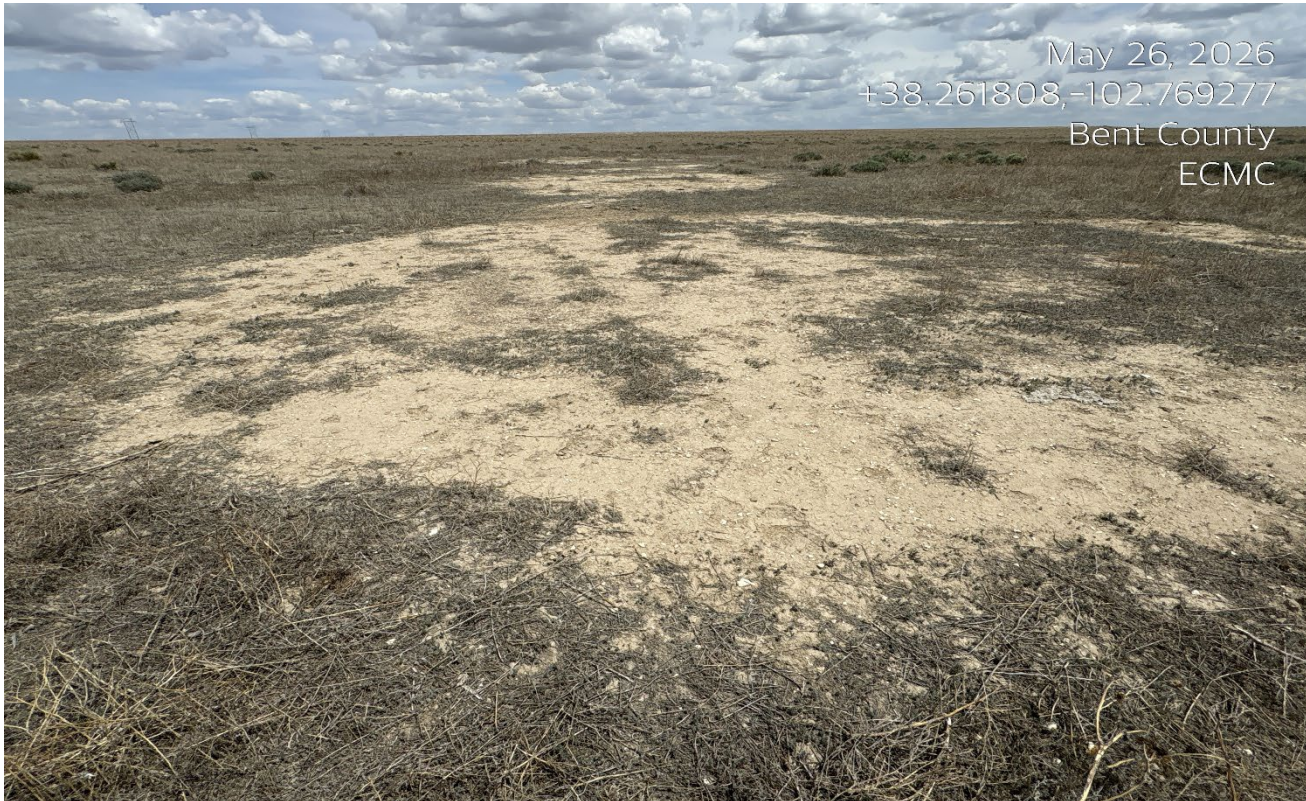
**Photo 4.** West side of the location facing east. The location has not been reclaimed.

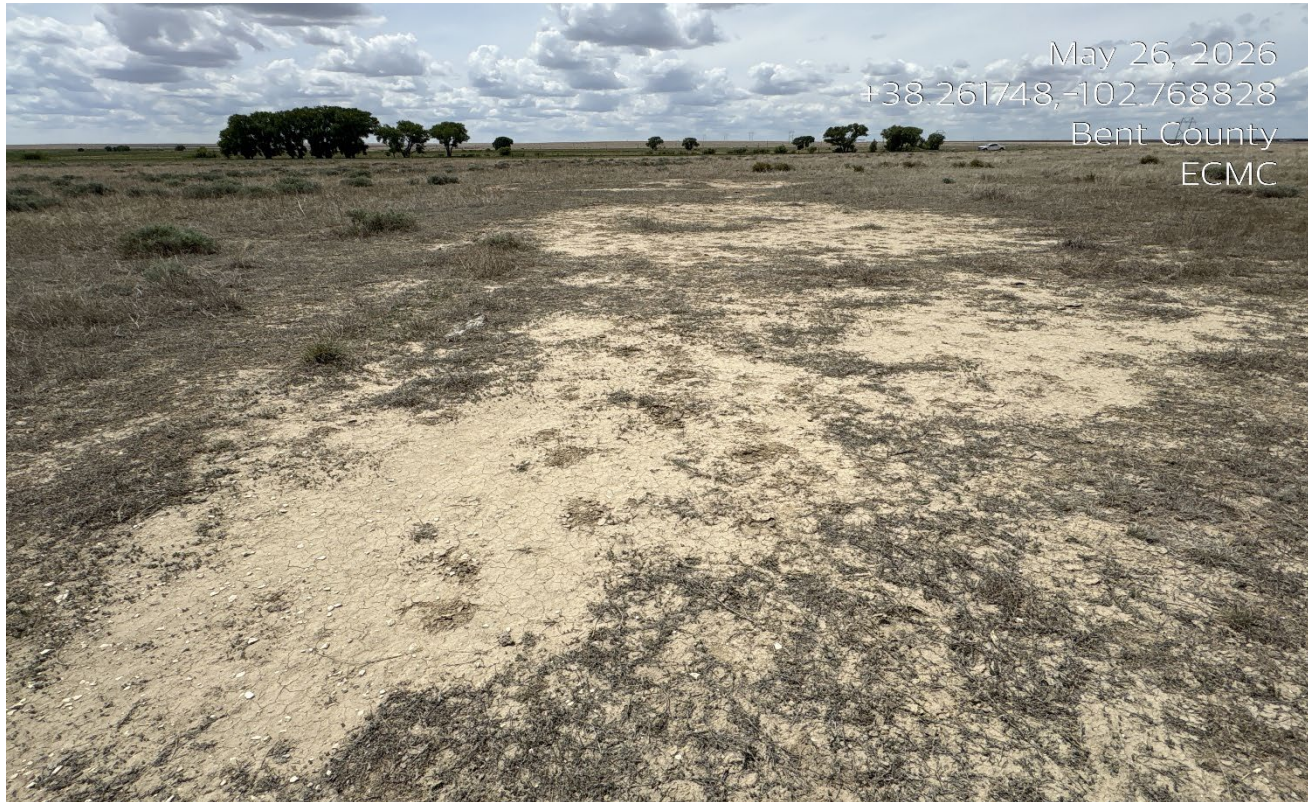
**Photo 5.** East side of the location facing west. The location has not been reclaimed.

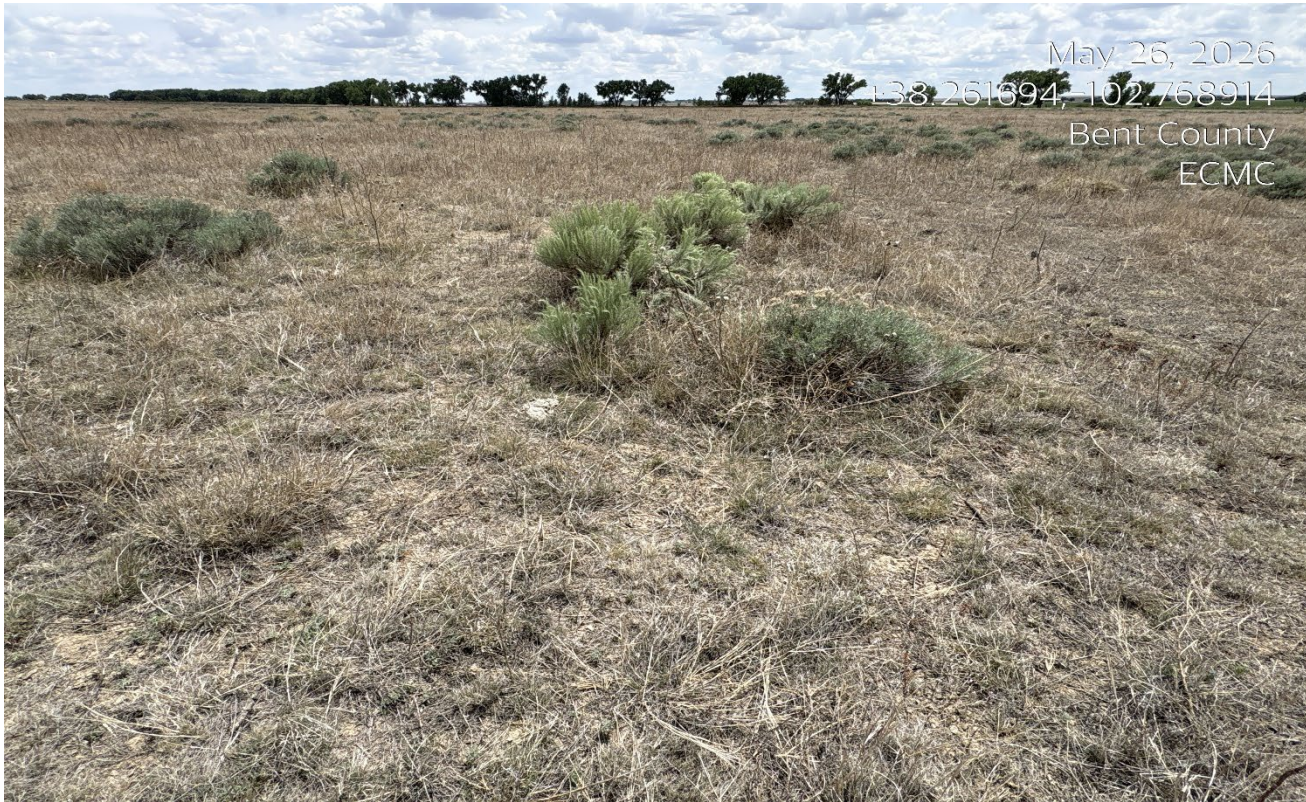
**Photo 6.** Facing south toward the undisturbed reference area.
