Inspection Photos

Location Name: Simcoe Walter Owens A1

Location ID: 333575 API 05-067-07767

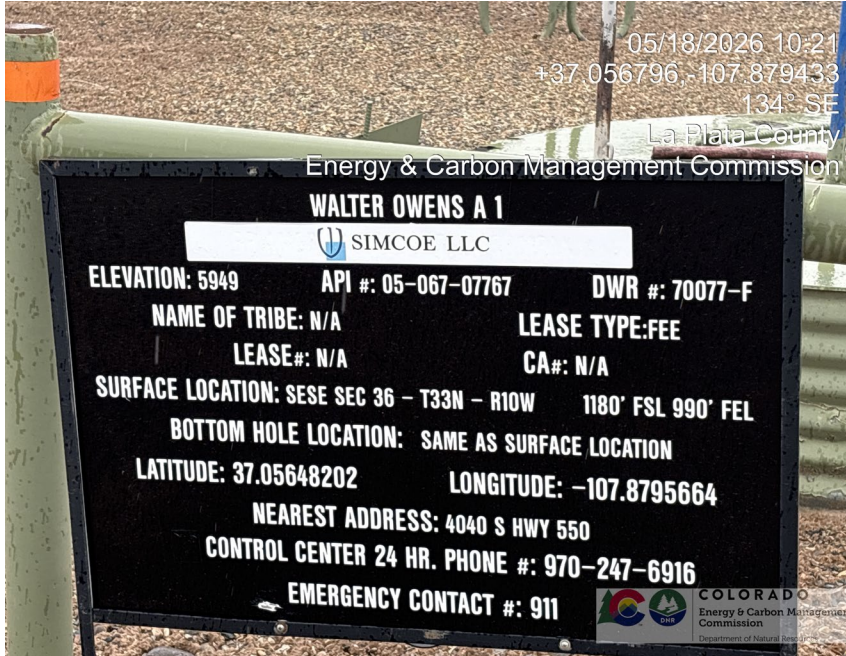
1. Well sign.

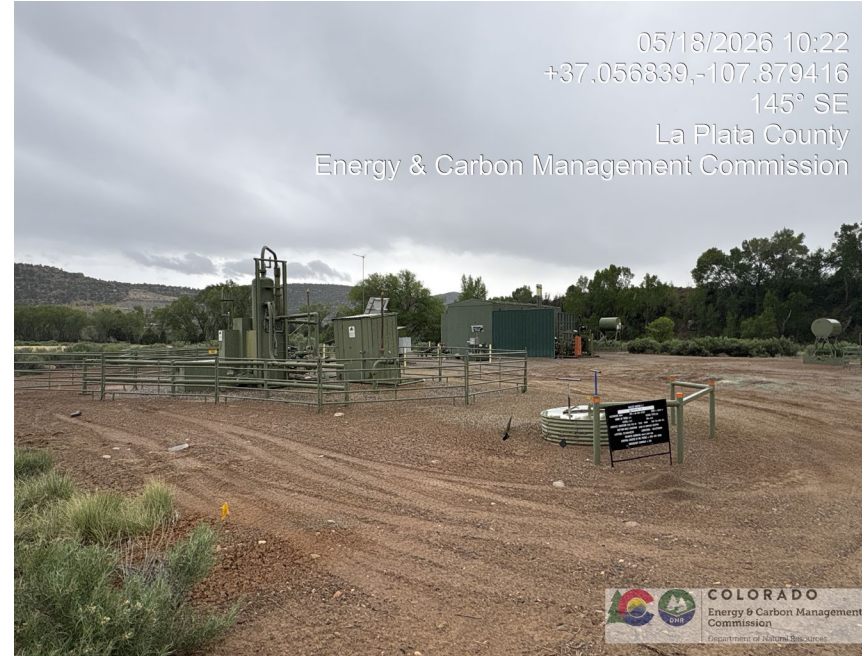
2. Entrance to well pad. Well sign on right.

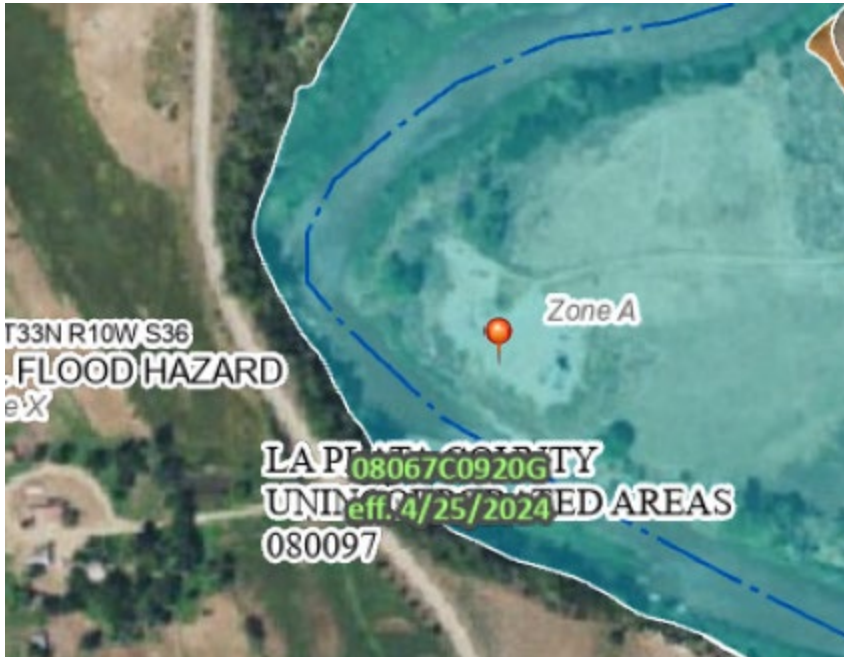
5. Detail of FEMA Floodplain website. Pin is location of well. Entire location is in flood zone. See full map linked in attachments section.

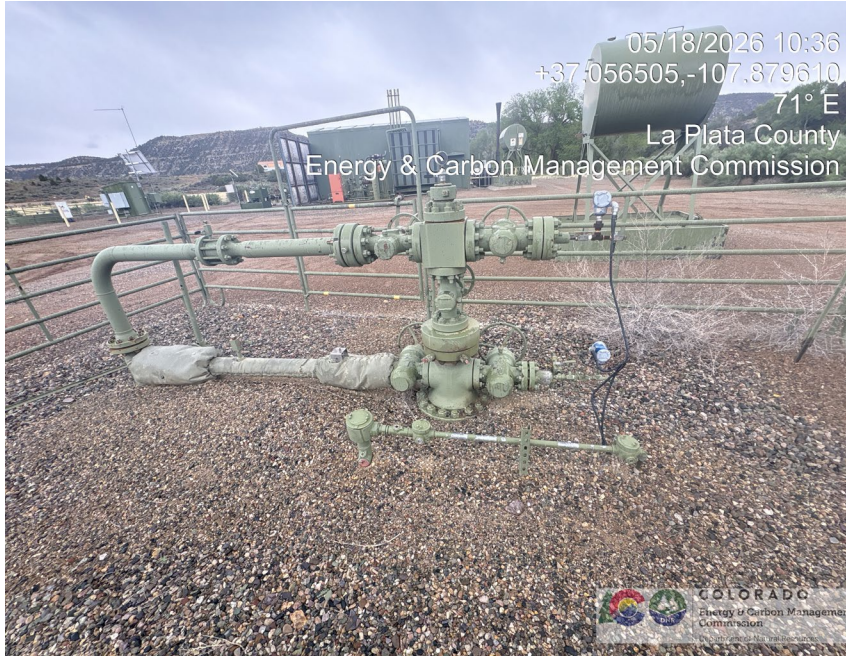
7. Wellhead. Note dead vegetative debris in fence.

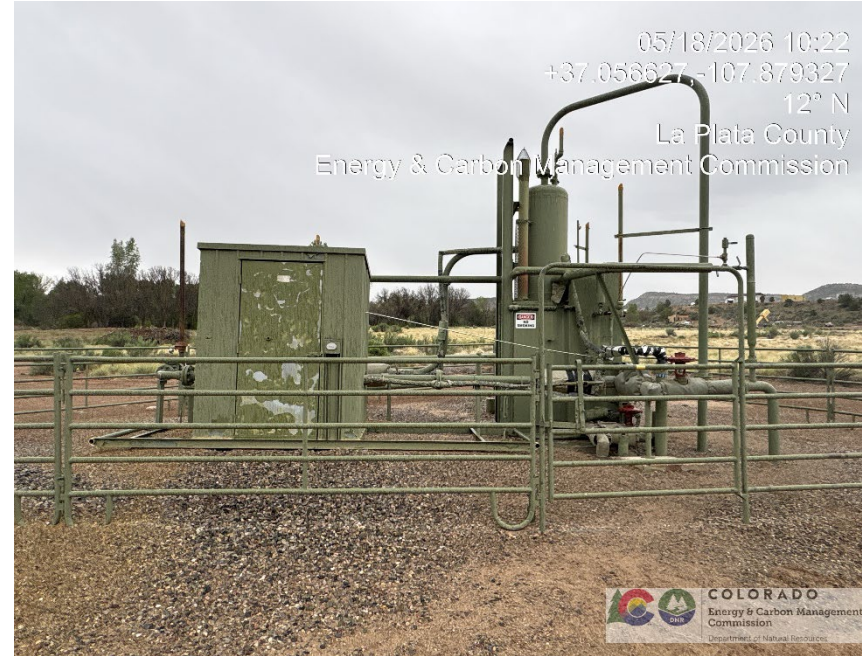
10. Meter run and vertical heated separator. Separator is anchored by turnbuckles connected to buried concrete and also by flow lines.

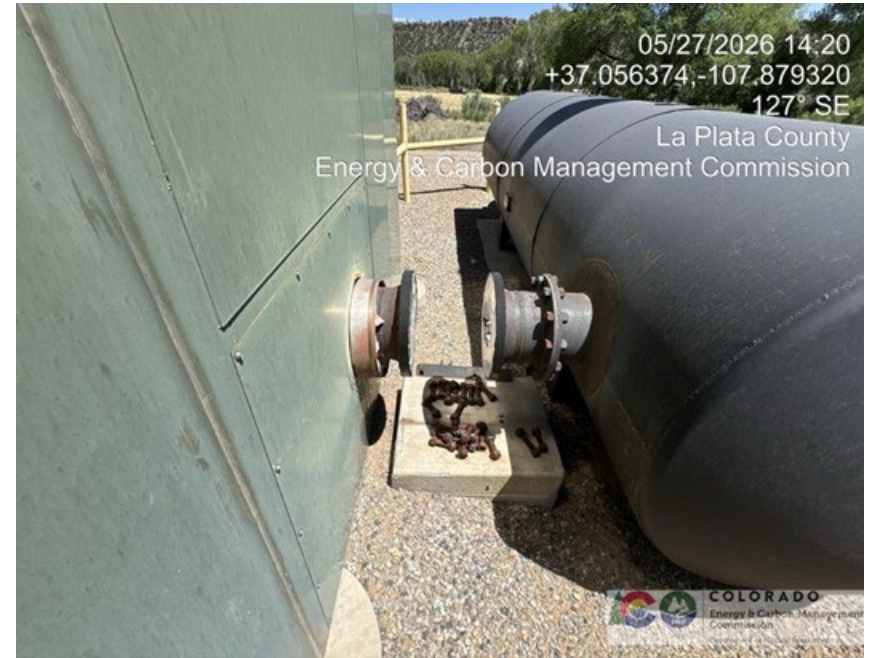
12. Two stage silencer is disconnected.

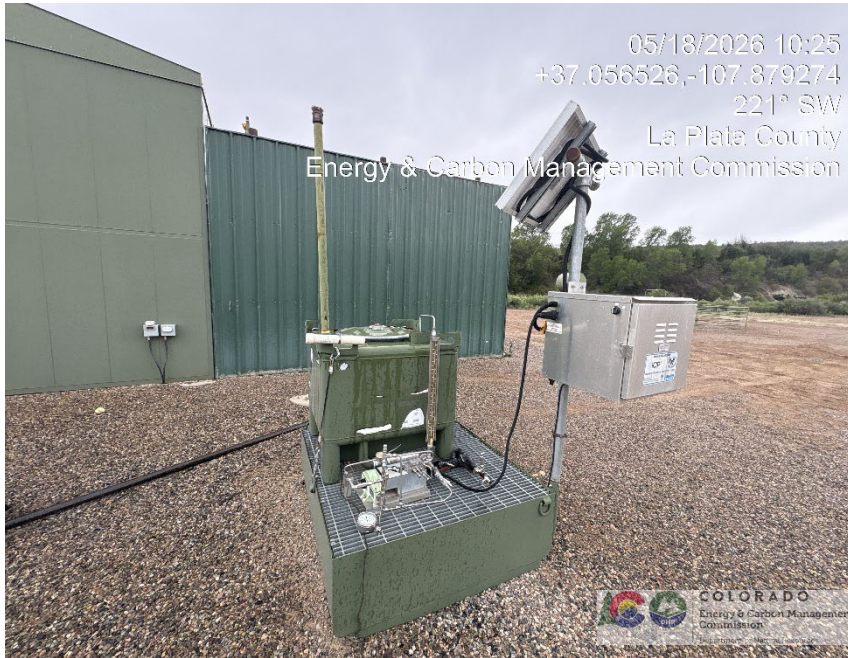
17. Chemical treatment container over spill prevention with solar telemetry on top of spill prevention. Manufacturer's labels not legible. Contents unknown. Est Vol ~50 gal.

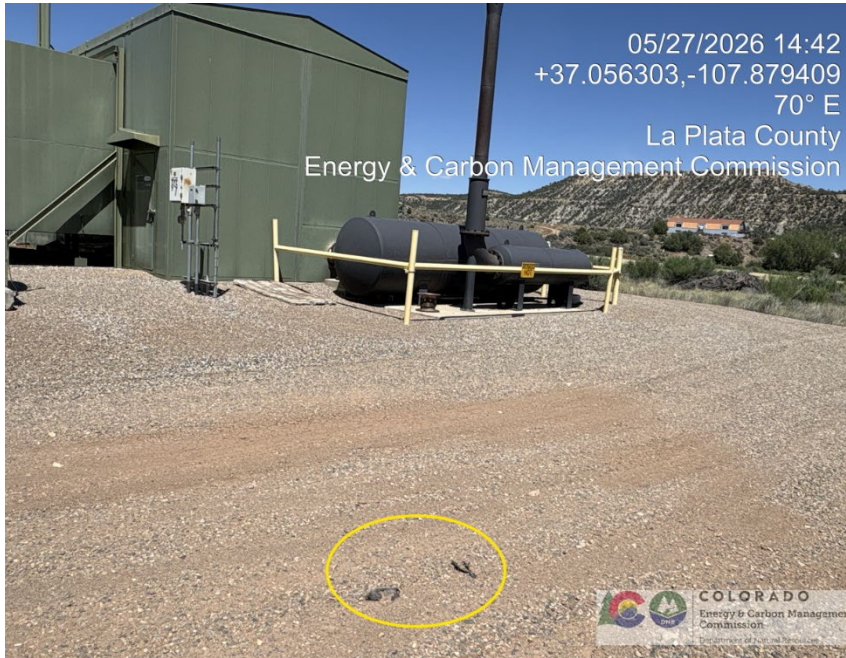
19. View of outside of compressor station. Liner debris observed.

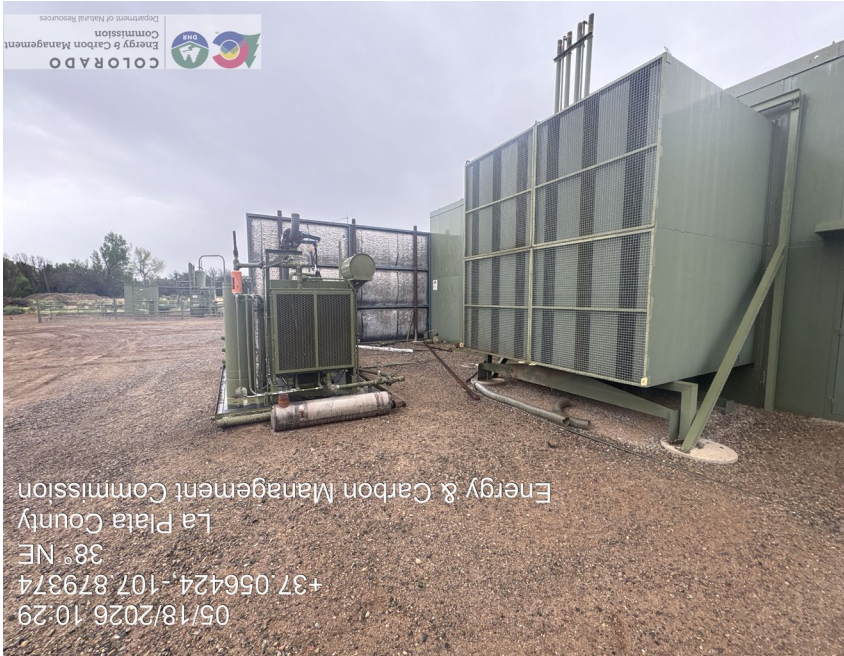
21. Skid mounted compressor (left) next to station structure lacks muffler and is noisy.

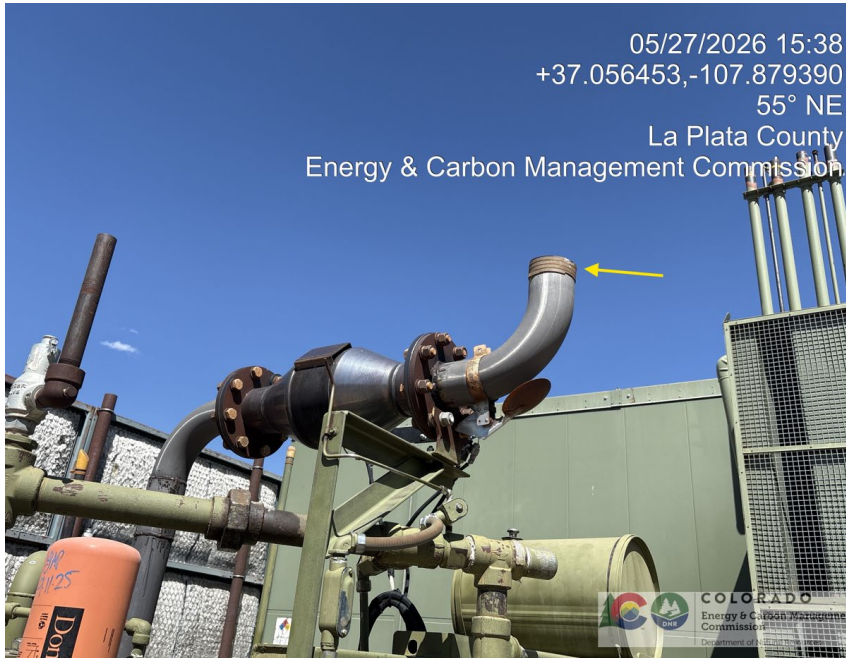
23. Exhaust stack on compressor is missing muffler. Yellow arrow shows flexible exhaust pipe remnants. Loud.

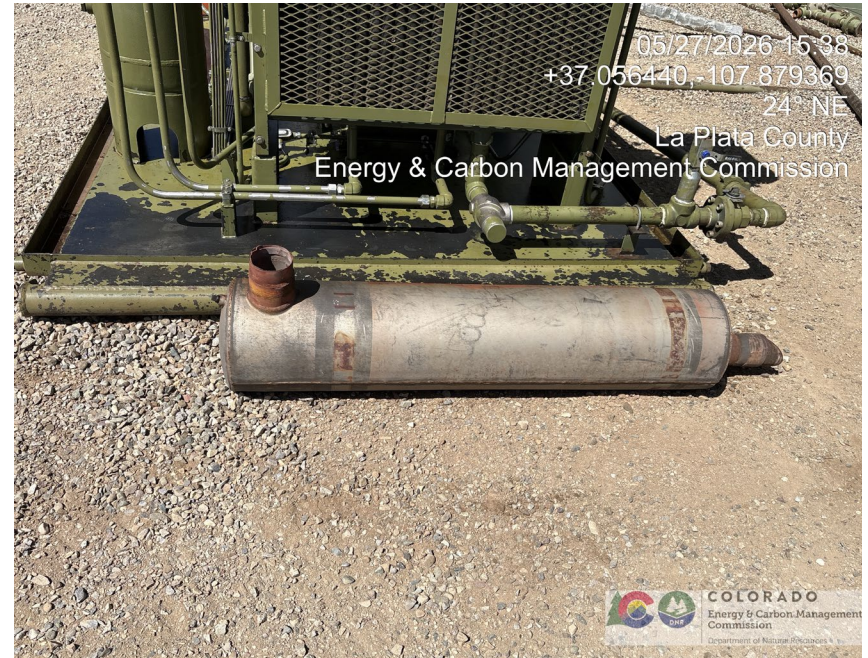
24. Muffler resting on ground. Unattached.

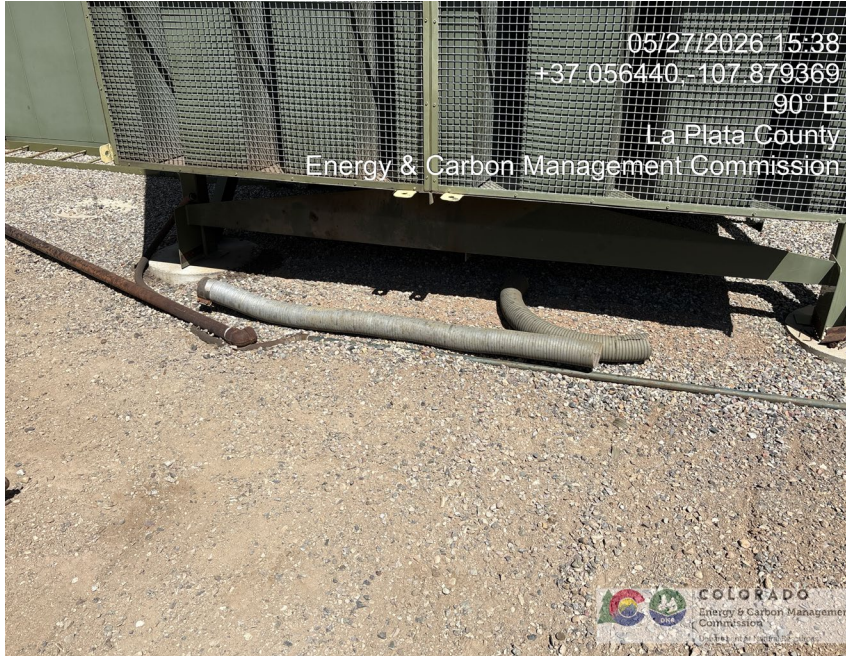
25. Segments of exhaust tubing from compressor. Also shows open ended lube oil hose from lube oil tank

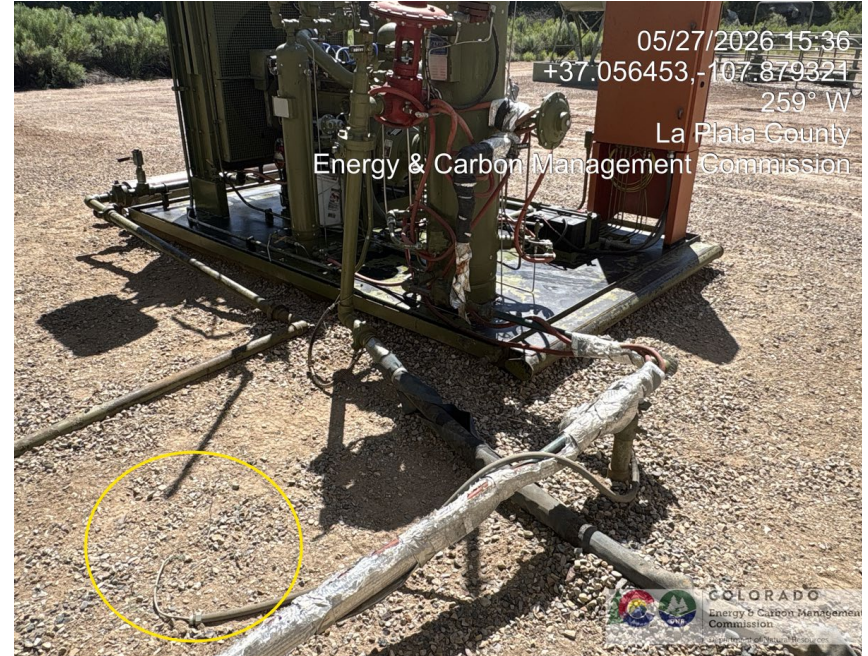
26. Frayed, disconnected wires protruding form conduit near skid mounted compressor.

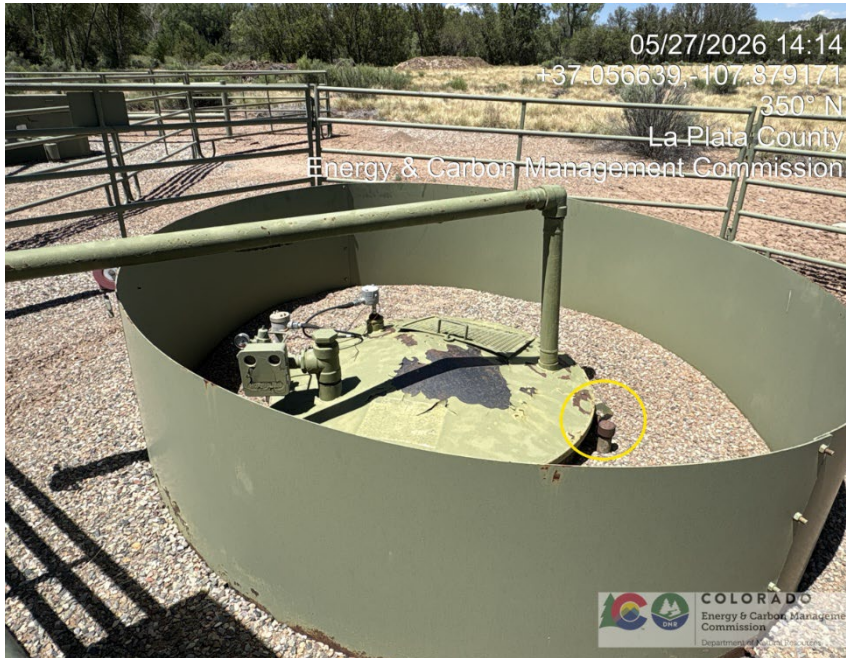
27. 21 BBL PBV tank in secondary containment showing single anchor tied down point observed. Paint on tank inadequate.

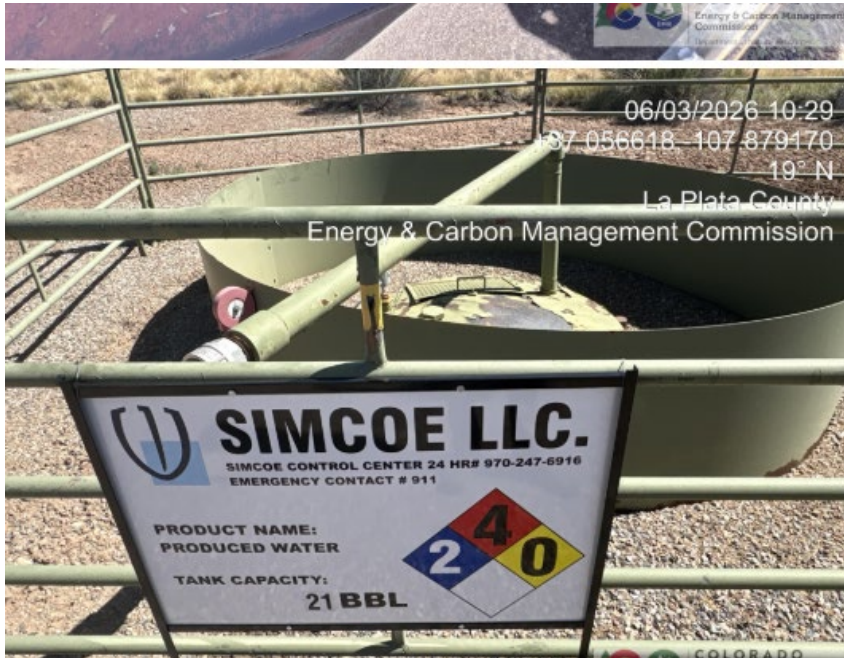
29. UPDATE – nearby location visited after report completed and noticed sign replaced. No corrective action.

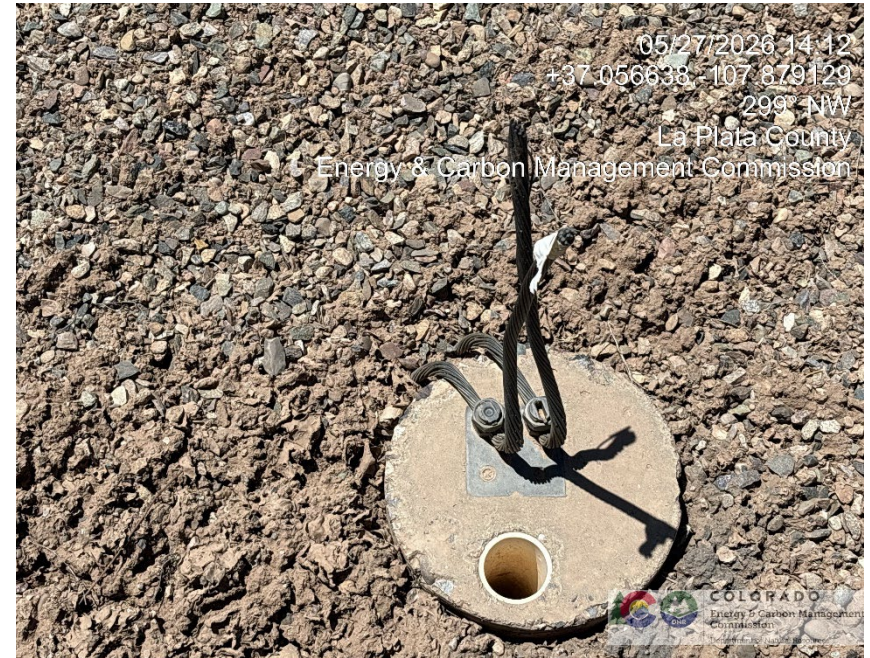
30. Grounding wires near tank. Appear to belong to equipment no longer present.

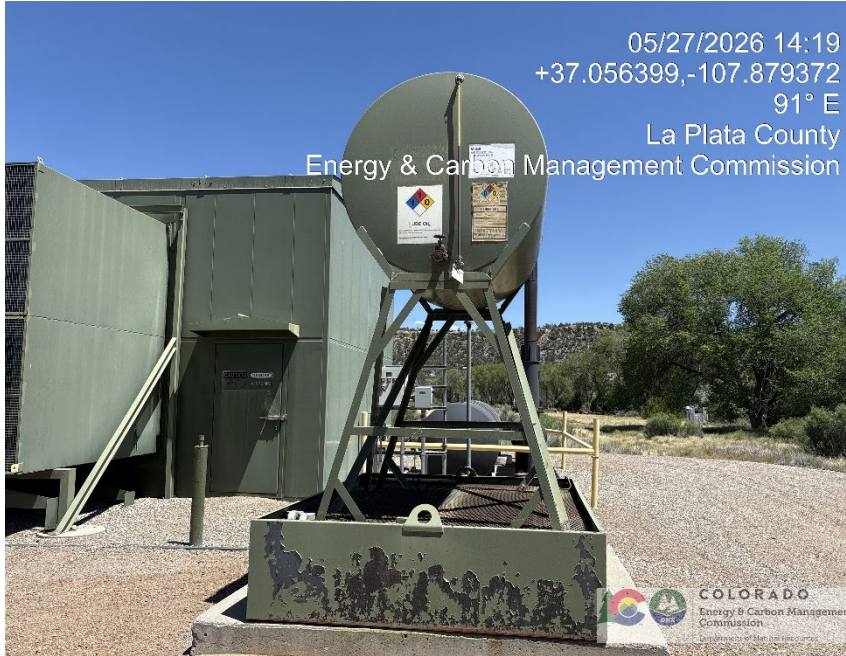
31. Lube oil tank on secondary containment. Is not anchored for potential flooding. There is a ball valve drain at the base connected to an open-ended rubber hose that rests on the ground several yards away. See photo 32

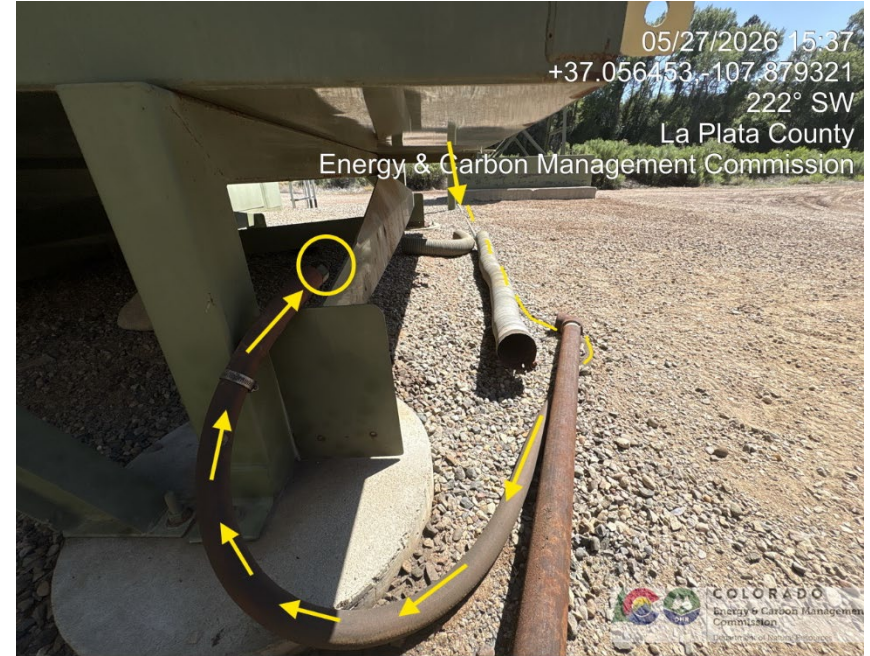
32 Lube oil hose can only be operated at the valve by the base of the tank shown in figure 31. The valve is attached to an ~1" pipe, and then flexible hose that is cut off at one end. There is a bolt loosely stuck in the open end of the hose, not tight enough to stop flow if the valve were turned on, the whole tank could drain quickly. Yellow arrows show path of tubing from tank in background to end of hose with no valve nozzle in yellow circle. Photo also shows unused flexible exhaust tubing and unused pipe segments.

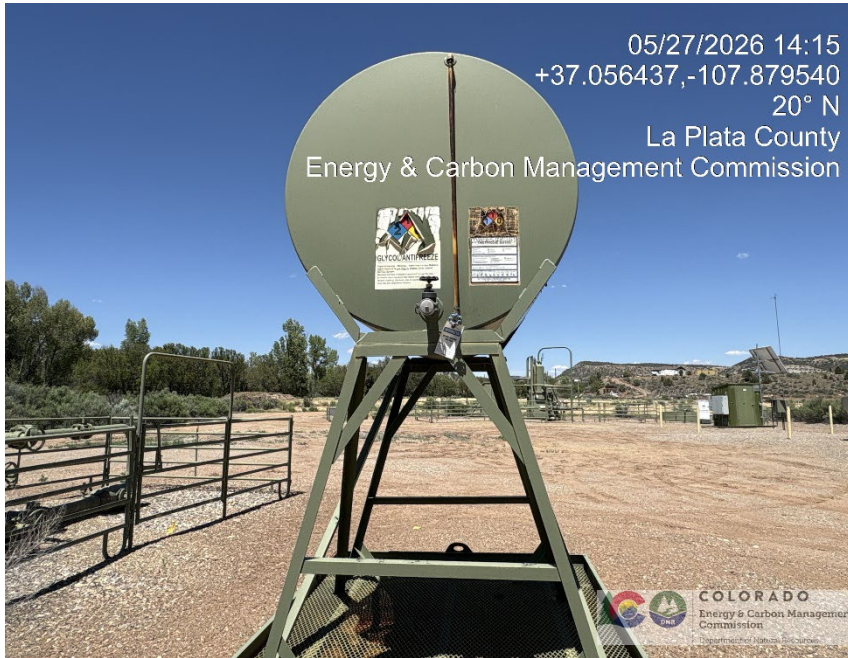
35. Glycol/antifreeze tank with spill prevention. Sight glass cloudy, unknown if contains product. In floodplain. Not anchored. Appears like it may not be in use.

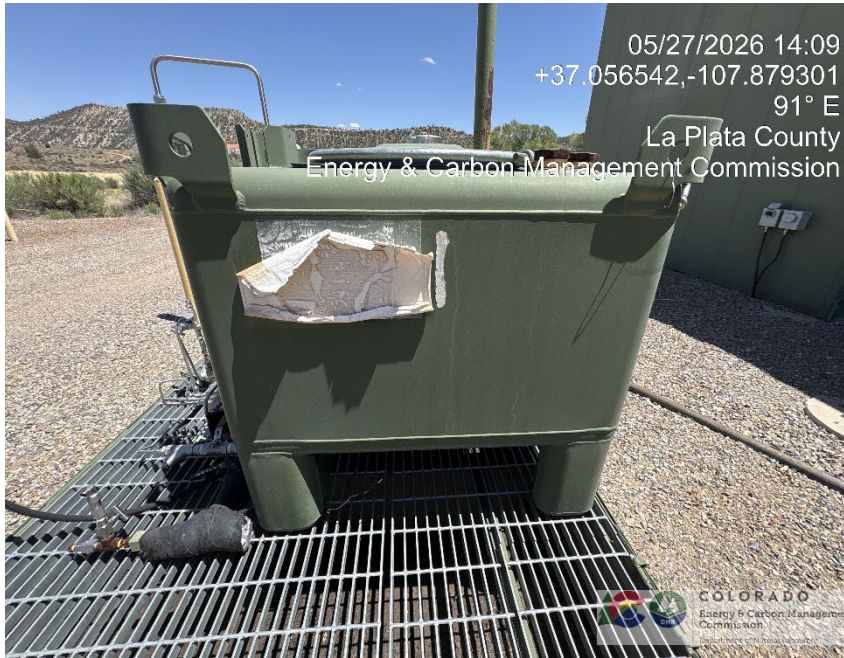
37. Chemical injection container. Manufacturer's label not legible. Contents unknown.

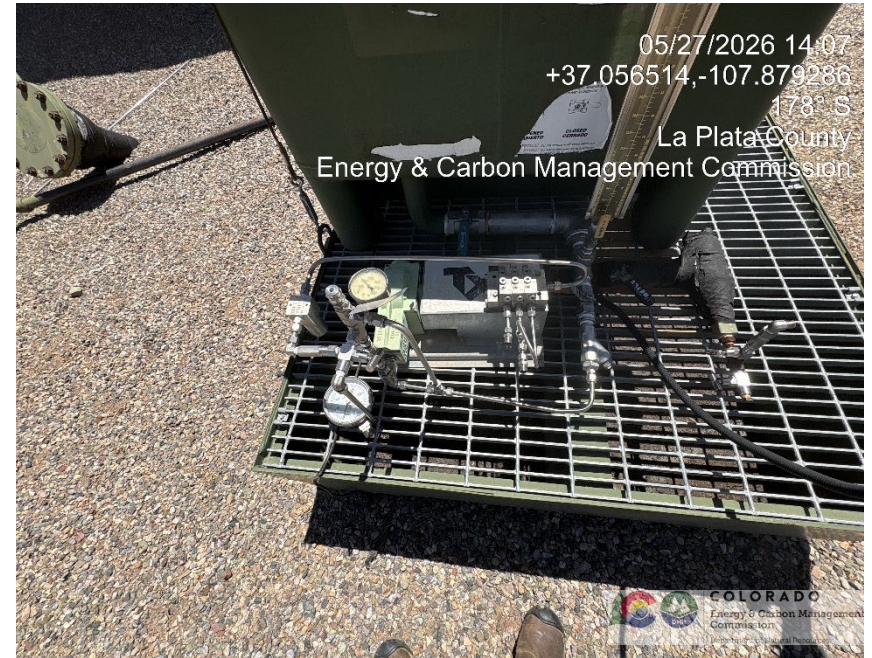
38. Detail of chemical injection container controls. Some stainless tubes disconnected. Unclear if in-use.

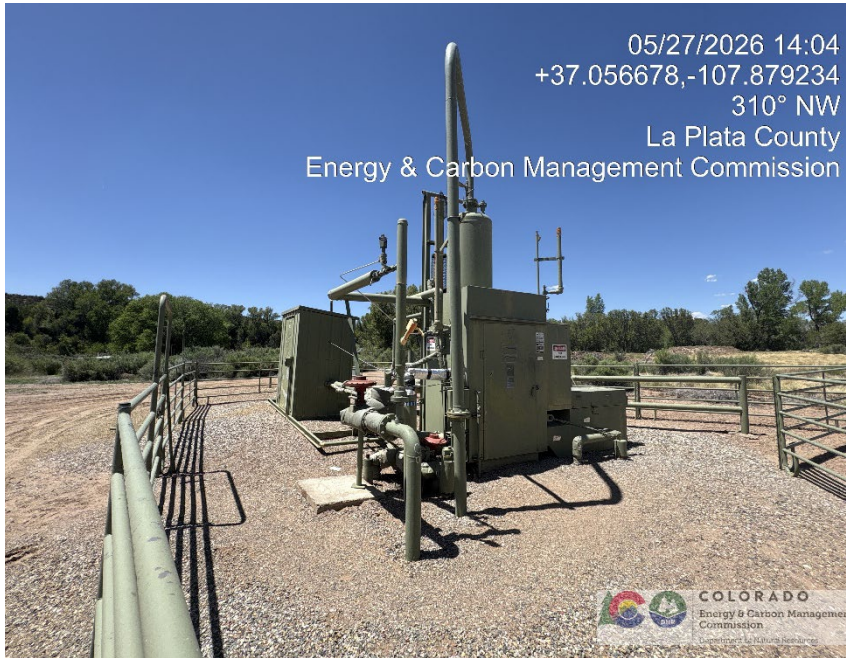
39. Vertical heated separator and associated flow lines. Appears to be anchored in at least 3 locations by turnbuckles attached to concrete pilings buried in the ground.

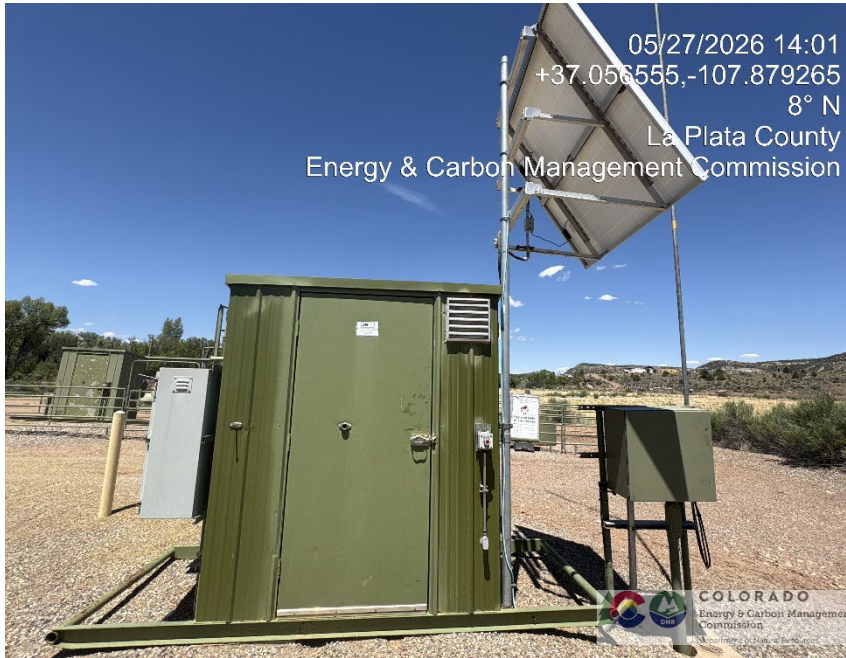
41. Shed structure. Door latch is locked or does not work. Contents unknown. Solar telemetry. Possibly midstream.

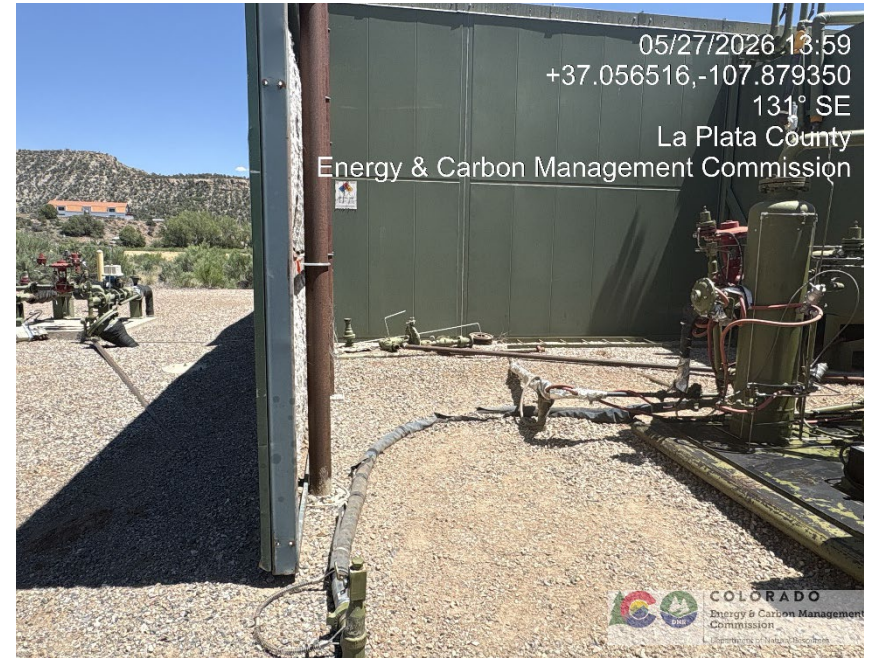
42. Skid mount compressor on right appears to be fed by 2 inch gas line on surface from equipment on left side of photo. Unused equipment in center of photo against wall.
