# Johnson 13-13J H.D.A. Field Inspection Picture

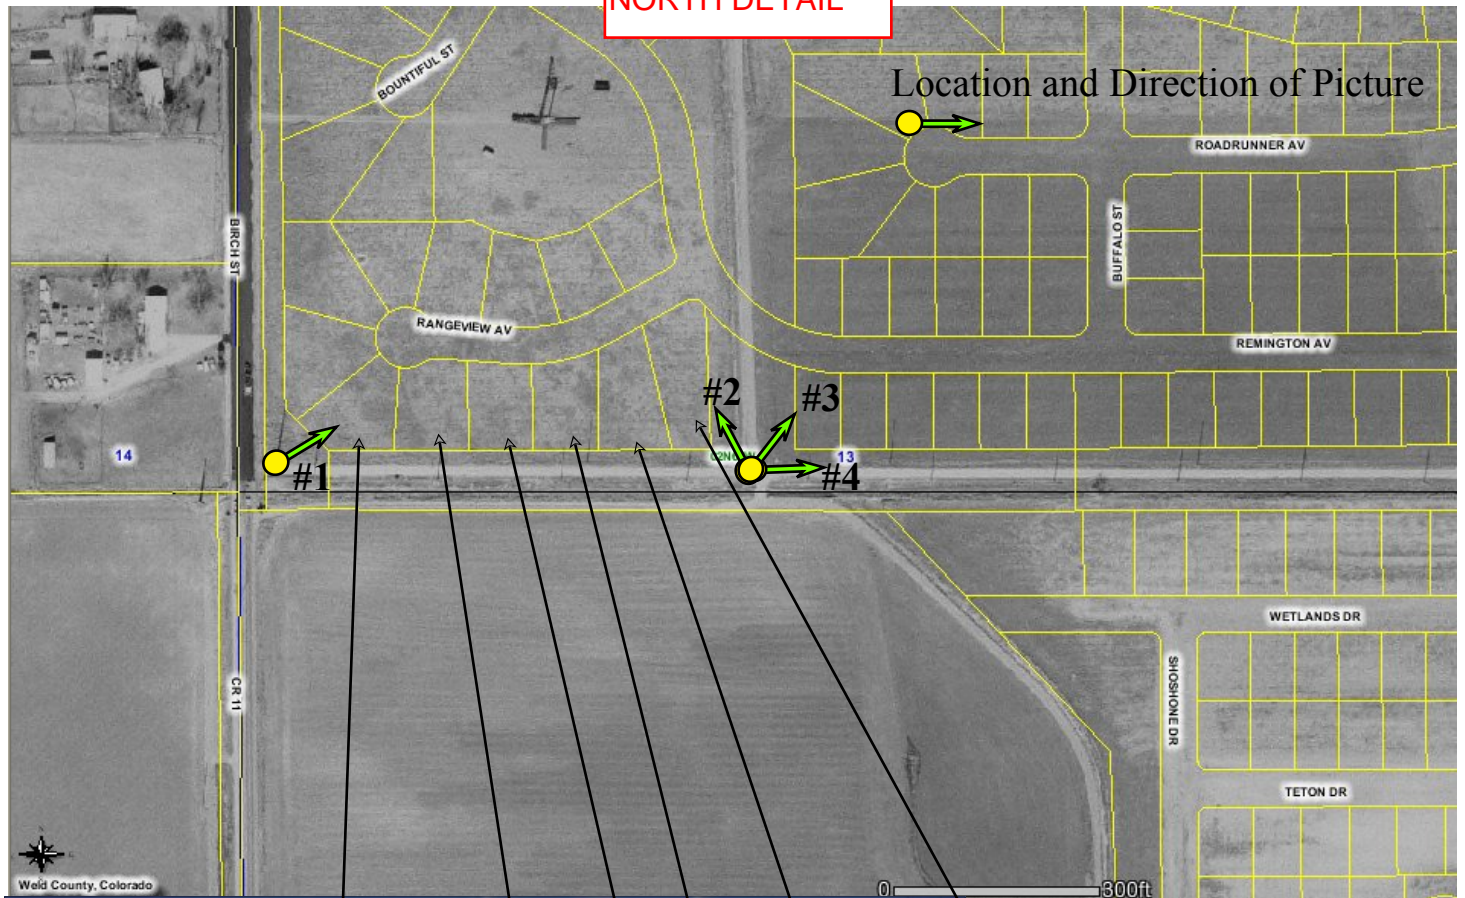
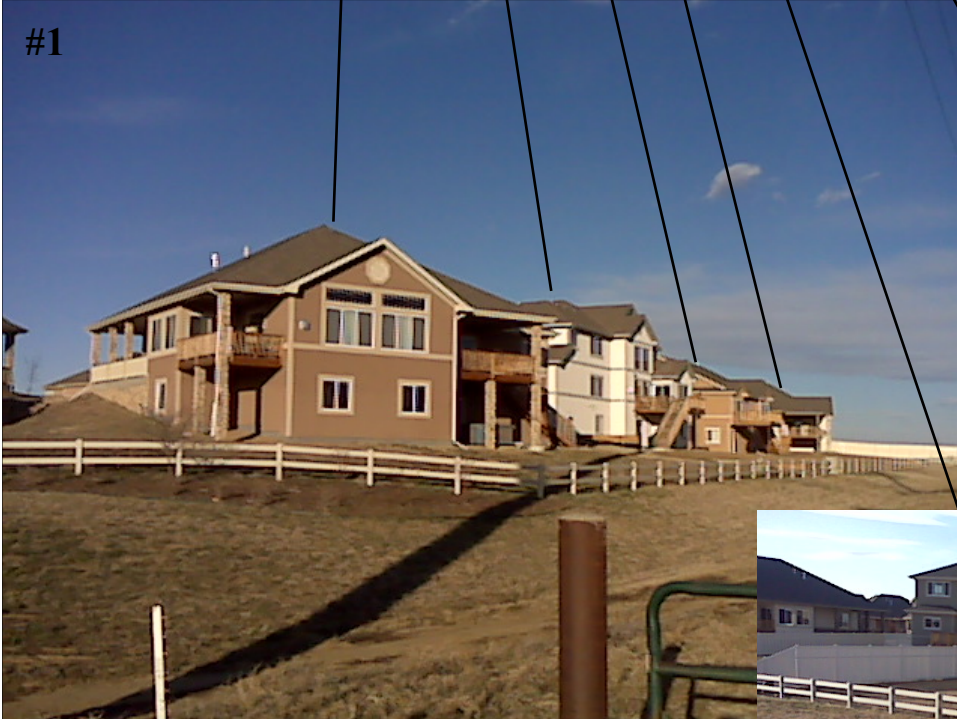
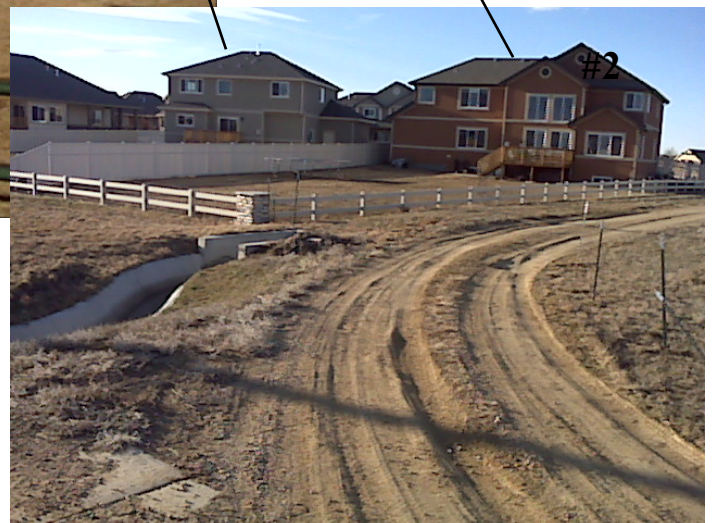
## NORTH DETAIL

Pictures combined with Weld Assessor parcel information show that there are less than 18 Building units within the half-circle and less than what is adequate to classify the Johnson 13-13J as in a HDA.
