Appendix 8: Geologic Hazards Report

**GEOLOGIC HAZARDS STUDY
THE HUB FACILITY
NORTHWEST CORNER OF WCR 6 AND WCR 7
WELD COUNTY, COLORADO**

September 12, 2013
Project No. 500707001

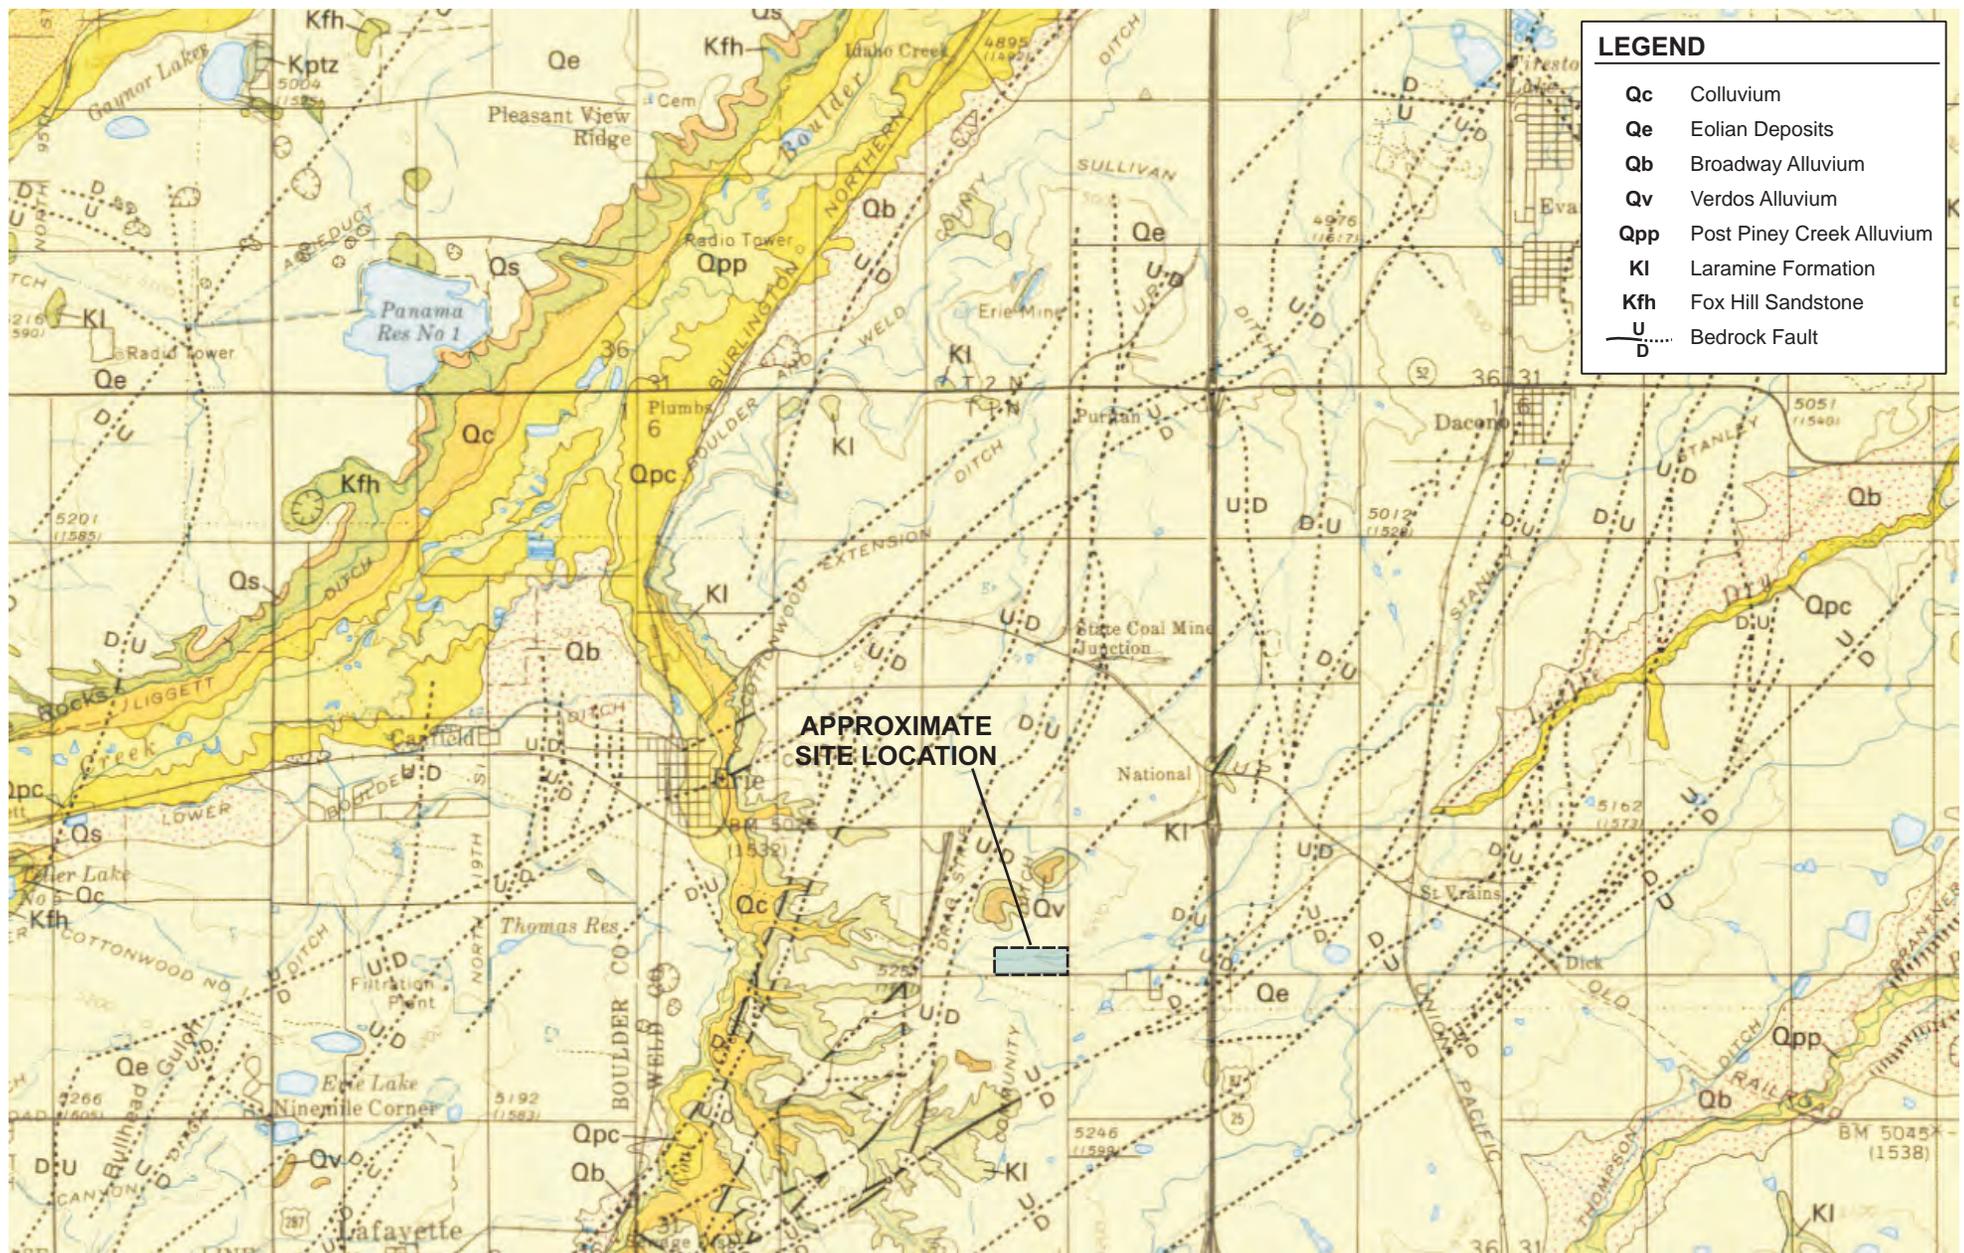
GEOLOGIC MAP

The surficial geology of the site is mapped by Colton (1978) as Holocene to late Pleistocene-age Eolian Deposits (wind-blown) including dune sand and loess deposits, which were deposited in the post-glacial period. The mapped geology at the site is presented on Figure 2. The Eolian Deposits are generally composed of silt and clay with varying amounts of sand. The underlying formational bedrock unit is mapped as the Upper Cretaceous-age Laramie Formation consisting of an upper and a lower part. The upper part is described as mostly gray claystone, shale, sandy shale, and lenticular beds of sandstone and lignite. The lower part is described as light gray to light yellowish gray sandstone and sandy shale interbedded with clay, shale, and several beds of coal.

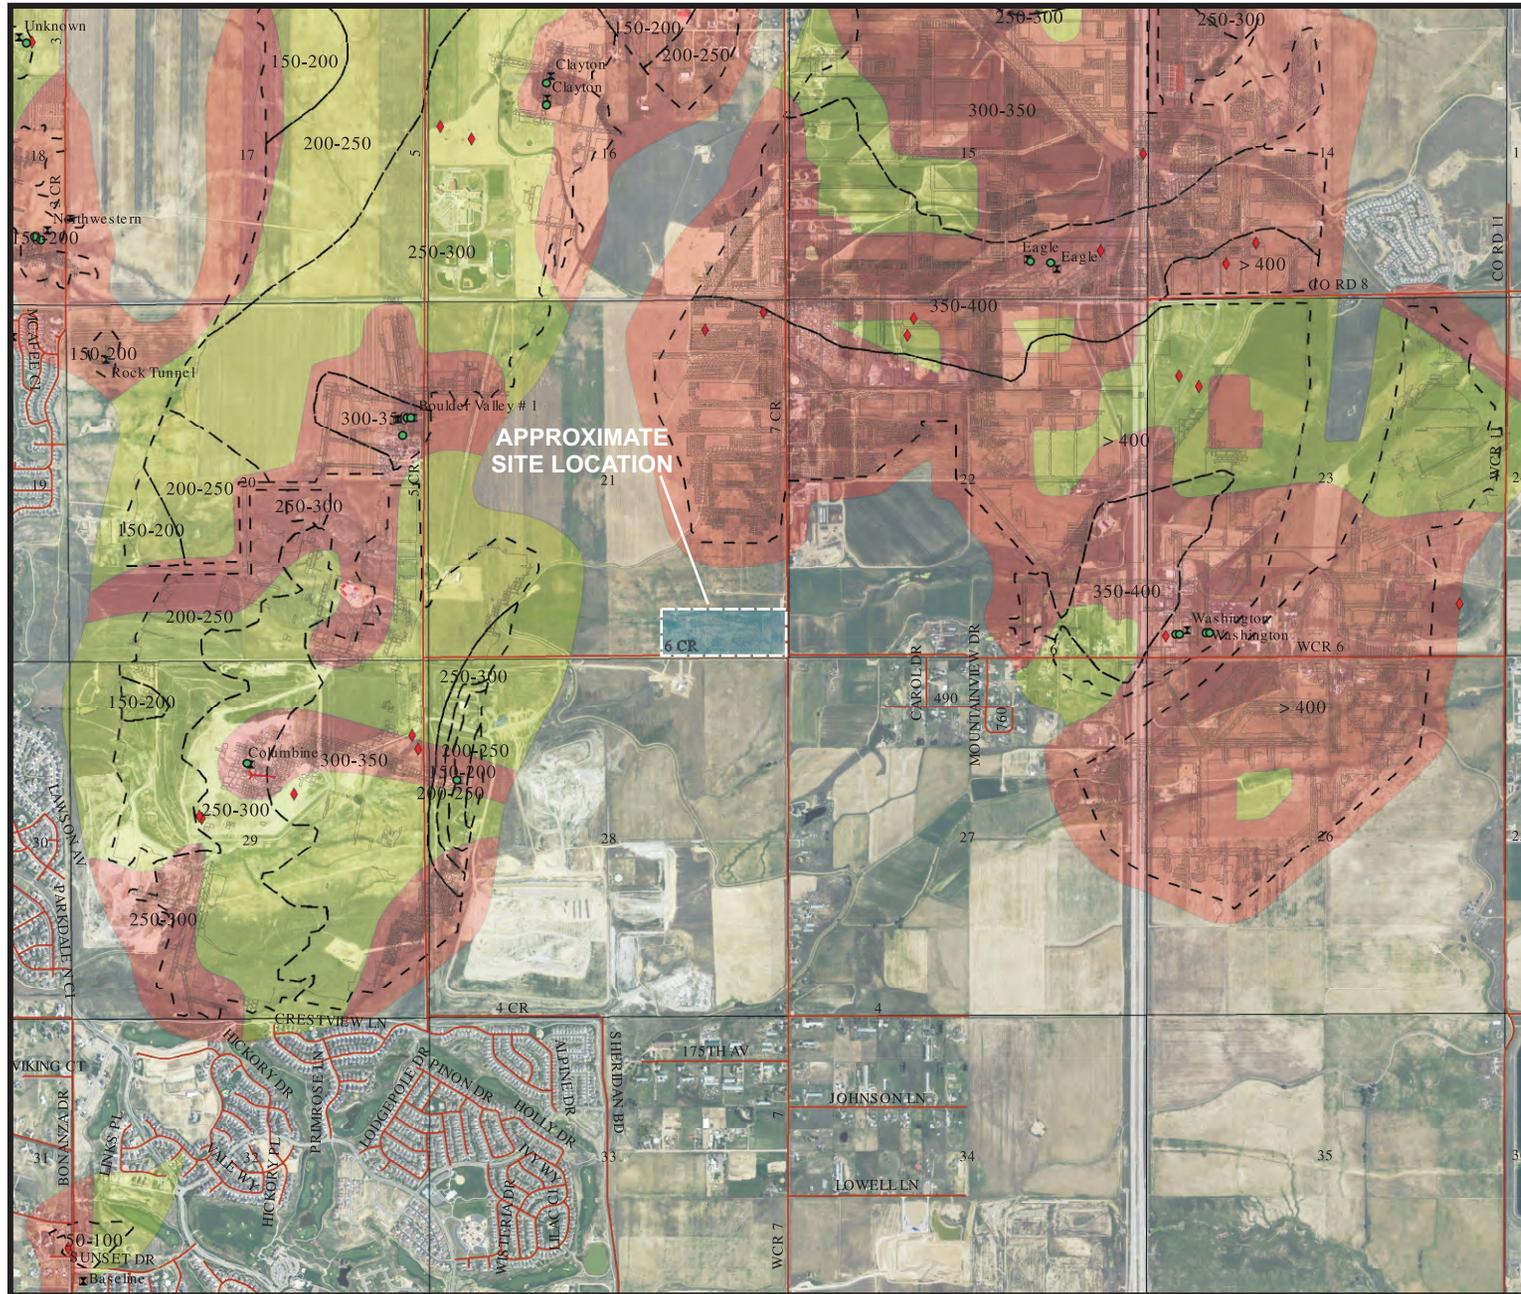
SUBSIDENCE HAZARD MAP

The Boulder-Weld Coal Field in the Erie, Colorado area has experienced numerous instances of damage to structures and infrastructure related to mine subsidence from abandoned mine workings. The Erie, Colorado area experienced a heavy period of mining, both surface and subsurface, from the 1800's through the late 1970's. We have reviewed numerous background documents (see the *References* section of this report) related to previous mining activity and subsidence-related hazards. Review of referenced topographical maps and published maps depicting areas of coal extraction and mine subsidence hazards indicate past mining activities to the north and west this project site. The location of the site relative to mapped coalmine subsidence hazards is presented on Figure 3.

No evidence of abandoned mine working was observed underlying the proposed improvement areas. We have evaluated the potential for subsidence hazards due to possible collapse of the subterranean mine workings in the site vicinity and it is our opinion that the likelihood of subsidence related hazards to the proposed improvements is negligible.

The area north of the subject site was the location of the Eagle Mine, which was mined from the 1930's to the late 1970's. The Eagle Mine was a subterranean coalmine that extracted coal from relatively flat-lying coal seams within the Laramie Formation. Based on our review of information from the Colorado Mine Subsidence Information Center (2013) and Roberts et al. (2001), the depth of the coalmine workings was greater than 400 feet below the ground surface. The nearest subterranean mine workings of the Eagle Mine are approximately 1,000 feet north of the project site. Therefore, the subsi-

dence hazard risk from the collapse of subterranean voids related to mining of the Eagle Mine is considered negligible.

The area west of the subject site was the location of the Columbine Mine, which was mined from the 1920's to the mid 1940's. The Columbine Mine was a subterranean coalmine that extracted coal from relatively flat-lying coal seams within the Laramie Formation. Based on our review of information from the Colorado Mine Subsidence Information Center (2013) and Roberts et al. (2001), the depth of the coalmine workings ranged between approximately 150 and 300 feet below the ground surface. The nearest subterranean mine workings of the Columbine Mine are approximately 2,400 feet west of the project site. Therefore, the subsidence hazard risk from the collapse of subterranean voids related to mining of the Columbine Mine is considered negligible.
