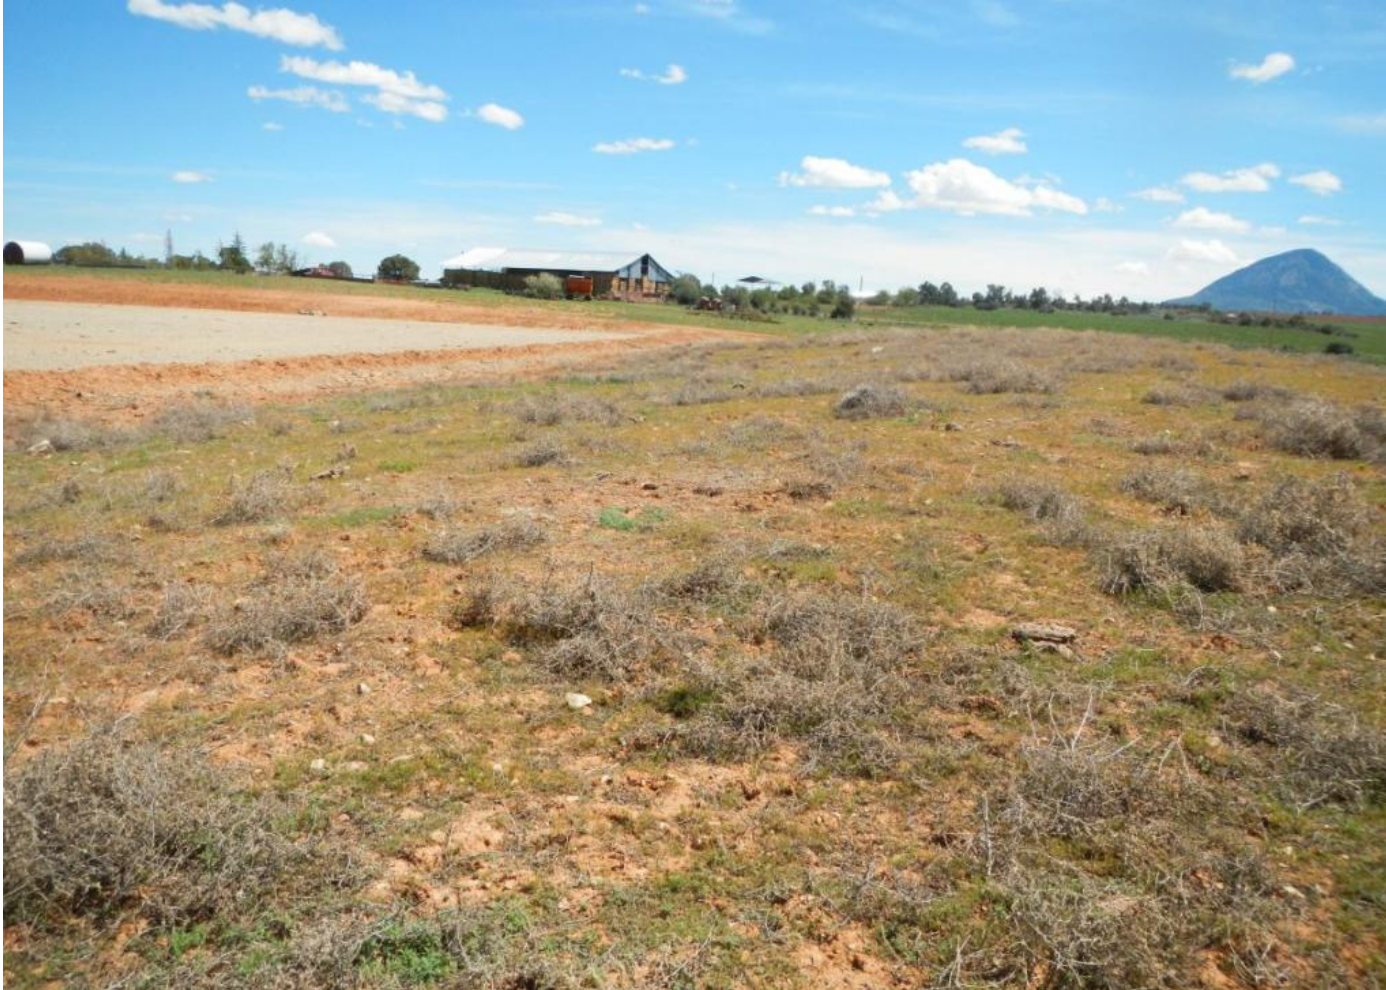
Photo 1. View of western portion of project area from northwestern corner facing southward. Vegetation within interim reclamation area is largely Russian thistle (*Salsola tragus*) seedlings.

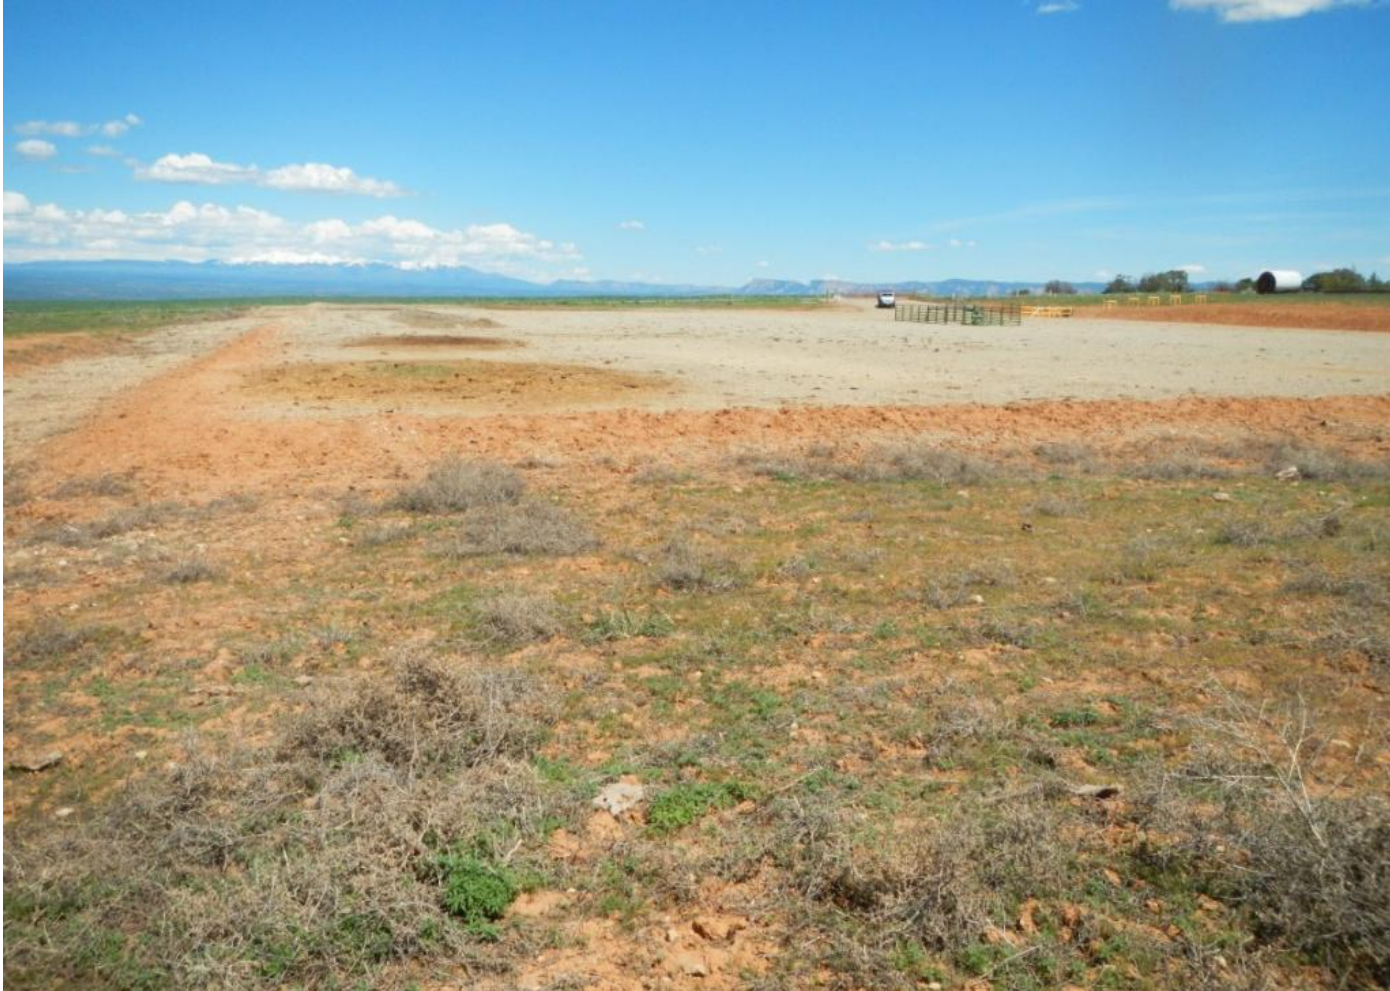
Photo 2. View from northwestern corner of project area facing center.

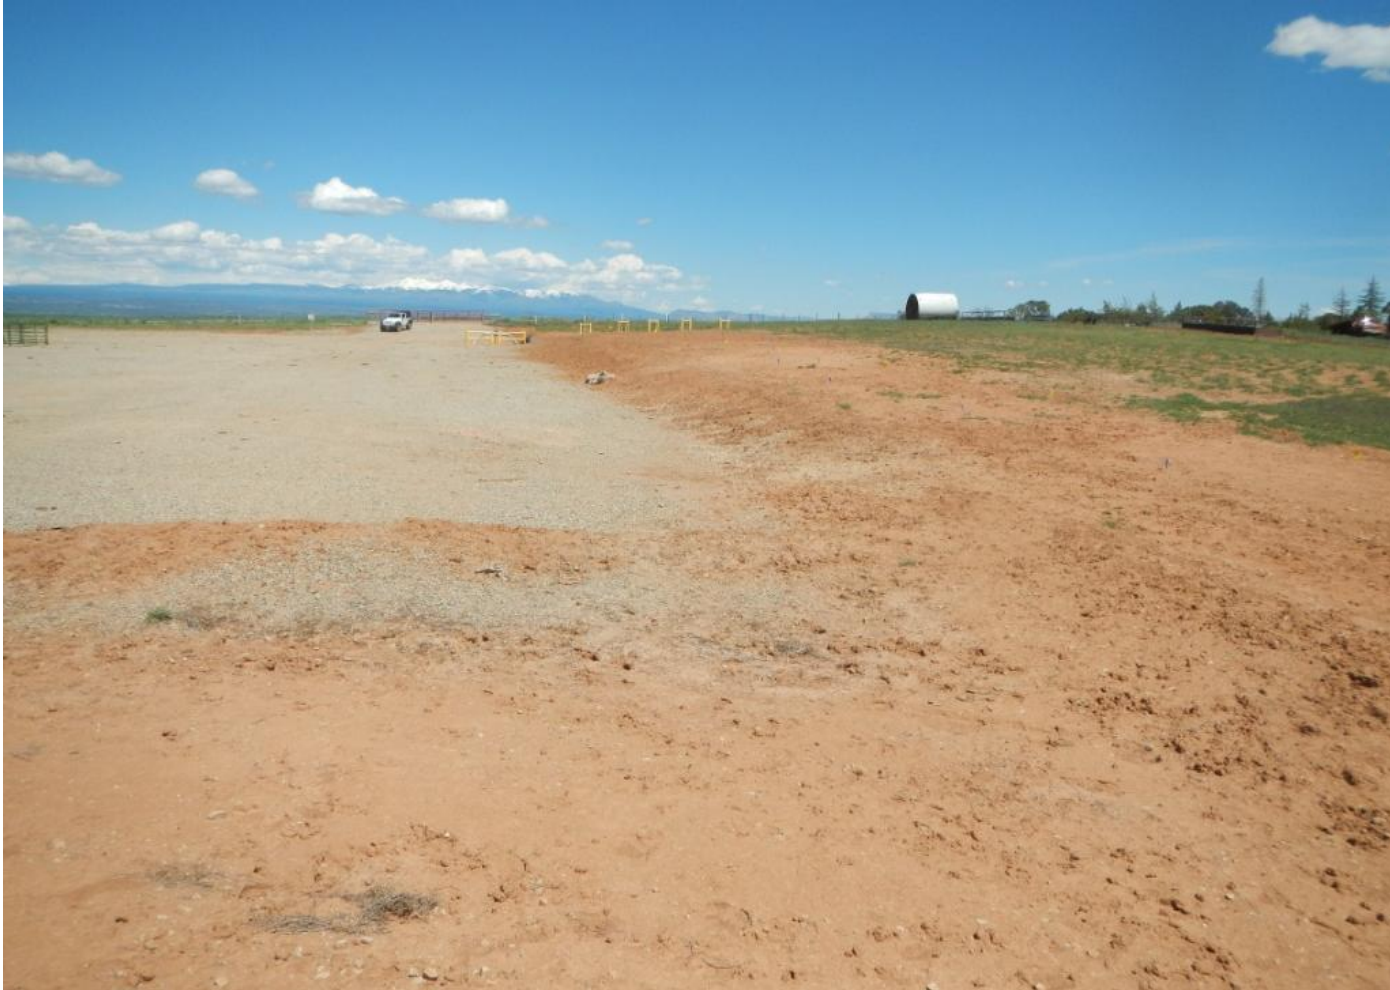
Photo 3. View of southern portion of project area from southwestern corner facing westward.

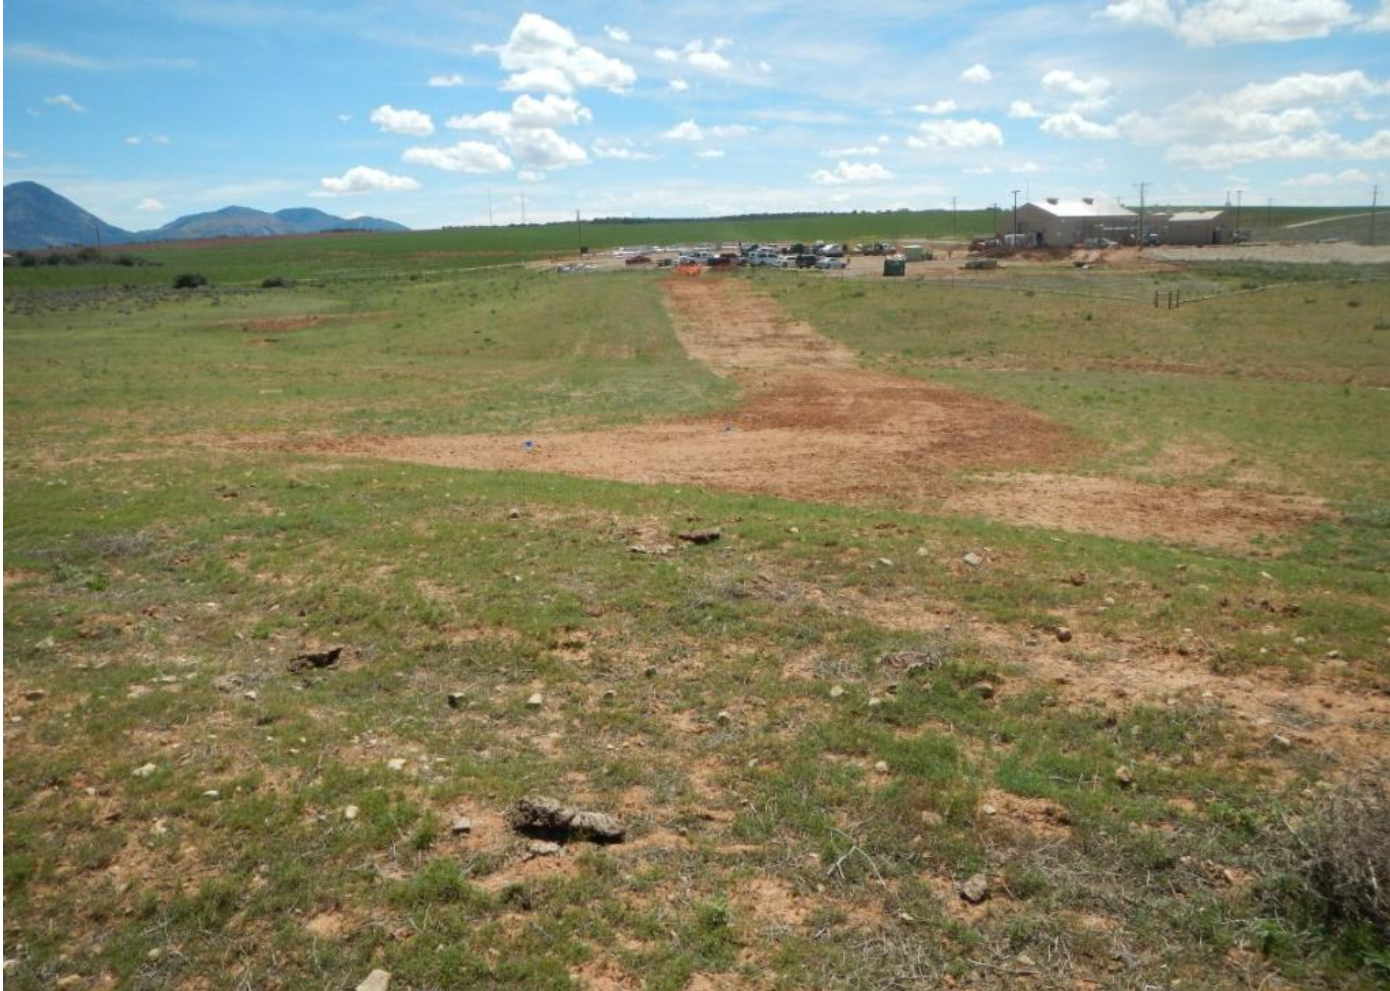
Photo 4. View of flowline running from southwestern corner of project area facing southwestward.
