Stormwater and Construction Inspection

Inspection 2 of 2

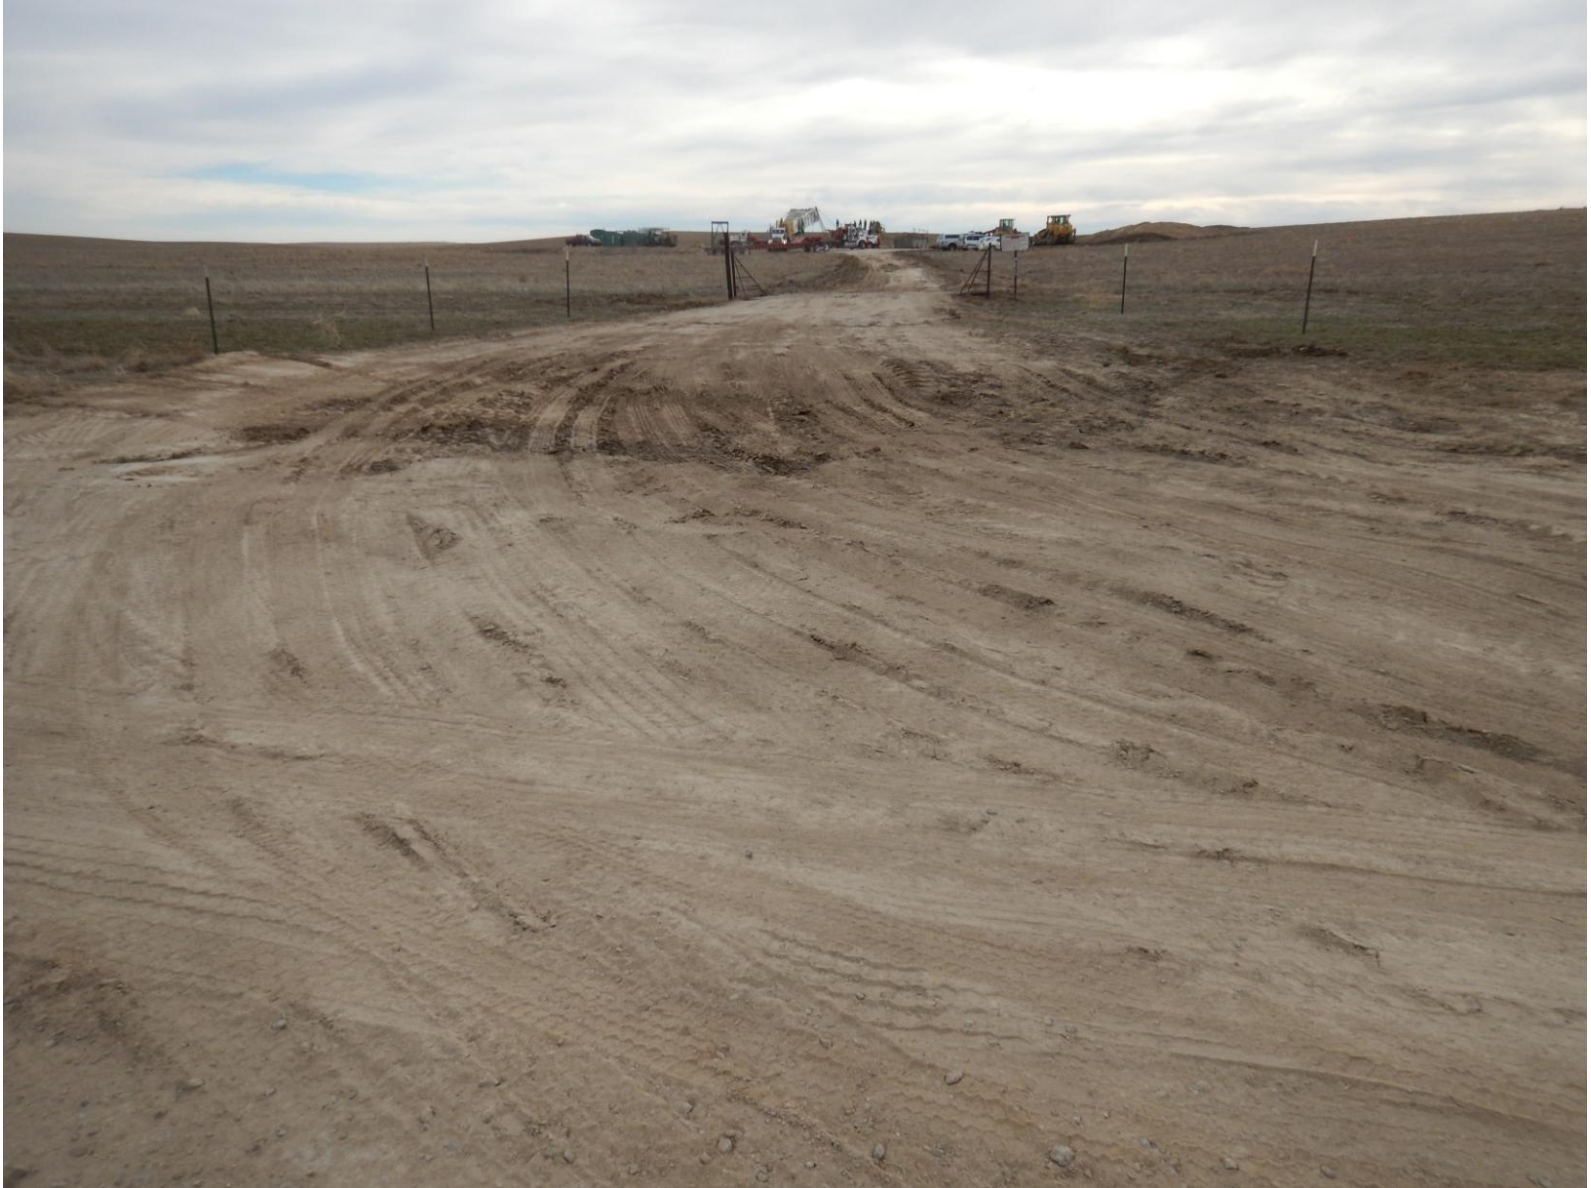
Figure 3: Photo taken from County Rd. 0 facing south towards location. Photo shows inadequate stormwater BMPs for site's access road.

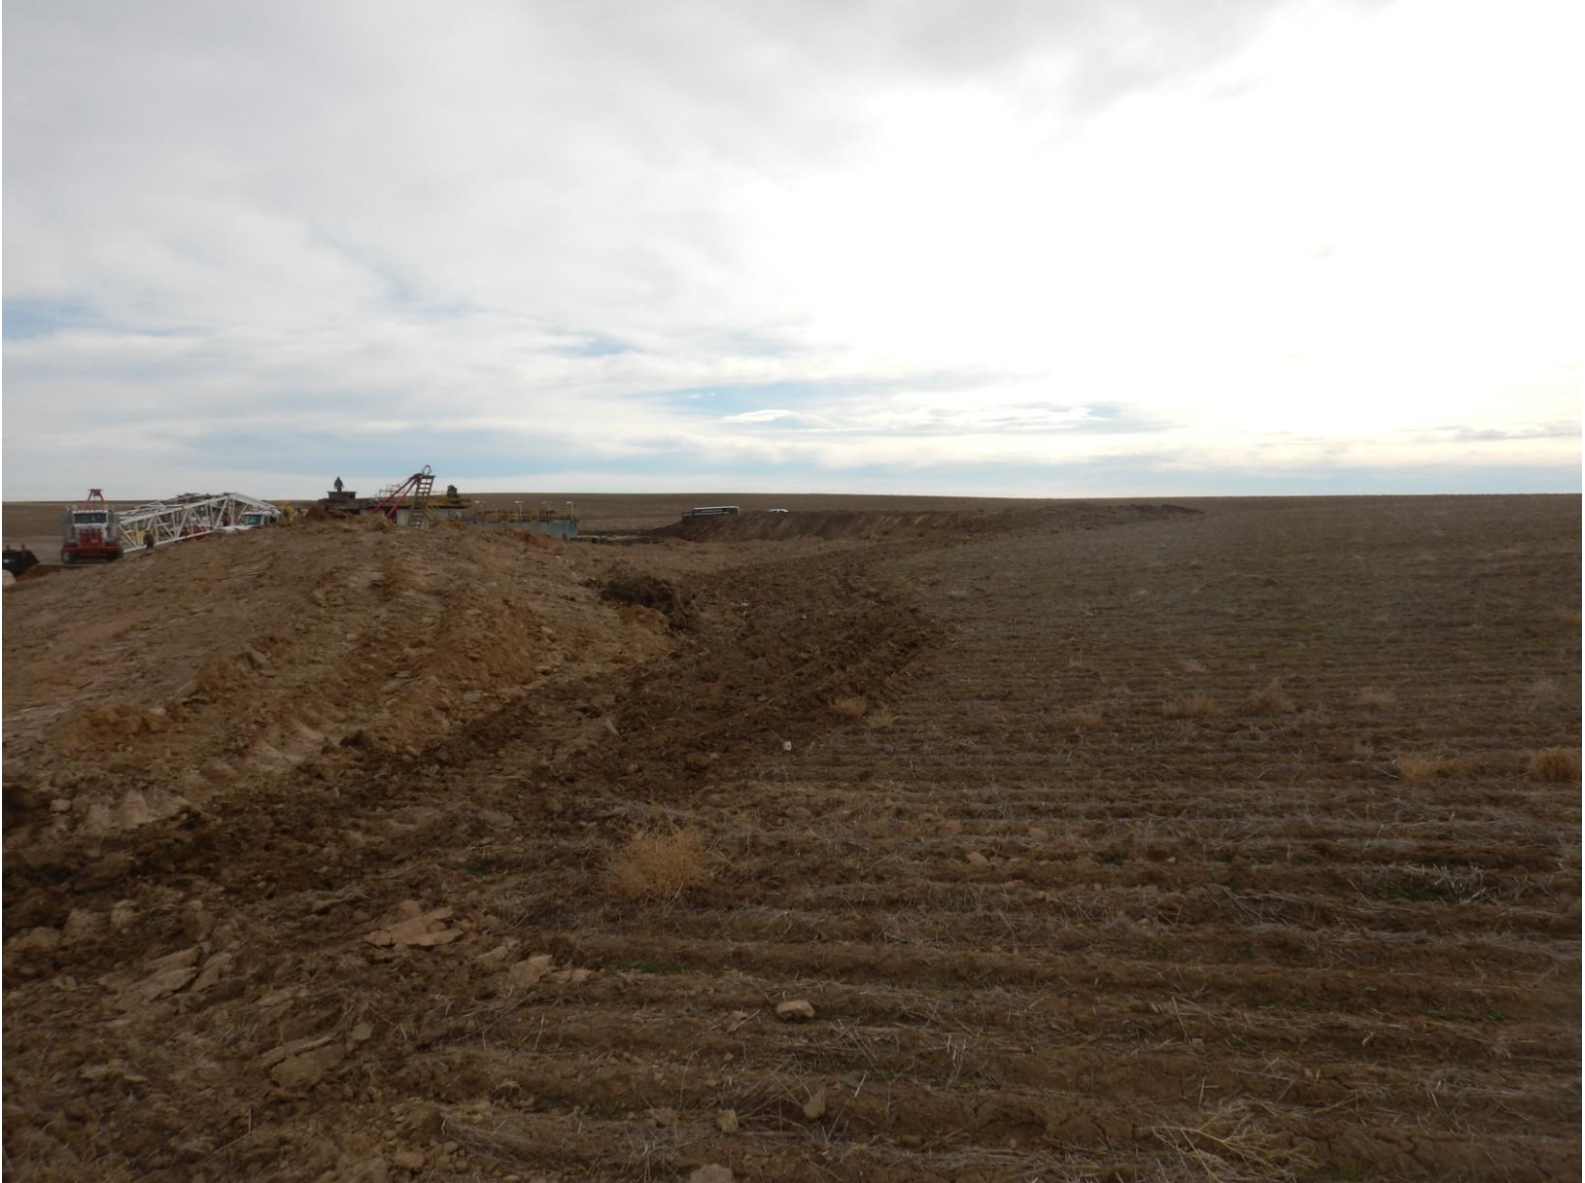
Figure 4: Photo taken from Northwest portion of location, facing south. Photo shows topsoil berm (left of photo), surface roughening (sediment control BMP) and construction in process.

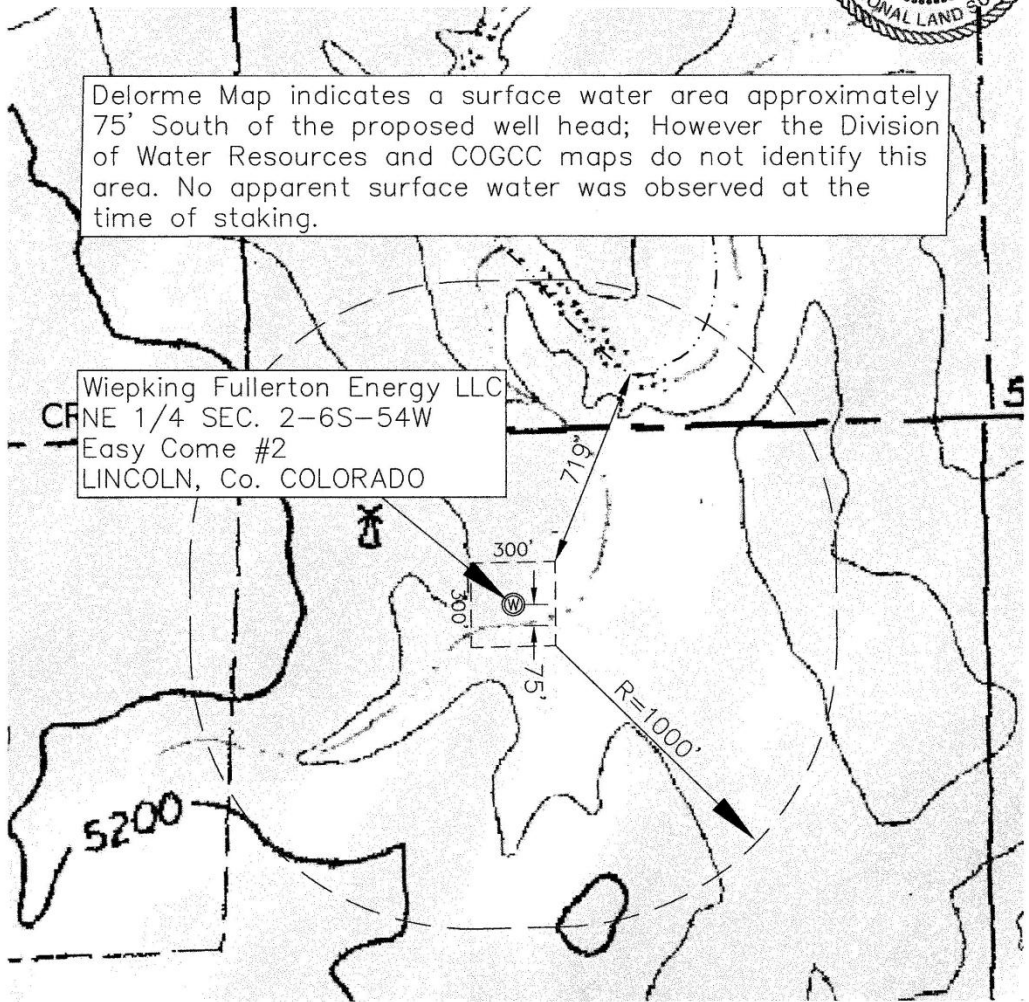
Figure 32: Image of Wiepking-Fullerton's Hydrology map. Document # 400884610
