Maverick 12-29 Reclamation Plan

PIONEER NATURAL RESOURCES
COGCC POST-CONSTRUCTION INSPECTION

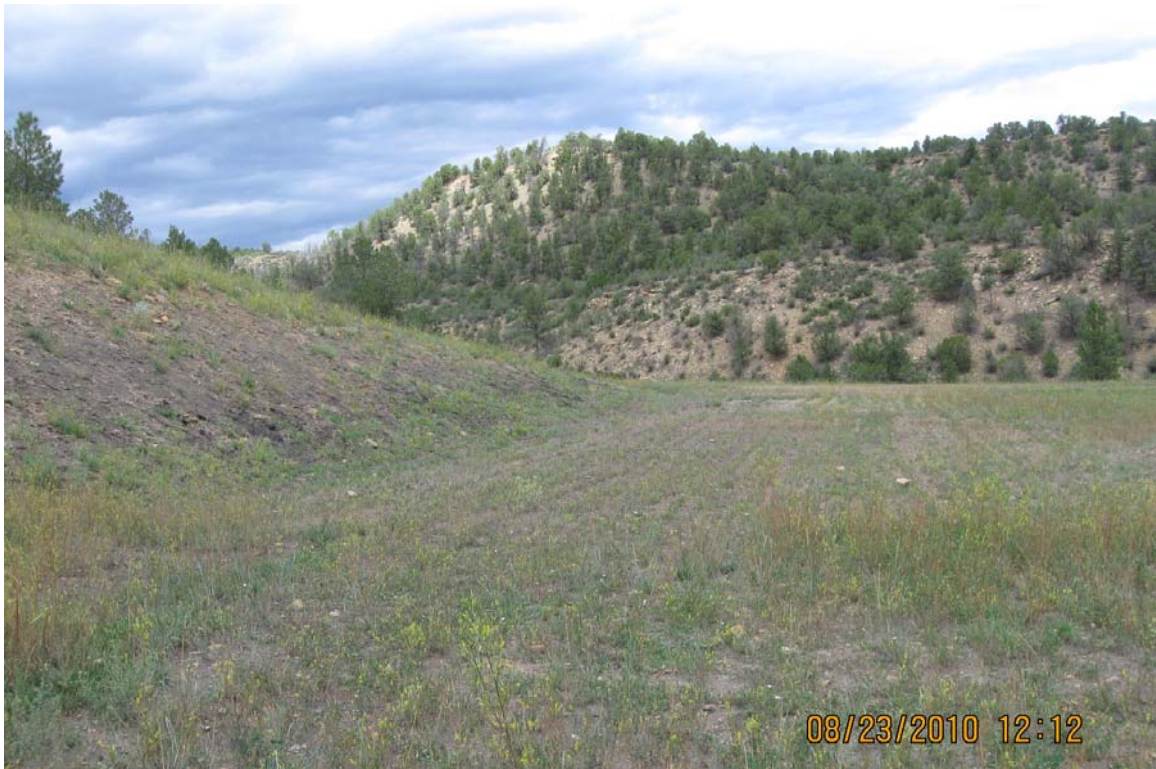
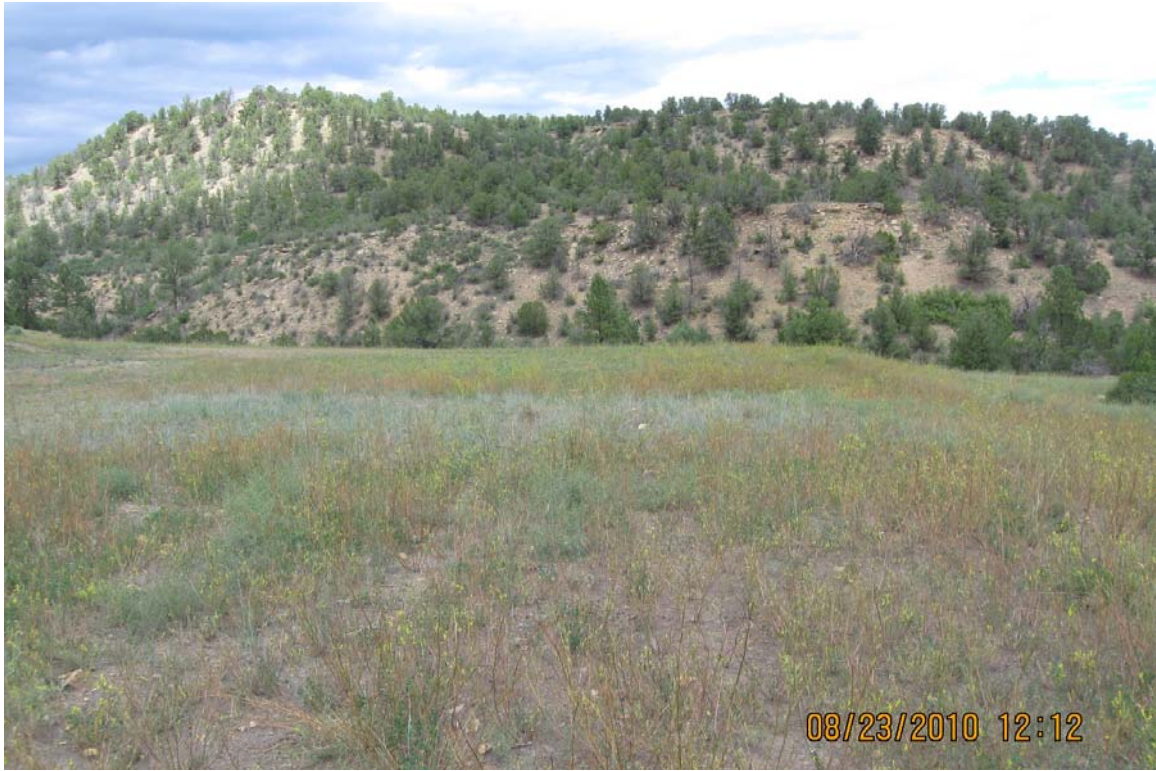
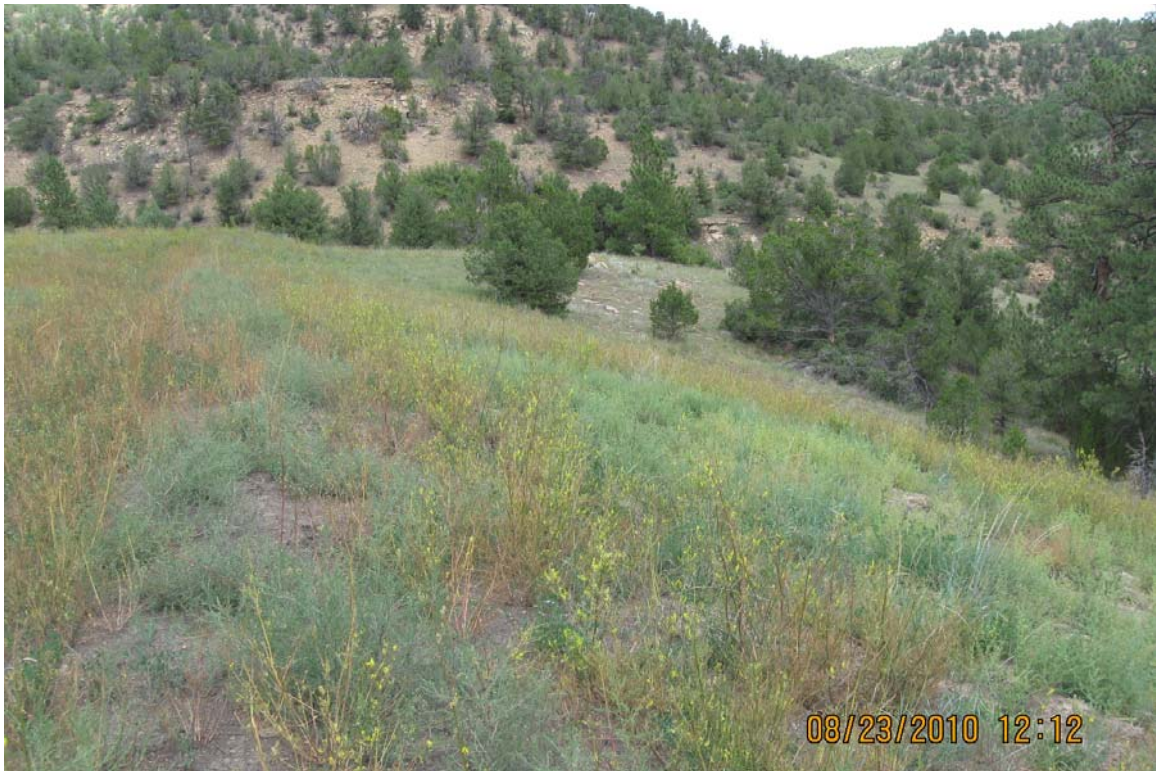
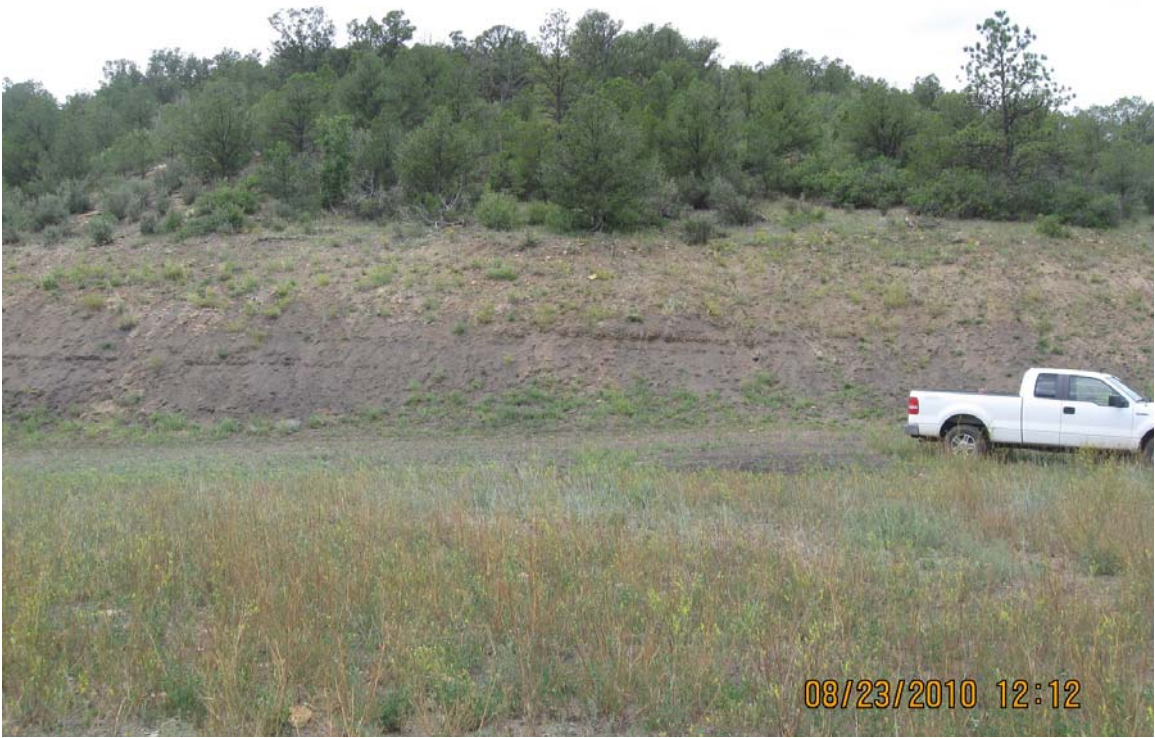
Notes: road has been completely reclaimed
