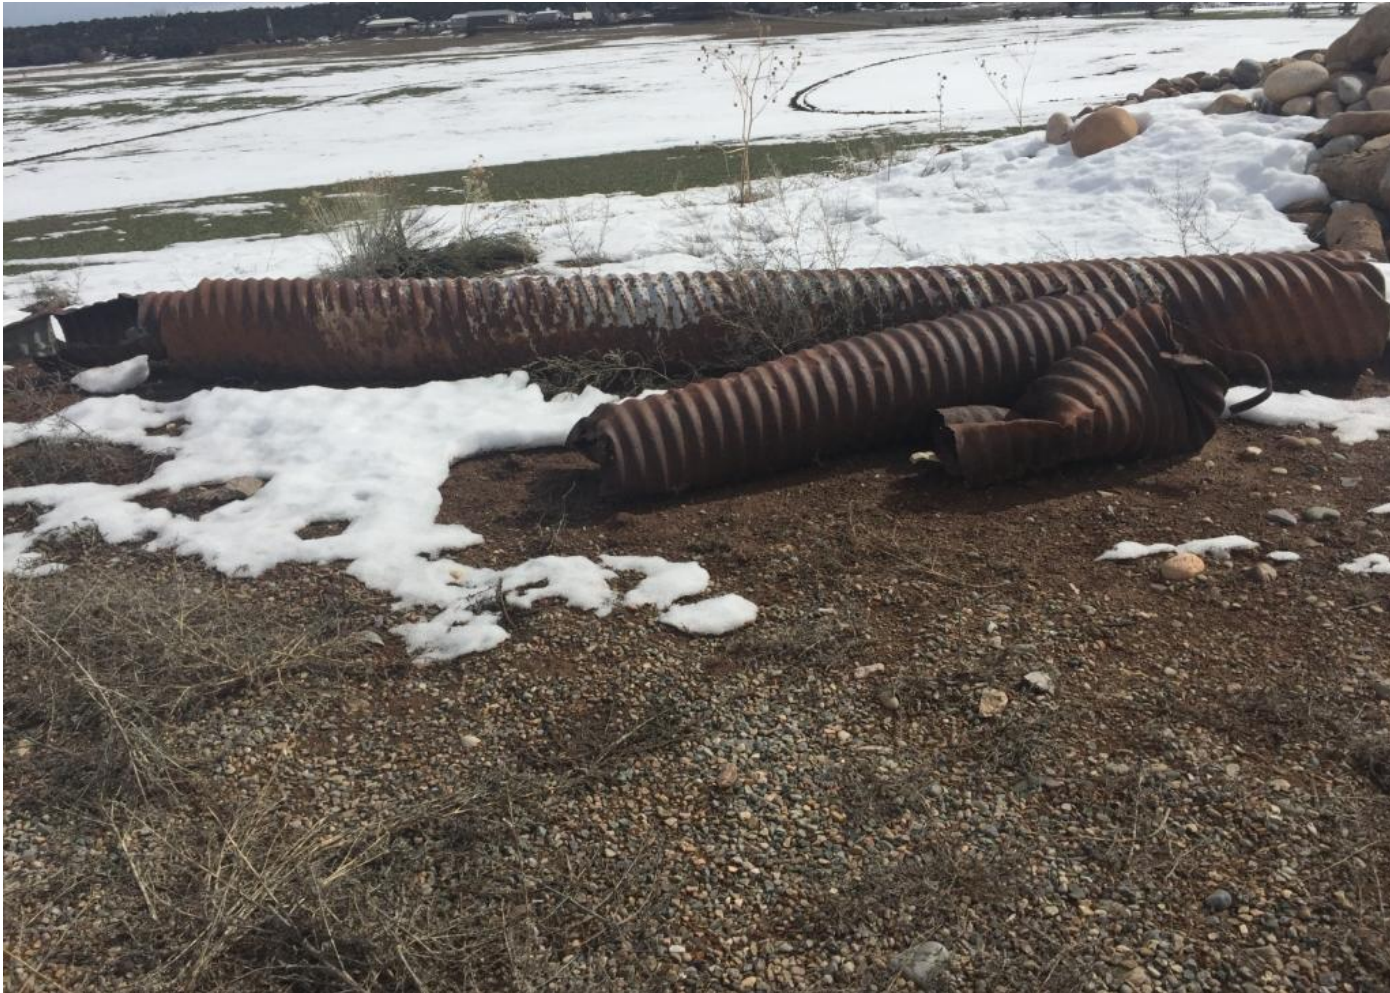
Photo 1. View of unused culverts in southeastern portion of the project area.

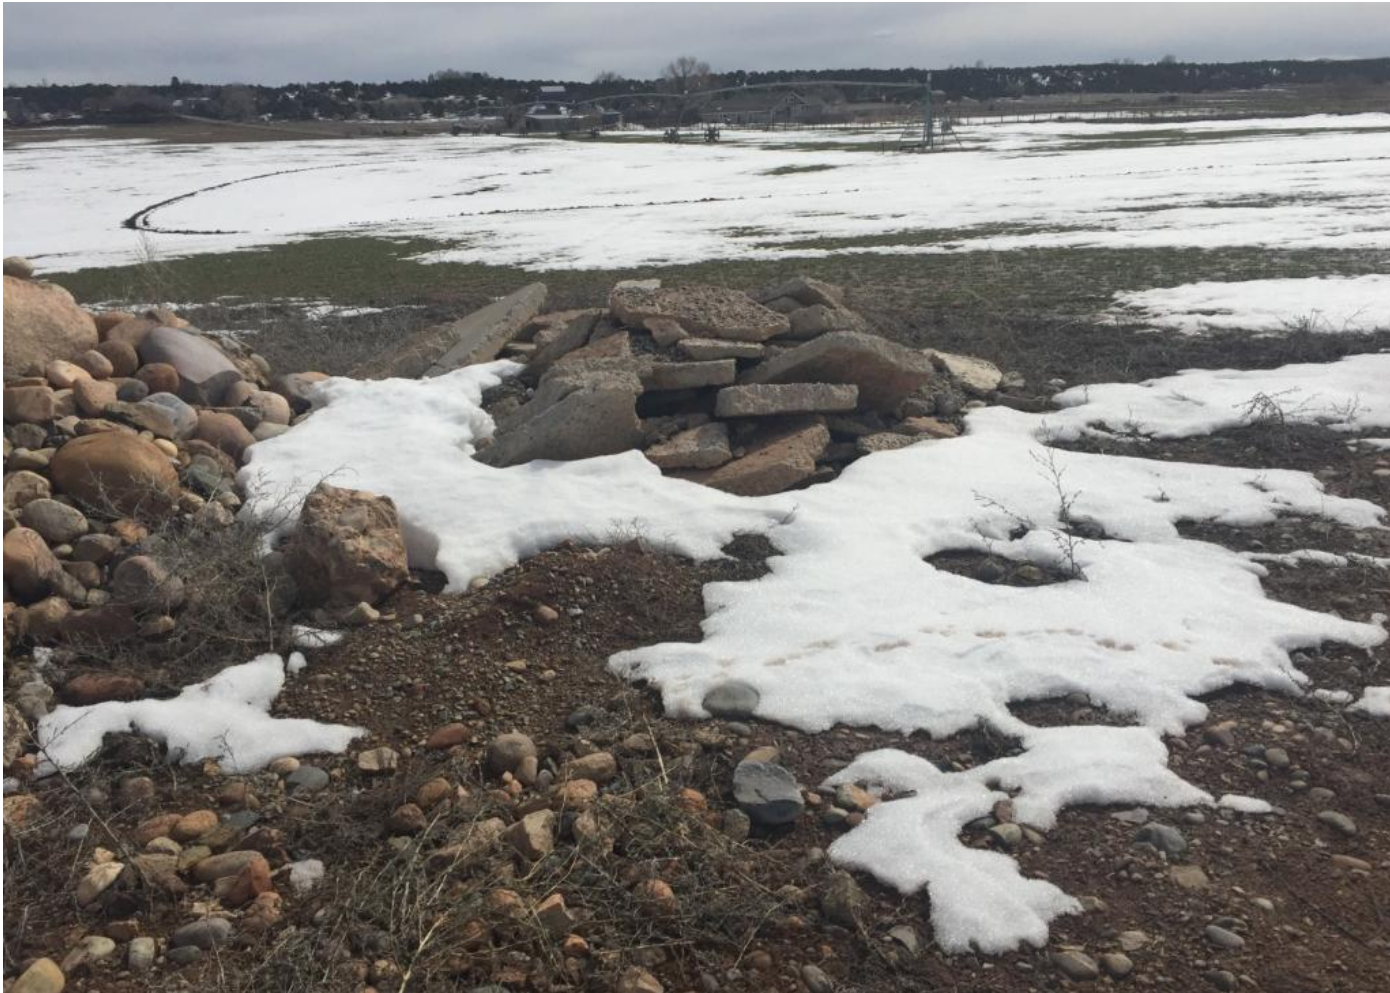
Photo 2. View of cement debris in southeastern portion of the project area.

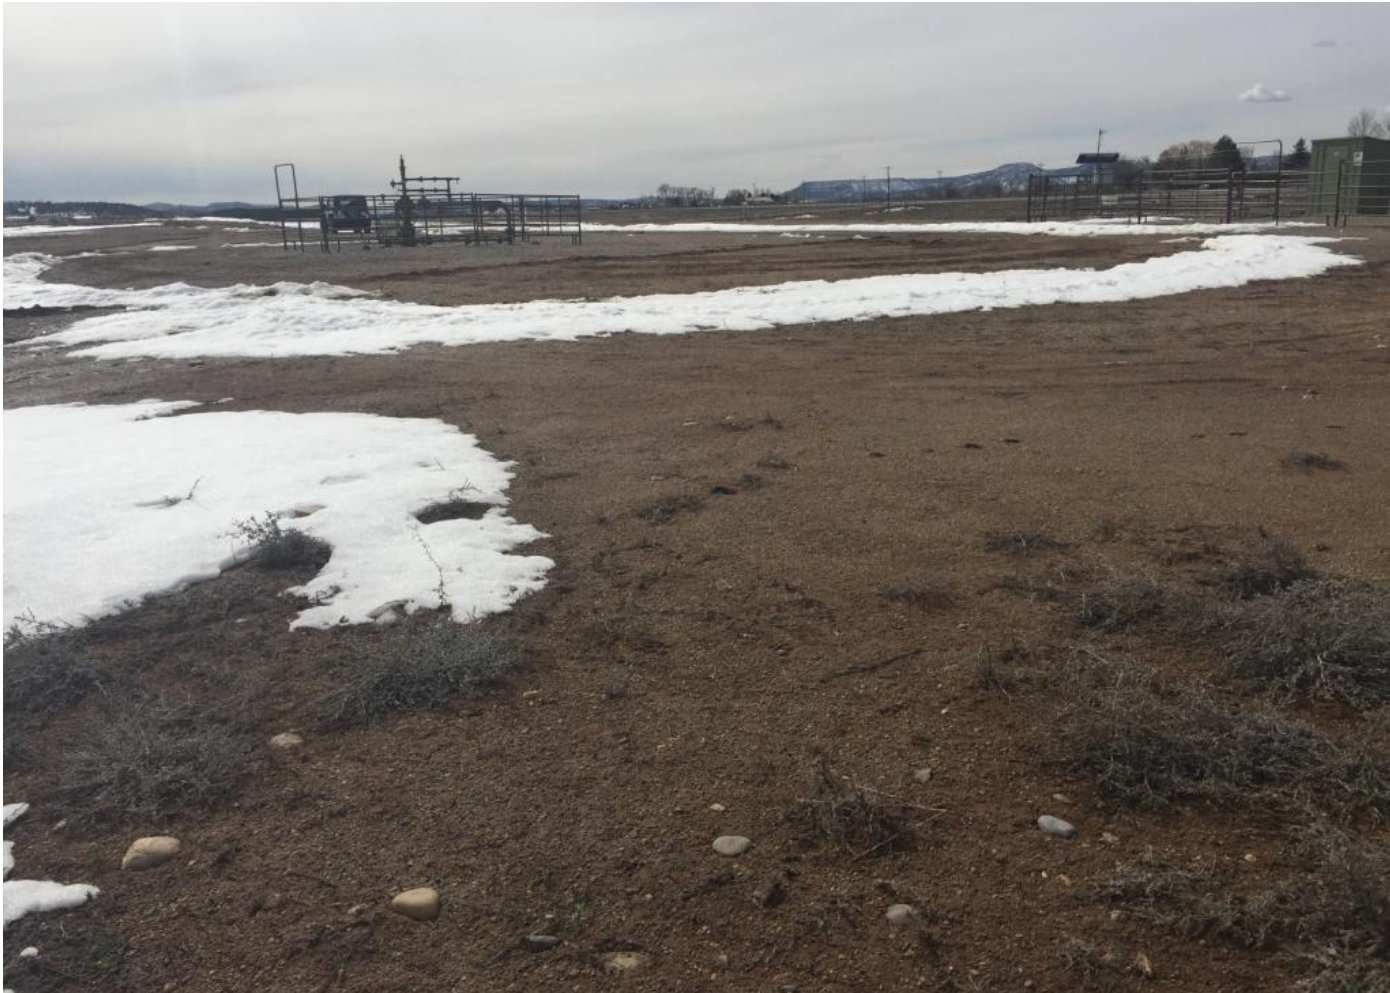
Photo 3. View of the project area from the northeastern corner facing center.

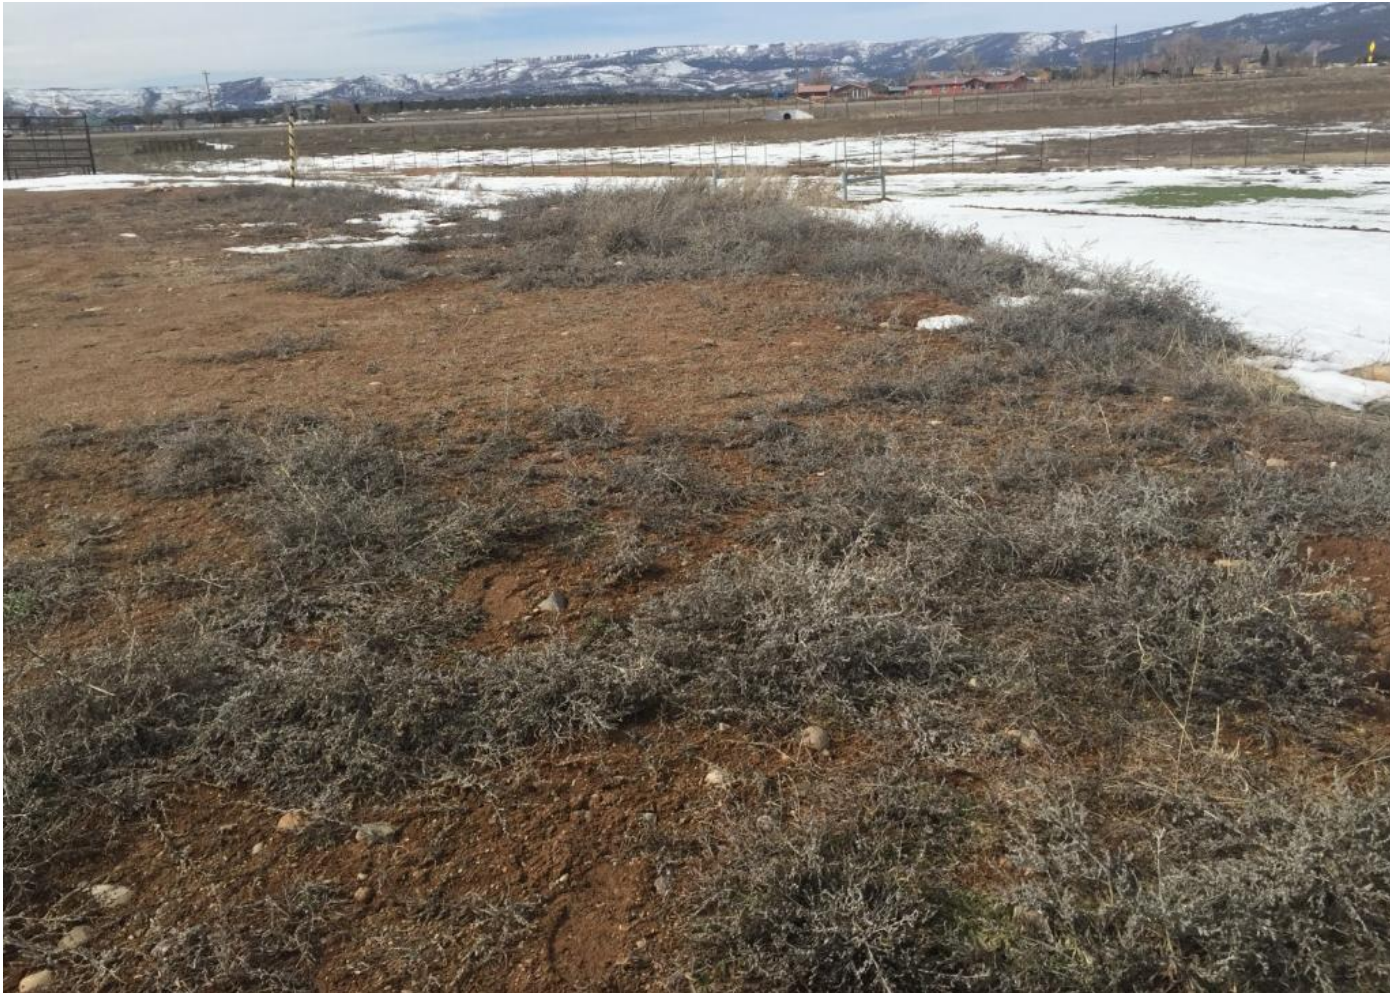
Photo 4. View of the northern portion of the project area from the northeastern corner facing westward. Vegetation is largely comprised of weedy kochia (*Kochia scoparia*) and intermediate wheatgrass (*Thinopyron intermedium*).

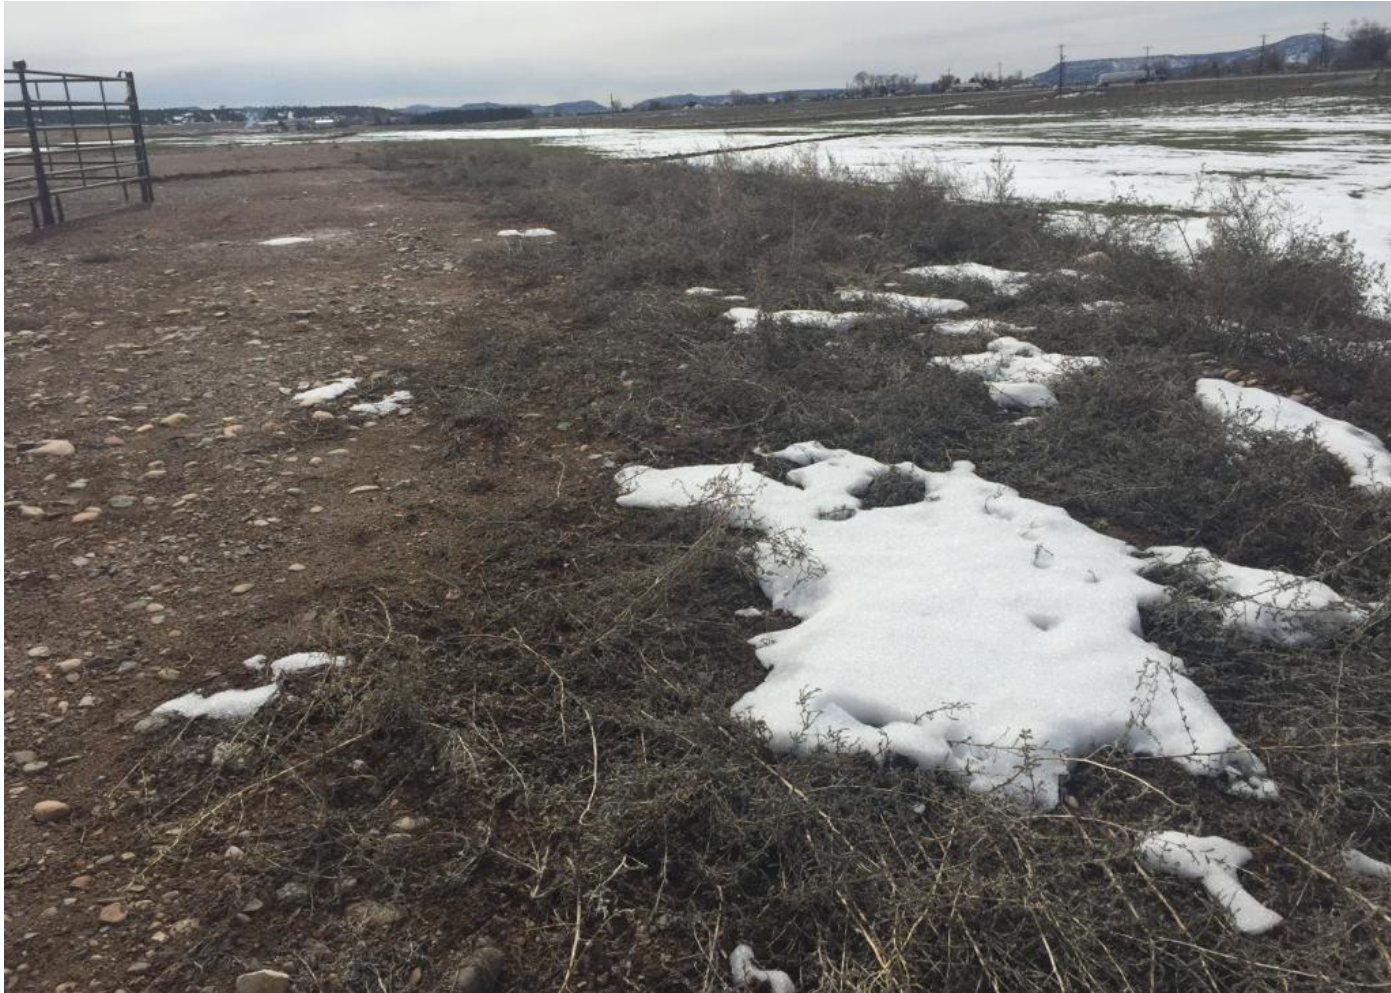
Photo 5. View of the western portion of the project area facing southward. Vegetation here is largely comprised of kochia debris.
