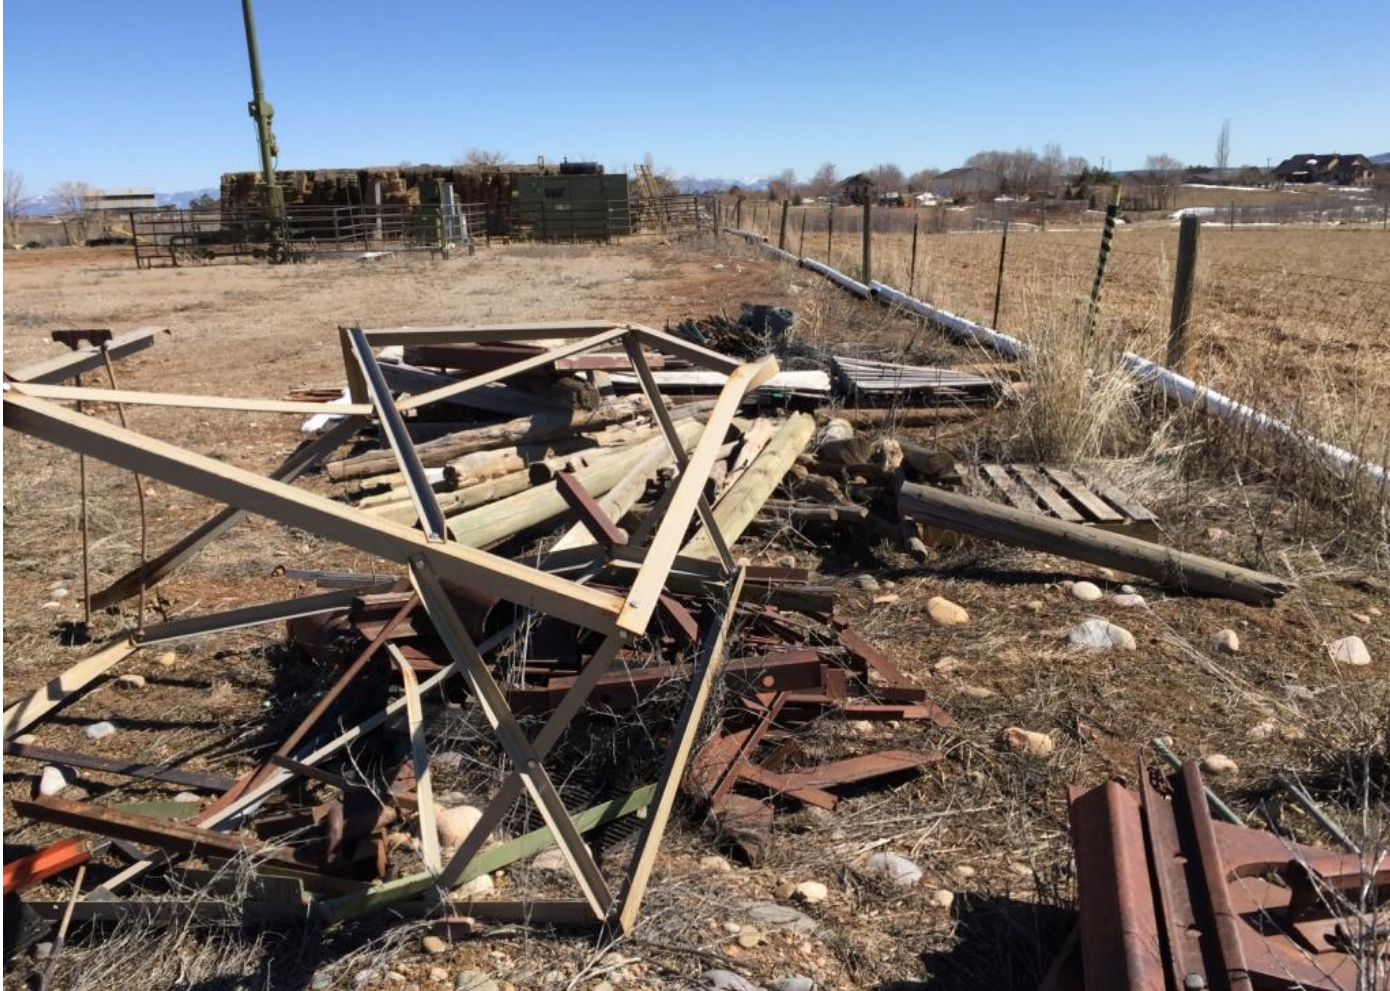
Photo 1. View of the southern portion of the project area from the southwestern corner facing eastward. What appear to be landowner junk and debris is piled up here.

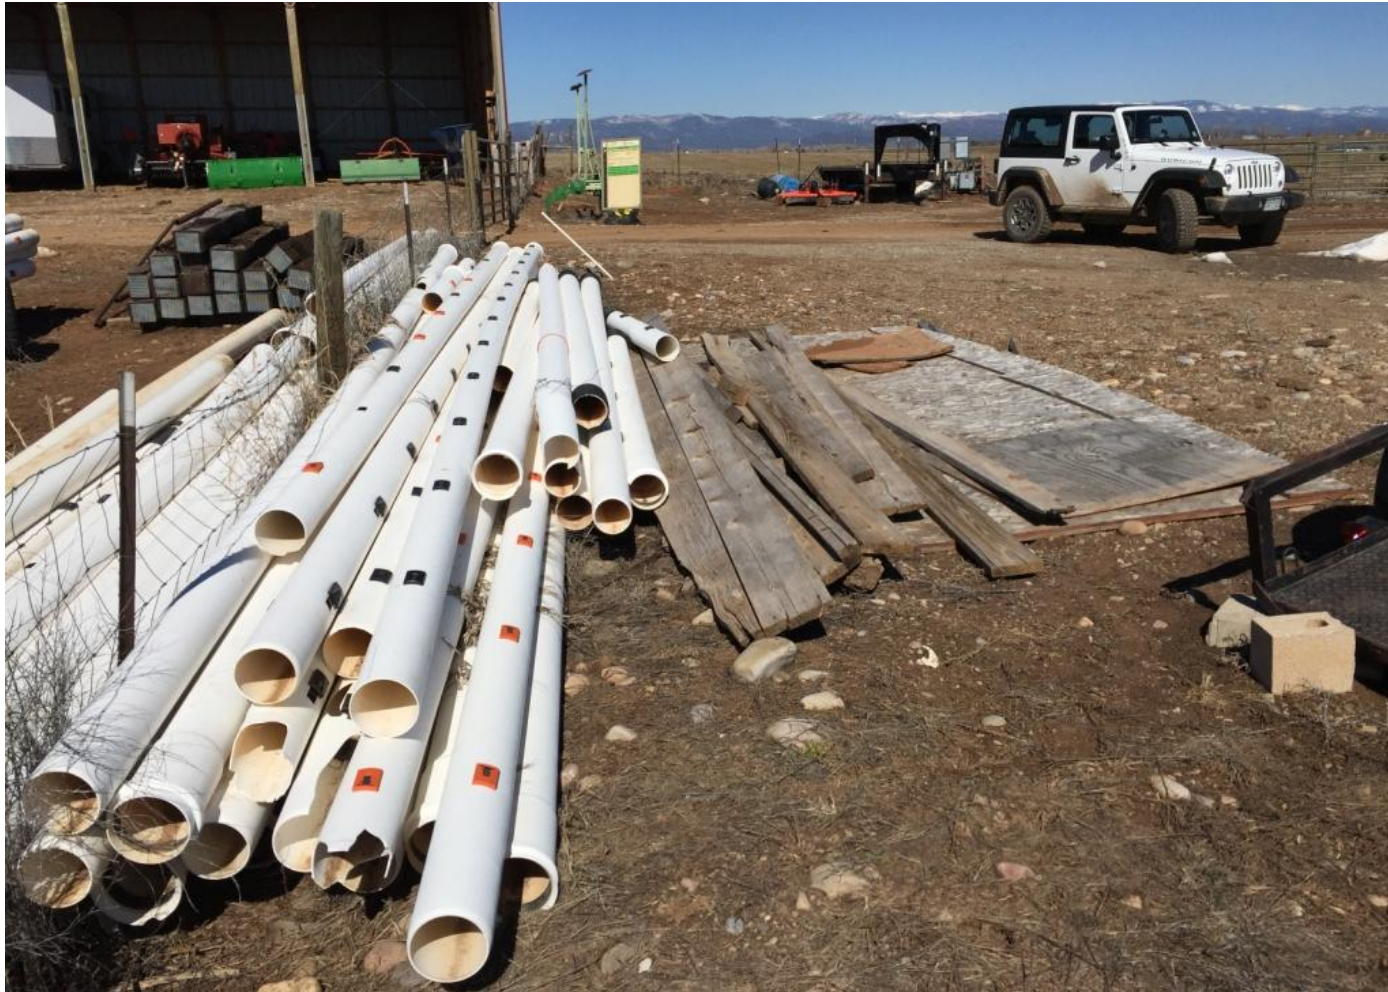
Photo 3. View of western portion of the project area from the southwestern corner facing northward. What appears to be several pieces of landowner junk and equipment are stored here.

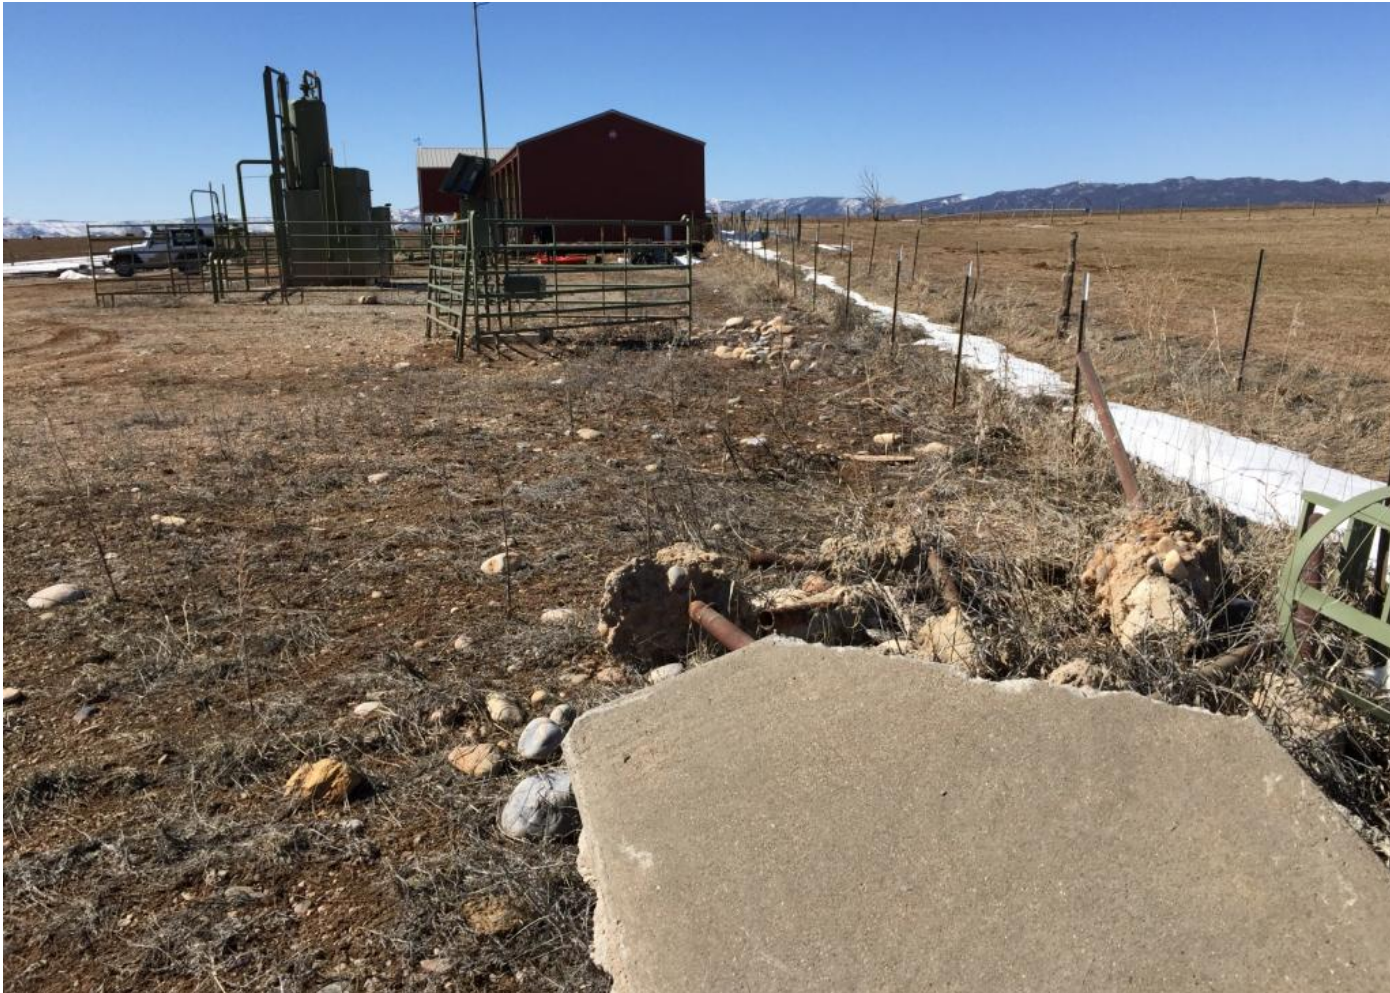
Photo 4. View of the northern portion of the project area from the northeastern corner facing westward. Cement debris is piled in the foreground.

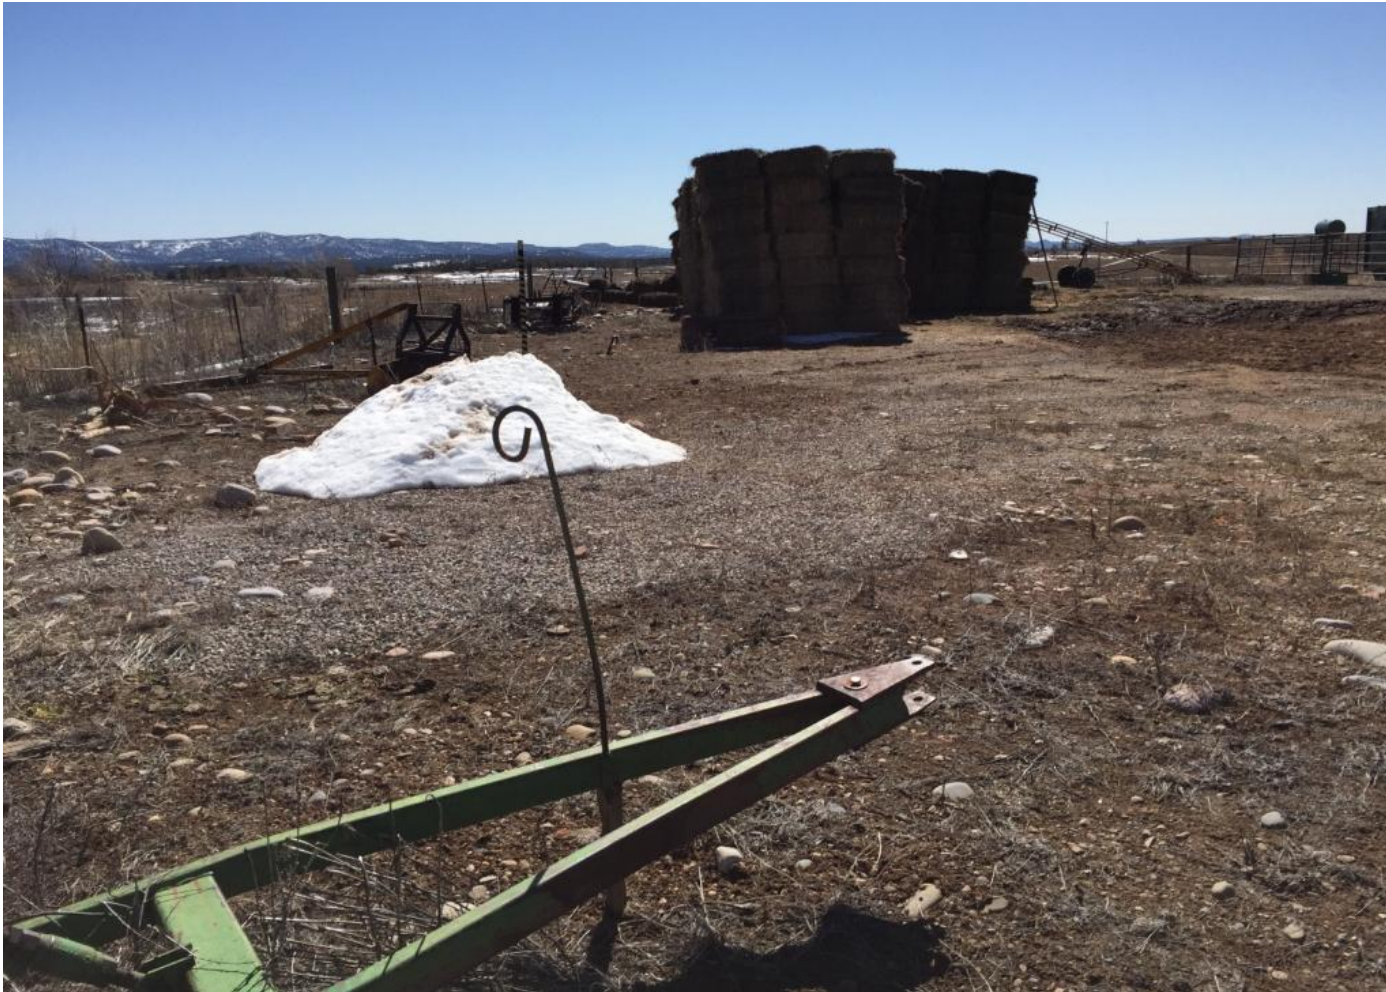
Photo 5. View of the eastern portion of the project area from the northeastern corner facing southward. What appears to be surface owner equipment and hay storage is occurring here.
