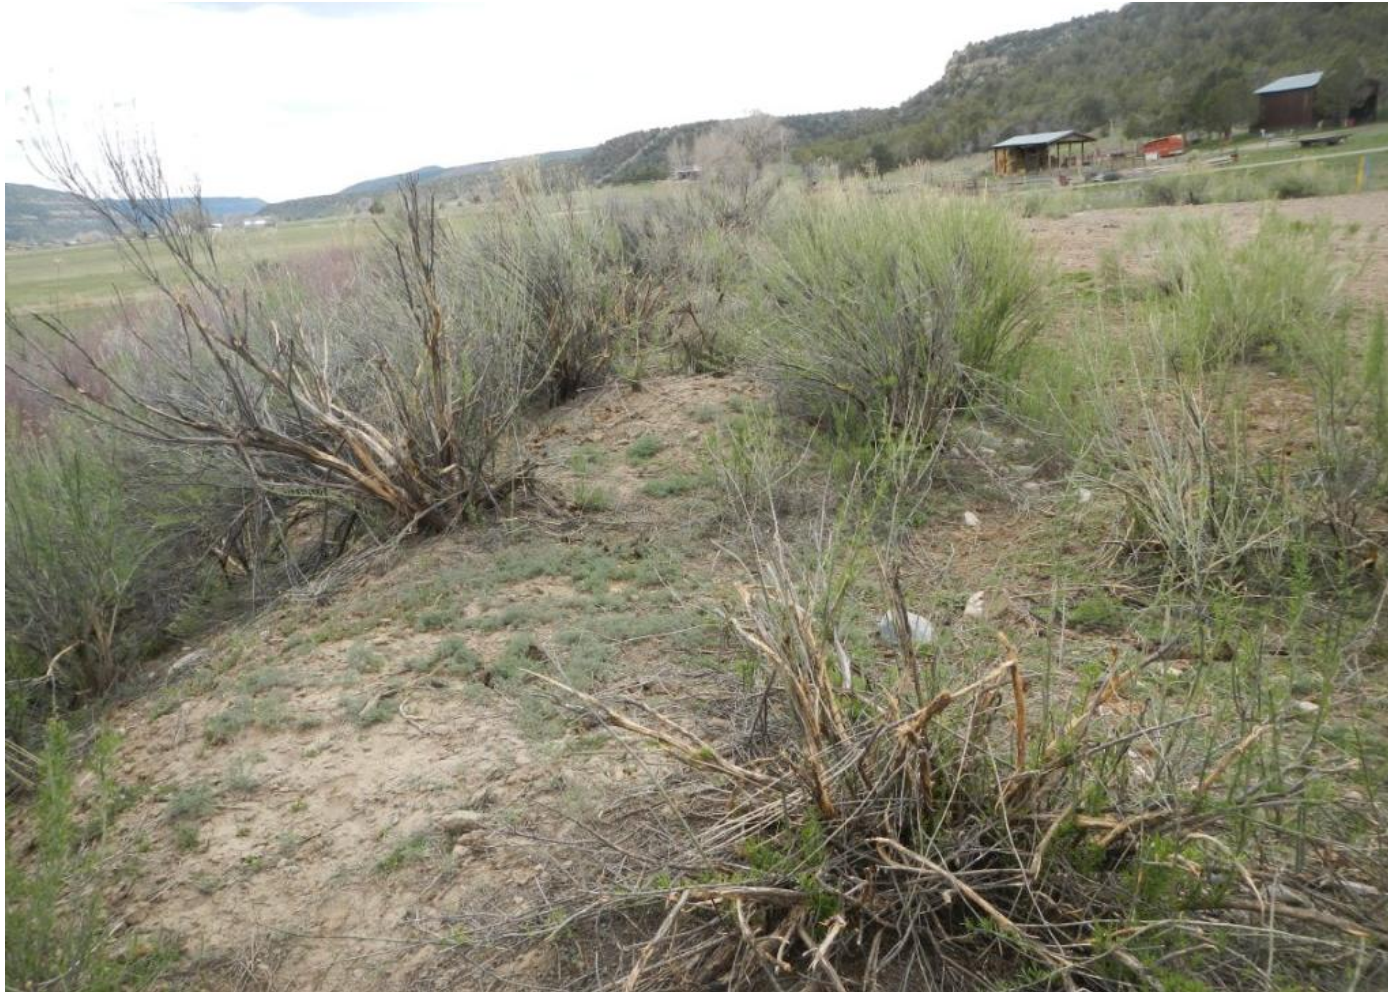
Photo 2. View of the eastern portion of the project area from the northeastern corner facing southward. Vegetation is largely comprised of rubber rabbitbrush (*Chrysothamnus nauseosus*), kochia (*Kochia scoparia*), and flixweed (*Descurainia sophia*).

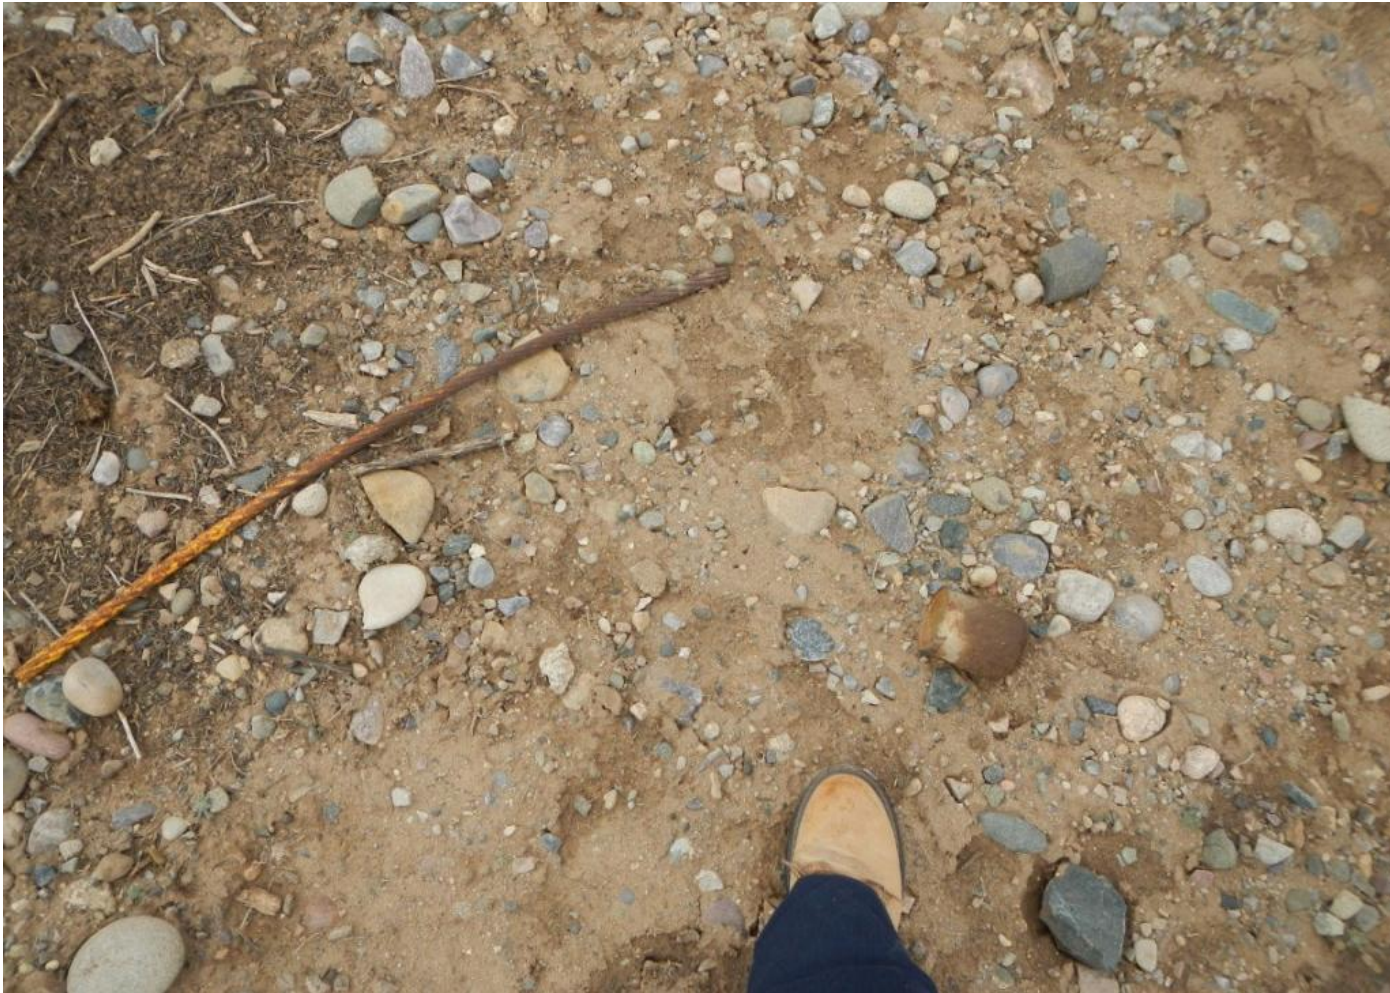
Photo 6. View of rig cable and small trash within the southern portion of the project area.

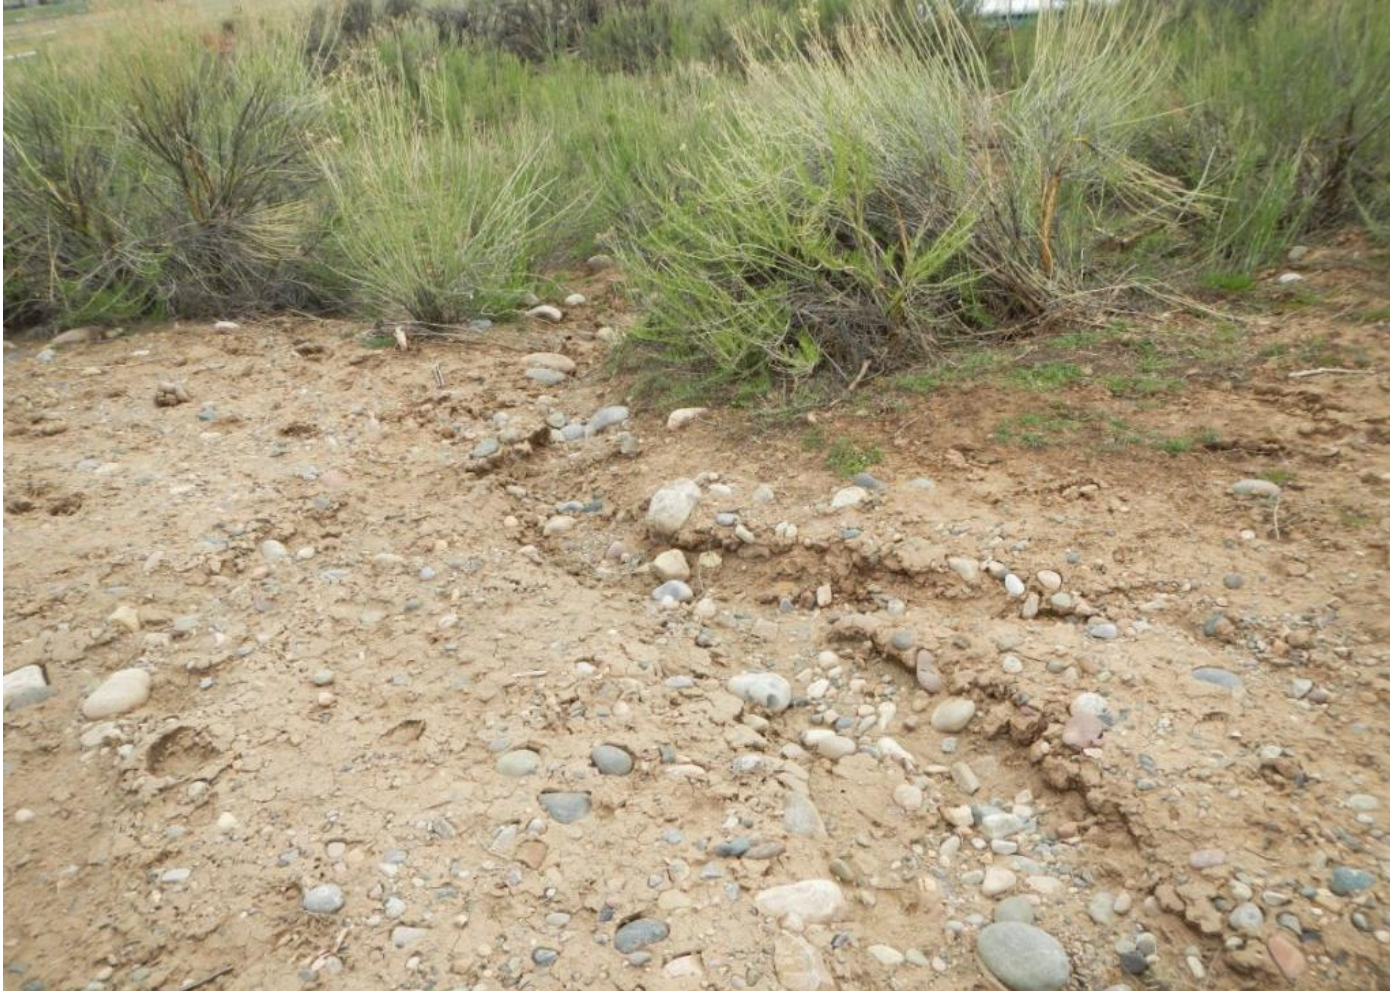
Photo 7. View of an erosional channel approximately 1 foot wide and 8 inches deep within the southern portion of the project area.
