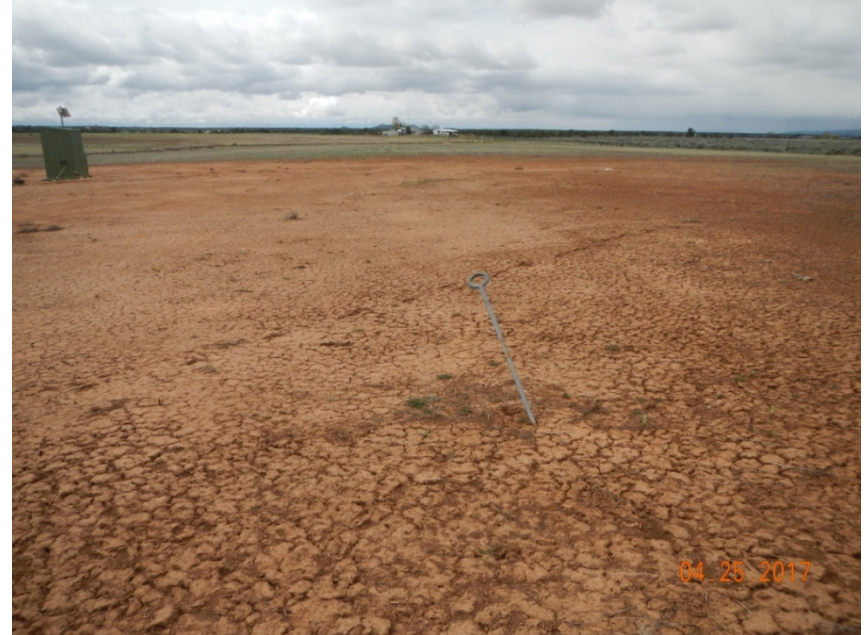
**Photo 2: View of the western portion of the project area from the northwestern corner facing southward. The majority of the project area is devoid of vegetation.**

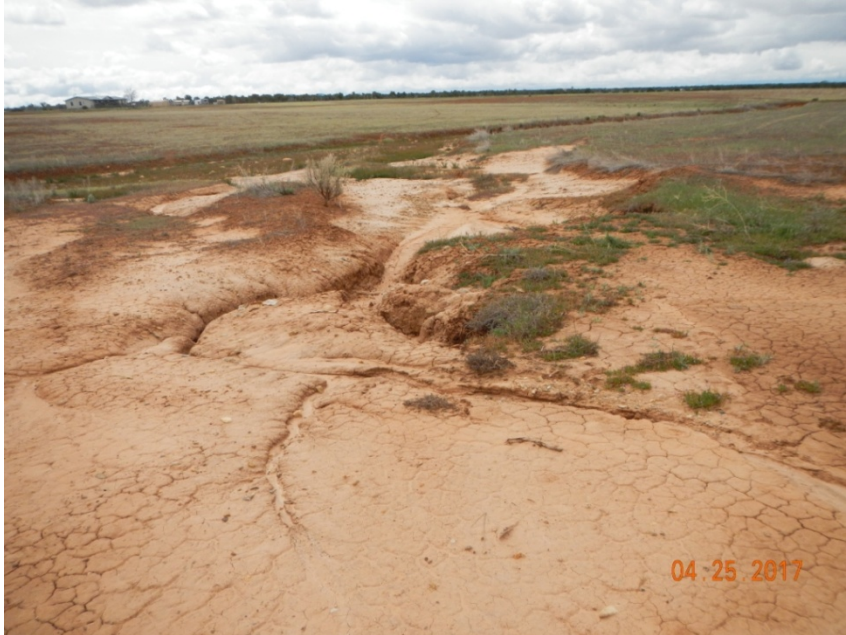
**Photo 5: View of stormwater erosion in the eastern portion of the project area from the eastern edge facing westward.**

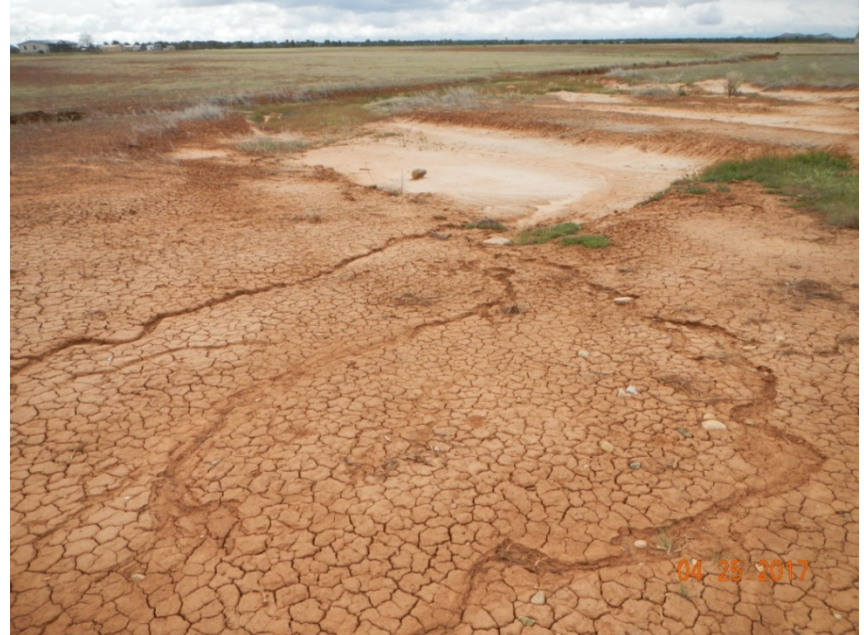
**Photo 6: Another view of erosion within the eastern portion of the project area from the eastern edge facing westward.**
