**Inspection Photos**  
**Location Name: Behring #1**  
**API: 05-123-05198**

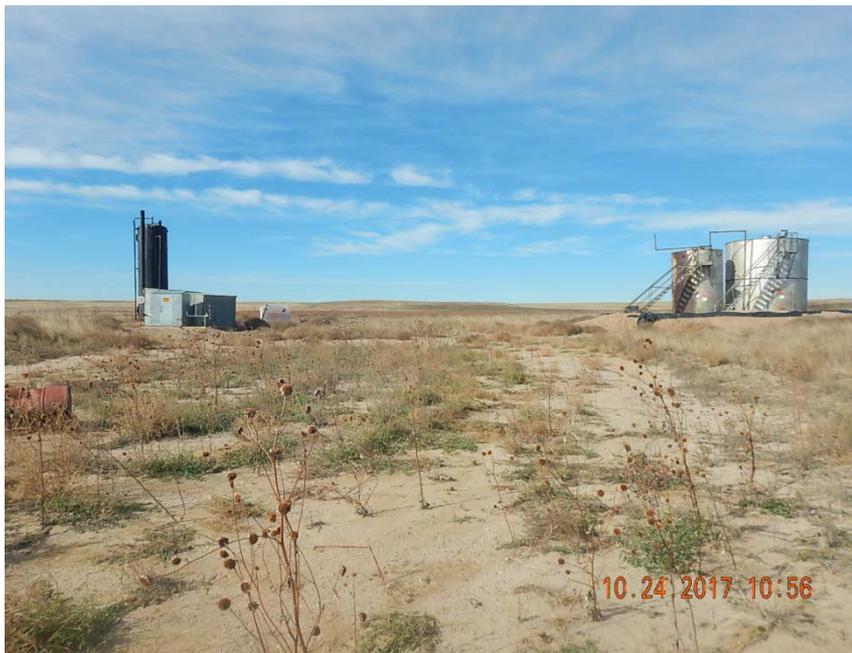
**Photo 1: Location, looking W**

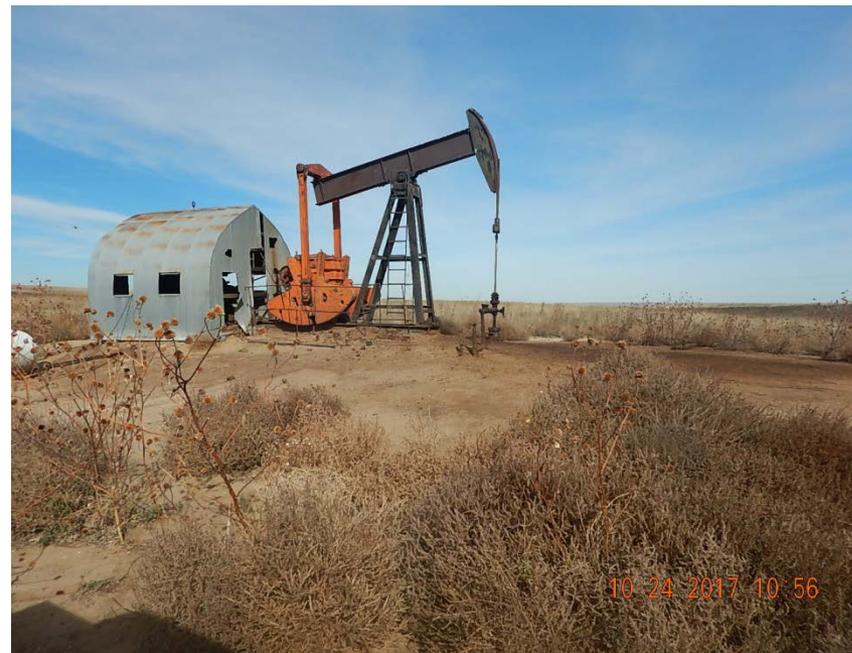
**Photo 2: Wellhead, looking NW**

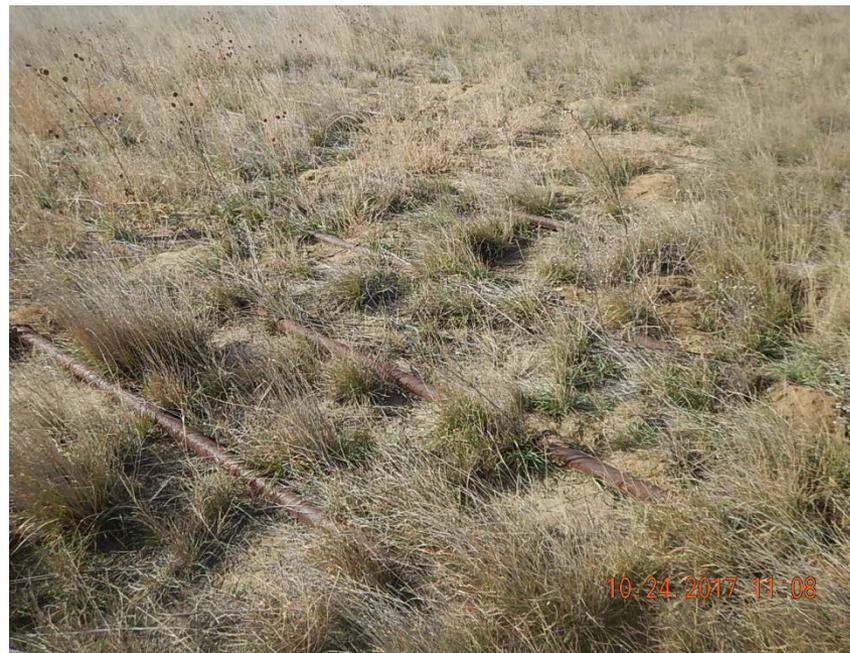
**Photo 3: Unused pipe S of pit excavation**

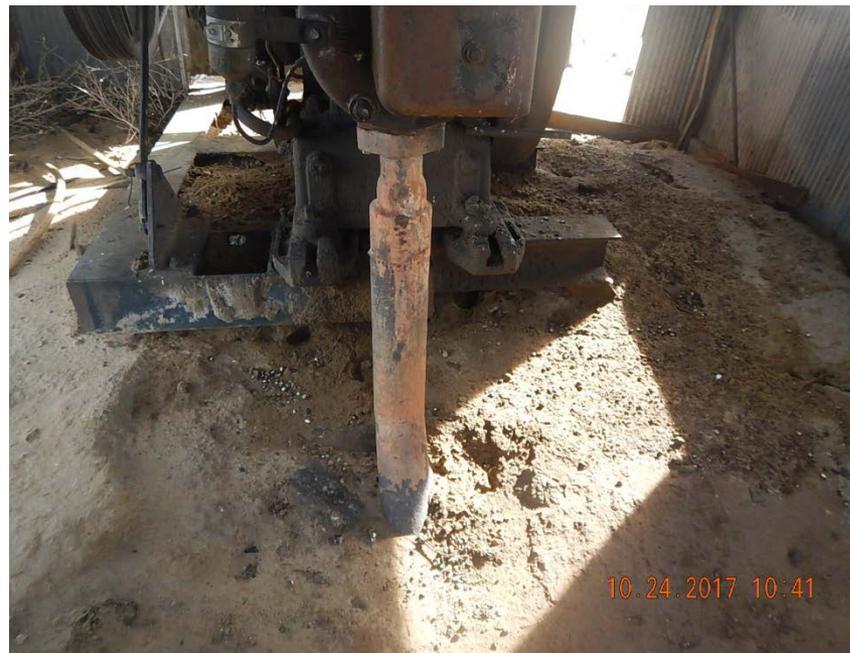
**Photo 4: Stained soil in engine house**

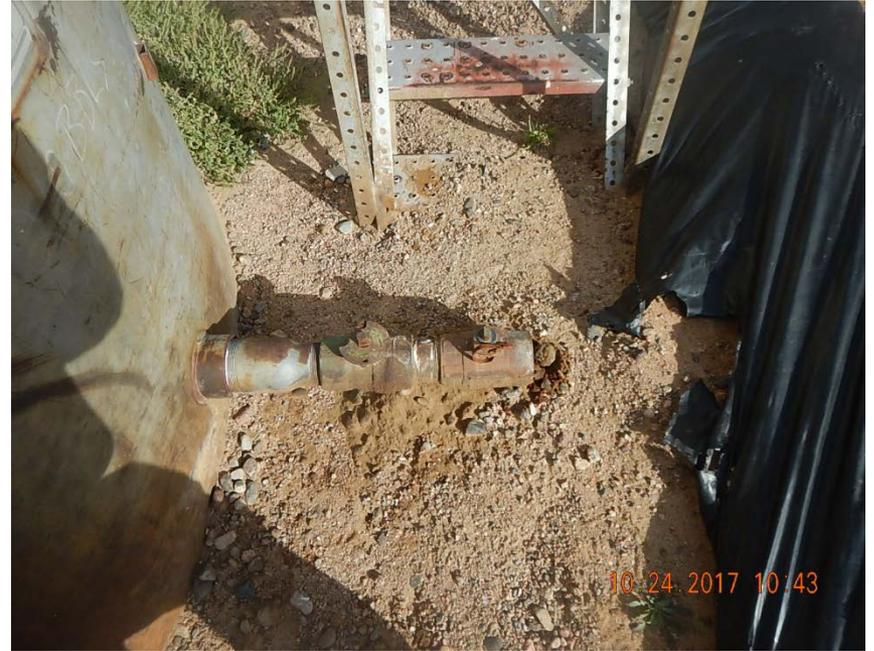
**Photo 5: Stained soil at truck loadout**

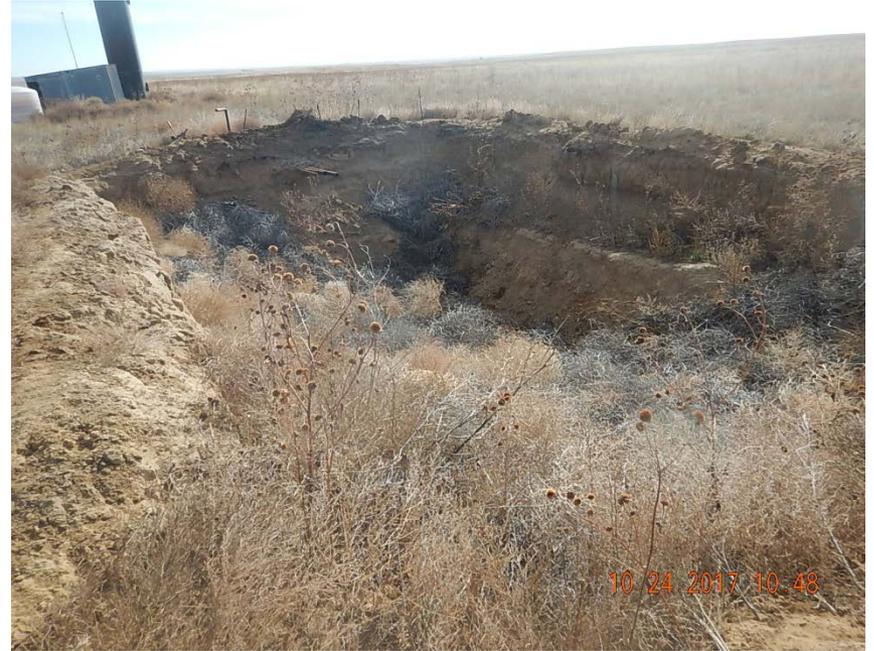
**Photo 6: Pit excavation**

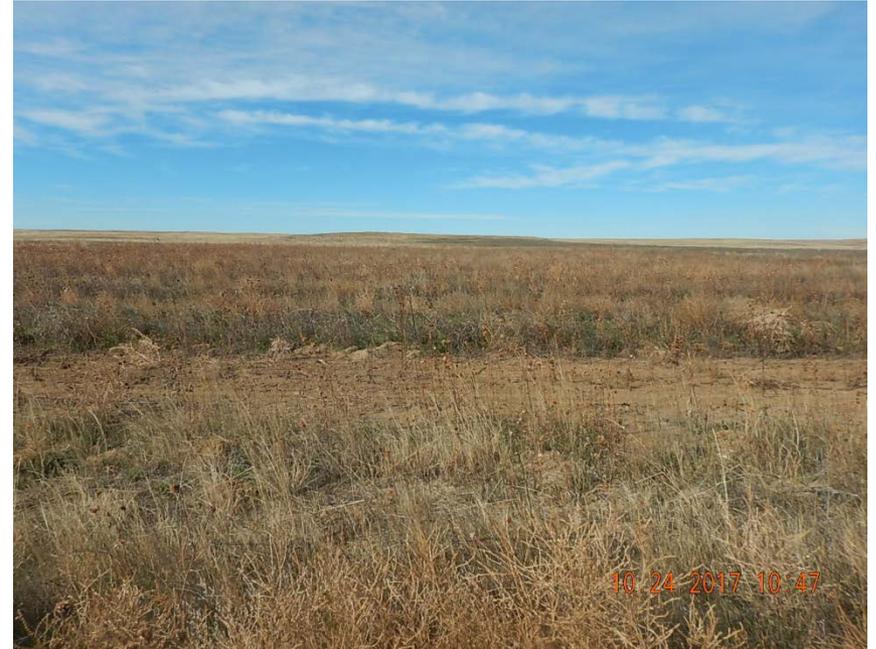
**Photo 7: Land farm, looking W**

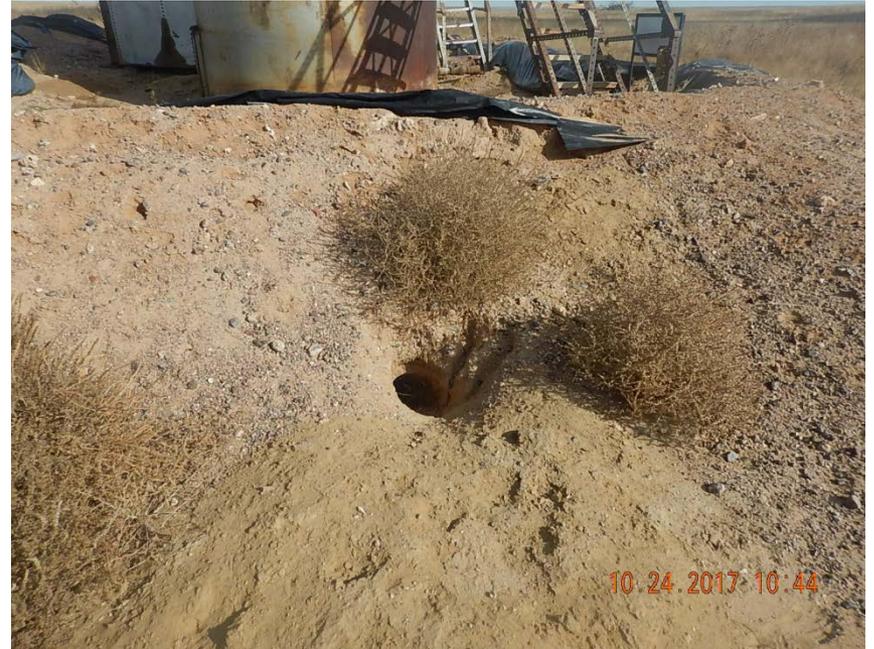
**Photo 8: Burrows, weeds in berms**

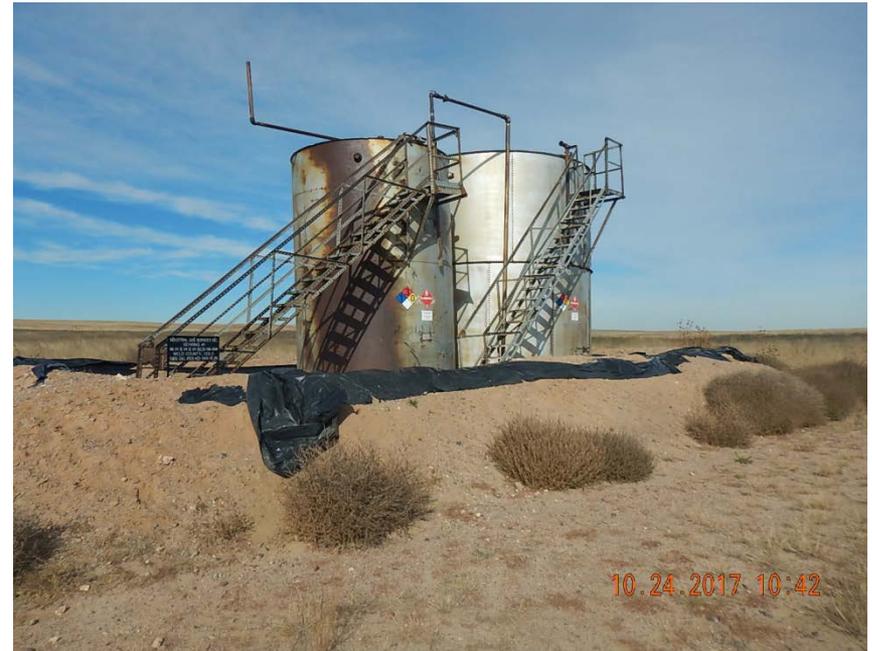
Photo 9: Labels on tanks, rusted production tank, weeds along berms

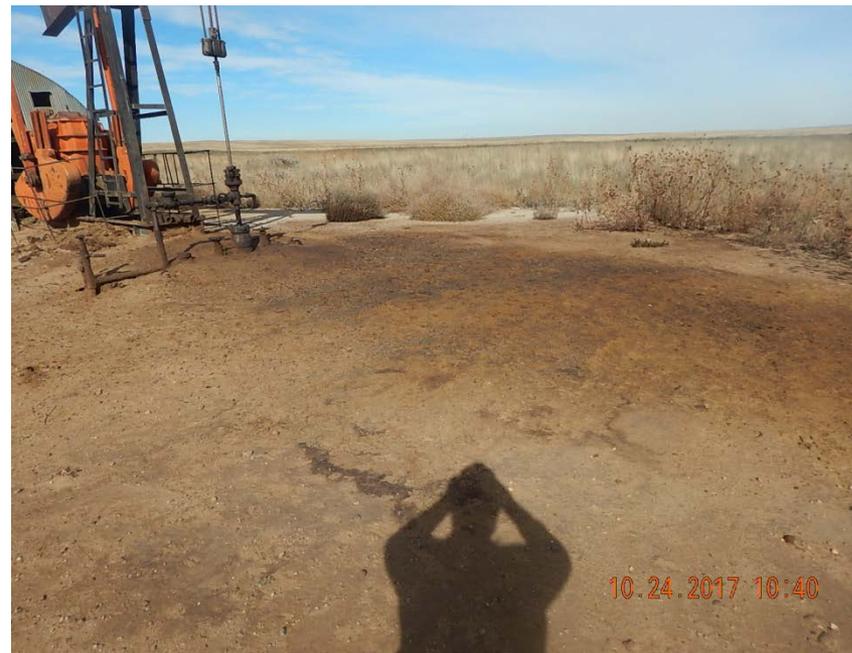
Photo 10: Stained soil at wellhead

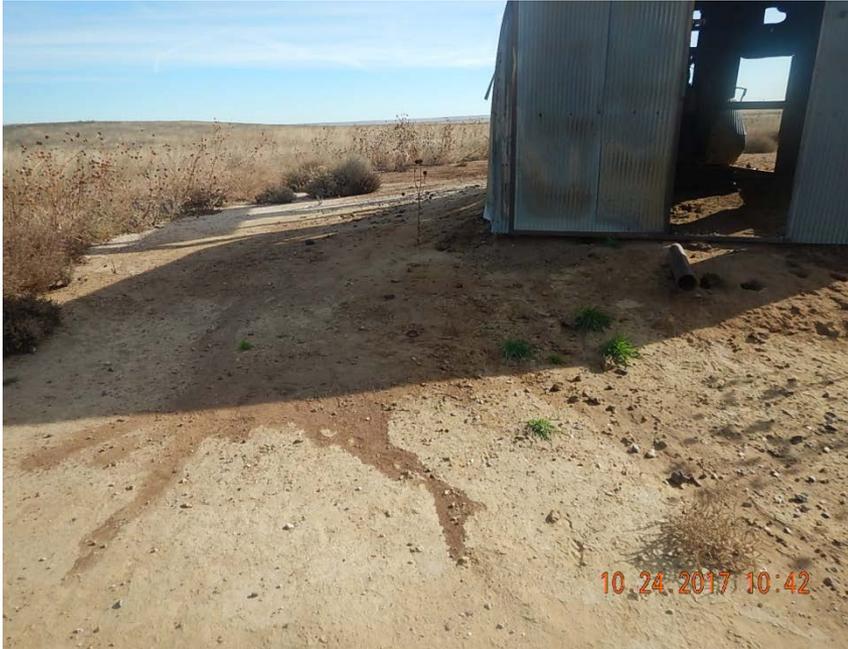
Photo 11: Stained soil around engine house

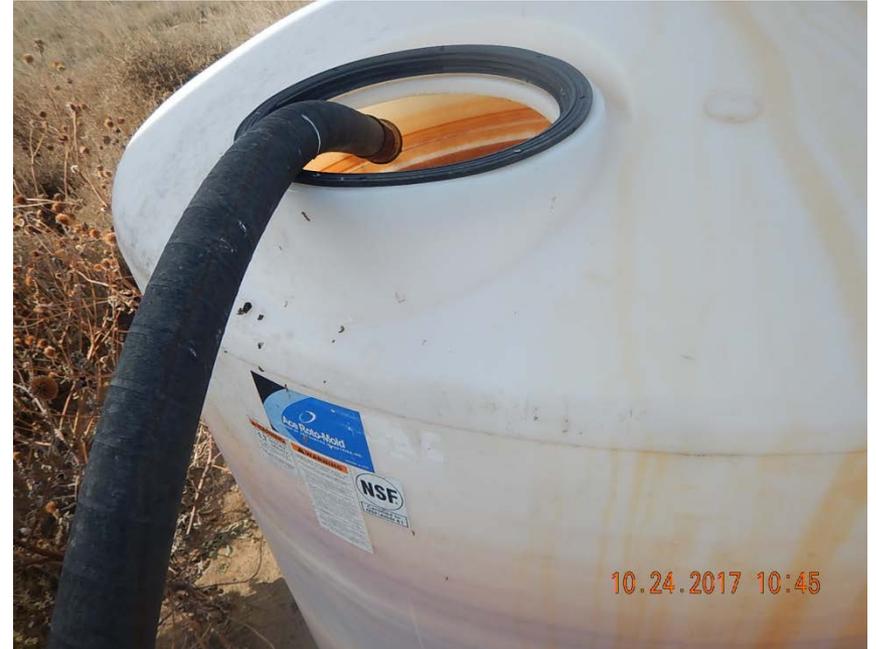
Photo 12: Open produced water tank

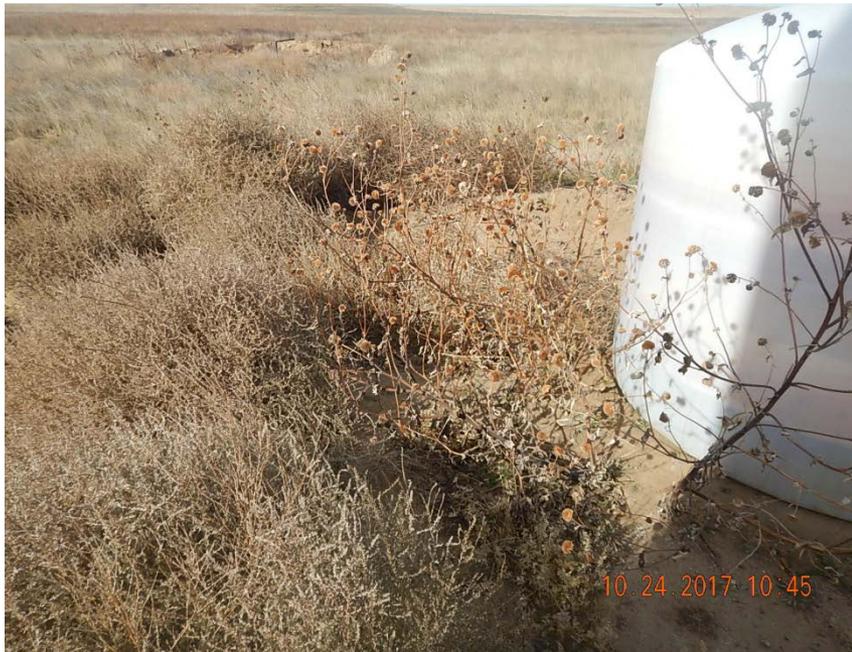
**Photo 13: Weeds along berm**

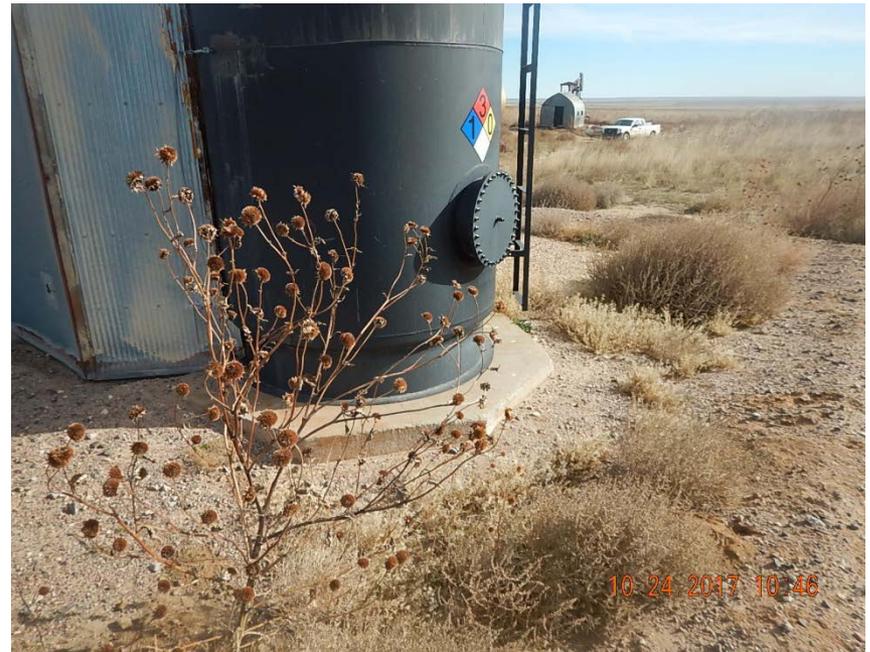
**Photo 14: Weeds around heater treater**

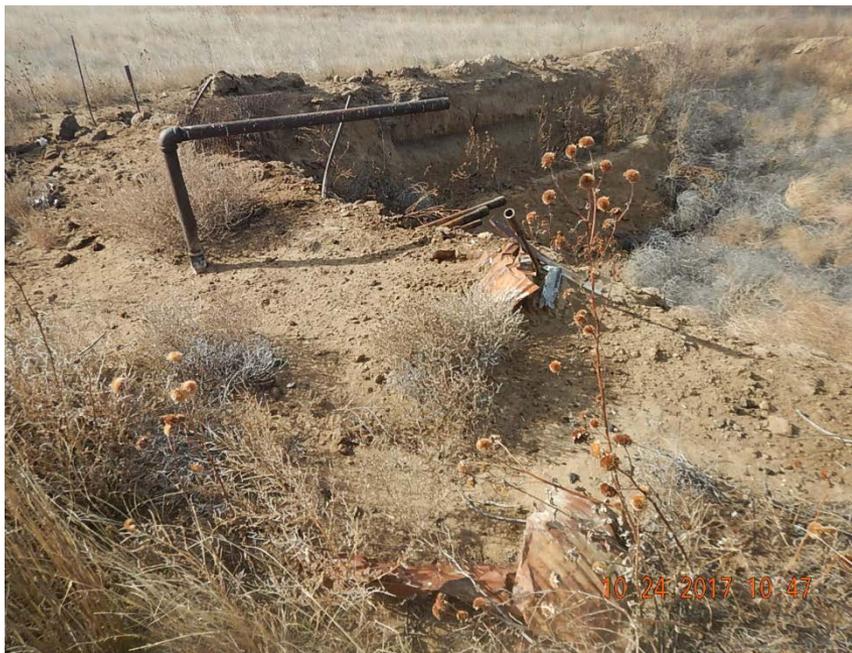
**Photo 15: Debris, risers at pit excavation**
