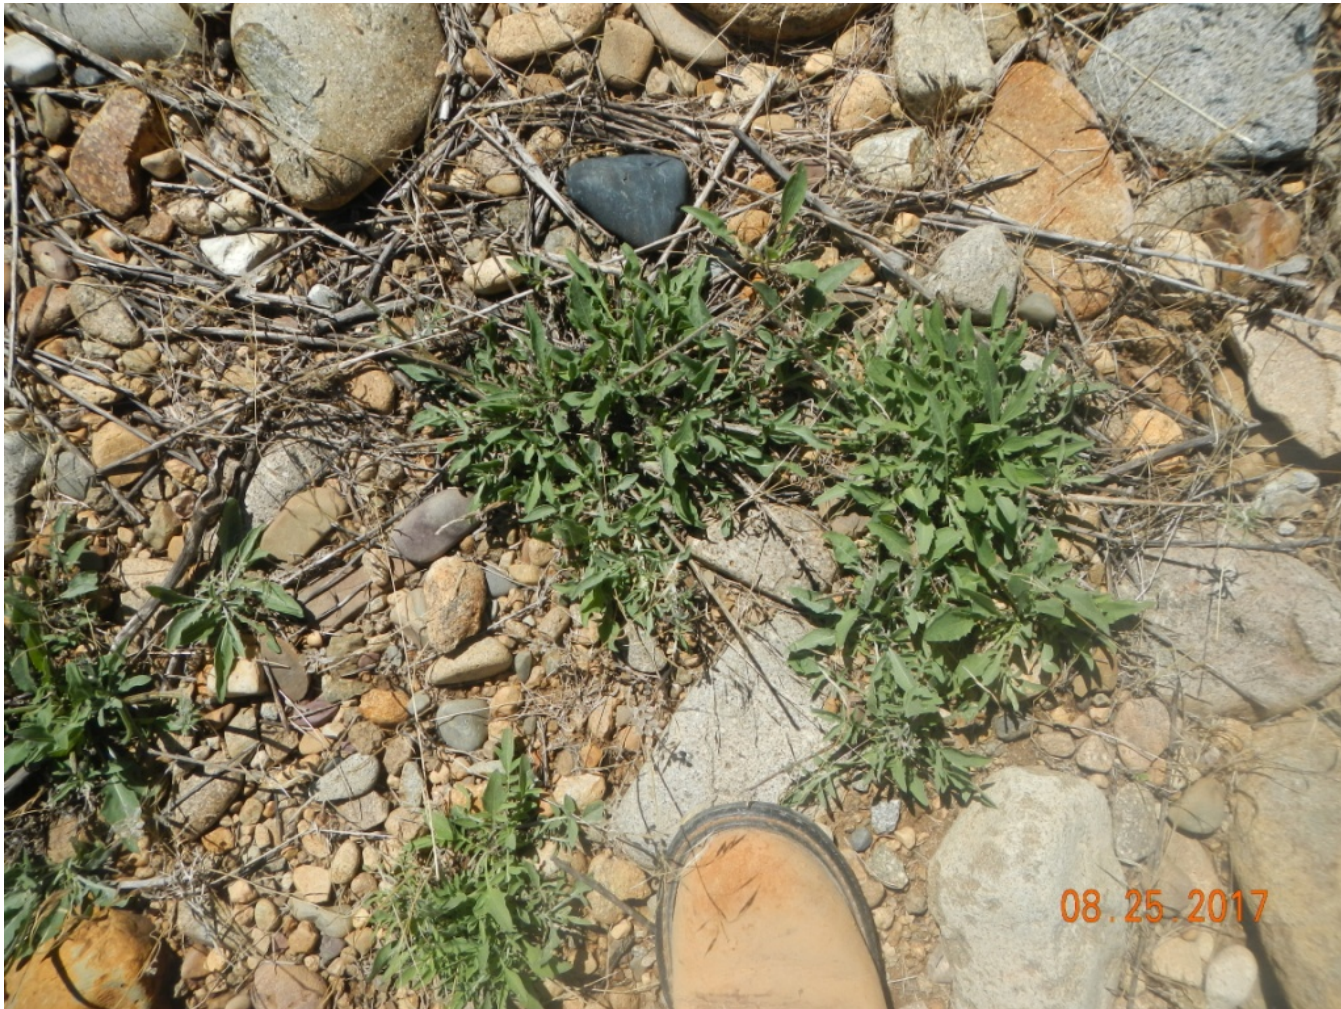
Photo 12. Birdseye view of spotted knapweed (*Centaurea stoebe*) rosettes within the project area.

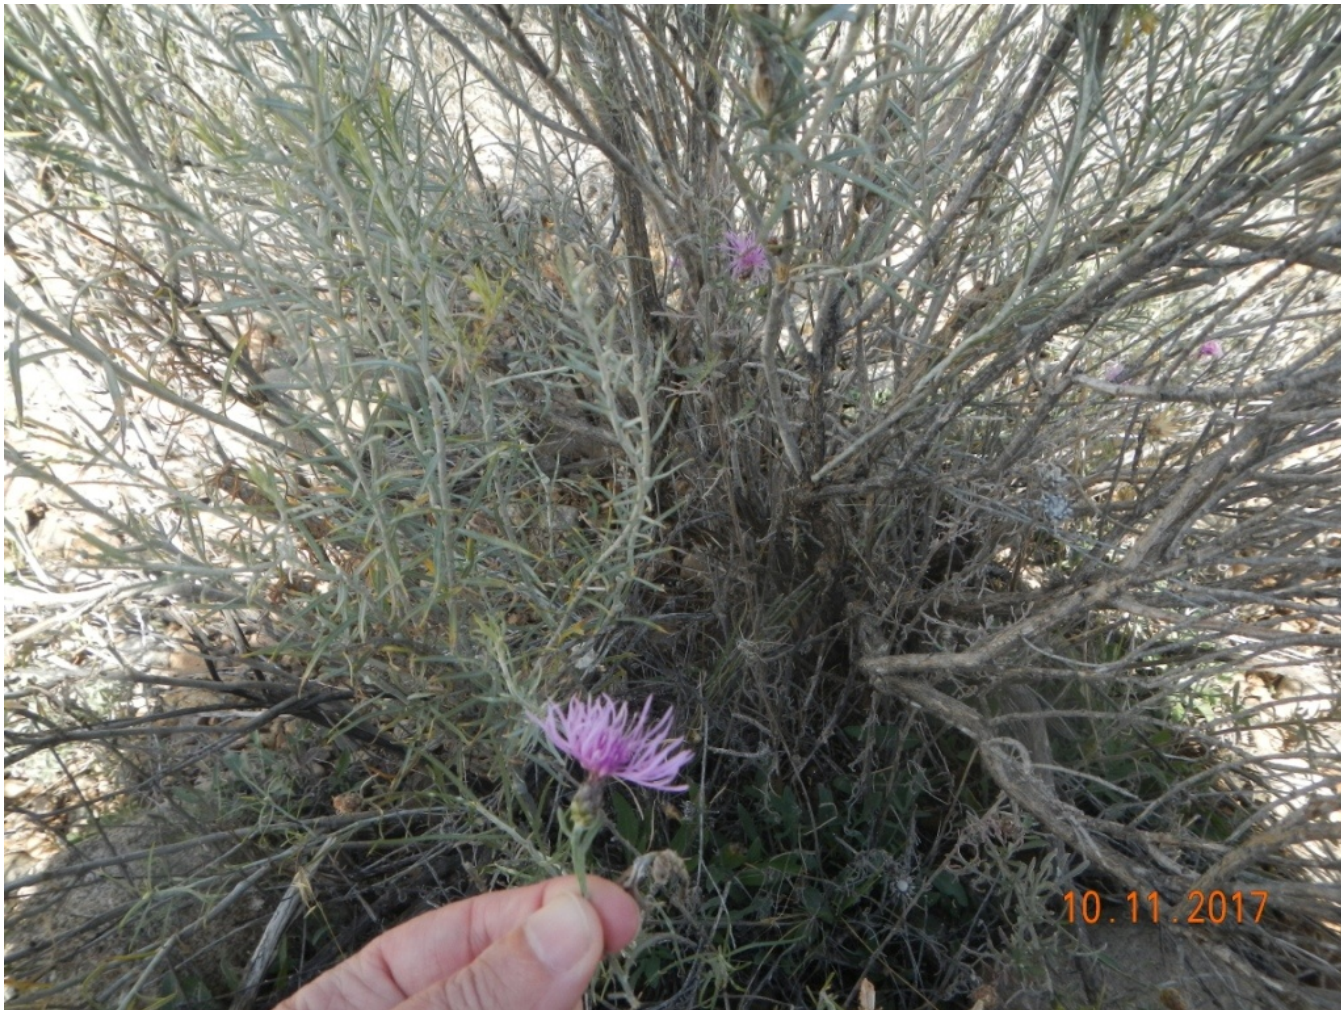
Photo 13. Birdseye view of spotted knapweed (*Centaurea stoebe*) rosettes within the project area in October.

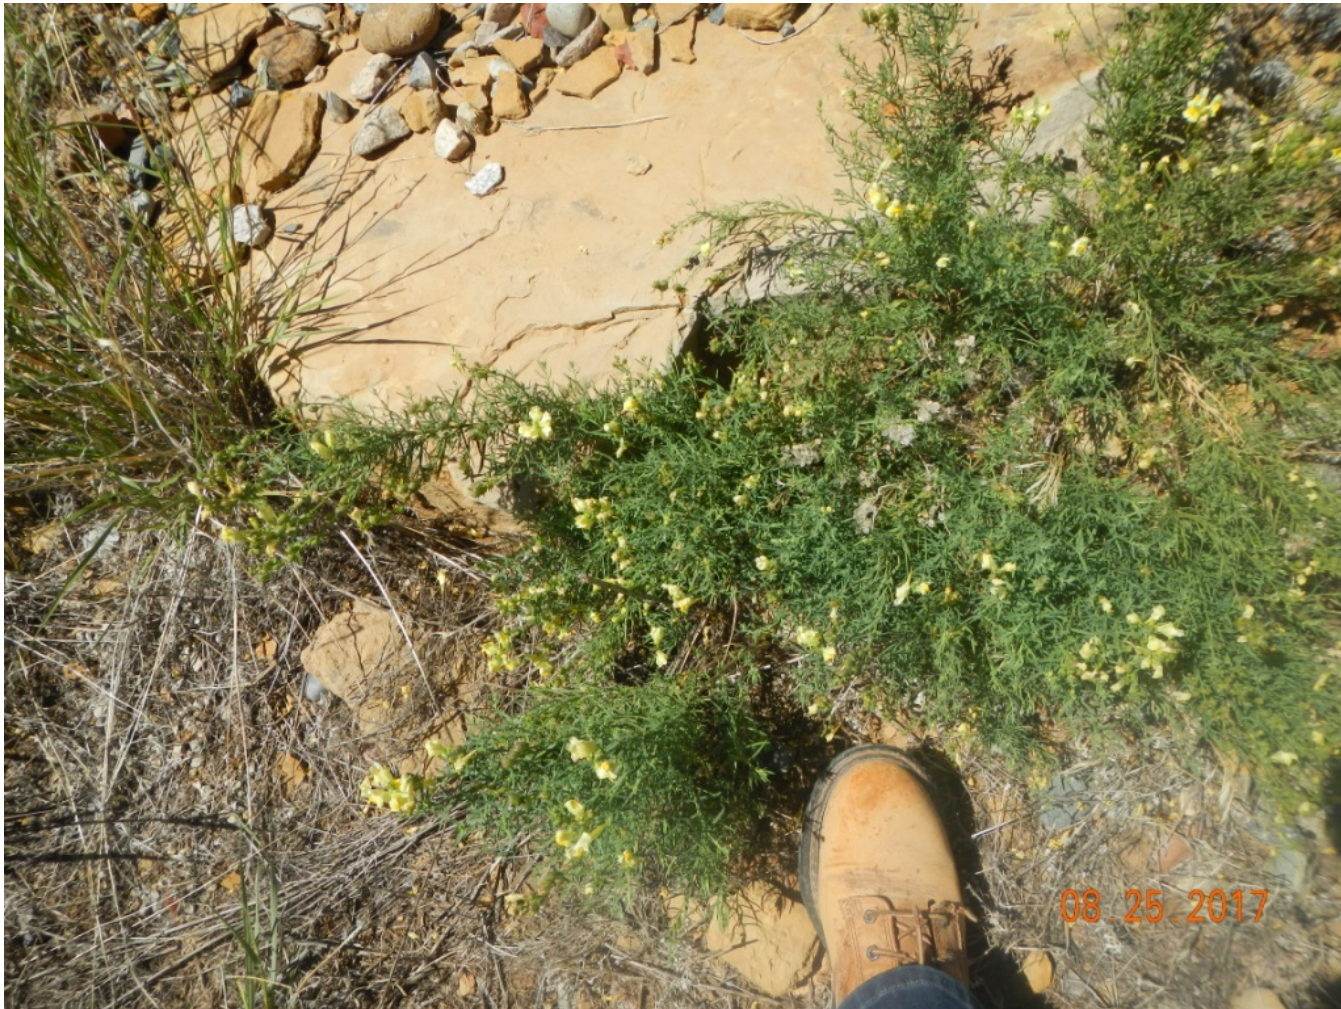
Photo 13. Birdseye view of yellow toadflax (*Linaria vulgaris*) within the southeastern portion of the project area.

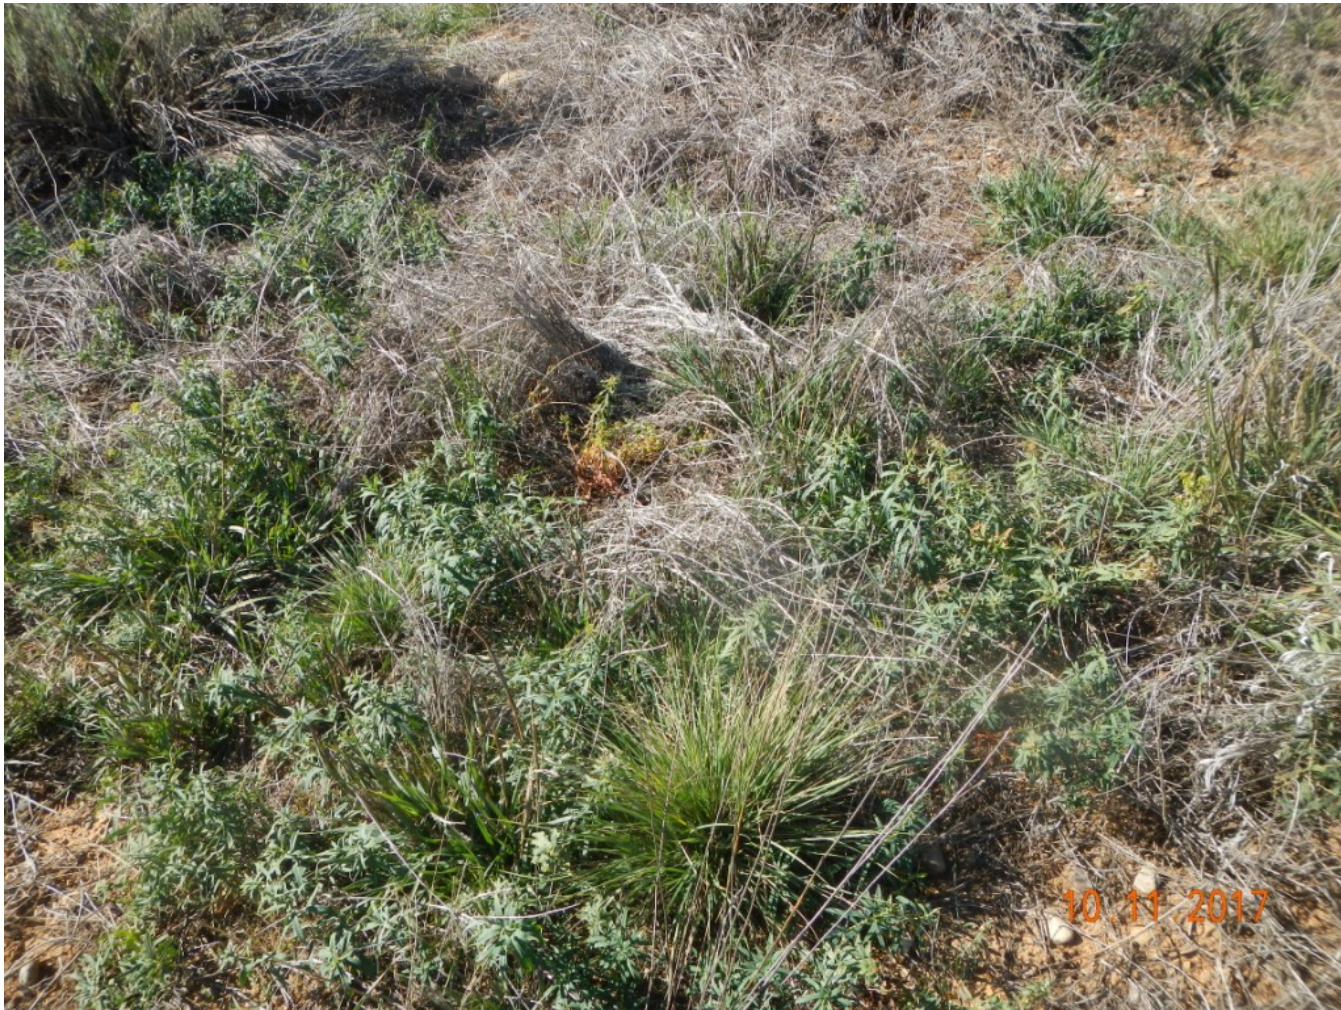
Photo 15. View of leafy spurge (*Euphorbia esula*) within the southern portion of the project area in October.

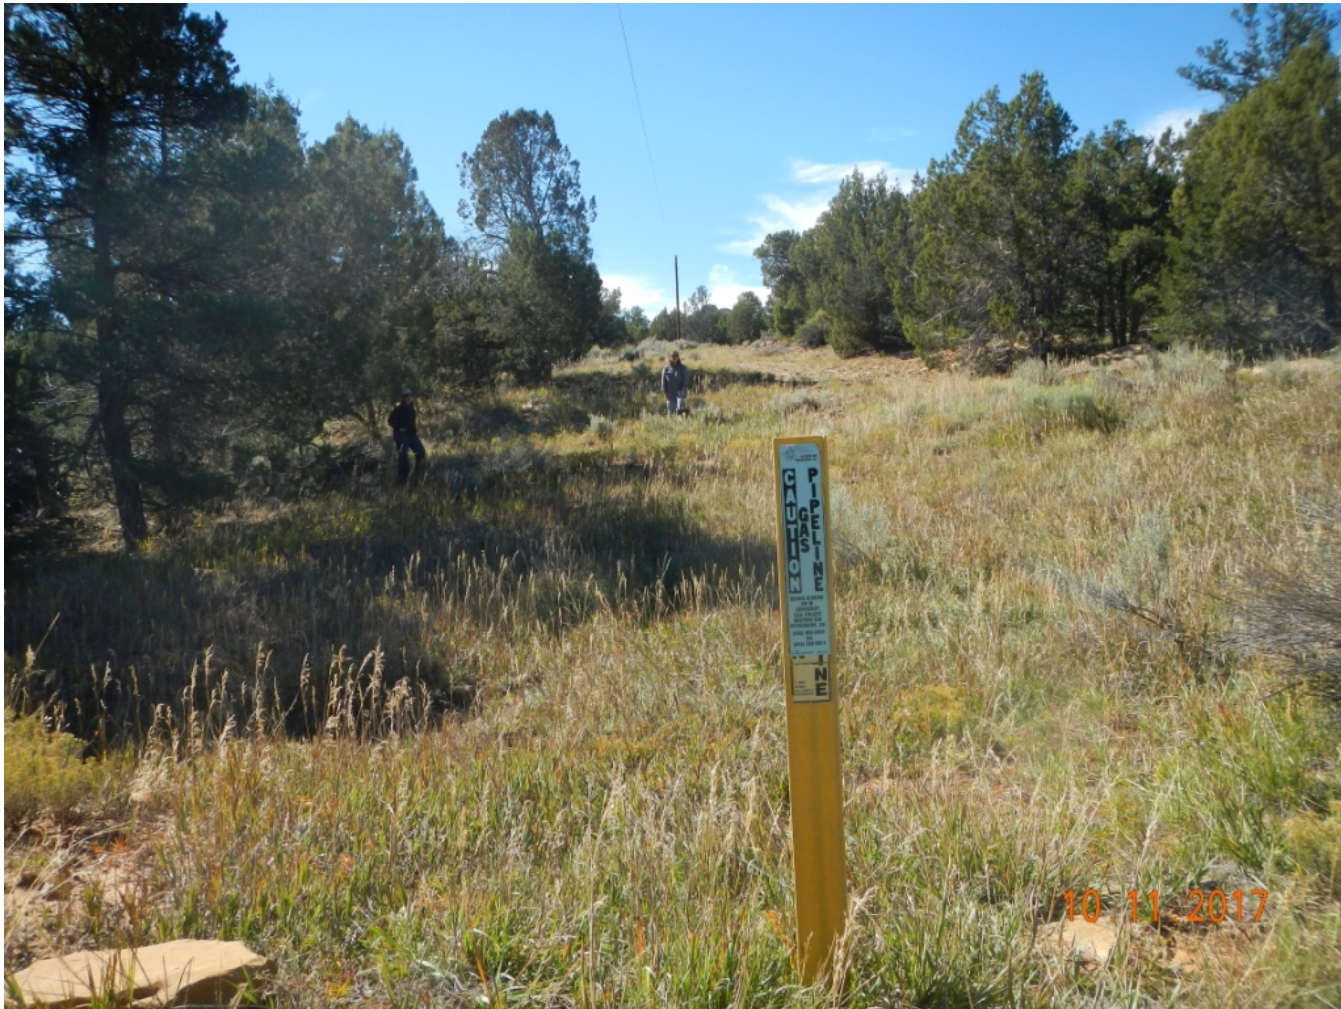
Photo 16. View of pipeline marker south of well pad in foreground. Pipeline riser that needs removal is located where Margaret Ash is in background.

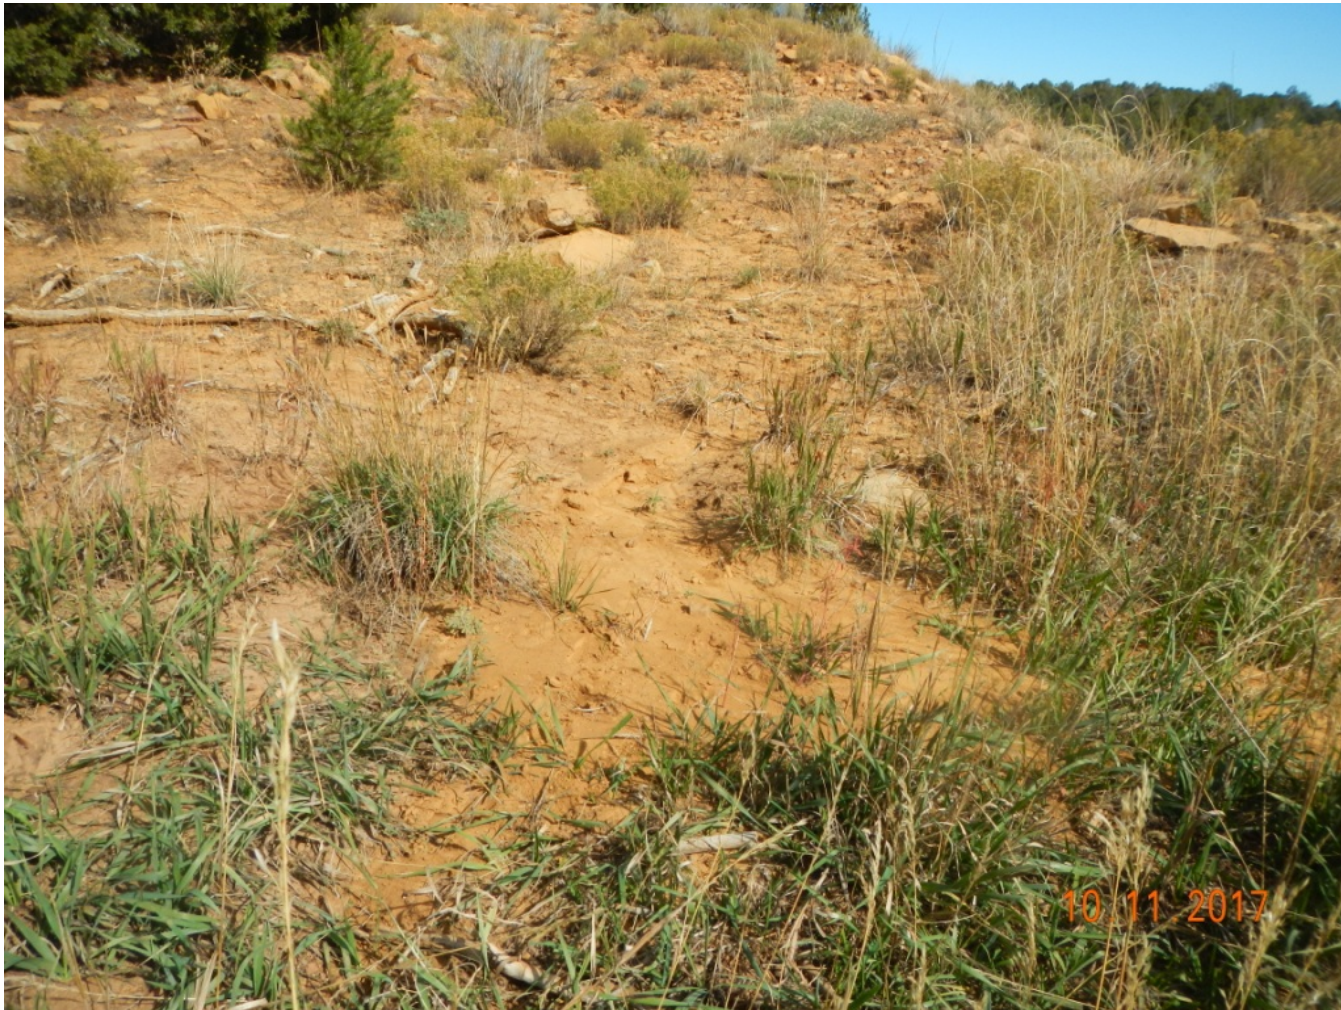
Photo 18. View of sediment deposition where sediment from the cut-slope is eroding into a swale in the southwestern corner of the project area.
