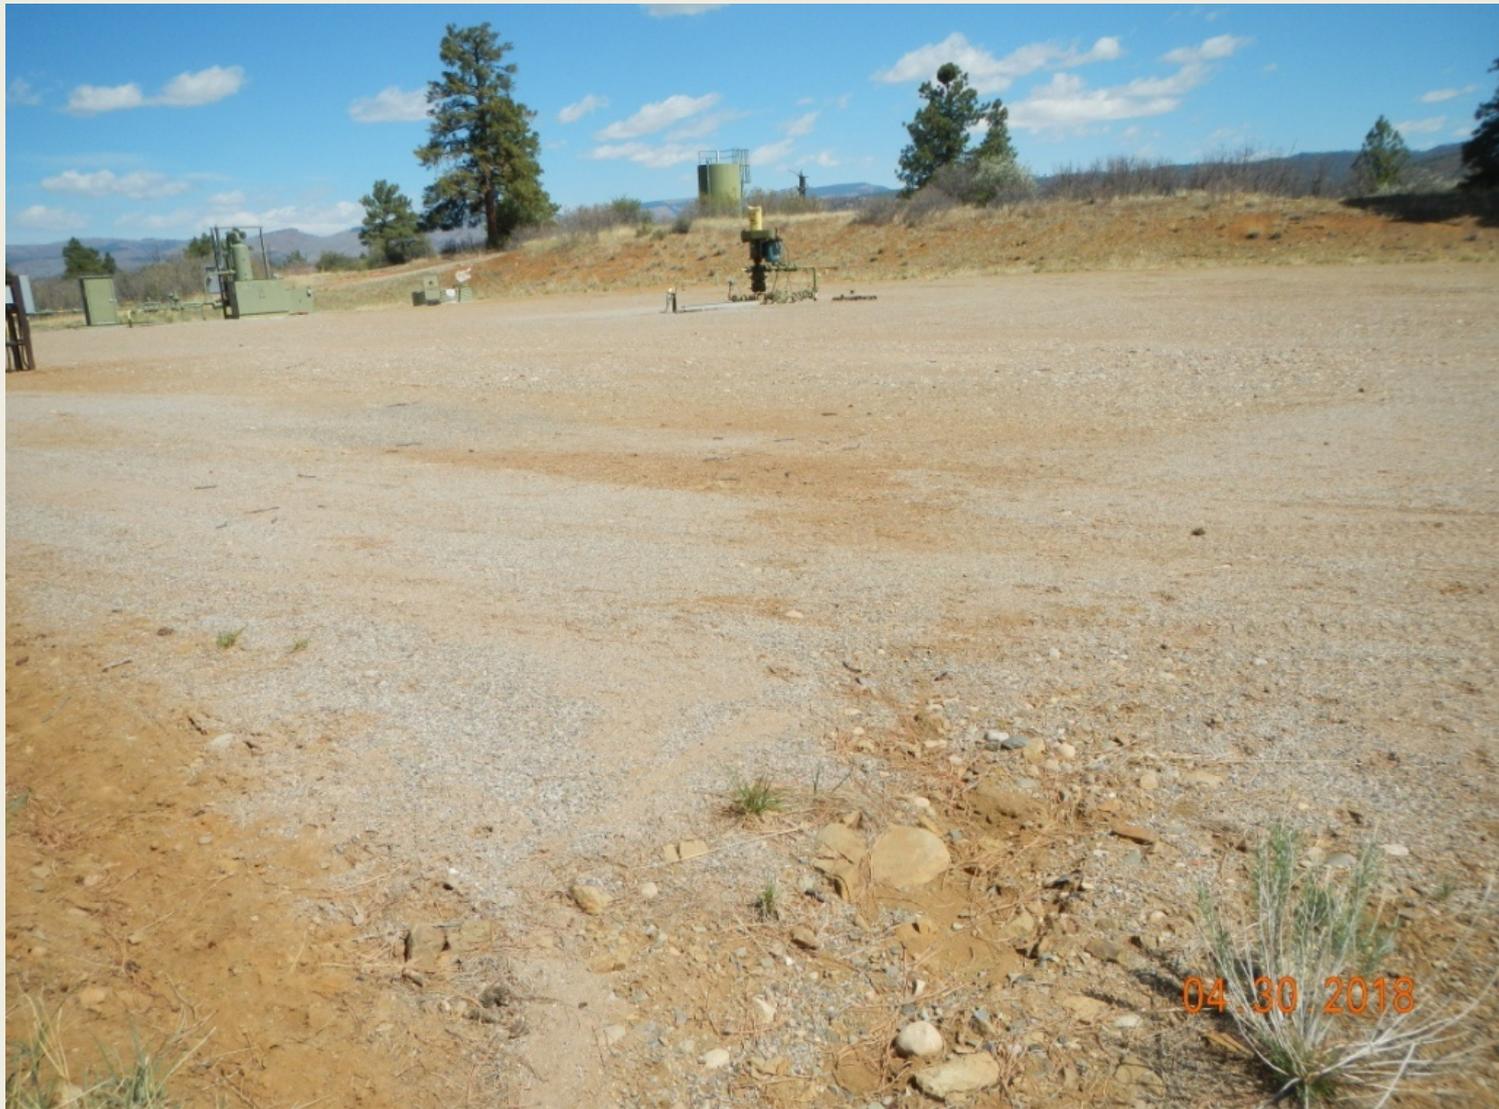
Photo 1. View of the project area from the southeastern corner facing center.

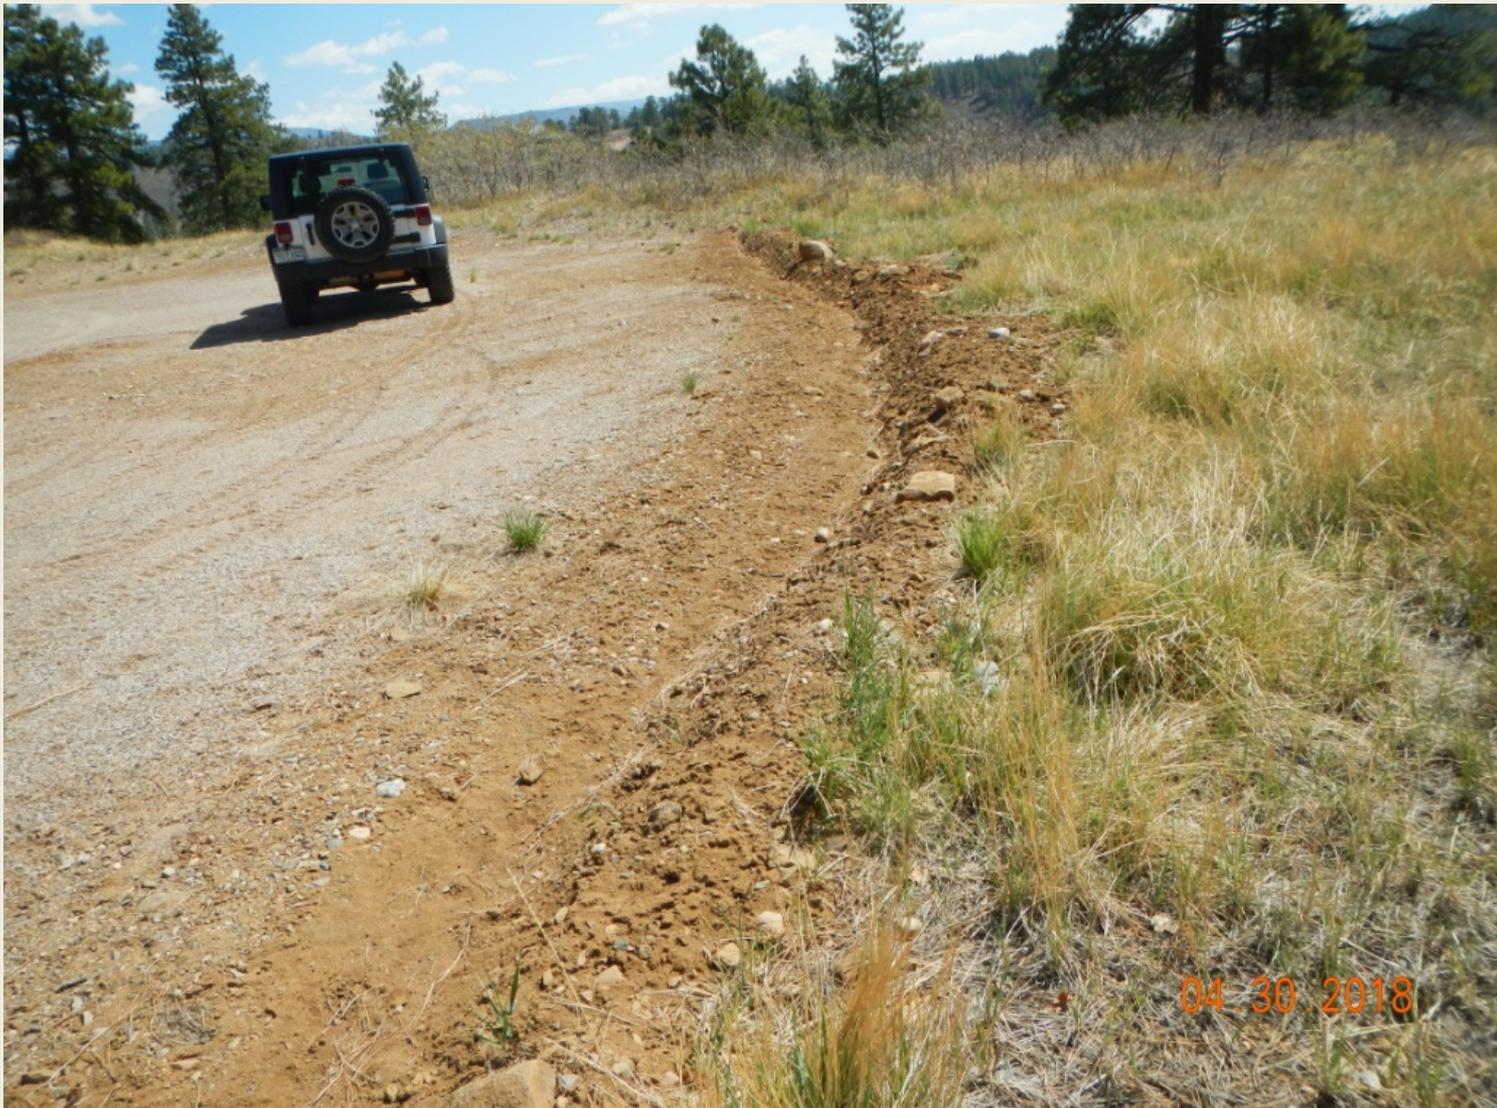
Photo 2. View of area that was recently graded to direct stormwater flows in the southeastern portion of the project area.

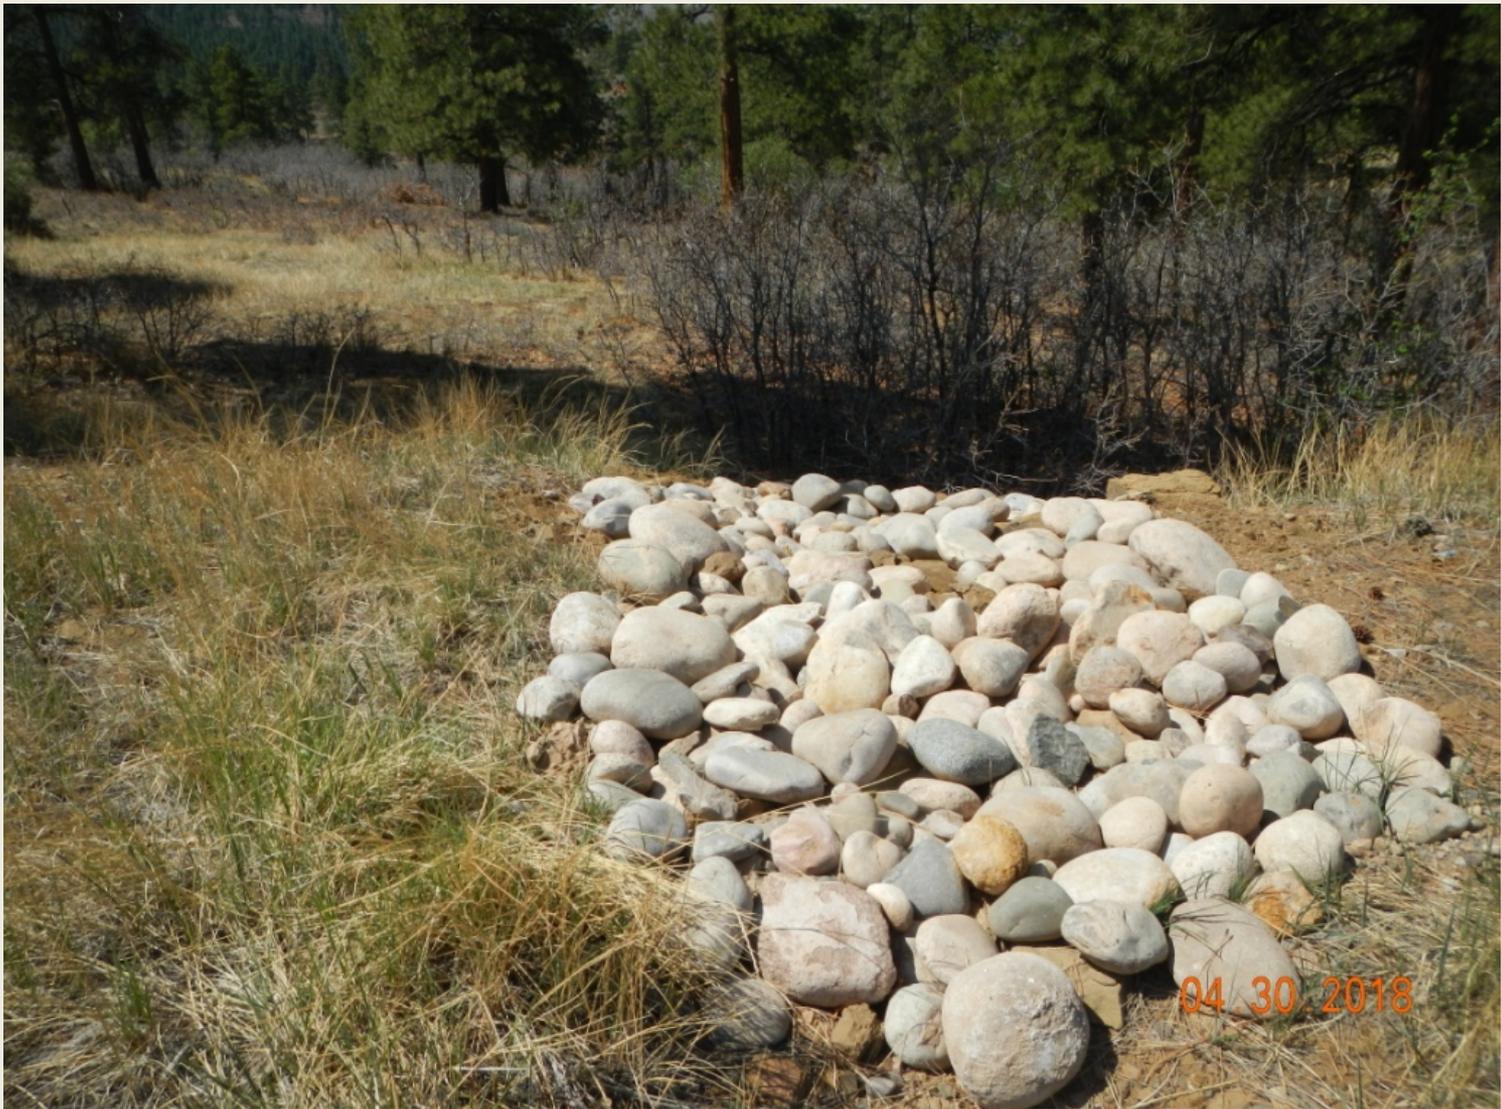
Photo 3. View of cobble run-down in the southern portion of the project area.

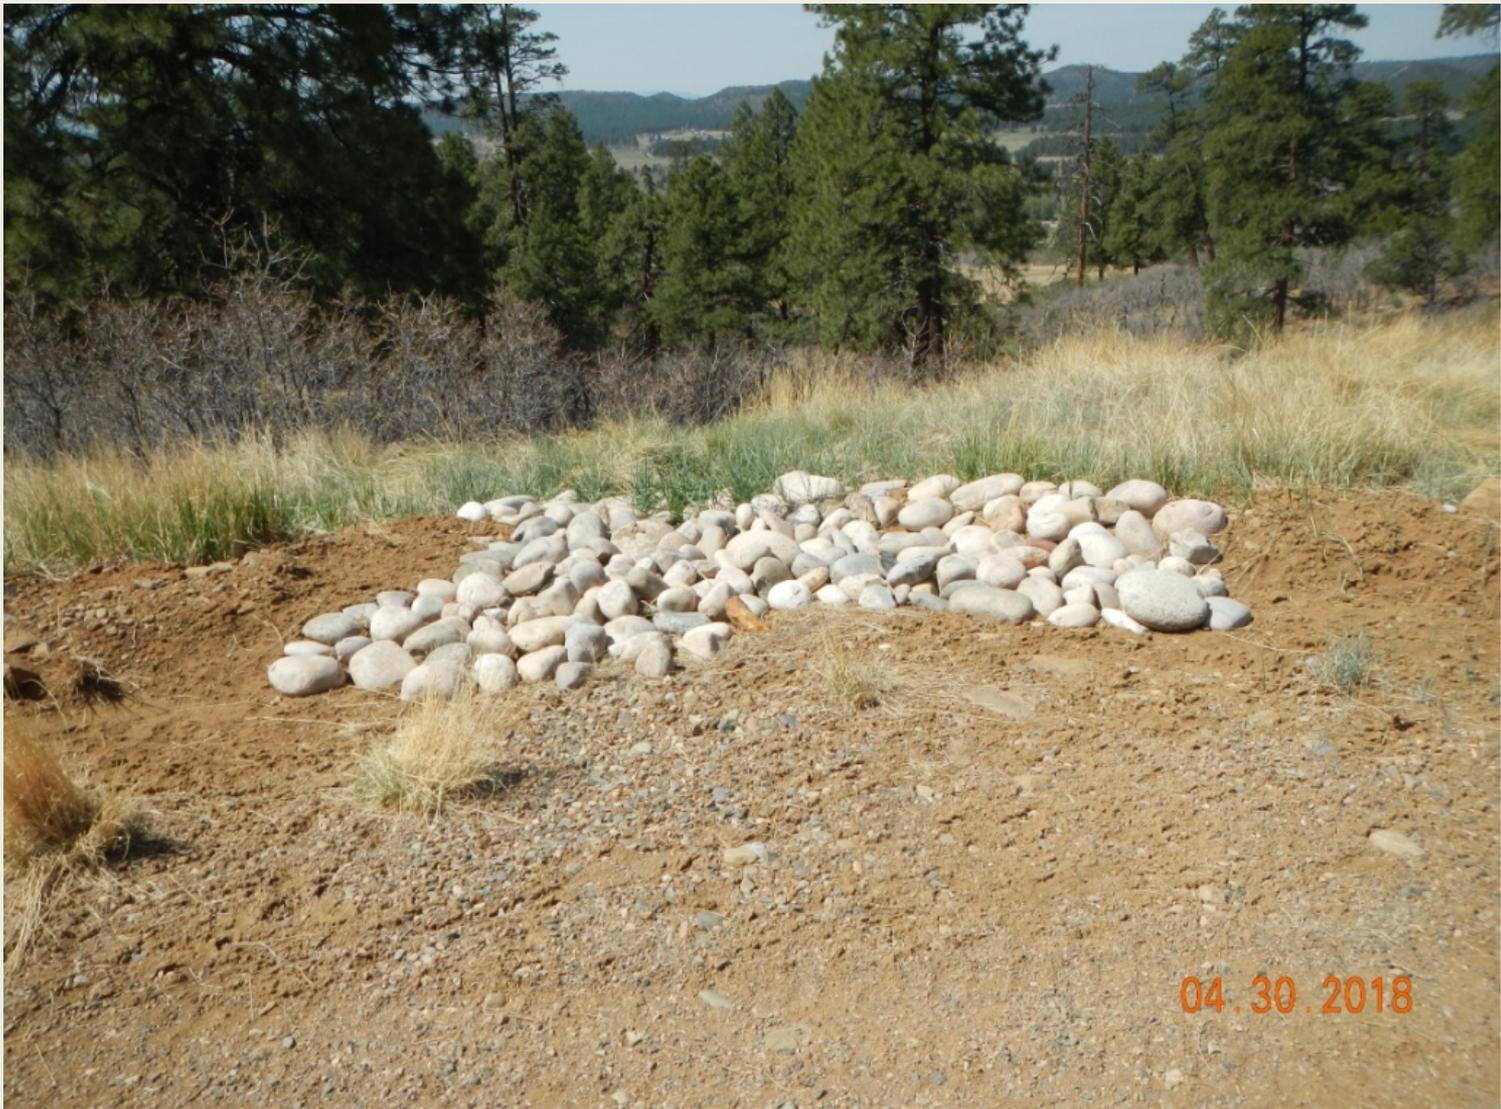
Photo 4. View of another cobble run-down in the southern project area.
