MEMORANDUM

Re: OHWM Assessment of Coal Creek for the Crystal Ruby Well Pad and Access Road in Elbert County, Colorado

Photo Log for the Proposed Crystal Ruby Well Pad and Access Road in Elbert County, Colorado
OHWM Assessment

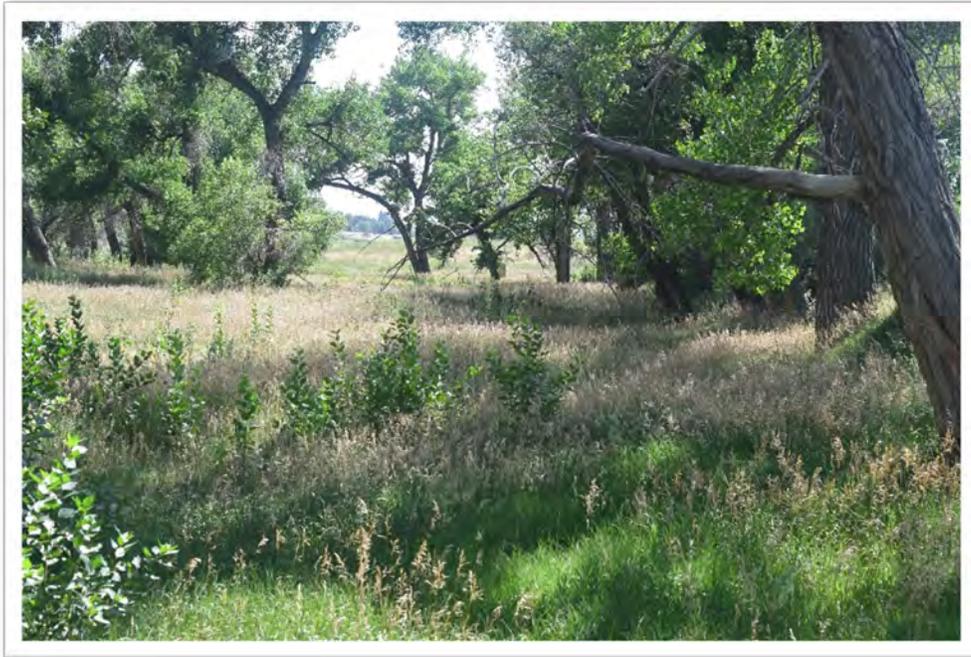
Photo 1. View of northern riparian area. This area does not exhibit destruction of terrestrial vegetation (OHWM indicator).

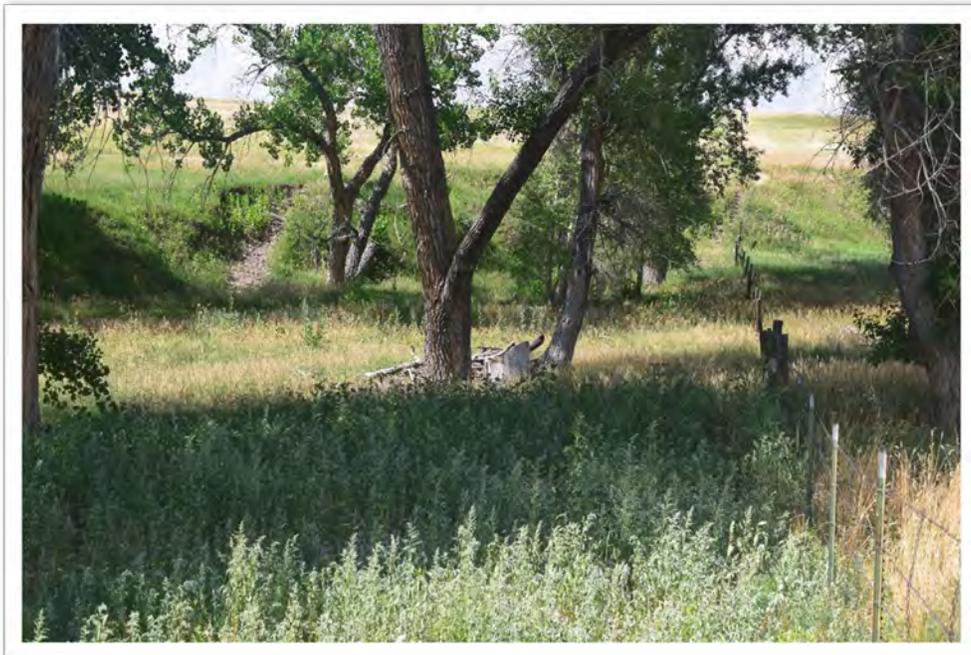
Photo 2. Alternate view of northern riparian area. Area is fully vegetated and does not exhibit matted down, bent, or absent vegetation (OHWM indicator).

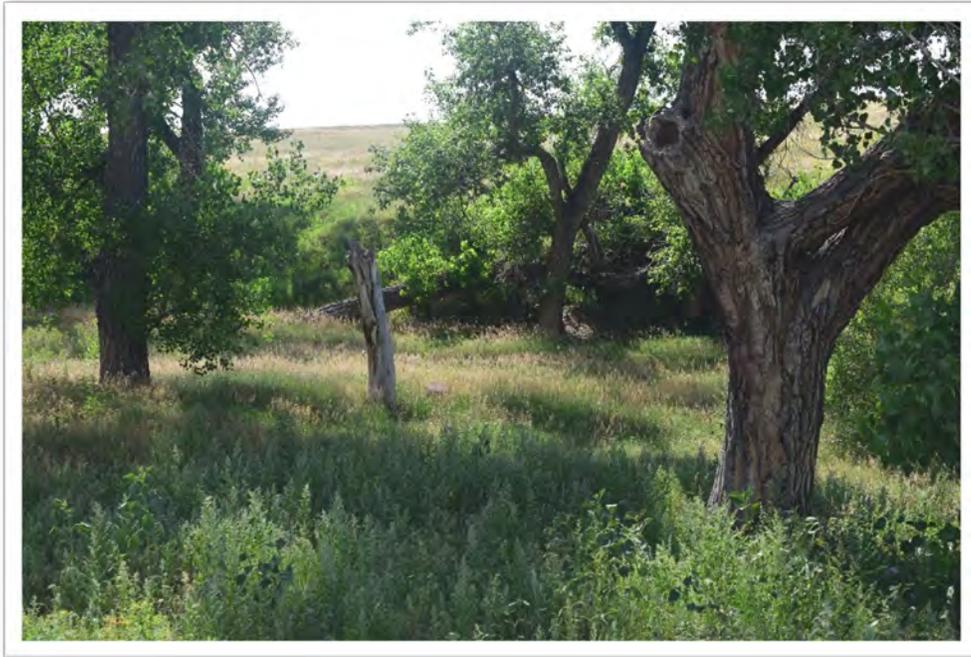
Photo 3. View of northern riparian area facing outside the riparian area. Area does not exhibit water staining on trees (OHWM indicator).

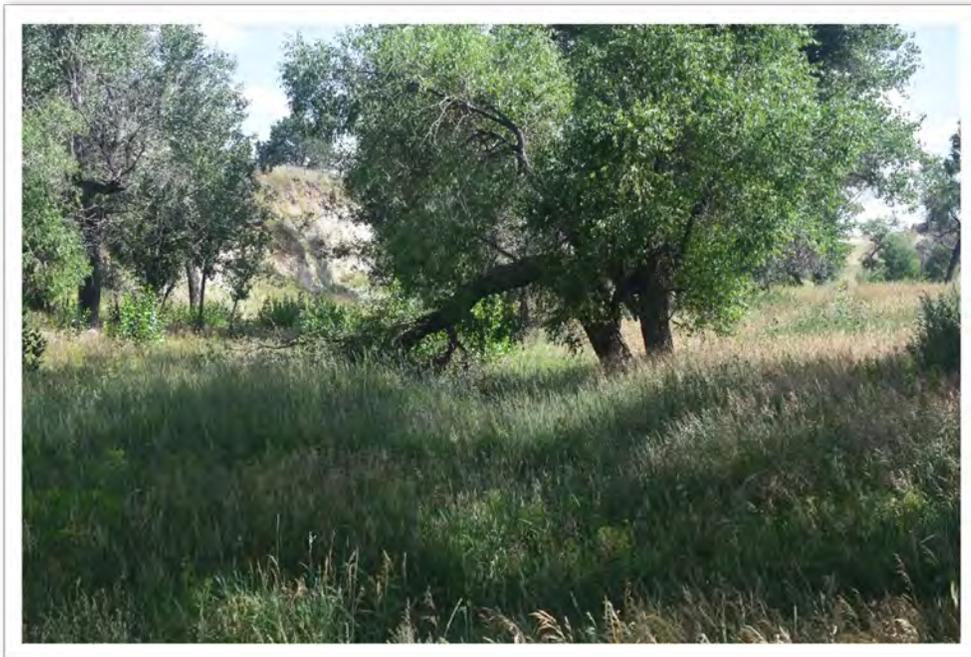
Photo 4. View within the riparian area showing no channel indicators and no evidence of observable flow events (OHWM indicator).

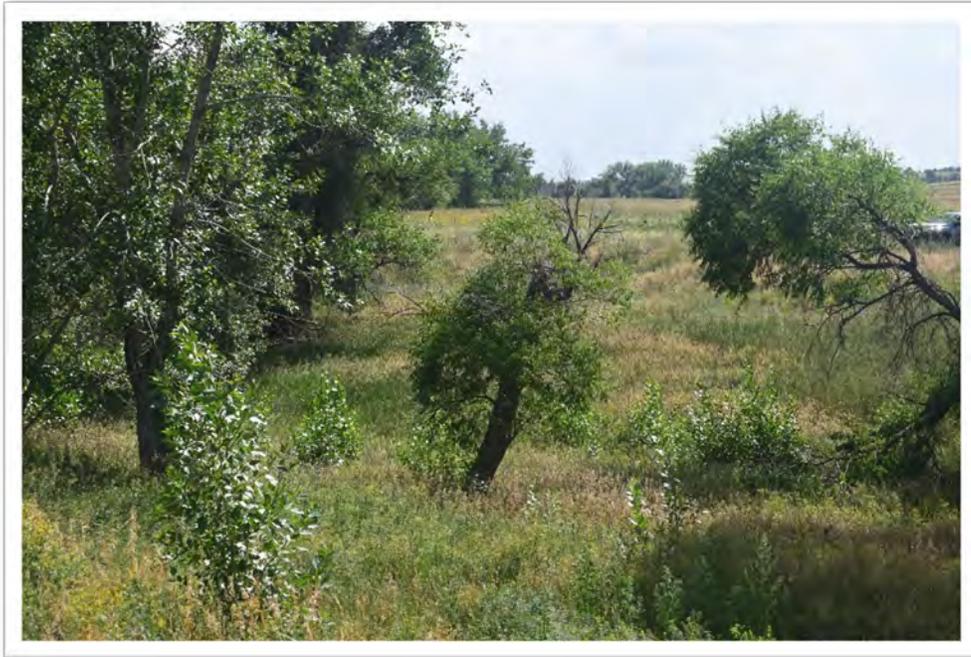
Photo 5. View looking across the riparian area with no channel indicators present. Vegetation community on the terrace exhibits overlap with species in the riparian area.

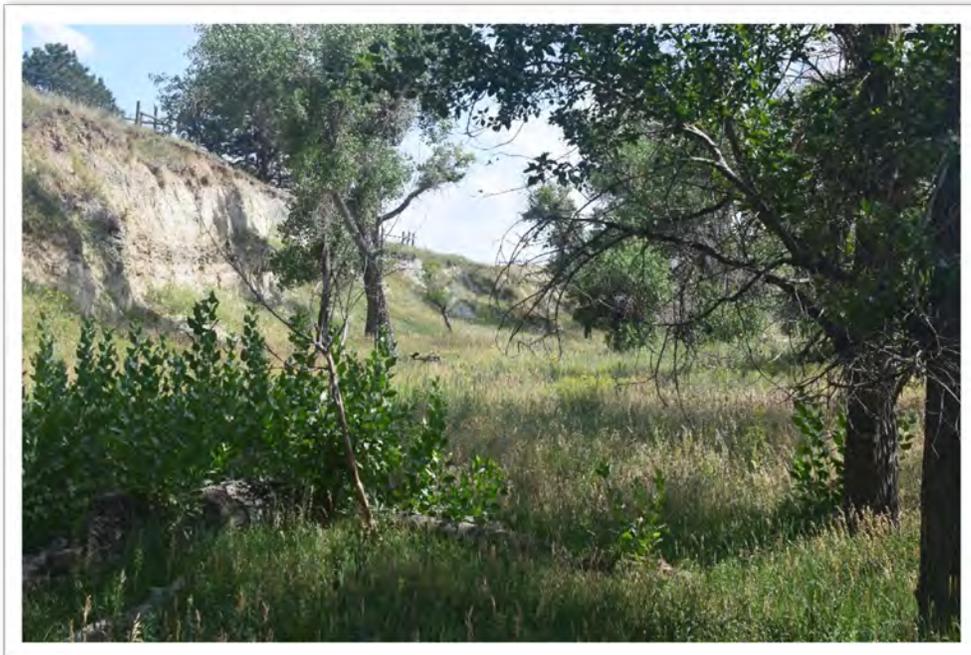
Photo 6. View along the eastern terrace with no channel indicators including bed and bank (OHWM indicator).

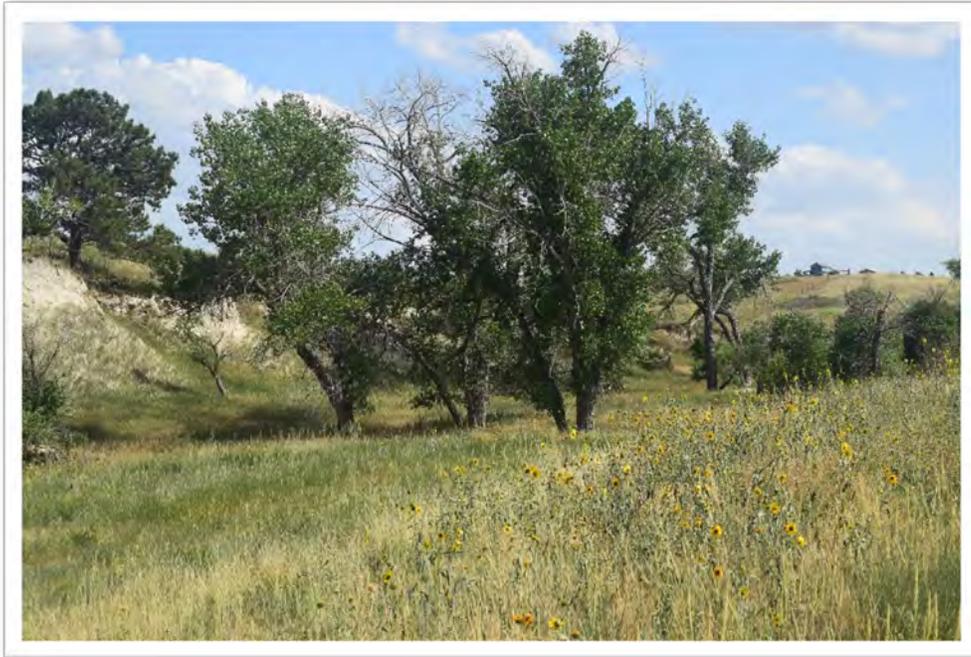
Photo 7. View looking into the riparian area with no destruction of terrestrial vegetation.

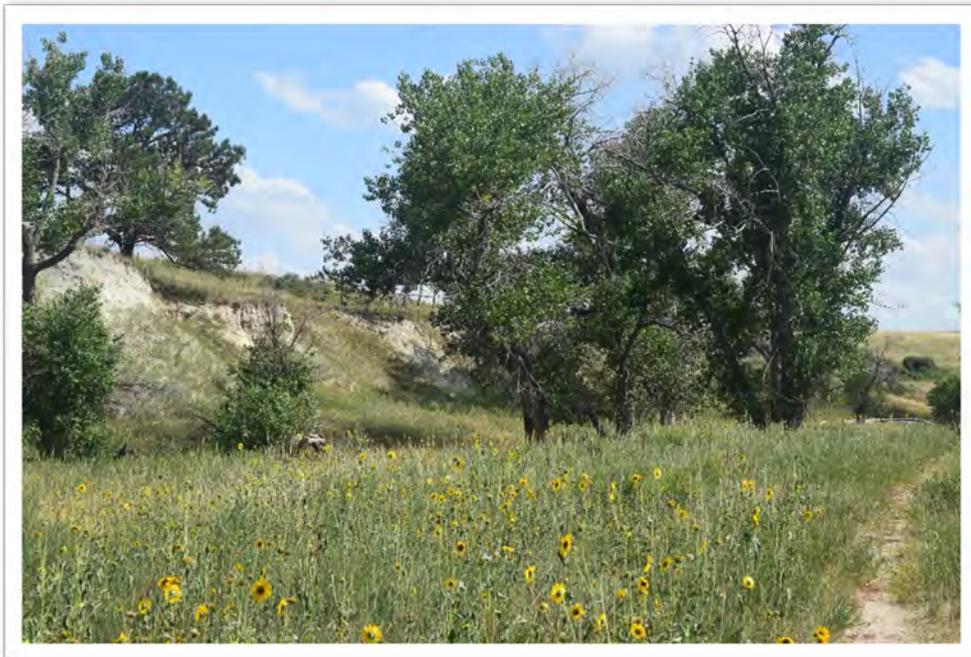
Photo 8. View of edge of two-track road within riparian corridor. No channel indicators present.

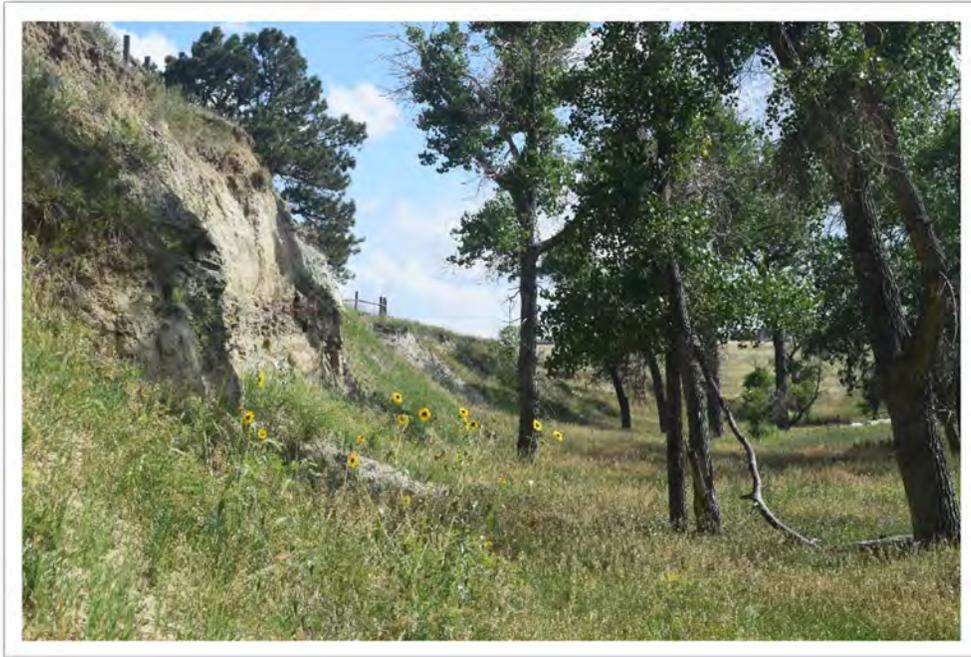
Photo 9. View of eastern terrace and upland vegetation community within the riparian area. Dominant grass species in the riparian area (smooth brome) also dominant on top of the terrace.

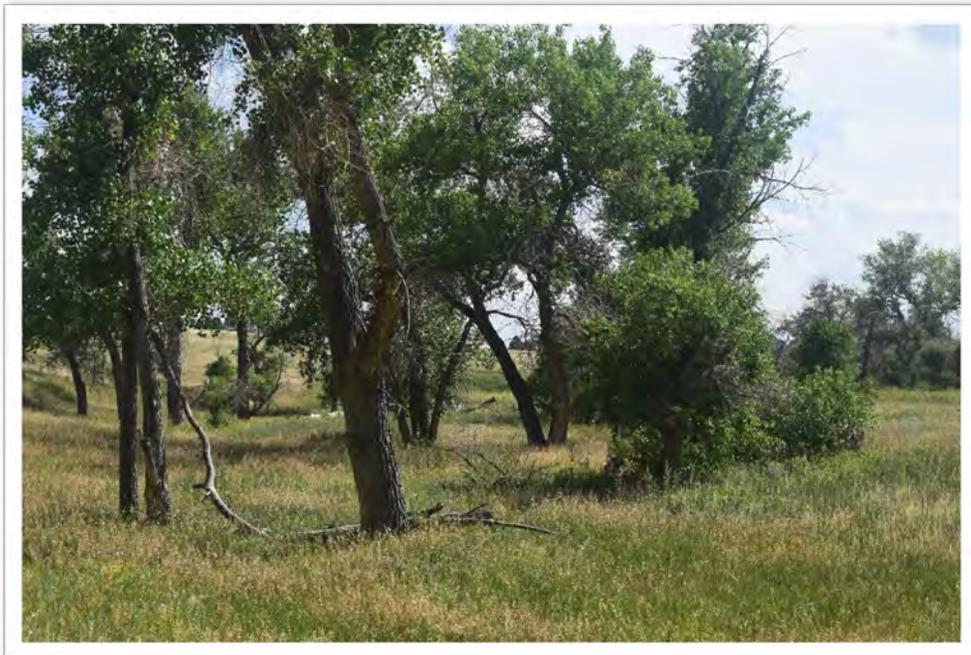
Photo 10. View of smooth brome understory within the riparian corridor. No water staining present on trees within the riparian corridor.

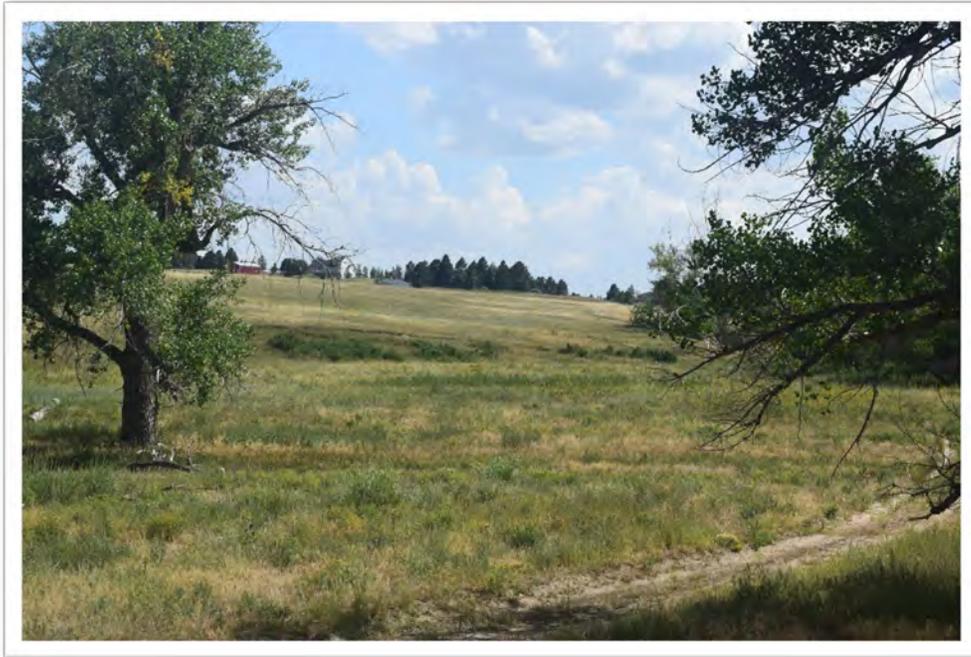
Photo 11. View of two-track road within the riparian corridor. Area lacks OHWM indicators.

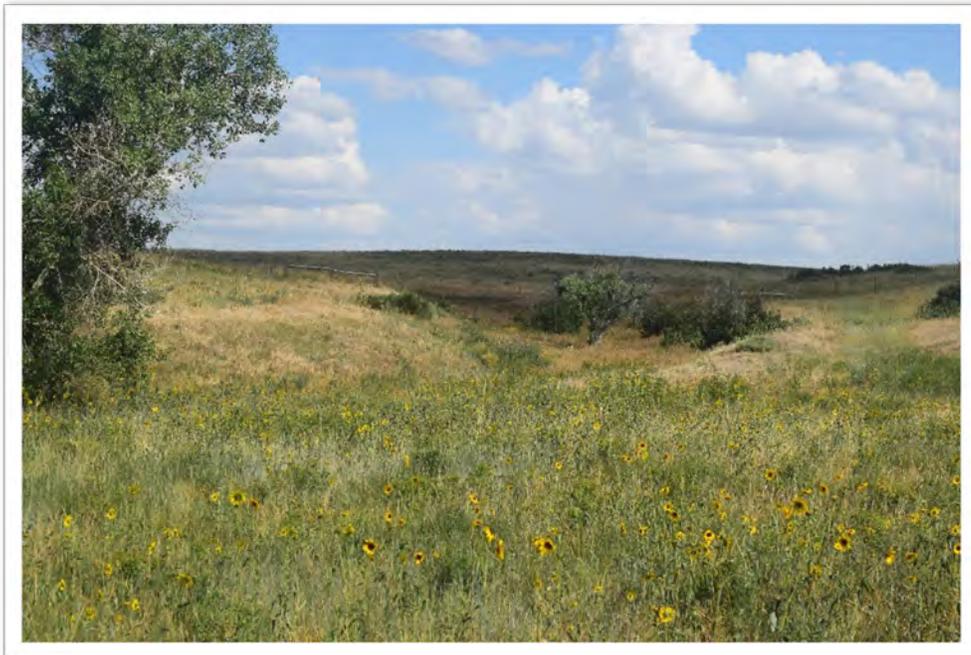
Photo 12. View in the southern portion of the site showing a fully vegetated riparian corridor with no OHWM indicators.

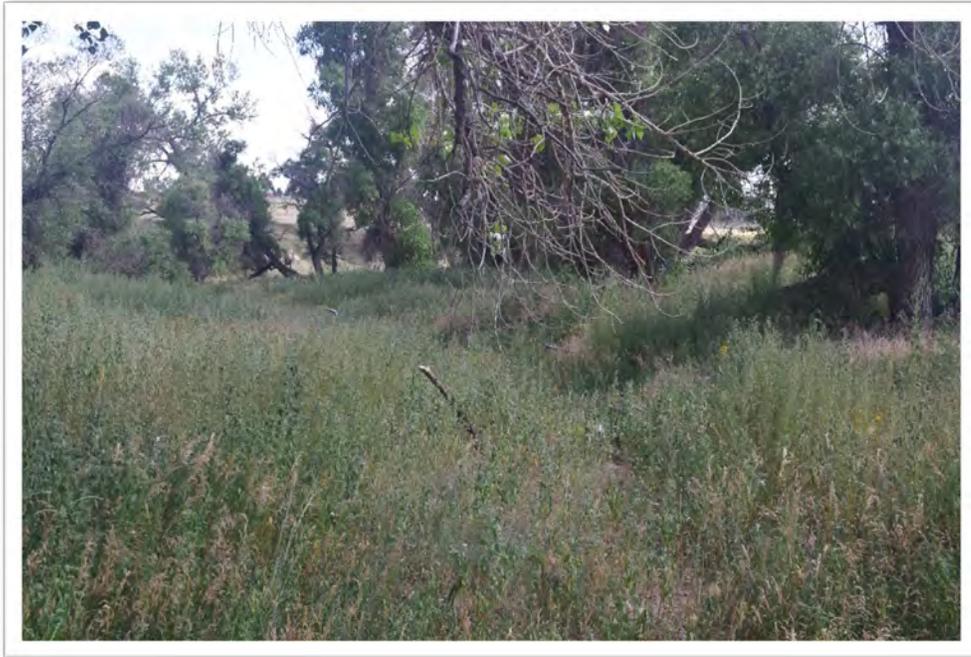
Photo 13. View within the riparian corridor showing robust vegetation cover with no matted down or bent individual's indicative of recent flow.

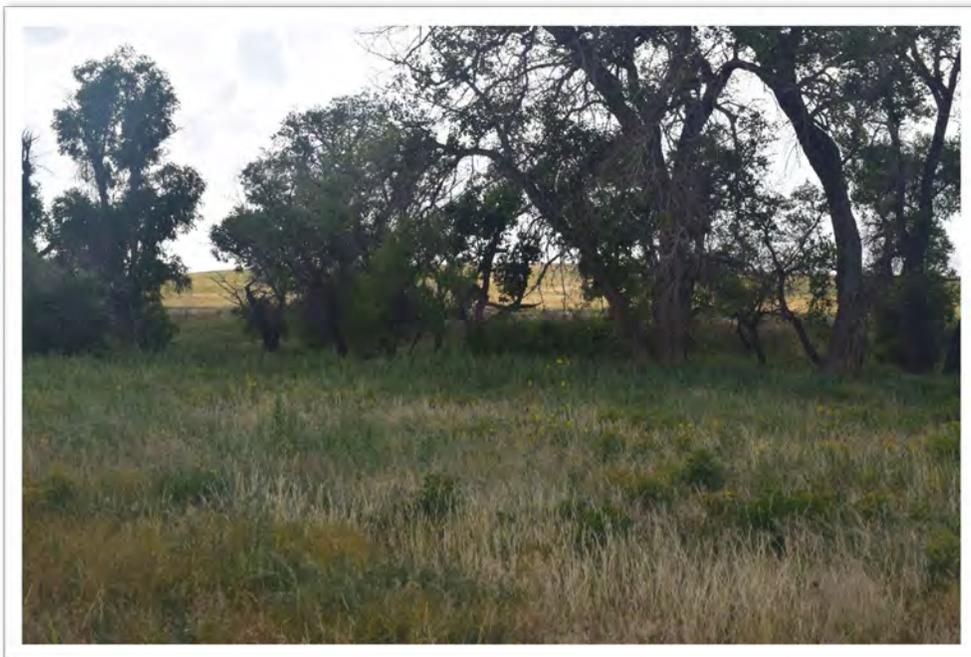
Photo 14. View within the riparian corridor showing full vegetation cover and a lack of OHWM indicators.

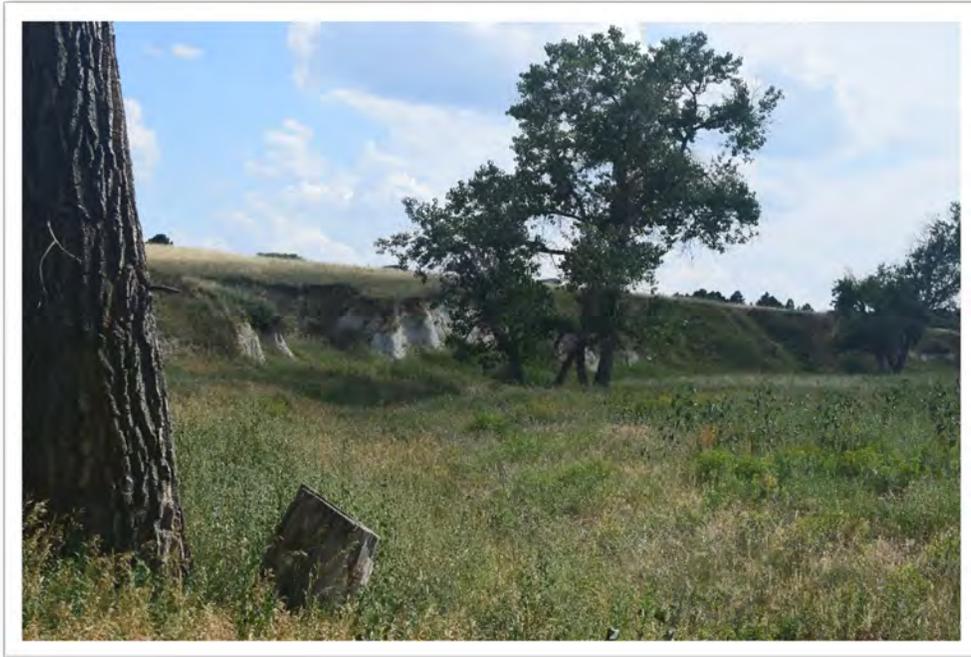
Photo 15. Eastern terrace and a fully vegetated riparian corridor lacking bed and banks.

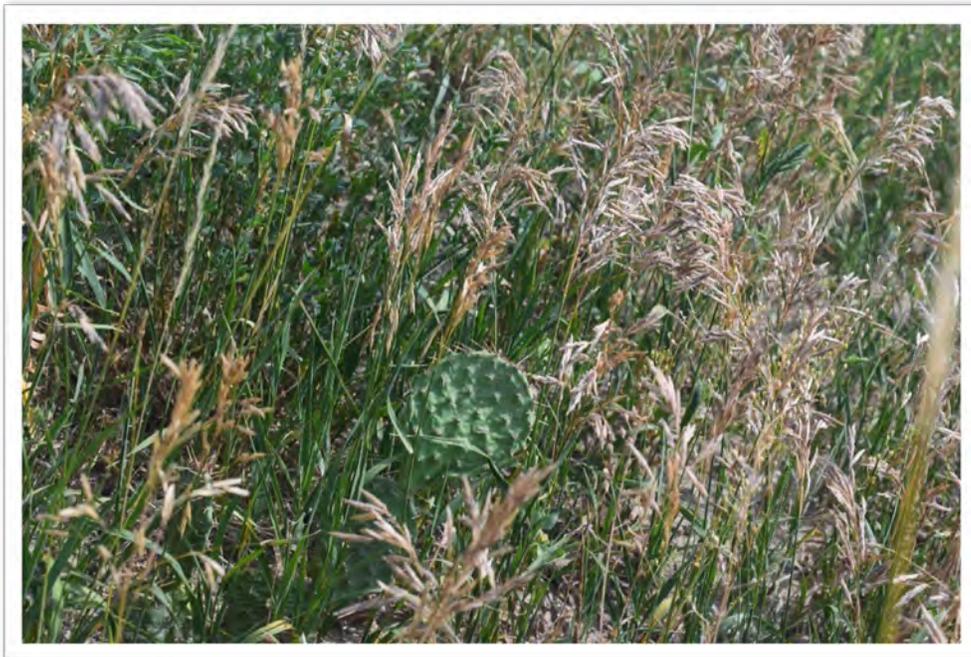
Photo 16. Up-close photo of upland vegetation within the riparian corridor including prickly pear cactus and smooth brome.

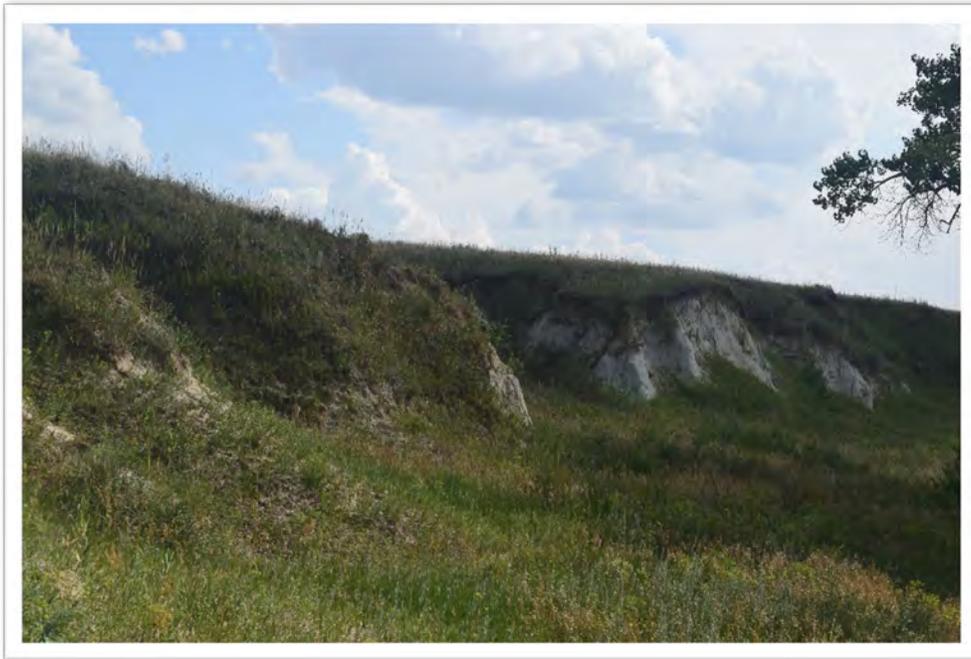
Photo 17. View of fully vegetated terrace with an upland vegetation community extending down into the riparian area.

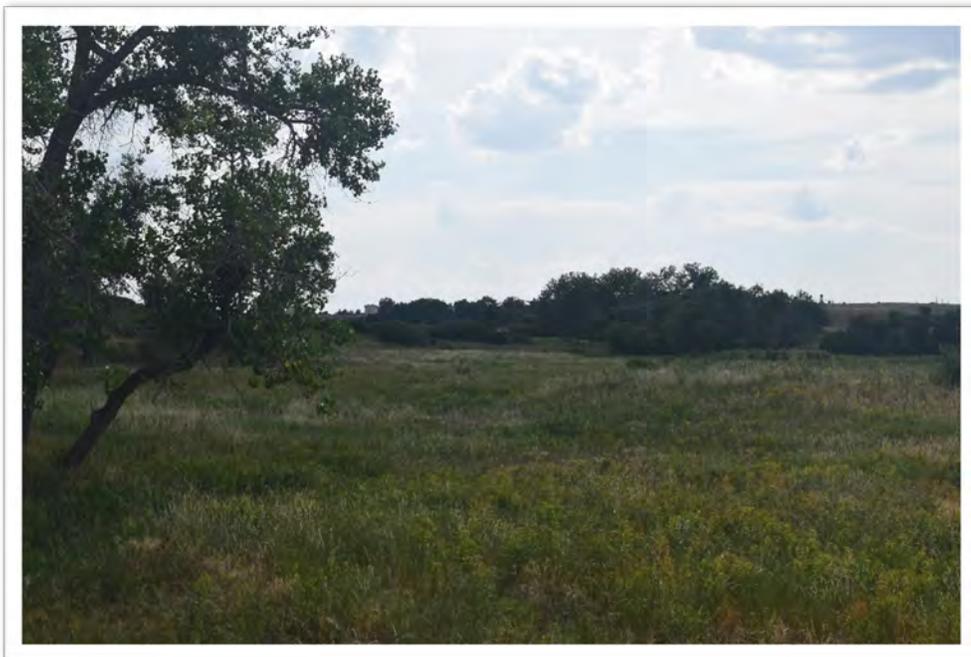
Photo 18. Alternative view of fully vegetated riparian corridor lacking bed and banks.

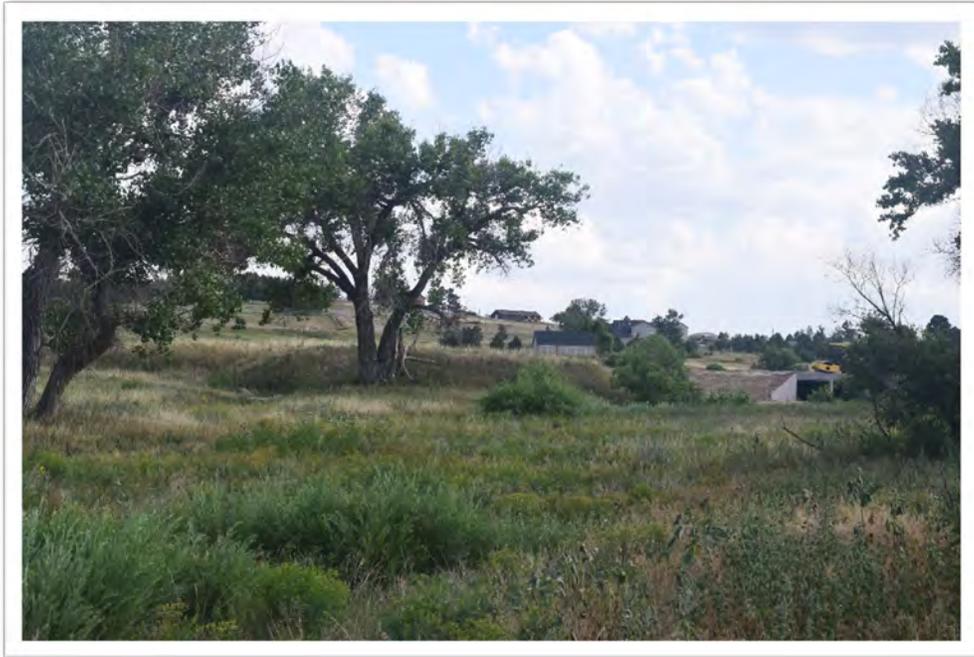
Photo 19. View of southern part of the site facing the County Road construction. Area is fully vegetated and lacking bed and bank characteristics.

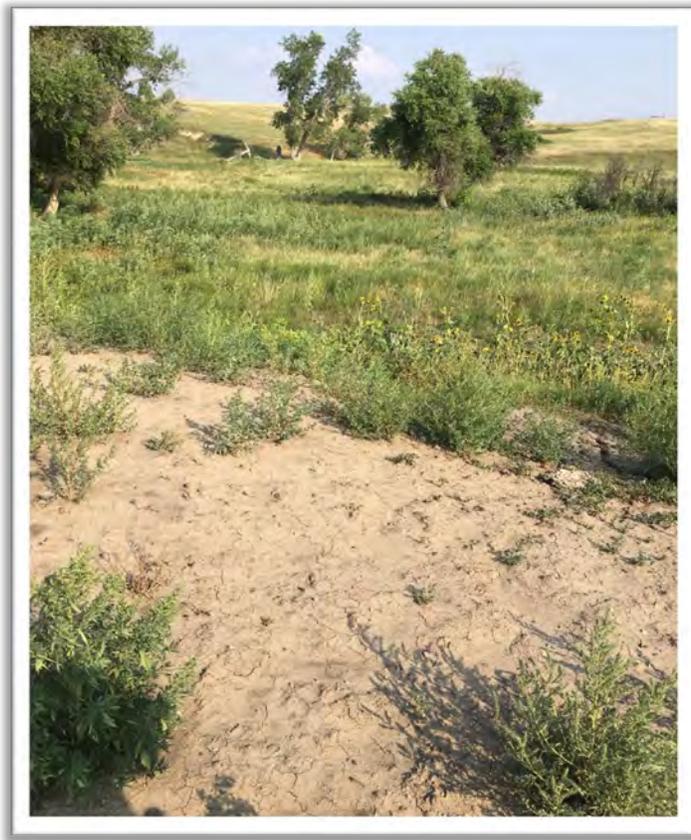
Photo 20. Example of one of two bare areas, where cattle likely wallow or contribute to loss of vegetation.
