Inspection Photos

API: 071-08730

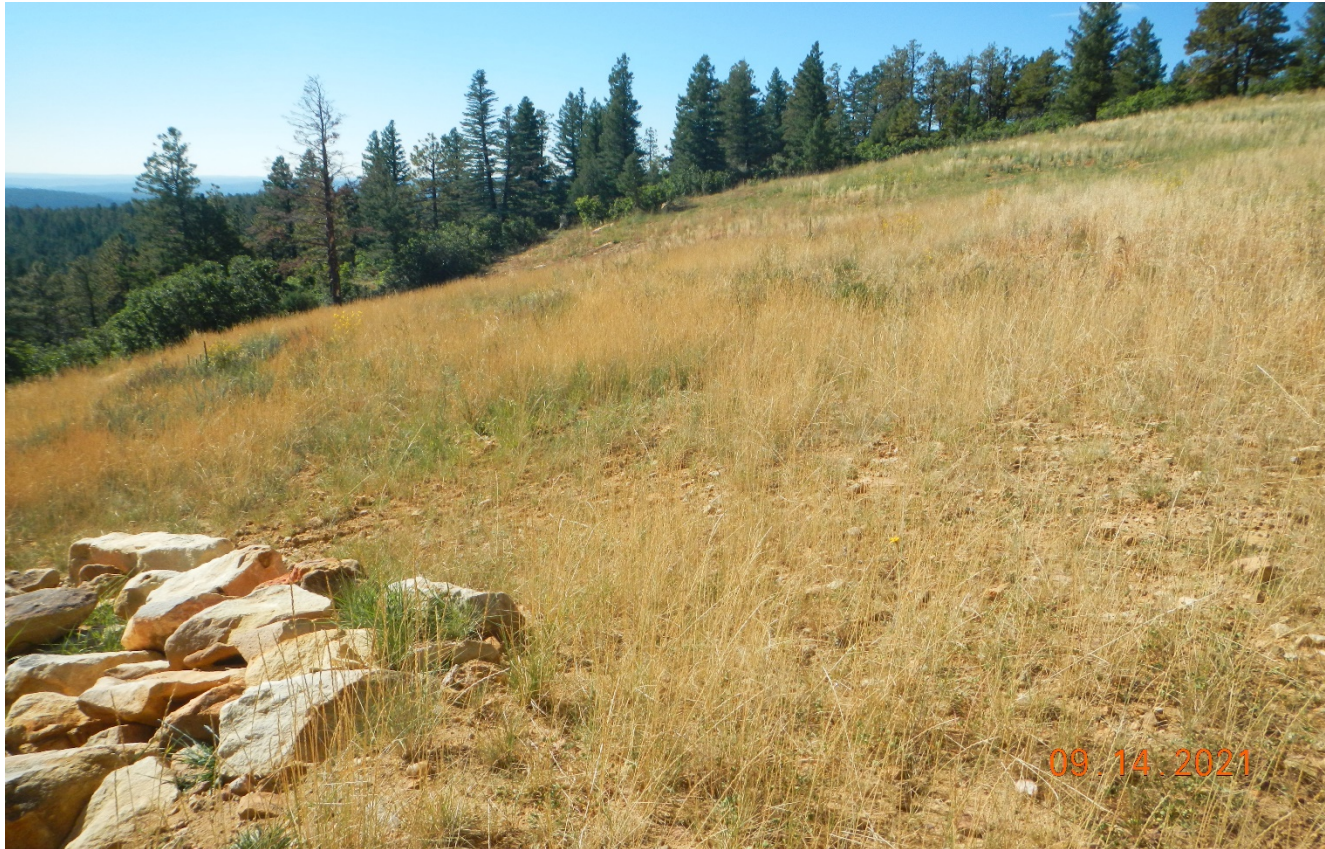
Photo 2. Facing south toward the lower portion on the location. The vegetation is progressing well for first year growth. Some of the vegetation is a cover crop of oats and other perennials were observed.
