Inspection Photos
Location Name: UPRR-Sanden-EHN 1-19
Location ID: 319648

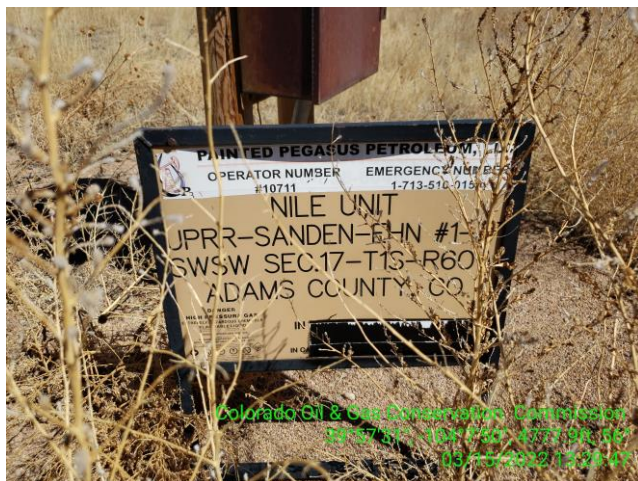
Photo 1 WH sign

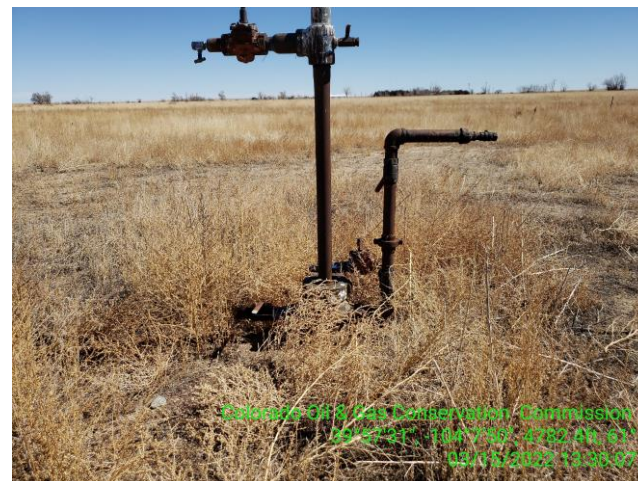
Photo 2 WH

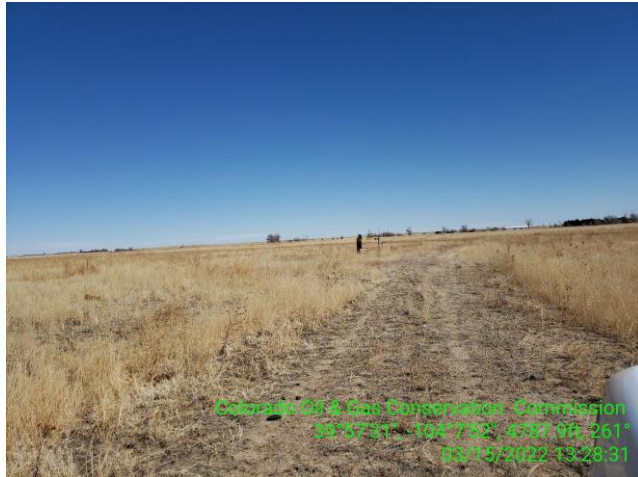
Photo 3 location

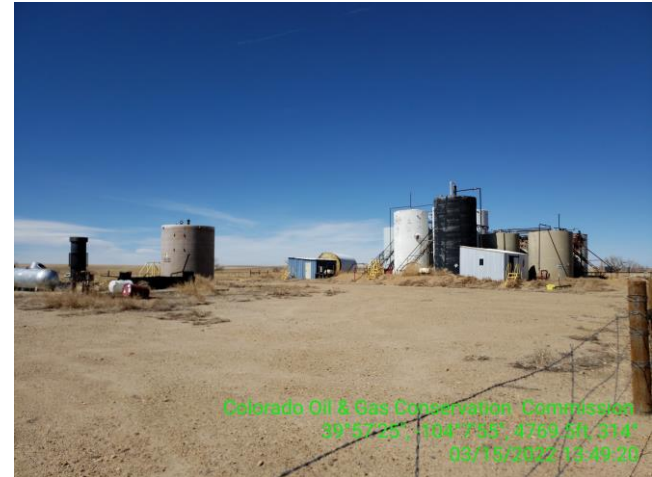
Photo 4 TB location SW of wellsite

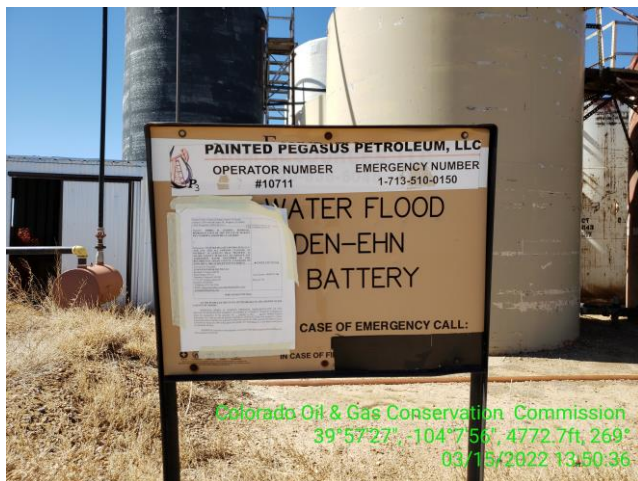
Photo 5 TB sign

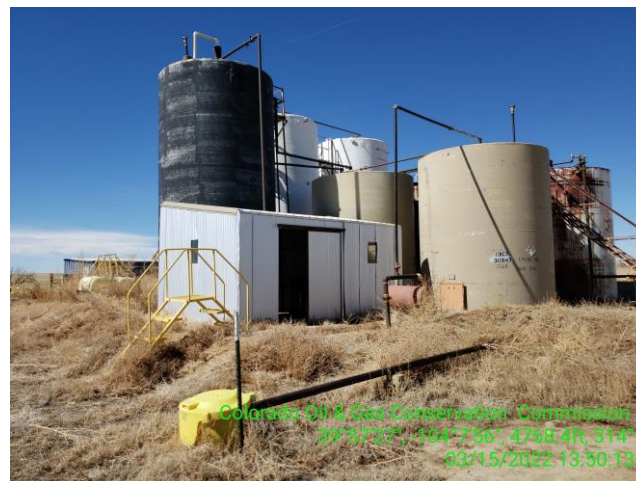
Photo 6 TB

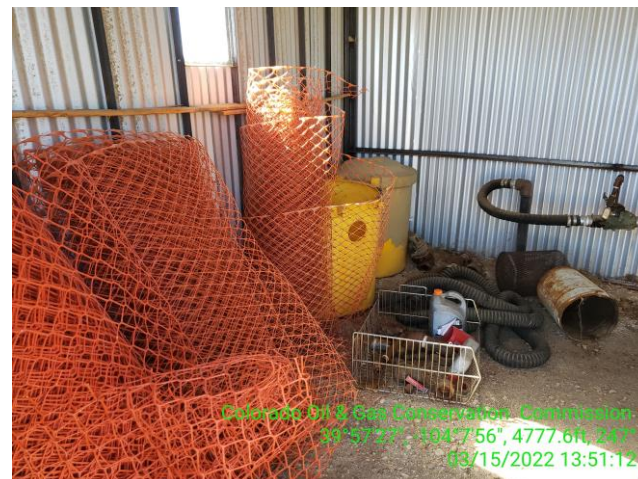
Photo 8 Misc. parts, trash in out building on ES of location

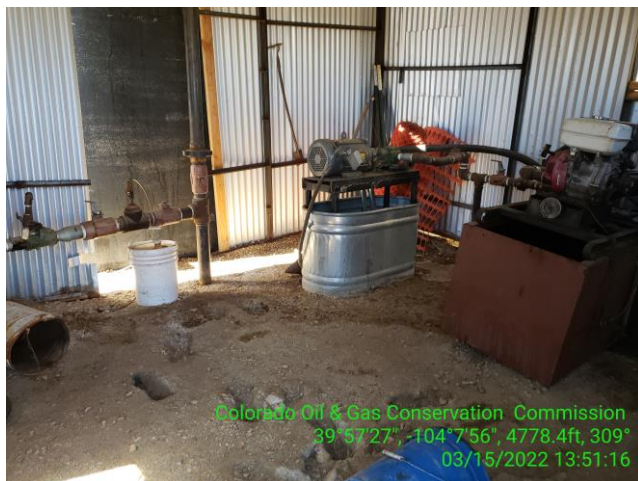
Photo 9 Misc. parts, trash in out building on ES of location

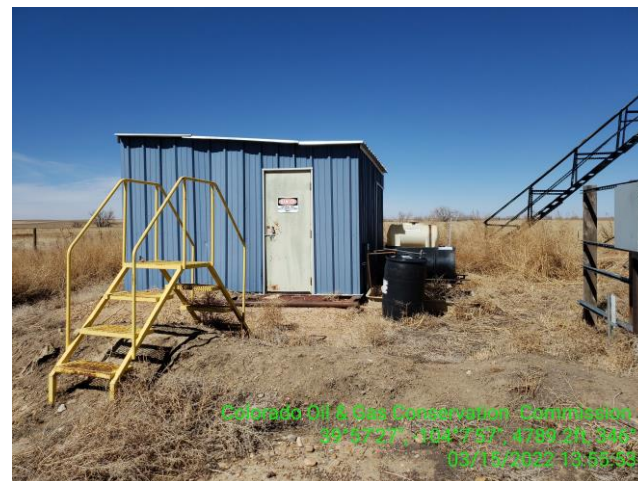
Photo 10 Out building on WS of location

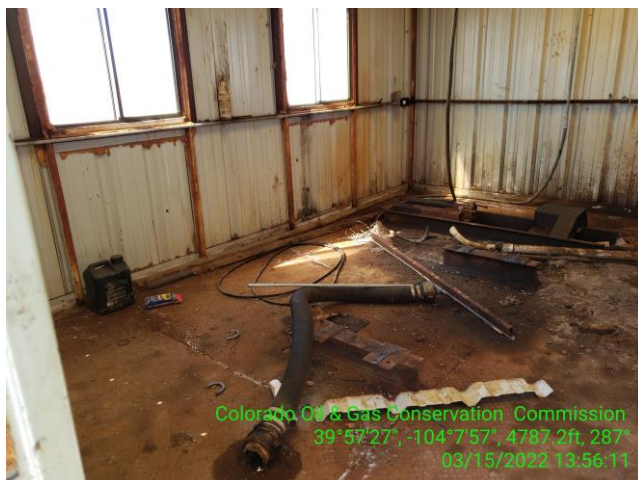
Photo 11 Misc. parts, trash in out building on WS of location

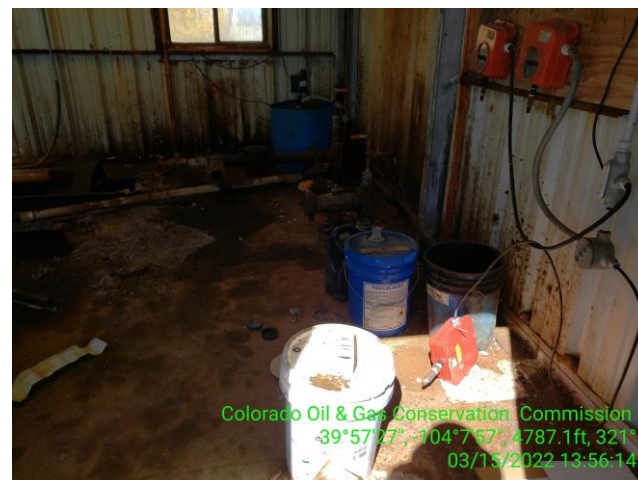
Photo 12 Misc. parts, trash in Out building on WS of location

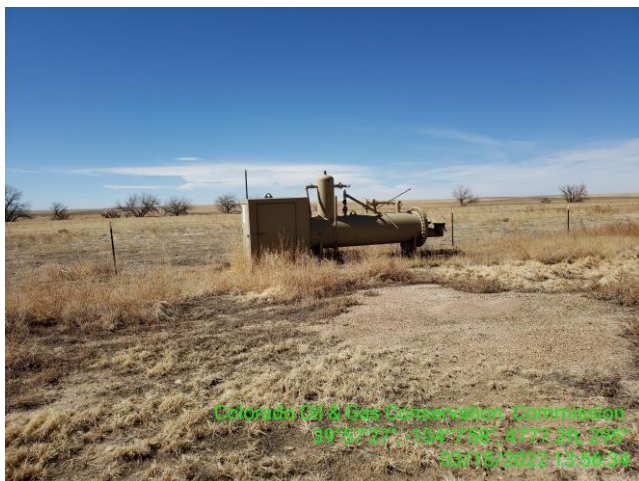
Photo 13 unused Horiz. Heated Separator

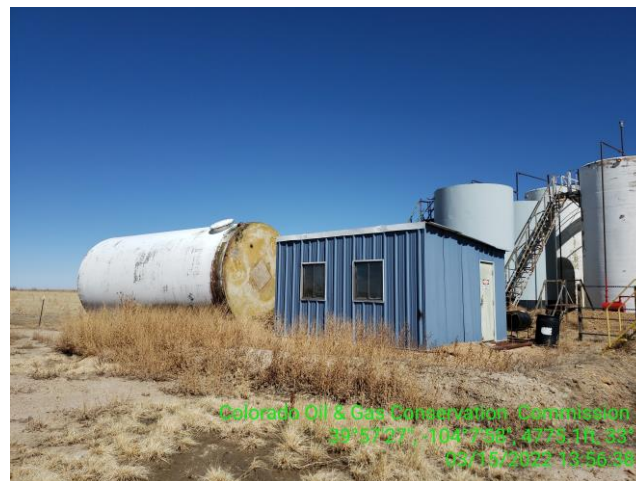
Photo 14 TB location

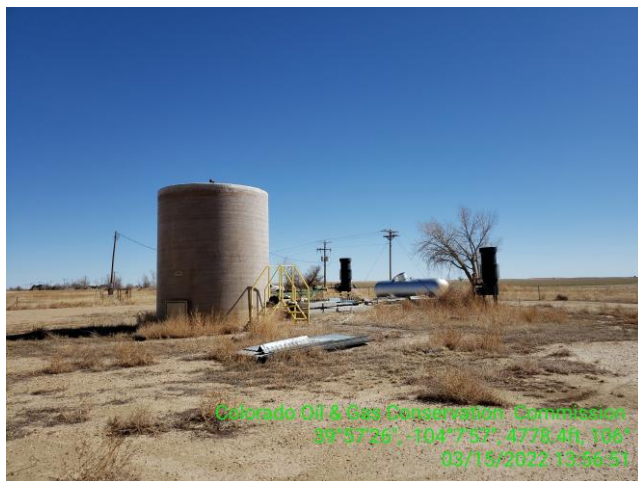
Photo 15 TB Location

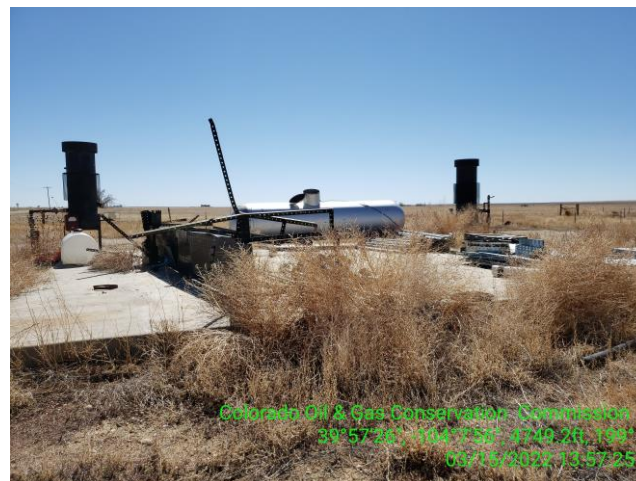
Photo 16 TB location
