HARAMBE 2920 PAD GEOLOGIC HAZARD MAP

Geologic Hazards Summary for Harambe 2920

Location: S ½ S ½ Section 32, T2N-R64W 6th P.M.

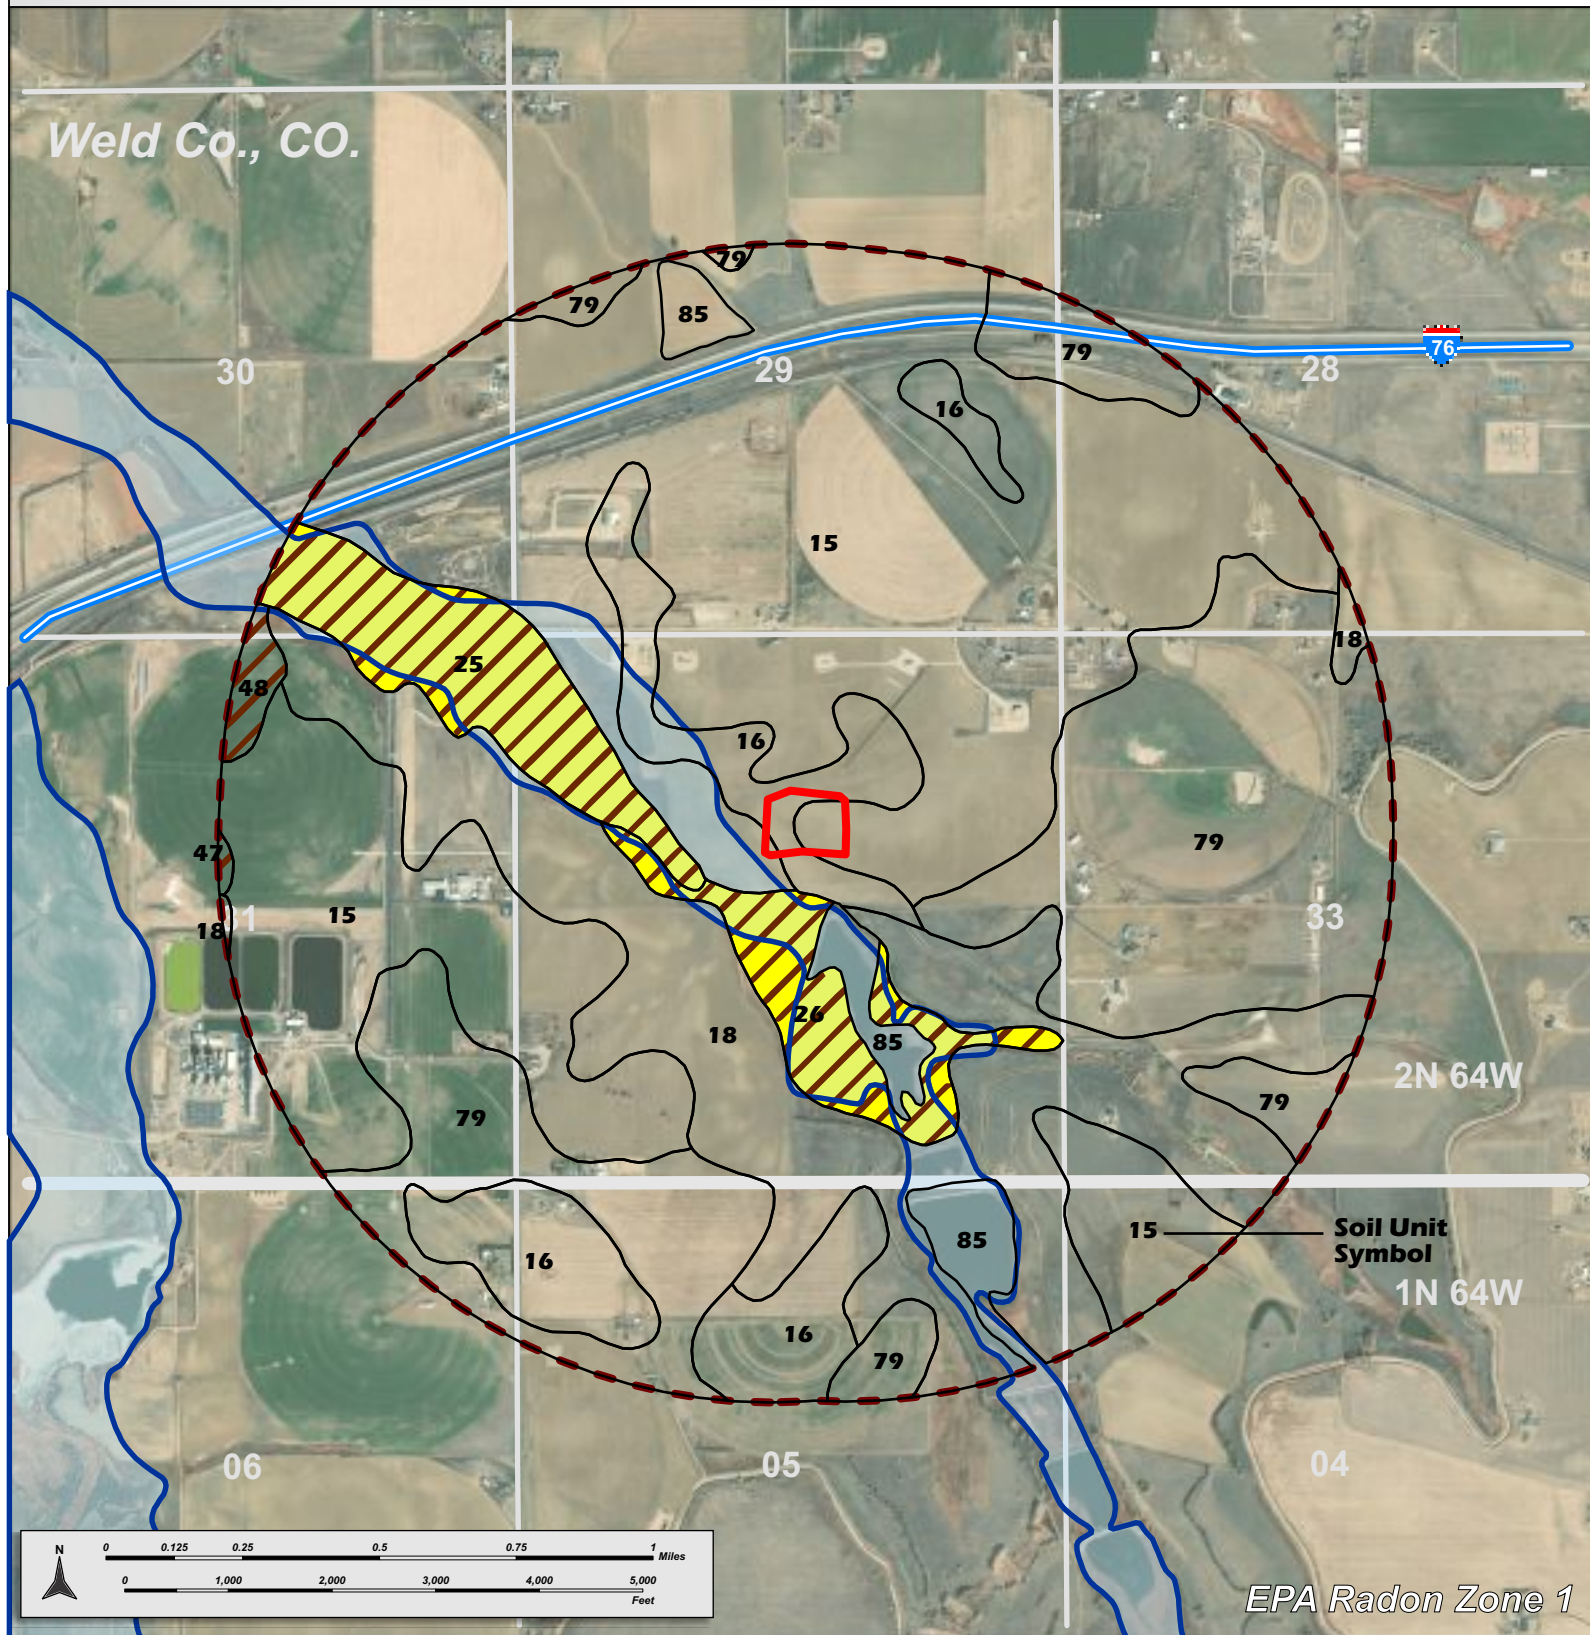
Based on this review of available geologic data comprised of experience, measurements, and published reports, I determine that hazards present within 1 mile of the proposed location are soil corrosion of concrete [1], soil corrosion of steel [1], 100-year flood plain [3], and Radon (NORM) [4]. Other examined, but absent hazards are landslides [1,2], expansive soils [1], NORM & TENORM [5], induced seismicity [6], natural rate seismicity [7], and coal mine subsidence [8]. A map summary of these findings is attached.

Corrosion to concrete is identified as a potential hazard near the proposed location. The concrete on location will serve as a combustor base. Considering the soil composition, and Verdad's facility design and management, I determine the soil corrosion to concrete hazard is insignificant.

Corrosion to Steel is identified as a potential hazard. No steel at the proposed location will be exposed to the soil because 1) all steel equipment on location will have impervious liners, and steel flowlines will have protective lining, and 2) imported gravel or roadbase will separate the natural soil from steel. Considering the primary soil on the location, and facility design and management, I determine the steel corrosion hazard from soil at the proposed location is insignificant.

The 100-year floodplain is near, but does not include the proposed location, an intentional result of our alternative location analysis. Additional protection results from anchored steel containment berms, and remote shut-in capabilities. Considering the flood plain area, and facility design and management, I determine flooding risk to be low.

Radon hazard is identified as a potential geo hazard on the map. However, there are no inhabited structures, or structures occupied throughout the working day, planned at the location. Considering the EPA radon zone, and the lack of inhabited structures, the radon hazard at the proposed location is determined insignificant
