**RE: Geological Hazards Map and Geological Hazards Report
COGCC Rule 304.b.(7).I and Rule 304.c.(21)
PCU A27 Well Pad Site, Rio Blanco County, Colorado**

PCU A27 197 Geologic Hazard and Soils Map

Geologic Hazard Plan
Caerus Oil and Gas LLC
PCU A27 197

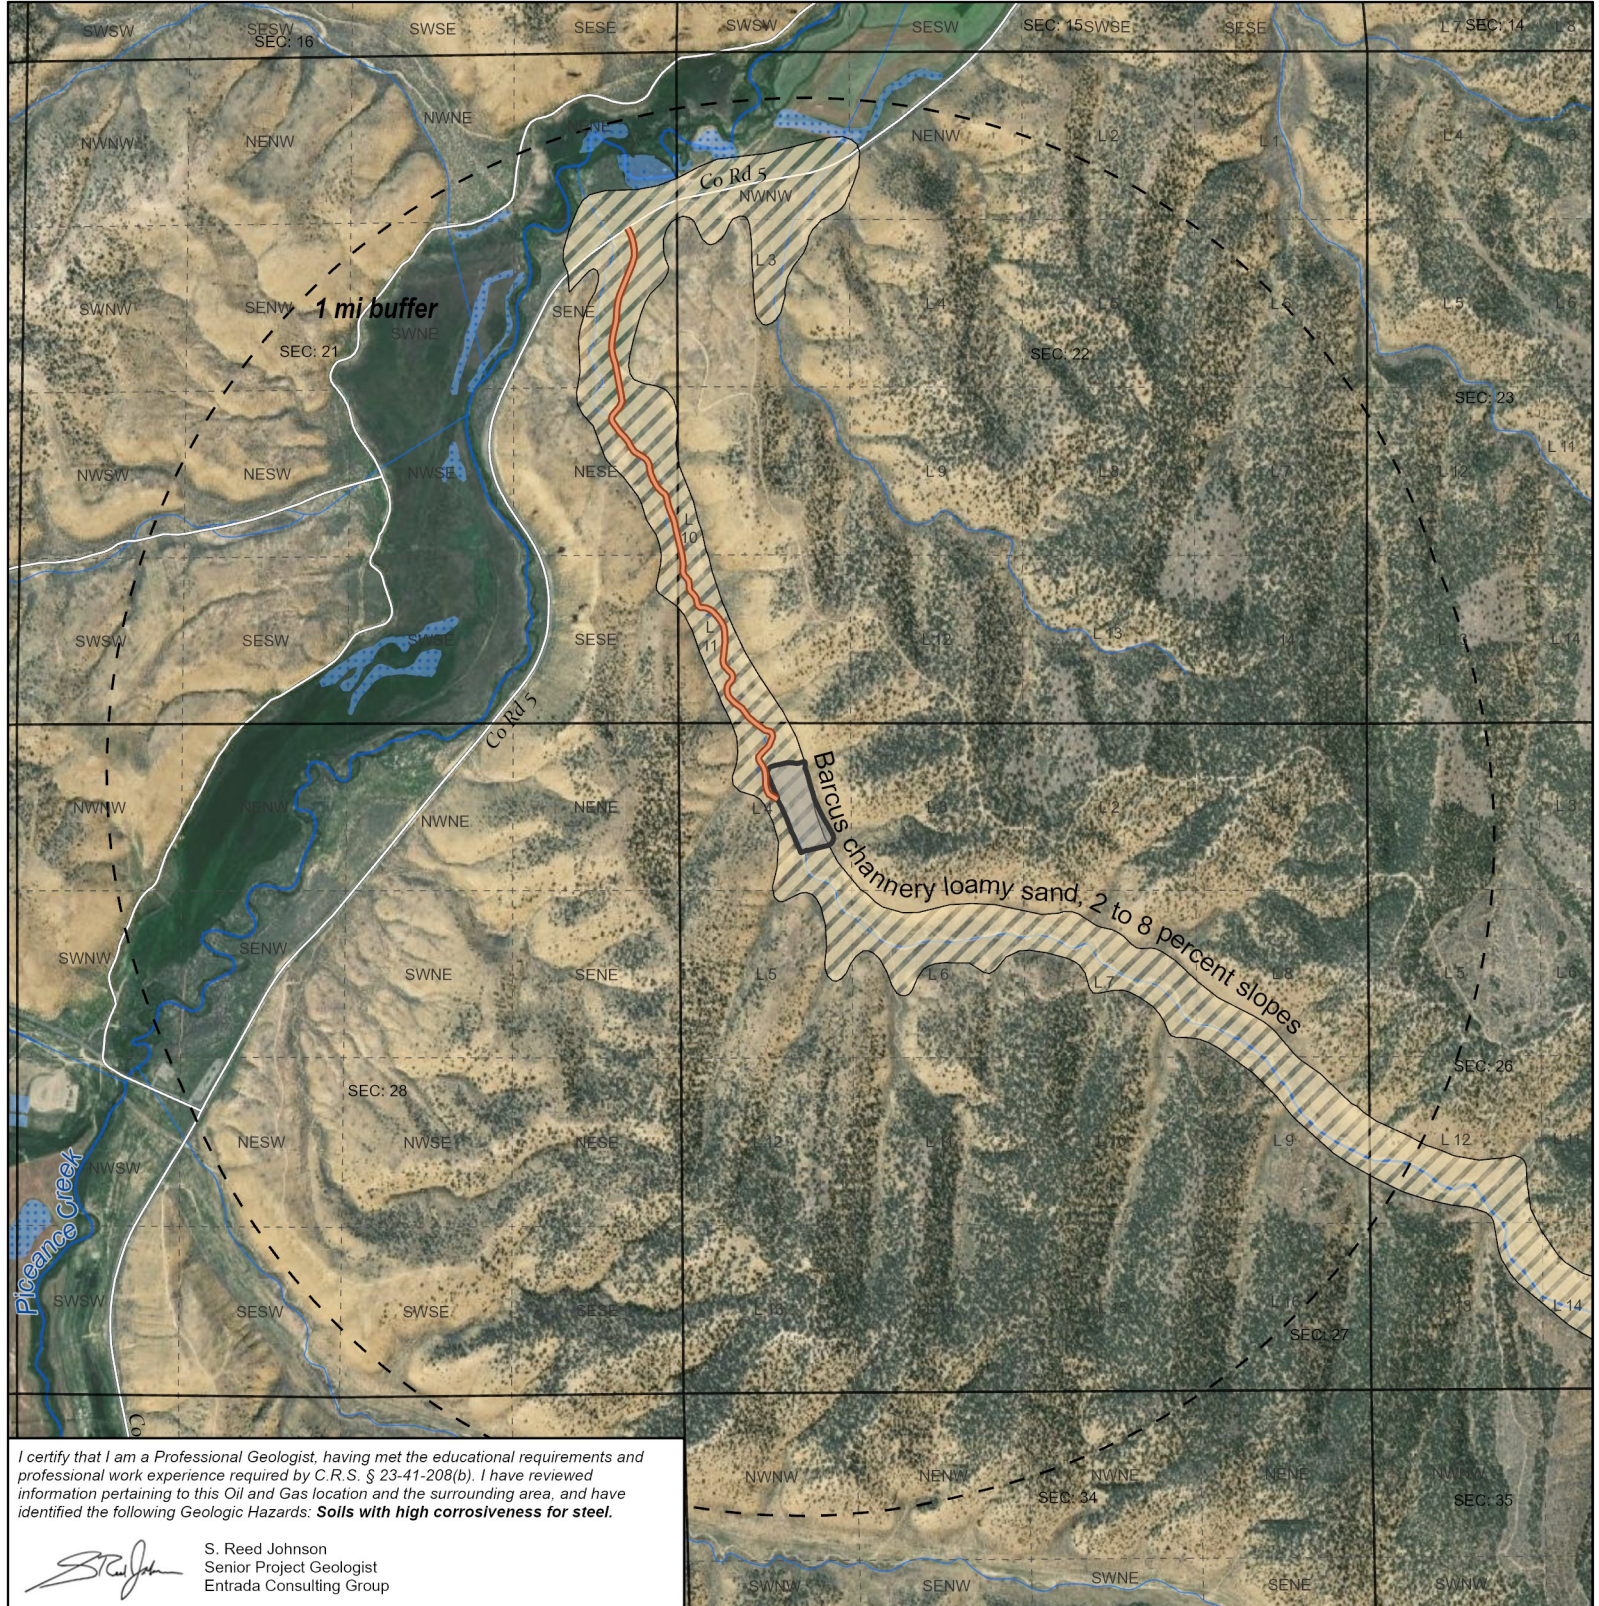
Figure 1

I certify that I am a Professional Geologist, having met the educational requirements and professional work experience required by C.R.S. § 23-41-208(b). I have reviewed information pertaining to this Oil and Gas location and the surrounding area, and have identified the following Geologic Hazards: **Soils with high corrosiveness for steel.**

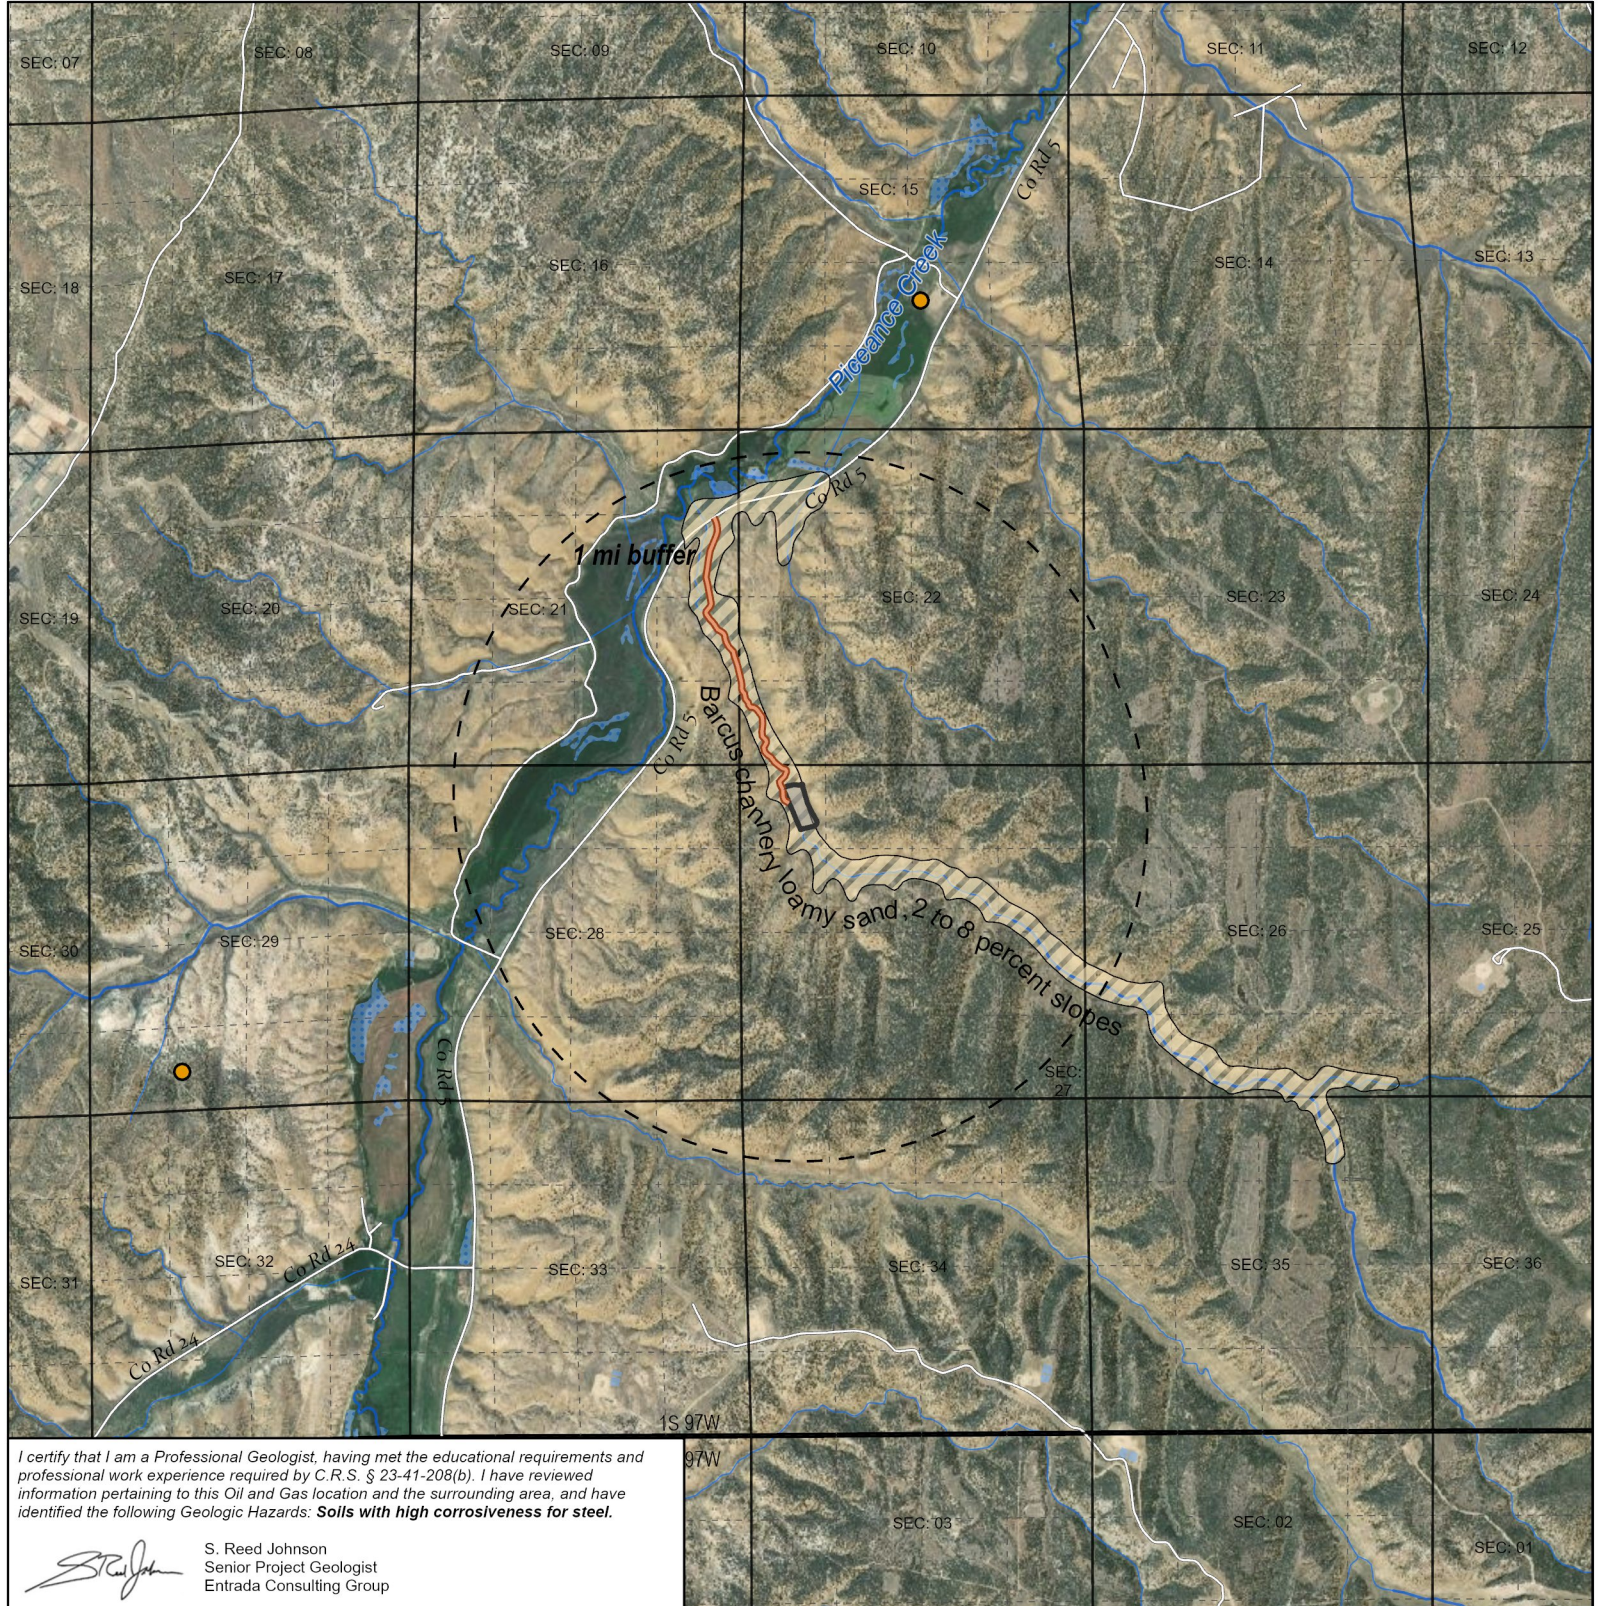
Figure 2

I certify that I am a Professional Geologist, having met the educational requirements and professional work experience required by C.R.S. § 23-41-208(b). I have reviewed information pertaining to this Oil and Gas location and the surrounding area, and have identified the following Geologic Hazards: **Soils with high corrosiveness for steel.**
