WELL NAME: MESSER WELL 1, API #: 043-40051, INSP. # 7163000

**PHOTO 1: VIEW FROM THE SOUTH AT THE GATE APPEARS TO BE A TWO TRACK DISTERBANCE CAUSED BY P&A EQUIPMENT AS THIS PATH WAS NOT PRESENT DURING PREVIOUS ECMC STAFF INSPECTIONS.**

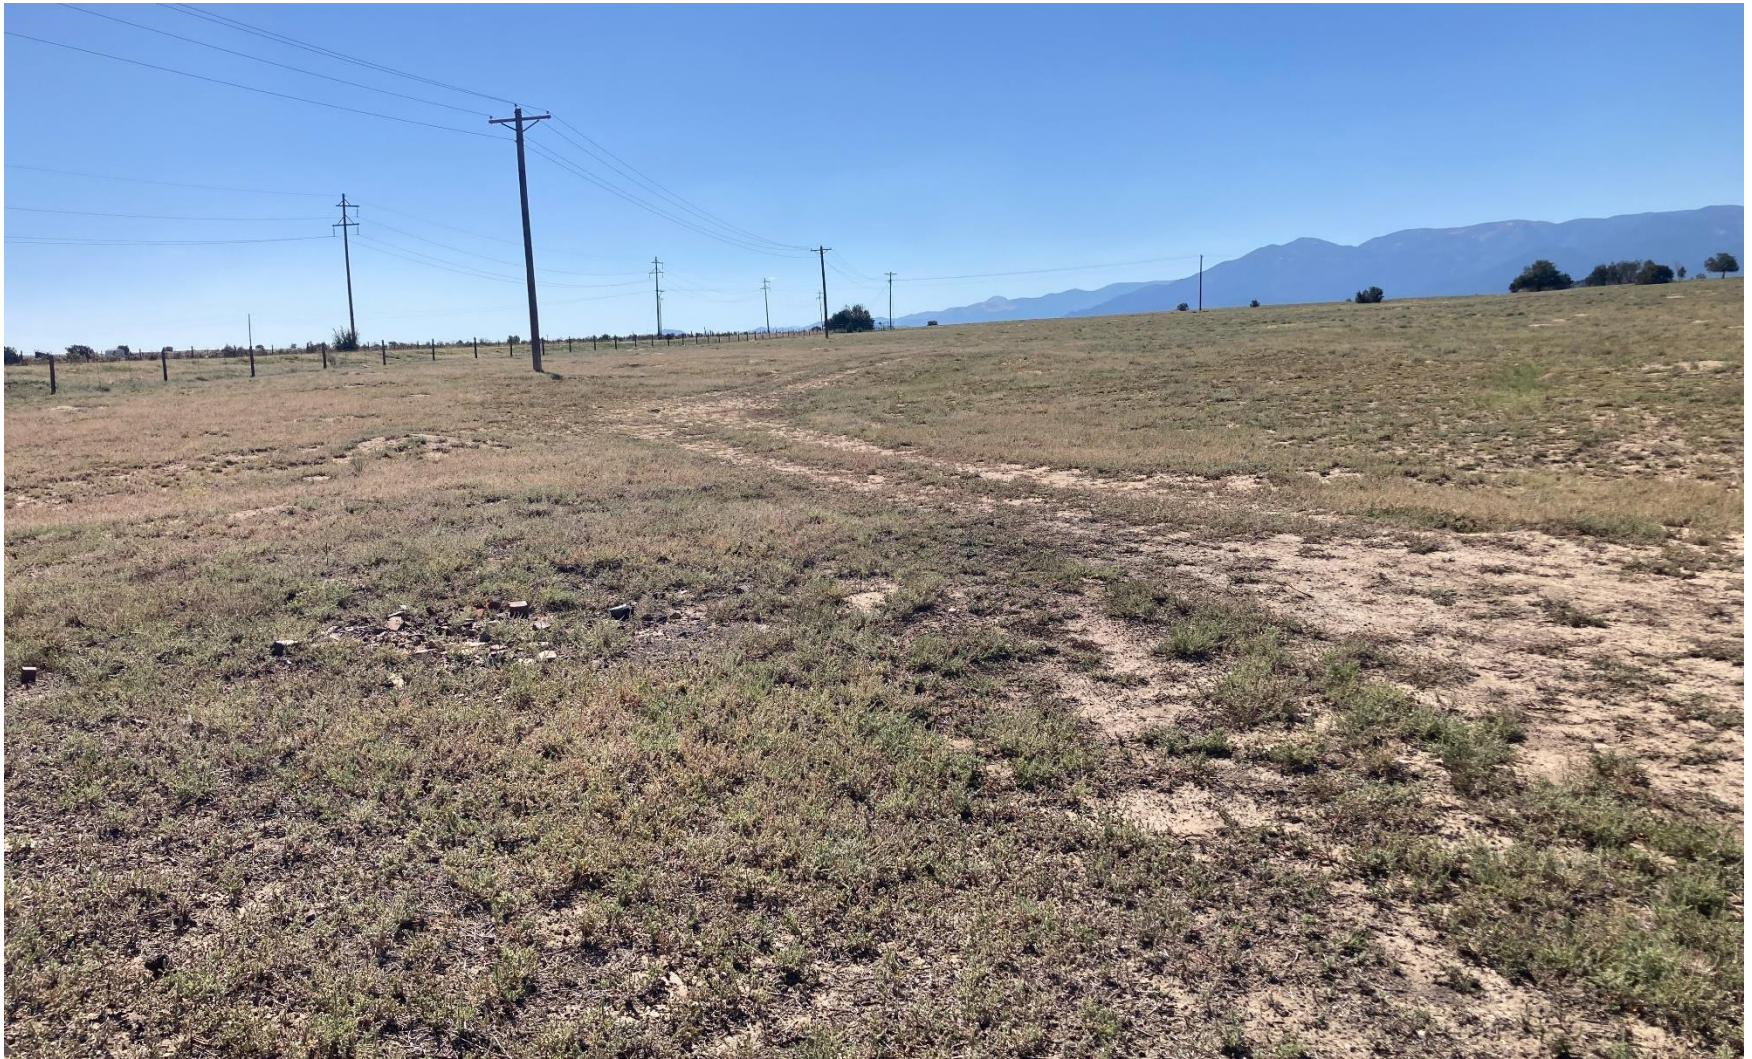
**PHOTO 2: VIEW FROM THE LOCATION LOOKING SOUTH APPEARS TO BE A TWO TRACK DISTERBANCE CAUSED BY P&A EQUIPMENT AS THIS PATH WAS NOT PRESENT DURING PREVIOUS ECMC STAFF INSPECTIONS.**

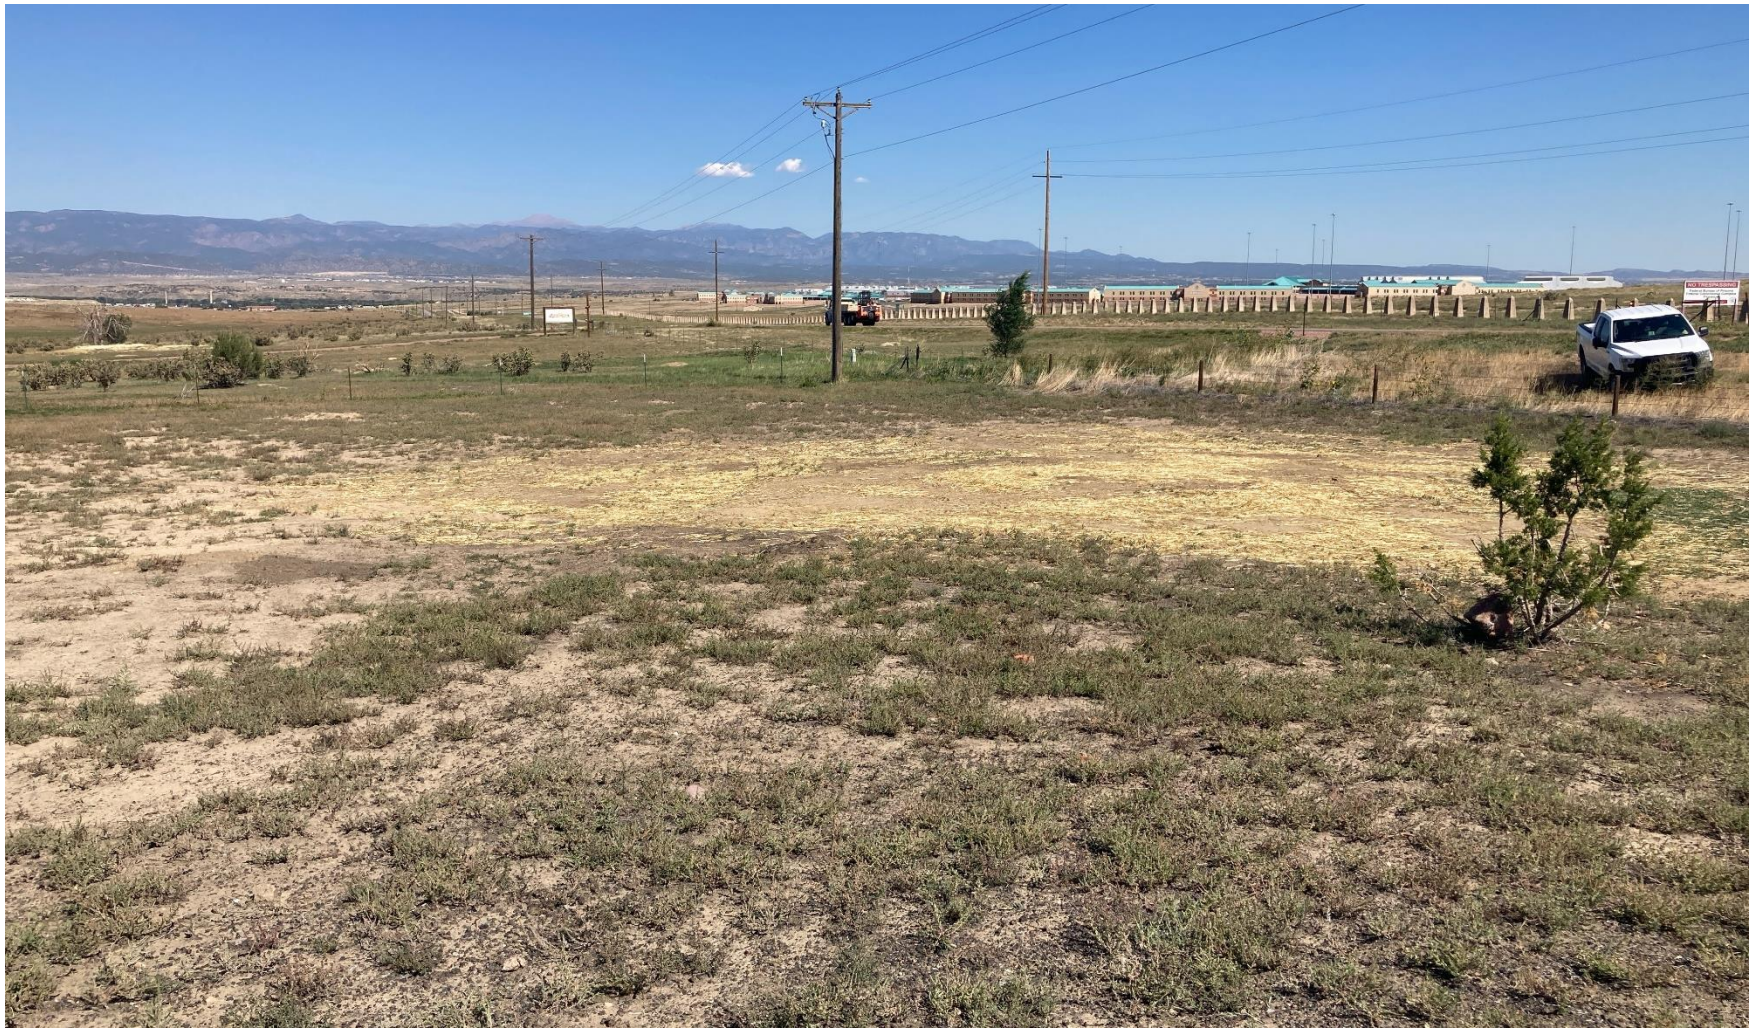
**PHOTO 3: VIEW OF P&A'D LOCATION FROM THE SOUTH, STRAW HAS BEEN SET OVER DISTERBED AREA IT DOES NOT APPEAR THAT IT WAS CRIMPED**

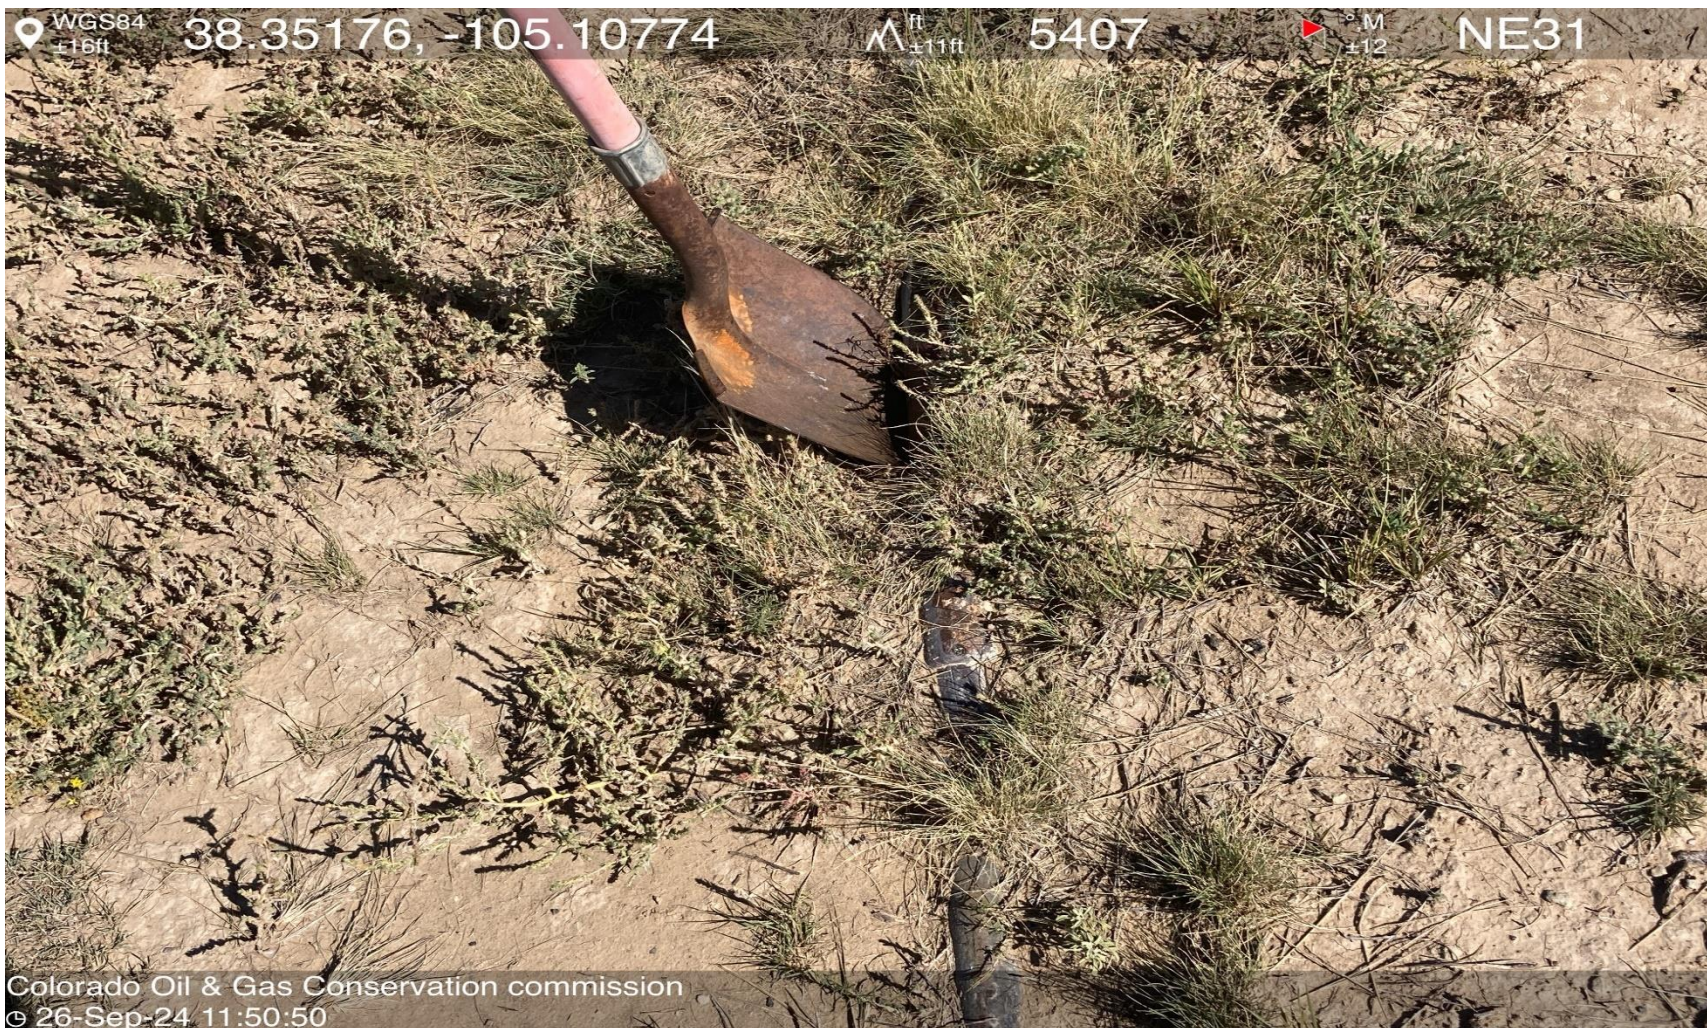
**PHOTO 7: 2" FLOWLINE FOUND APP. 30 YARDS EAST OF LOCATION RUNNING TOWARD THE AREA WHERE THE HOUSE USED TO BE.**

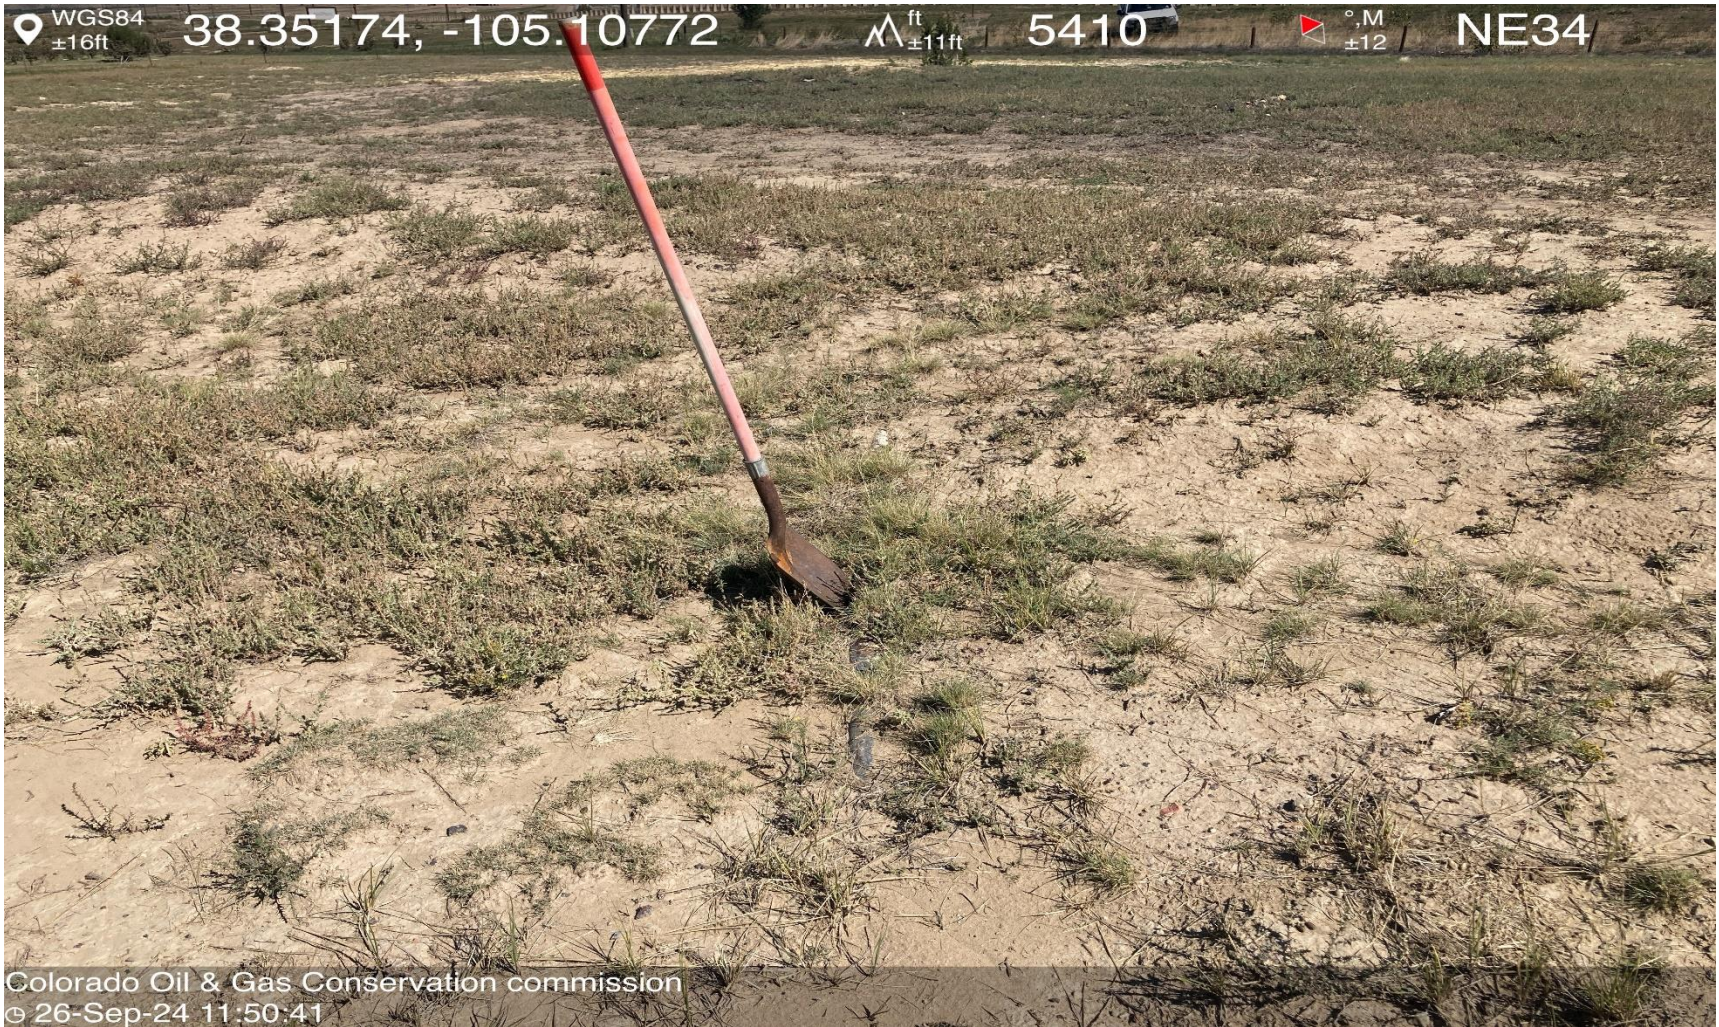
**PHOTO 8: 2" FLOWLINE FOUND APP. 30 YARDS EAST OF LOCATION RUNNING TOWARD THE AREA WHERE THE HOUSE USED TO BE.**
