# Inspection Photos

**Operator:** TEP Rocky Mountain LLC #96850

**Location ID:** 439173

**Inspection Doc:** 719200910

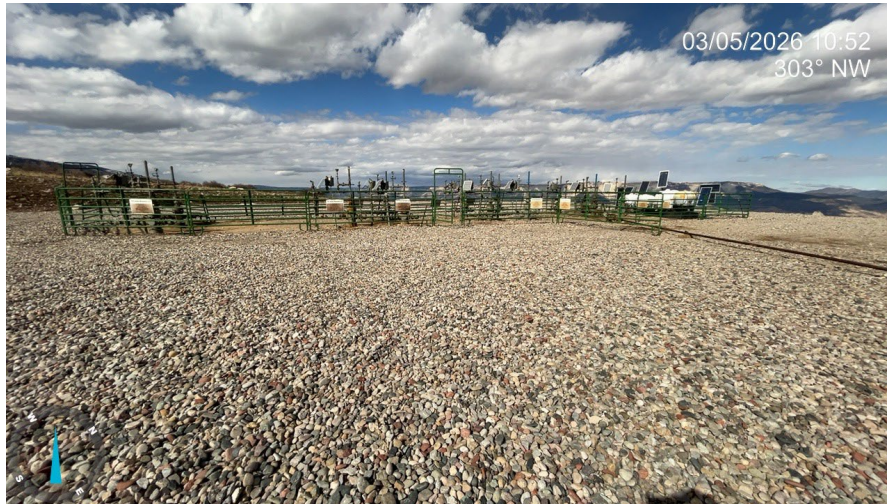
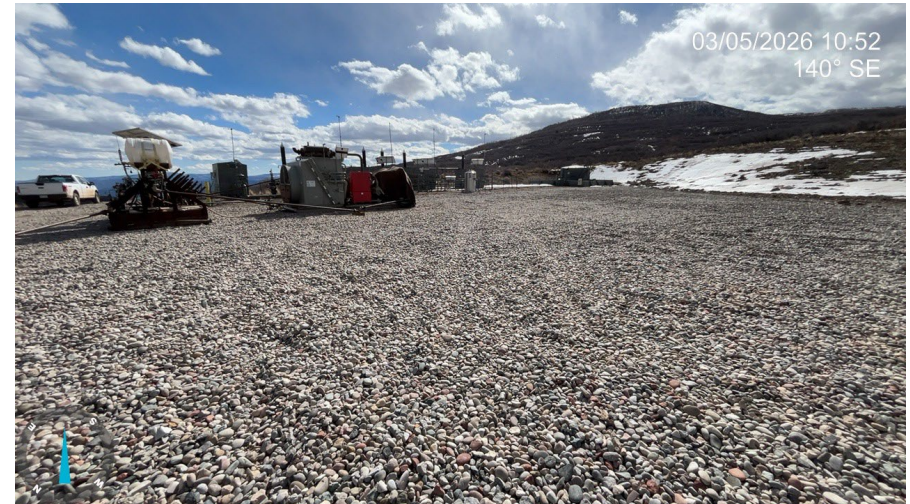
**Photo 1:** Photos showing an overview of the location looking northwest and southeast, respectively.

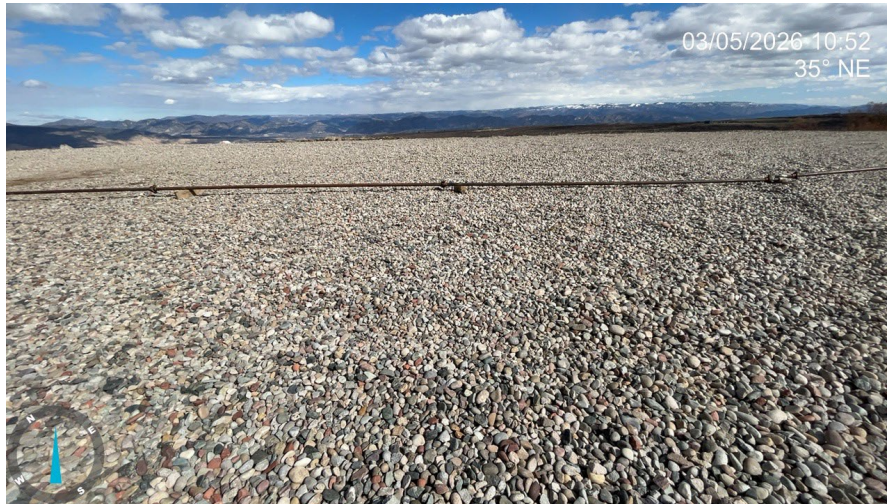
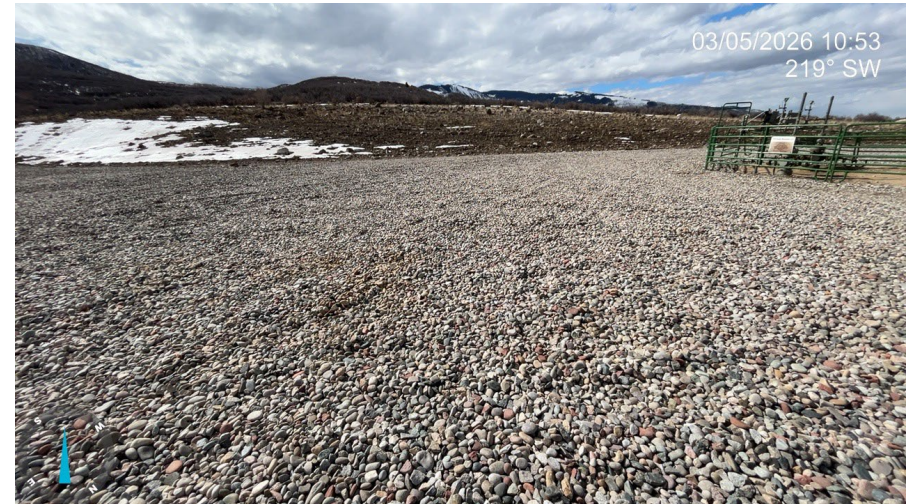
**Photo 2:** Photos showing an overview of the location looking northeast and southwest, respectively.

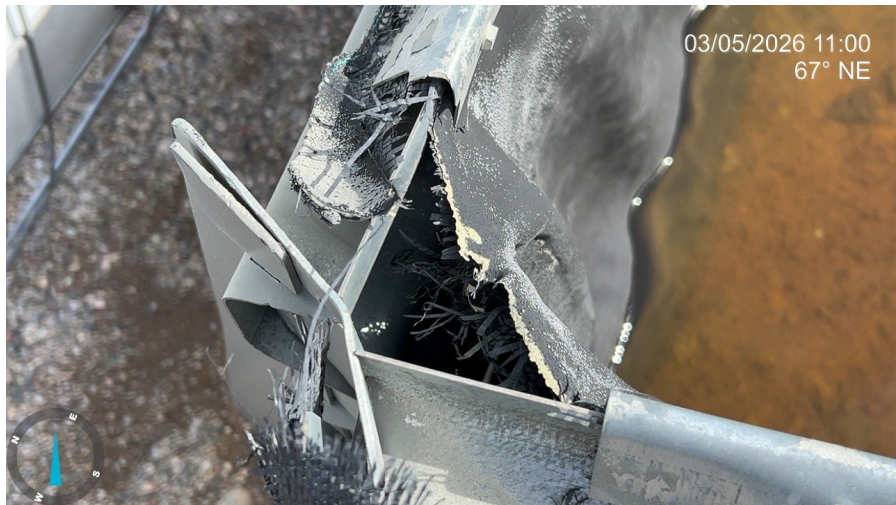
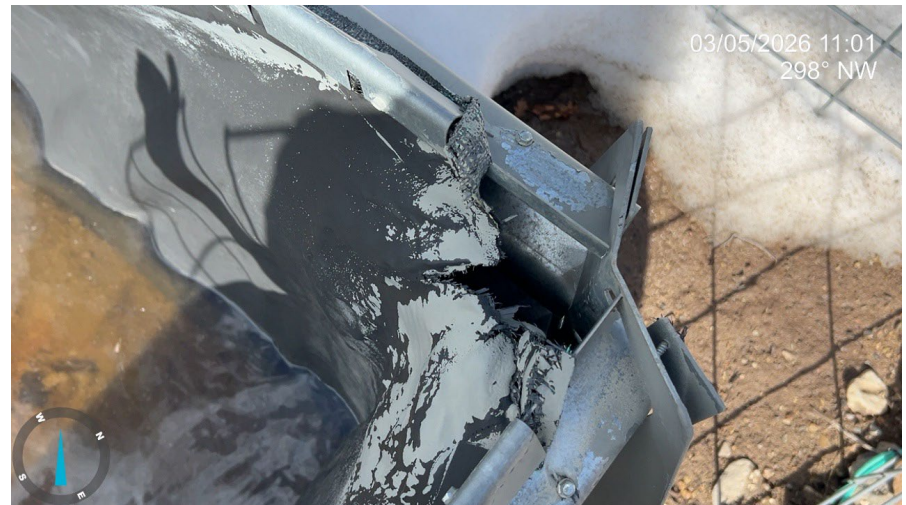
**Photo 3:** Photos showing examples of rips and tears in the corners of the tank's secondary containment black geotextile liner. Comply with Rule 603.o.

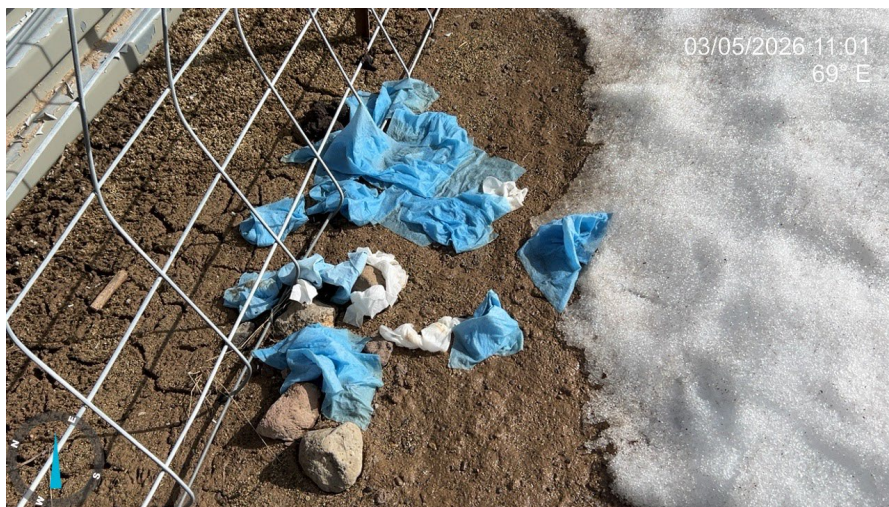
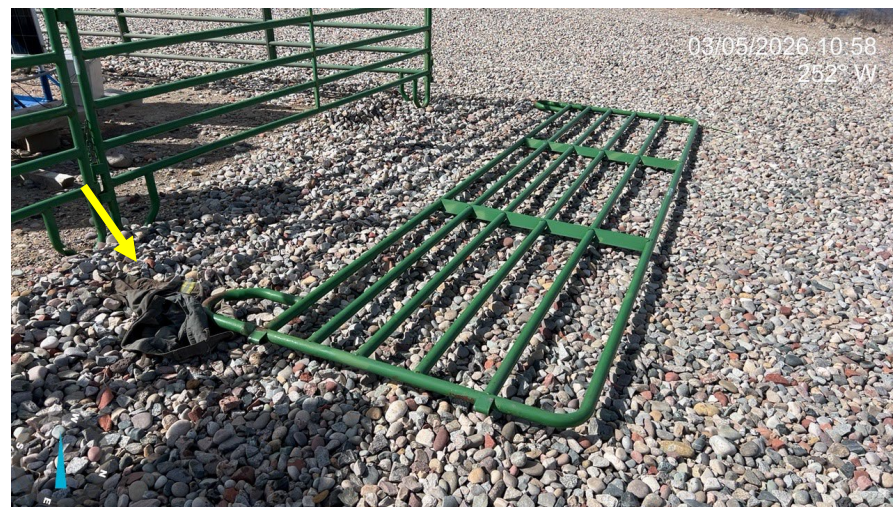
**Photo 4:** Photos showing trash near the tank's secondary containment system (left), an article of clothing (yellow arrow) and an unused fence panel at the location. Removal is required; comply with Rules 606.d. and 606.a.

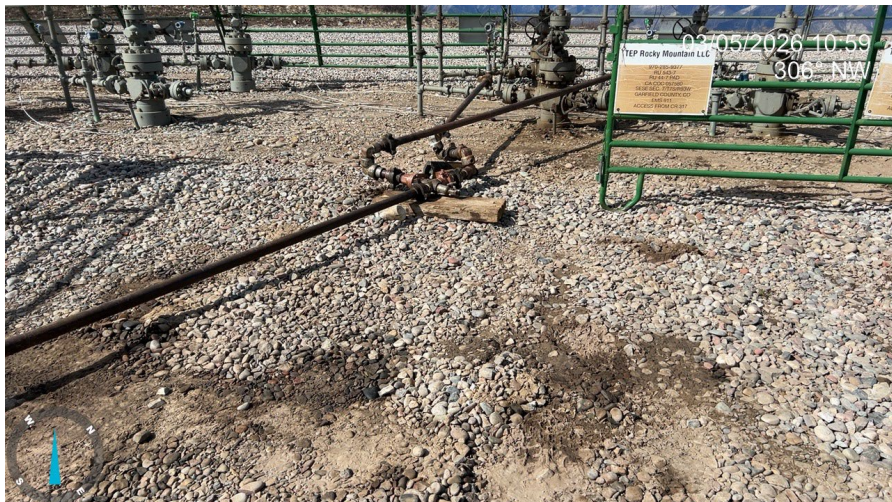
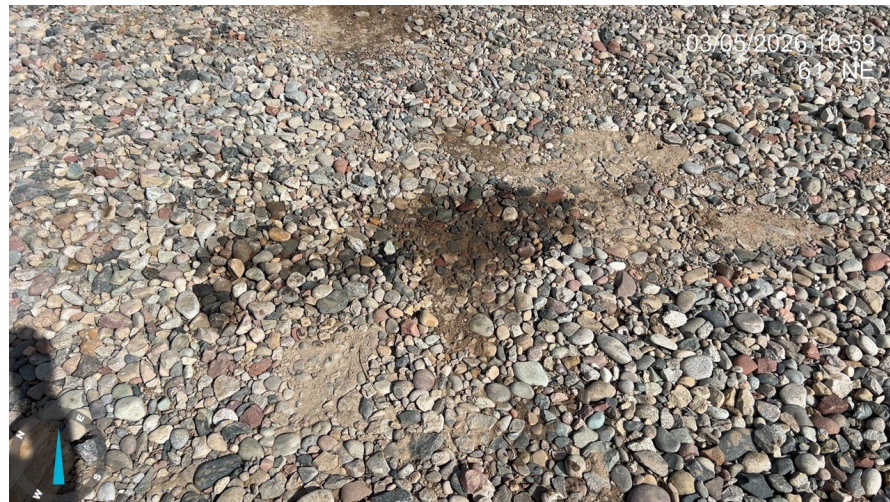
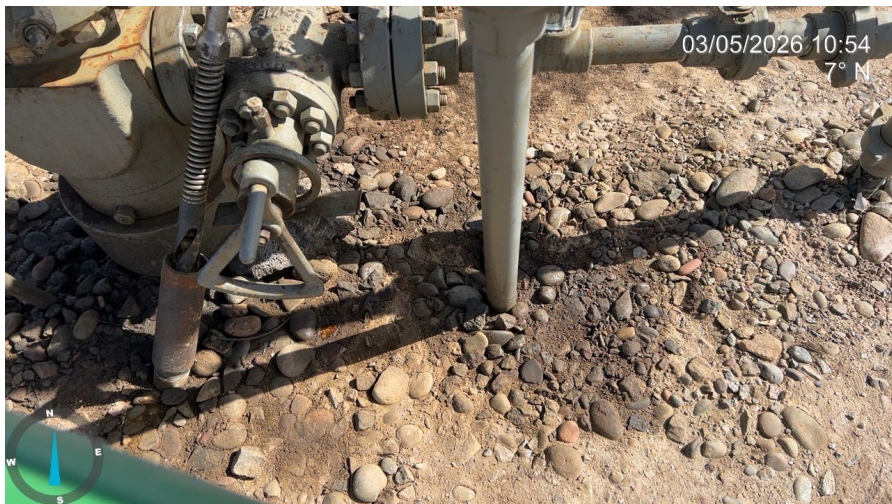
**Photo 5:** Photos showing examples of stained soils around the base of a wellhead and around the wellhead area; comply with Rule 912.a. and clean up/remove stained soils.

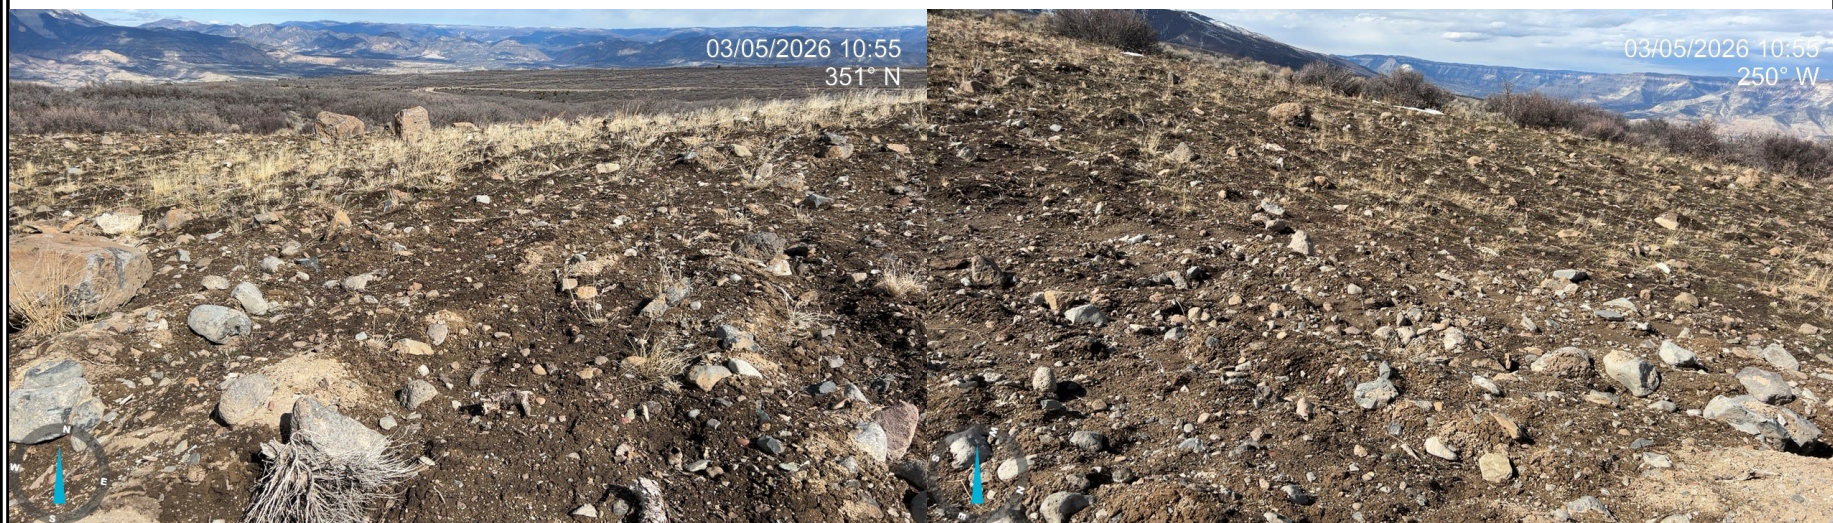
**Photo 6:** Photos showing and overview of the northern and western interim areas, respectively. Interim reclamation was delayed with an approved Variance until 11/30/2025. Interim areas are primarily composed of cheatgrass; it is unclear if interim reclamation activities have commenced. A follow-up inspection will be conducted during future growing seasons to determine compliance with 1003 reclamation standards.

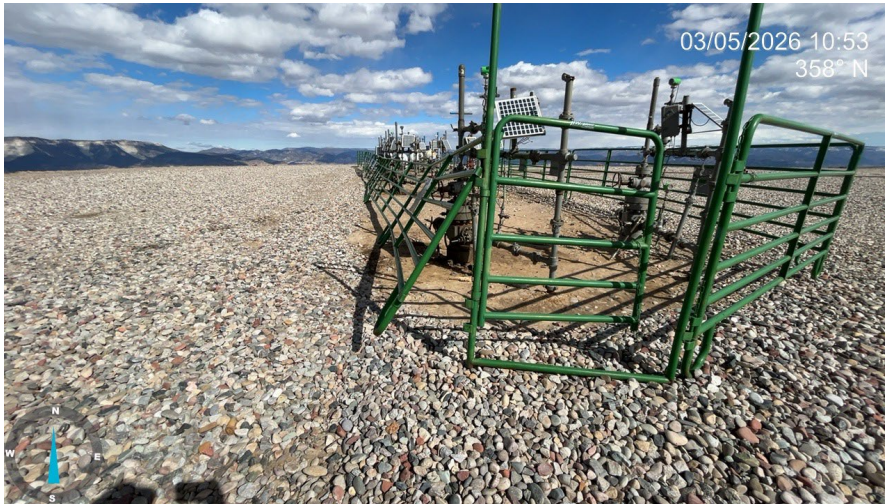
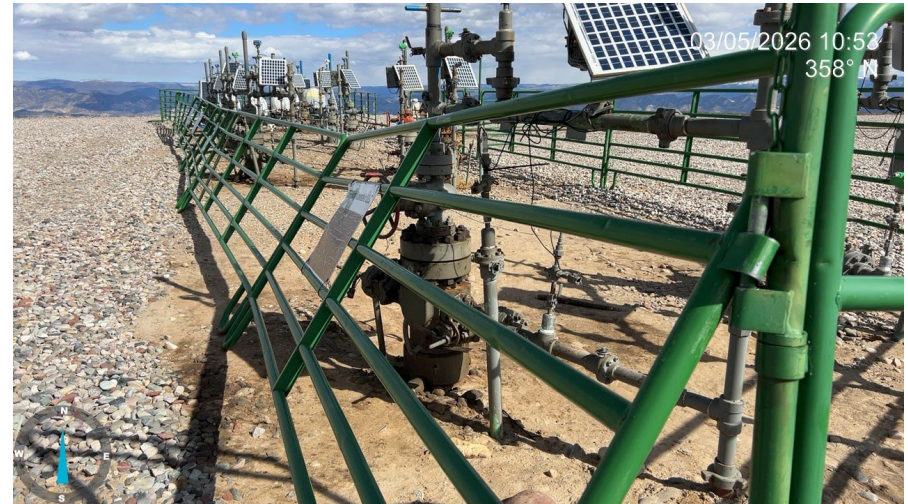
**Photo 7:** Photos showing panel fencing has fallen against a wellhead at the location; maintenance is recommended.
