# **FRUITLAND OUTCROP MONITORING REPORT**

**LA PLATA COUNTY, COLORADO**

**OCTOBER 2004**

**LT ENVIRONMENTAL, INC.  
4400 West 46<sup>th</sup> Avenue  
Denver, Colorado 80212  
(303) 433-9788**

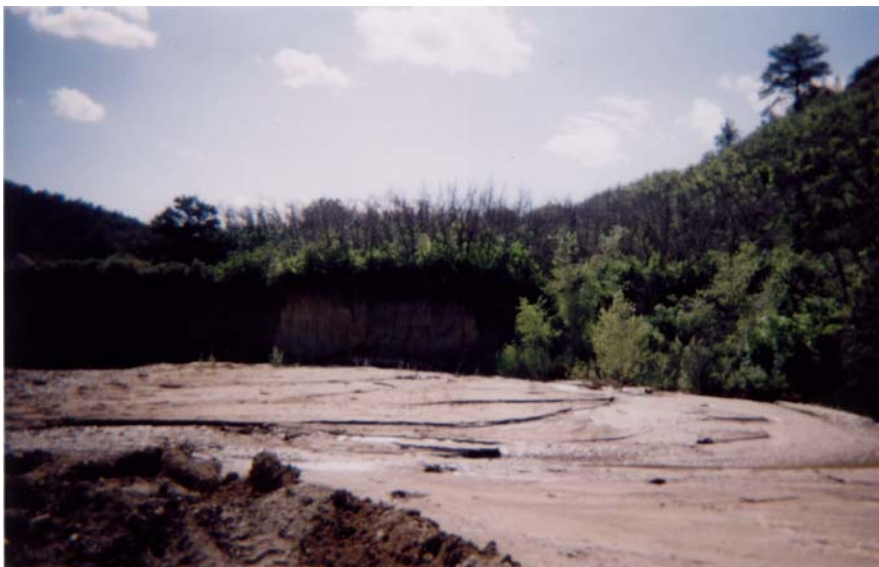
The stream bed in the Basin Creek area was not mapped due to construction activities. The construction of the dam, and removal of vegetation caused large quantities of sediment to accumulate in the stream bed, thus making the area inaccessible for seep mapping. The areas

Sediment in Basin Creek  
View east.

adjacent to the stream bed were mapped as planned but based on recent observations, the construction area appears to be steadily increasing in size, reducing the observable seep features and further limiting access to map and monitor seep activity at Basin Creek.

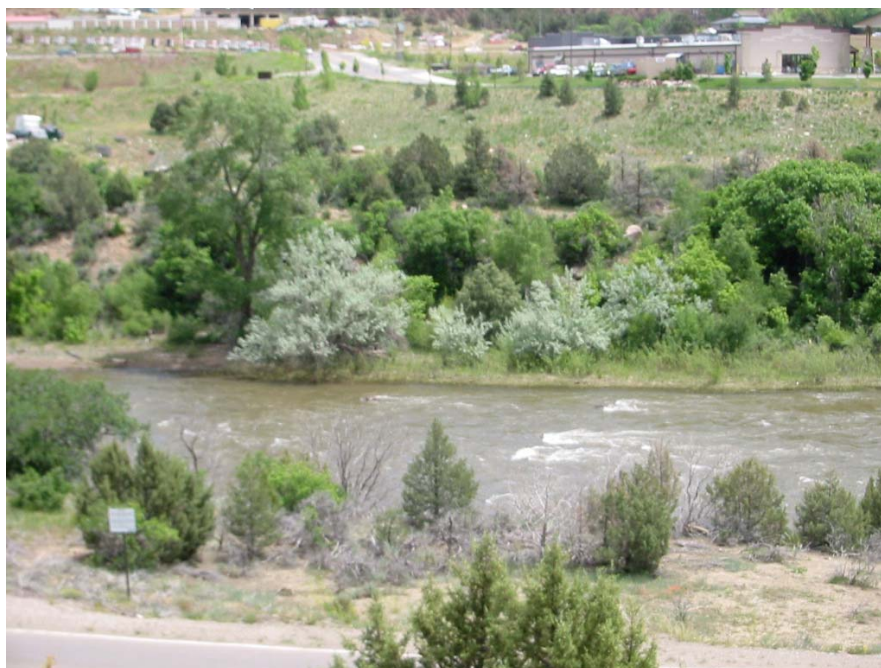
Animas River at  
Carbon Junction,  
view north.

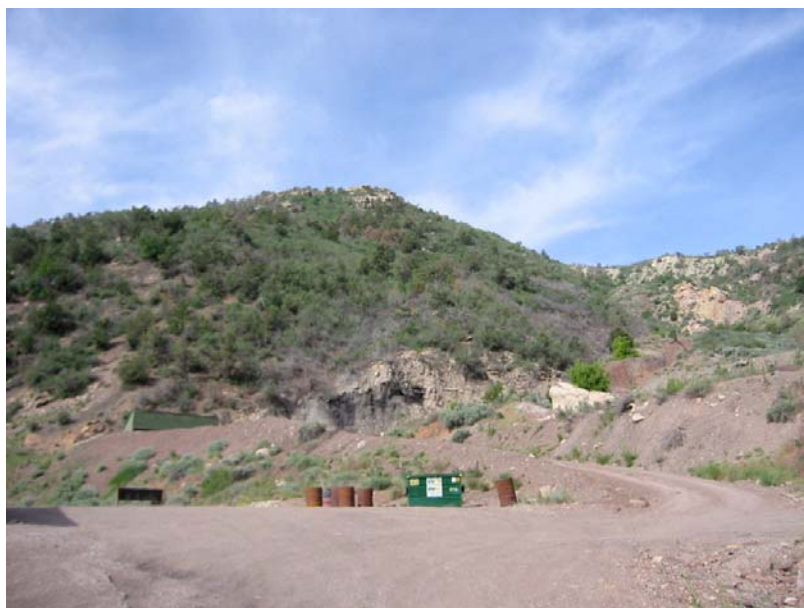
Four stressed/dead vegetation areas and 12 dead trees were mapped west of the shooting range (CJ-3, Figure 6). This seep area has been noted in previous detailed mapping events. Methane concentrations ranged from 1,500 ppm to 400,000 ppm (40%). Many of the readings collected from this area reported methane concentrations around 500,000 ppm (50%). Five of the 12 measurements reported methane concentrations of 150,000 ppm (15%) or greater.

Shooting Range  
and Text Reference  
Location CJ-3,  
view south.

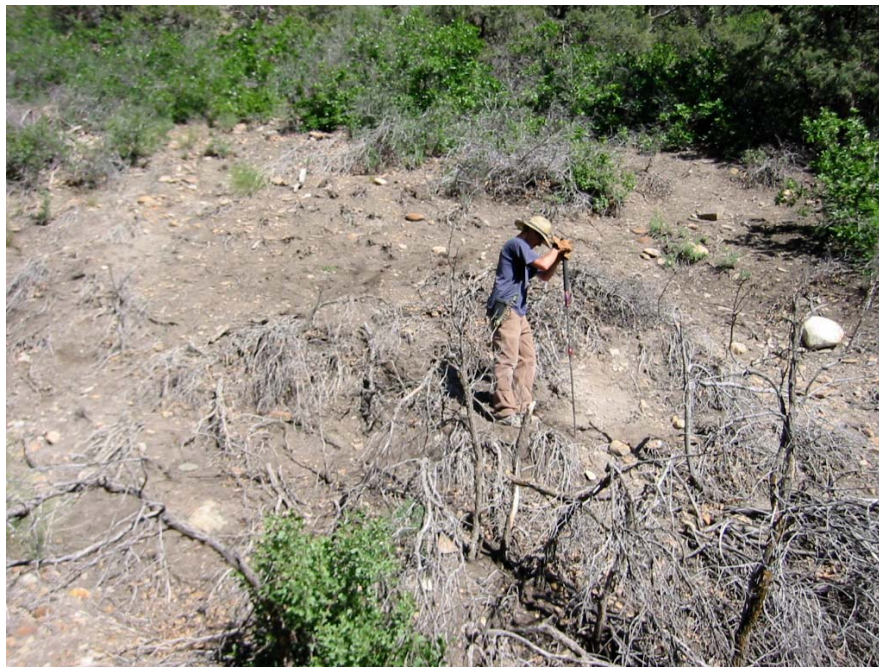
The other upland areas east of Highway 3 contain large areas of stressed/dead and non-vegetation areas, many dead trees, and very high concentrations of methane in the subsurface. The maximum methane concentration reported in this area was 940,000 ppm (94%). This area is a known active seep area and also contains two permanent monitoring probe lines (CJ-5, Figure 7).

Seep Areas at  
Text Reference  
CJ-5, View  
east.

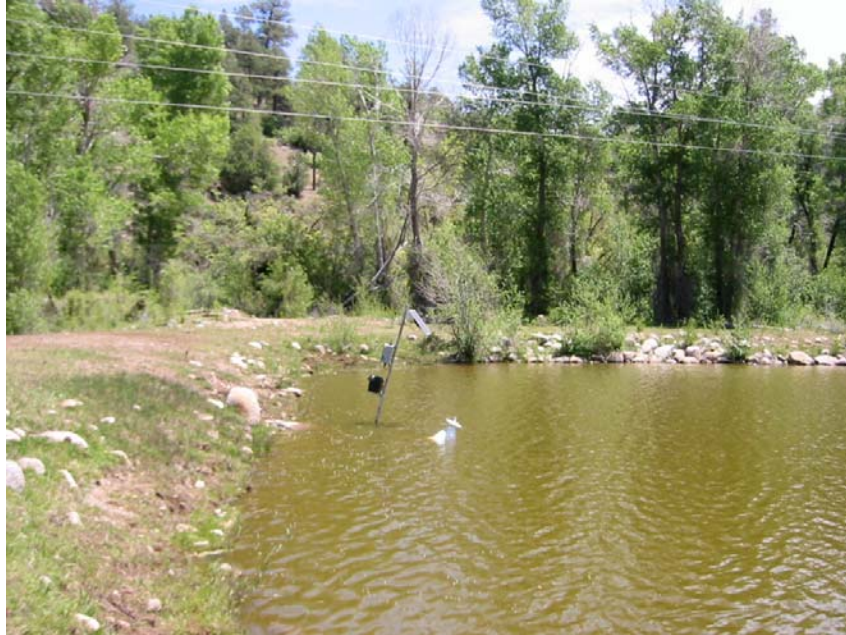
Numerous visible methane seeps were noted in the private pond located at Terry Palmer Ranch. The pond corresponds with the middle and upper portions of the Kf based on surface geology. Methane seeps were identified in the river north of the private pond, which stratigraphically correlates with the lower portion of the Kf based on surface geology. Methane seeps were noted for approximately 0.10 mile upstream of the private pond.

Methane seepage in the pond at Terry Palmer Ranch, View east. Note sinking flux chamber.

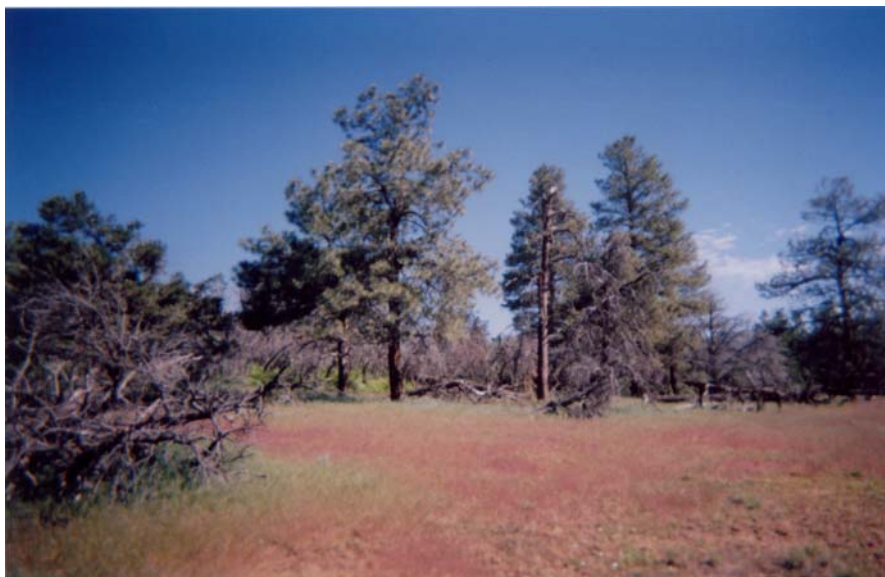
Location FR-3,  
view north

Approximately 0.15 miles southwest of location FR-2, a second cluster of dead pine trees and stressed/dead vegetation areas were observed (FR-3, Figure 11). The stressed/dead vegetation areas were located in a small open meadow bordered mostly by pine trees. Subsurface methane measurements ranged from 500 ppm to 580,000 ppm (58%). Approximately half of the measurements collected in this area were 10,000 ppm (1%) or higher.

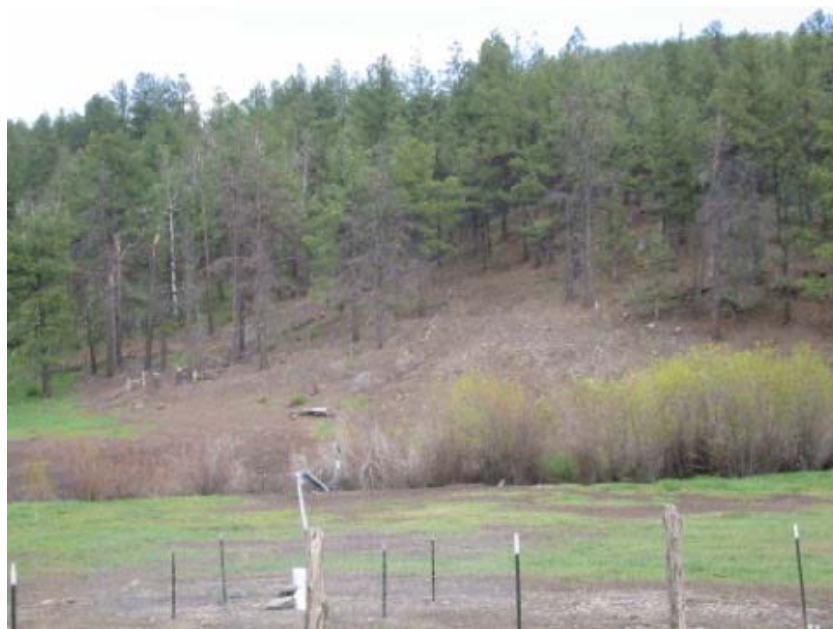
Location TC-1,  
view east

approximately 200 feet north and south of the flux chamber (TC-1, Figure 17). Approximately 0.34 miles west of the main seep area a visible seep area (approximately 100 feet by 200 feet) was observed where the creek had flooded the meadow (TC-2, Figure 16).

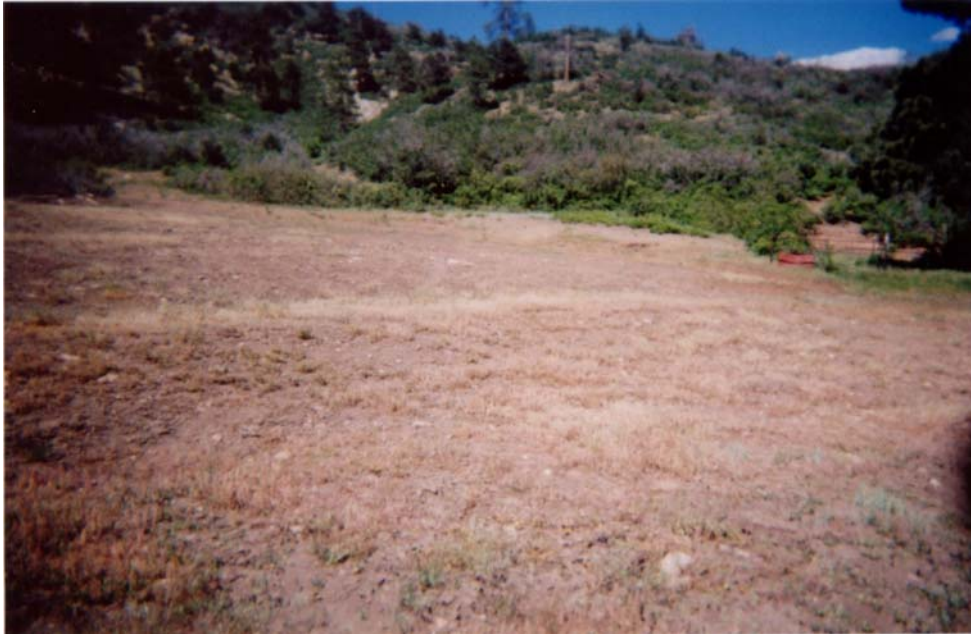
The Hoier Property was added to the detailed seep mapping program following the completion of the IR imagery regional reconnaissance mapping program. The Hoier Property is an upland area west of Pine River. According to the Hoiers, they have experienced increased areas of dead

Dead vegetation on  
Hoier property,  
view north.

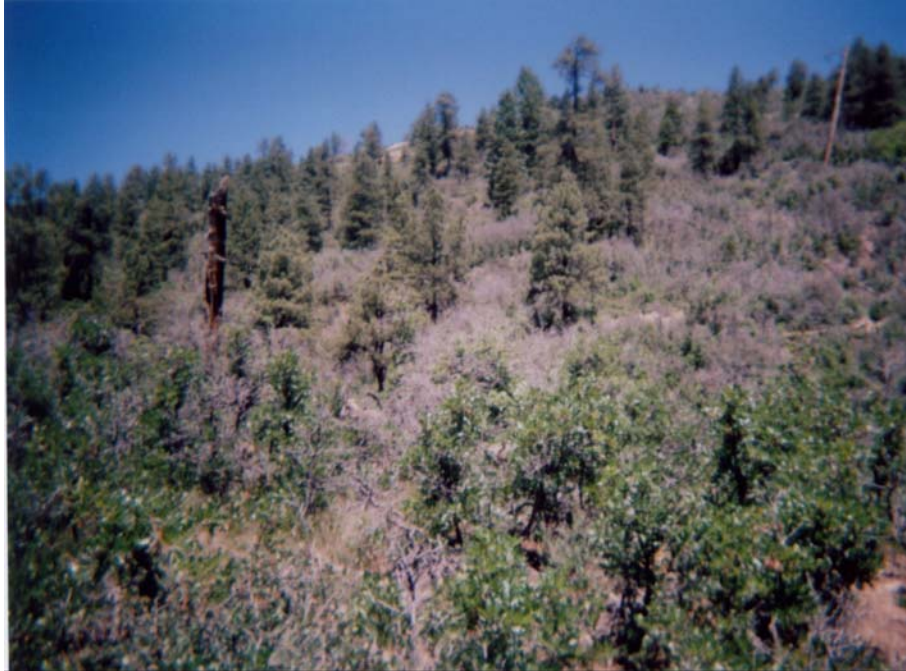
An additional mapping event was performed at the Beaver Creek Ranch (BCR) on May 28, 2004 at the request of Debbie Baldwin of the COGCC. BCR is located approximately 20 miles east of Durango on the northern side of Hwy 160. This area is in close proximity to the East Pine study area. The COGCC had requested the mapping of the area because of an existing COGCC monitoring wells (MW35-6-17-1 and MW35-6-17-2) located down-dip of the BCR mapping area. Monitoring well MW35-6-17-2 has consistently recorded high gas pressures at the well head.

Stressed Vegetation at  
Beaver Creek Ranch,  
view north.

At Beaver Creek Ranch, several areas of stressed/dead vegetation were noted, but no methane was detected from any of the gas readings collected.

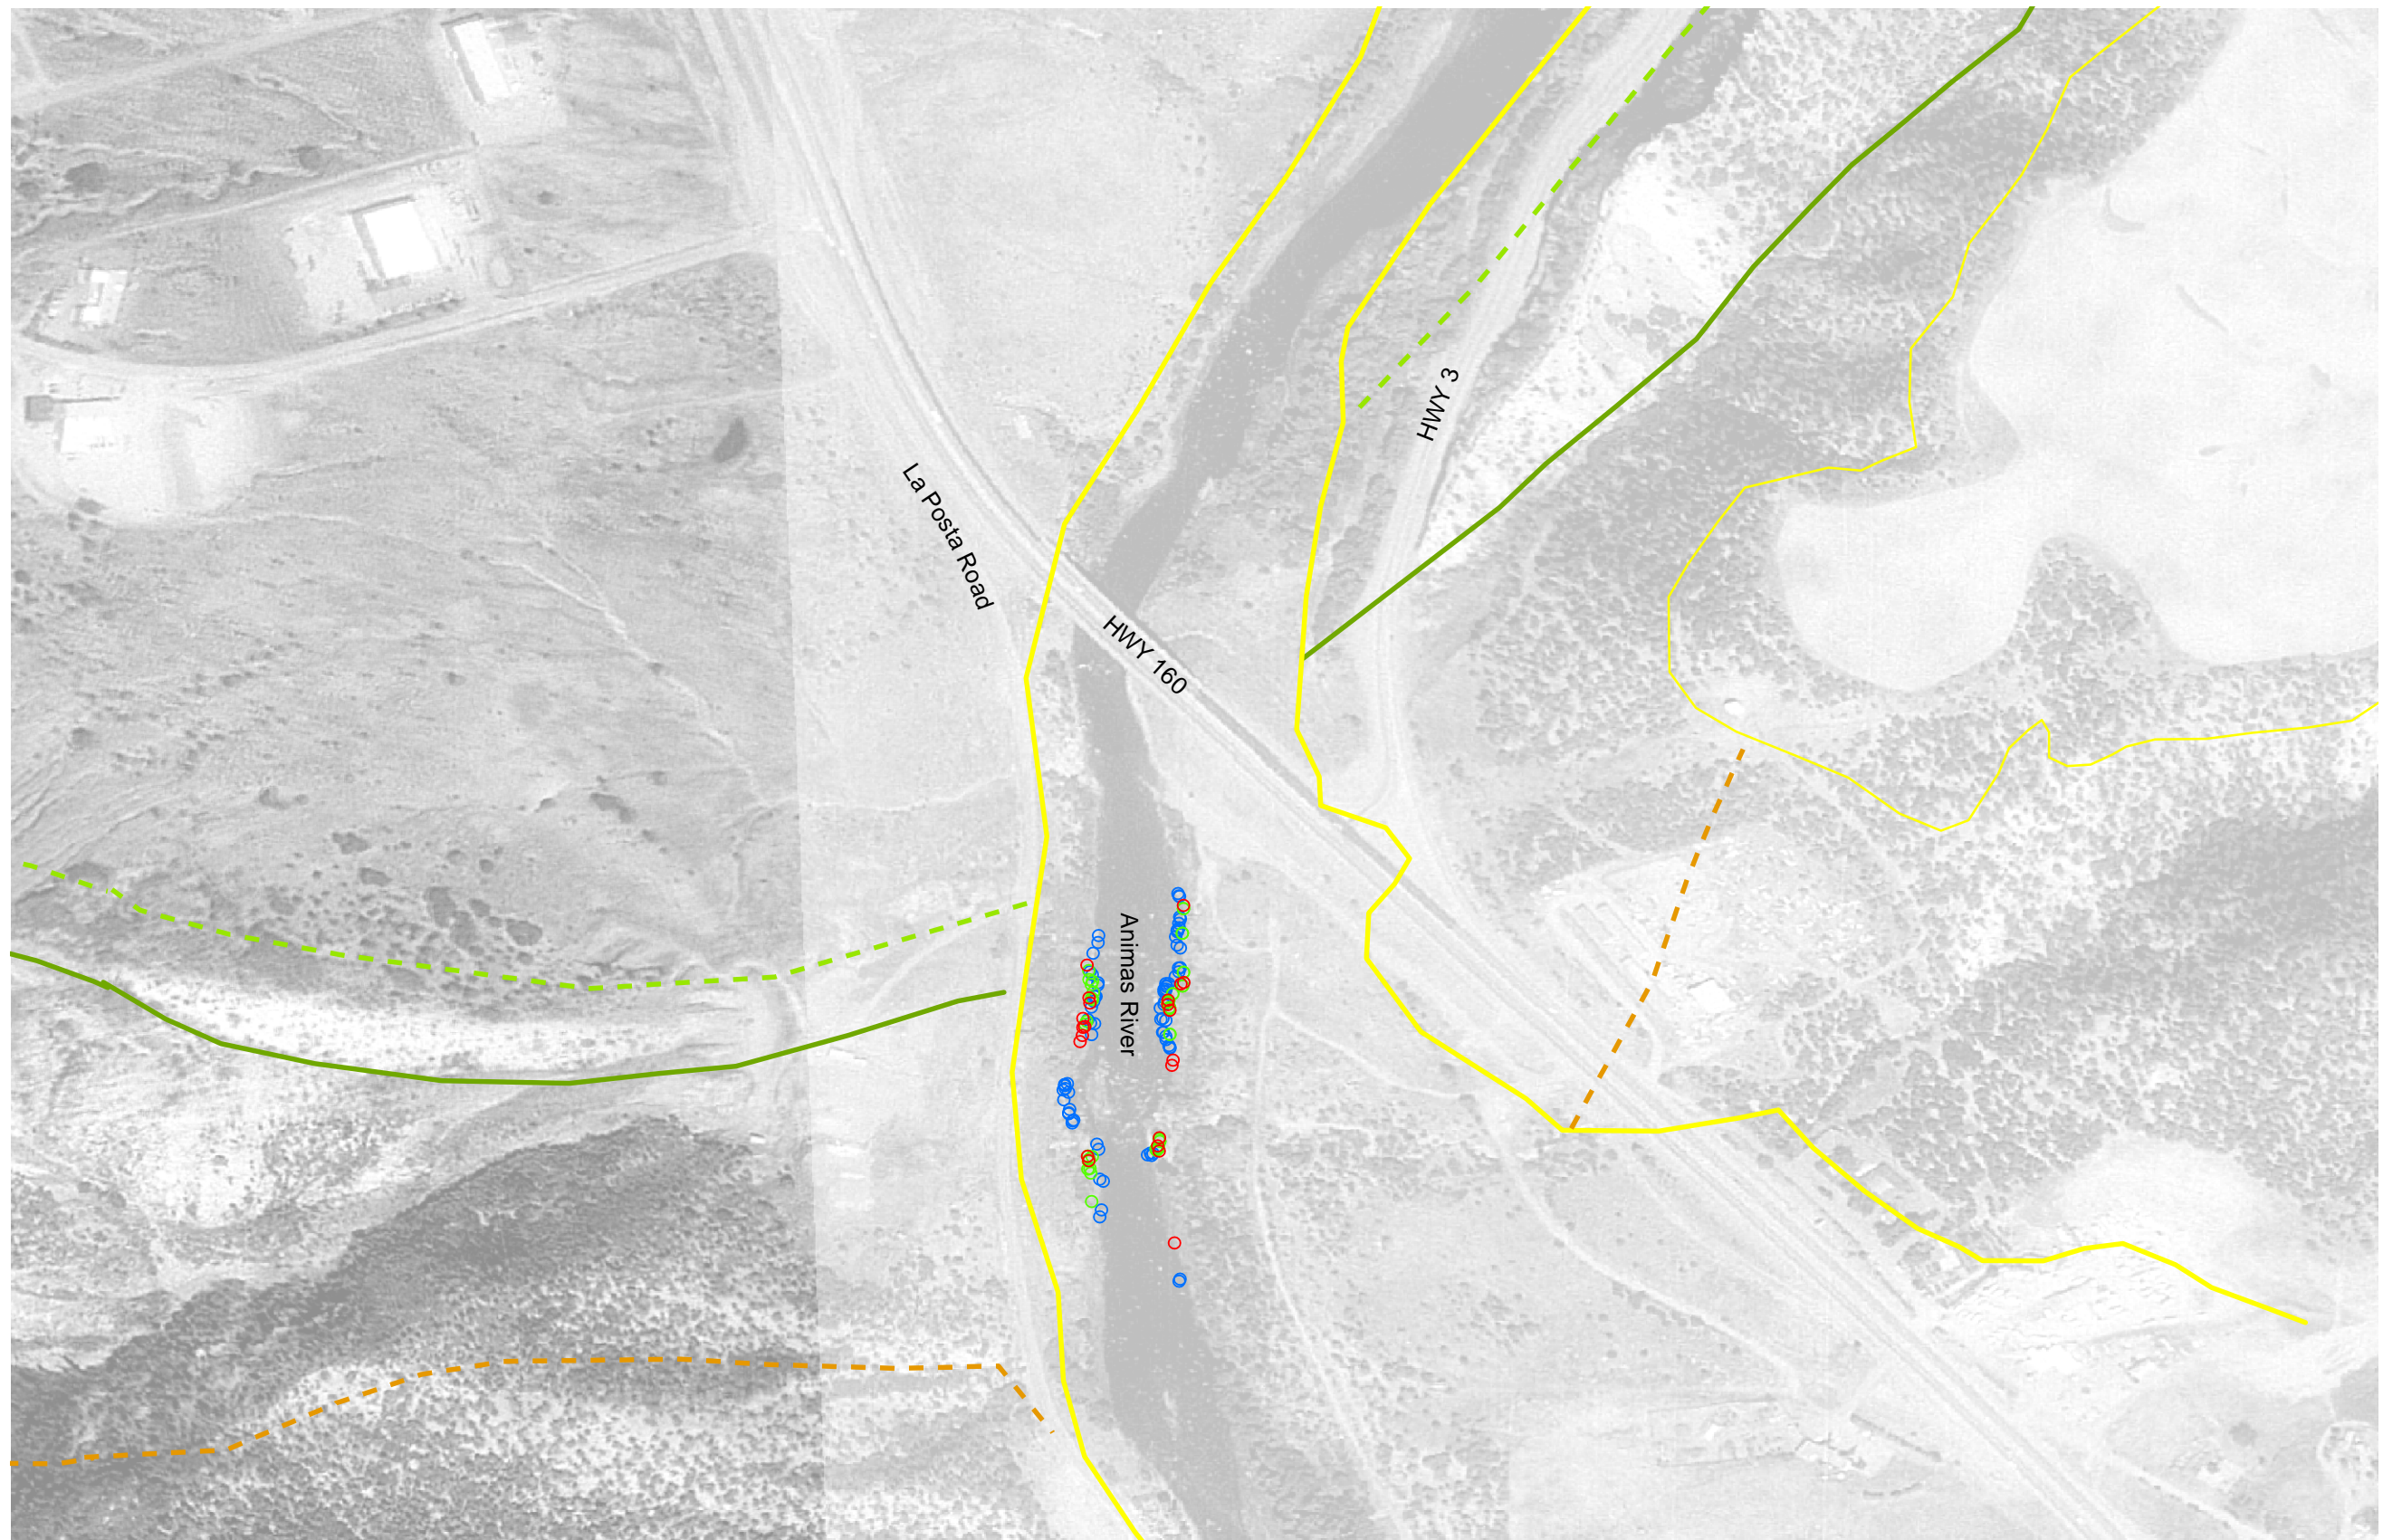
**FIGURE 9**  
**HISTORICAL DATA COMPARISON**  
**STRESSED/DEAD VEGETATION**  
**CARBON JUNCTION**  
**THE GROUP**

When comparing the number and extent of stressed/dead vegetation areas and stressed/dead trees, data suggest that impacts to vegetation have increased from the previous year, particularly along the west and east banks of the Animas River. Figure 9 illustrates the historic data comparison of stressed/dead vegetation at Carbon Junction.

At Carbon Junction, LTE collected more measurements during the 2004 mapping event as compared to previous years. Mapping results noted the presence of additional dead trees, particularly along the creek banks as compared to previous mapping events.
