CORDILLERAN

**RE: Summary of Tow Creek Bridge Asbestos Abatement and Bridge Removal
Activities, Milner, Colorado.**

Tow Creek Bridge Demolition and Asbestos Abatement
March 2001

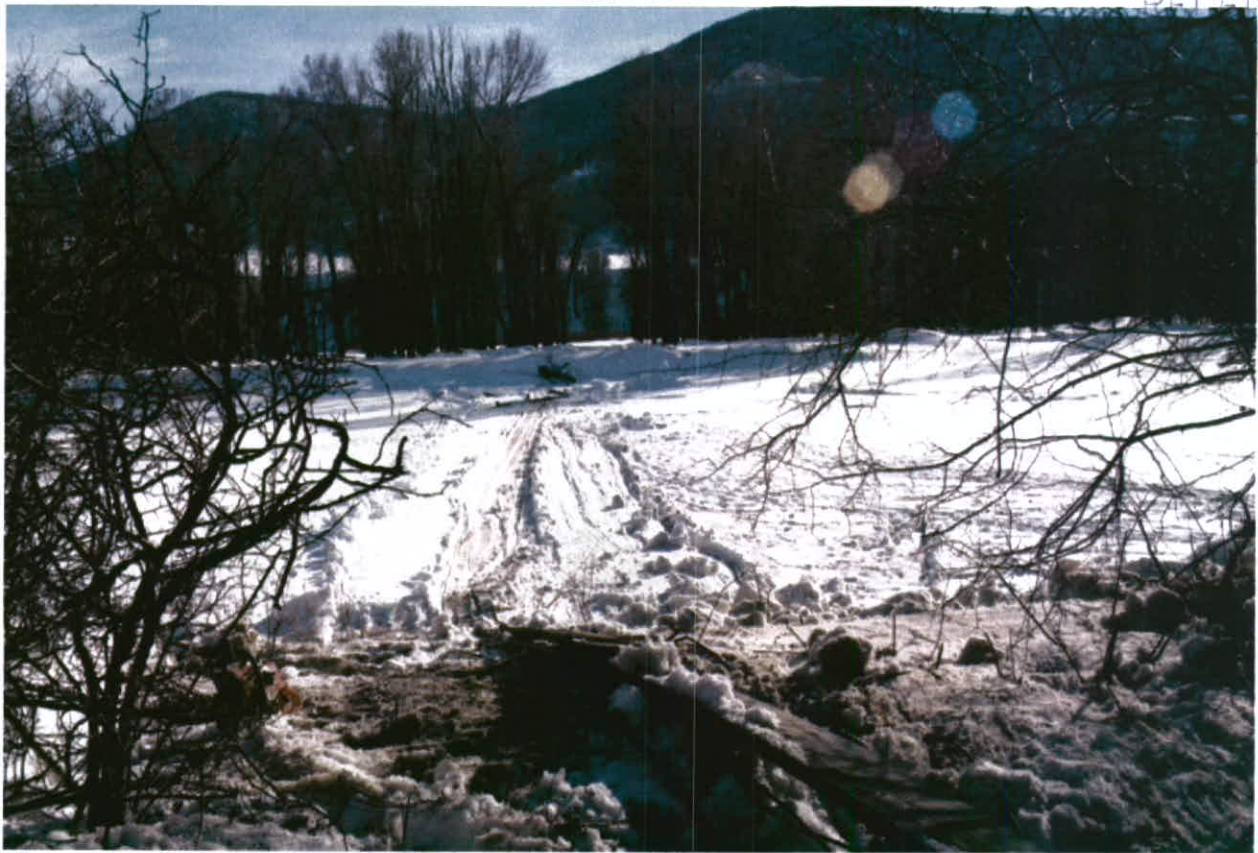
Photo 18 – View looking south across river after bridge was dragged to north side.

Sloan then used the suspension cables on the north side of the bridge to drag the bridge across the river to the staging area around the north bridge abutment. After the bridge was dragged to the north side of the river the pipeline, cables and steel abutment frames were cut up, placed in a roll-off container and the site was cleaned up. The metal and debris that was not impacted by asbestos was taken to the Milner landfill for disposal. The work was completed during the week of March 5, 2001.

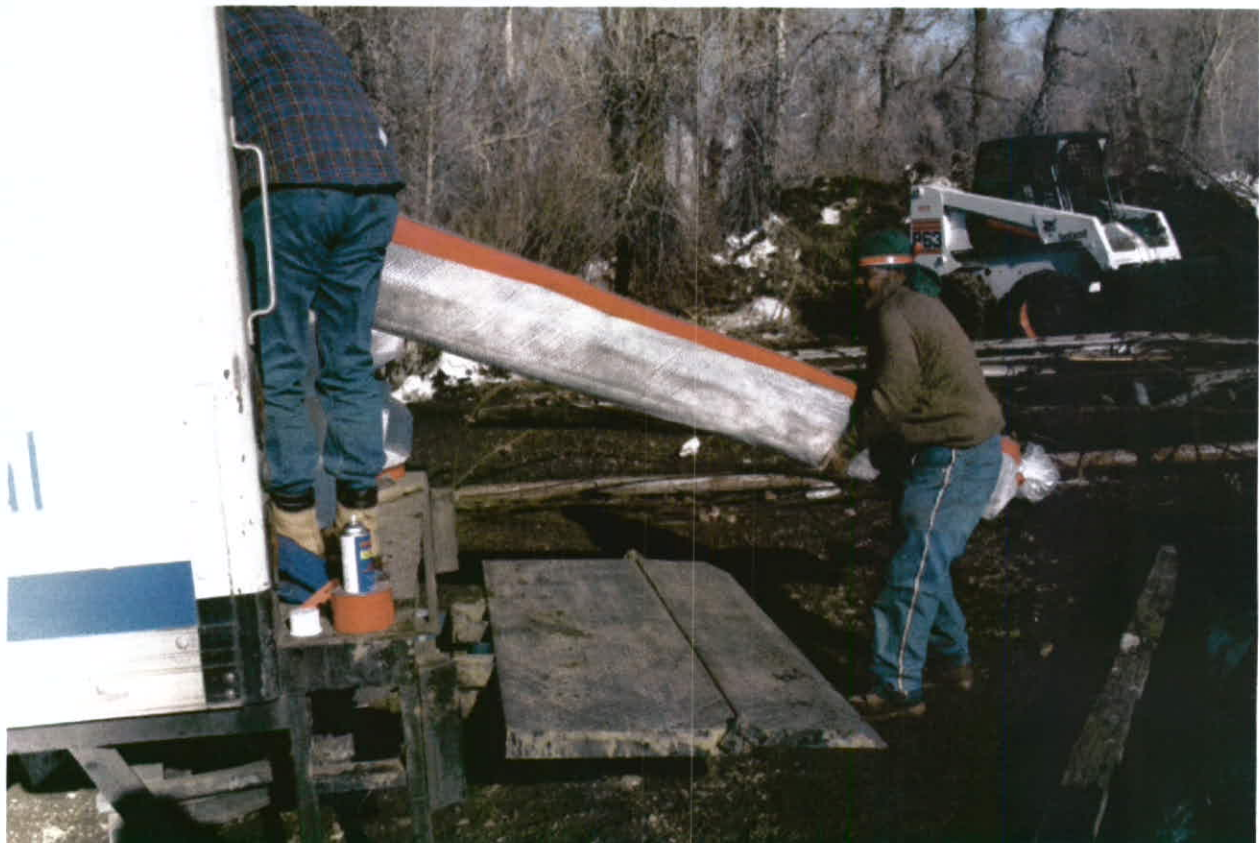
Photo 19 – View of abatement crew loading wrapped timbers and insulation onto service truck

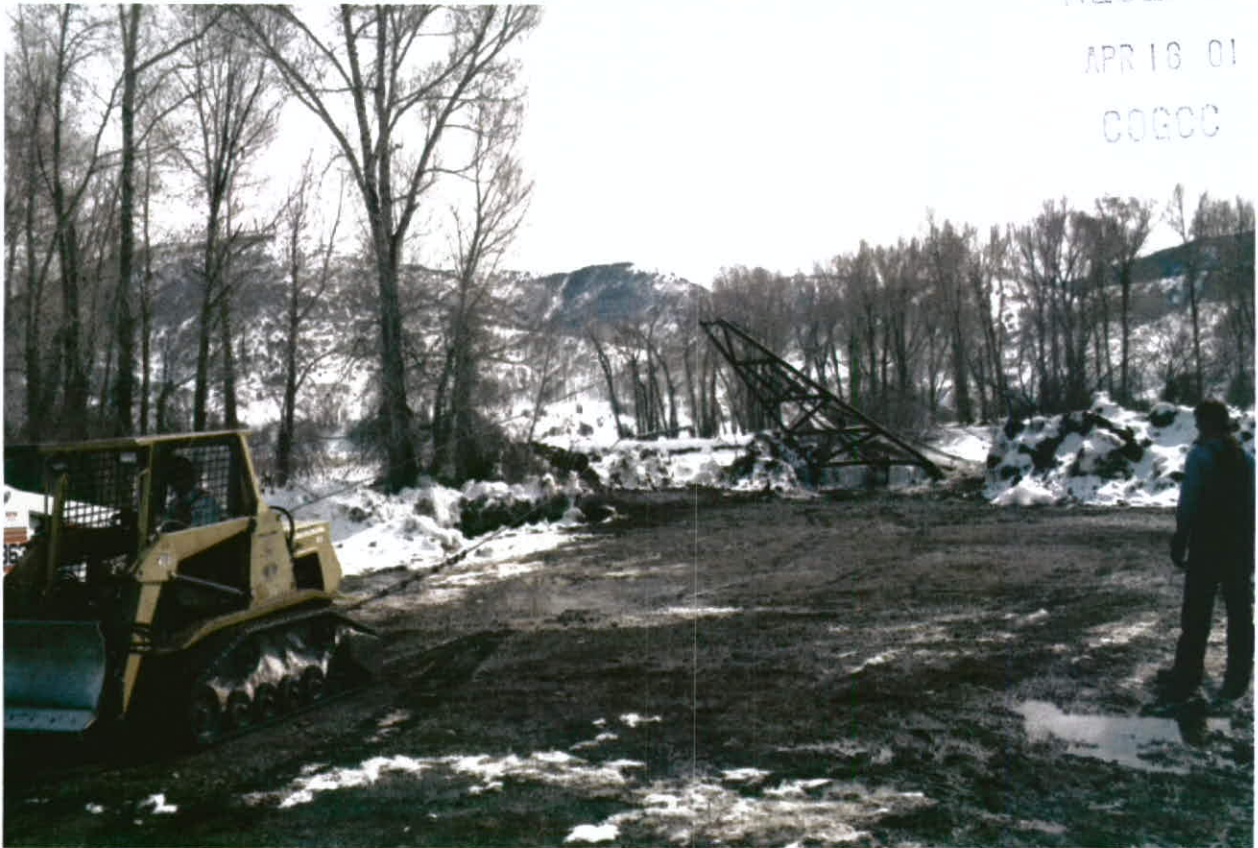
Photo 16 – View of north abutment as it is dragged from its position by the river.

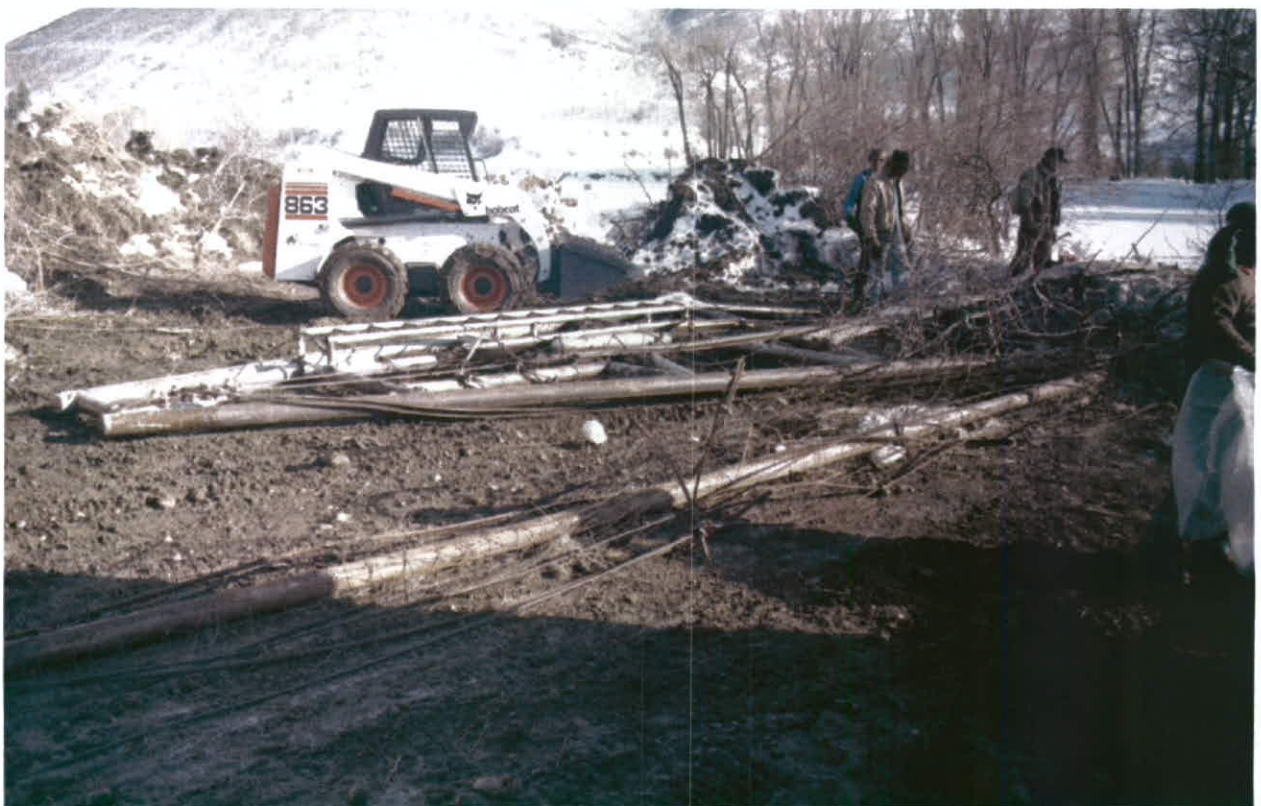
Photo 17 – View of north abutment area with south abutment structure and pipeline on ground.

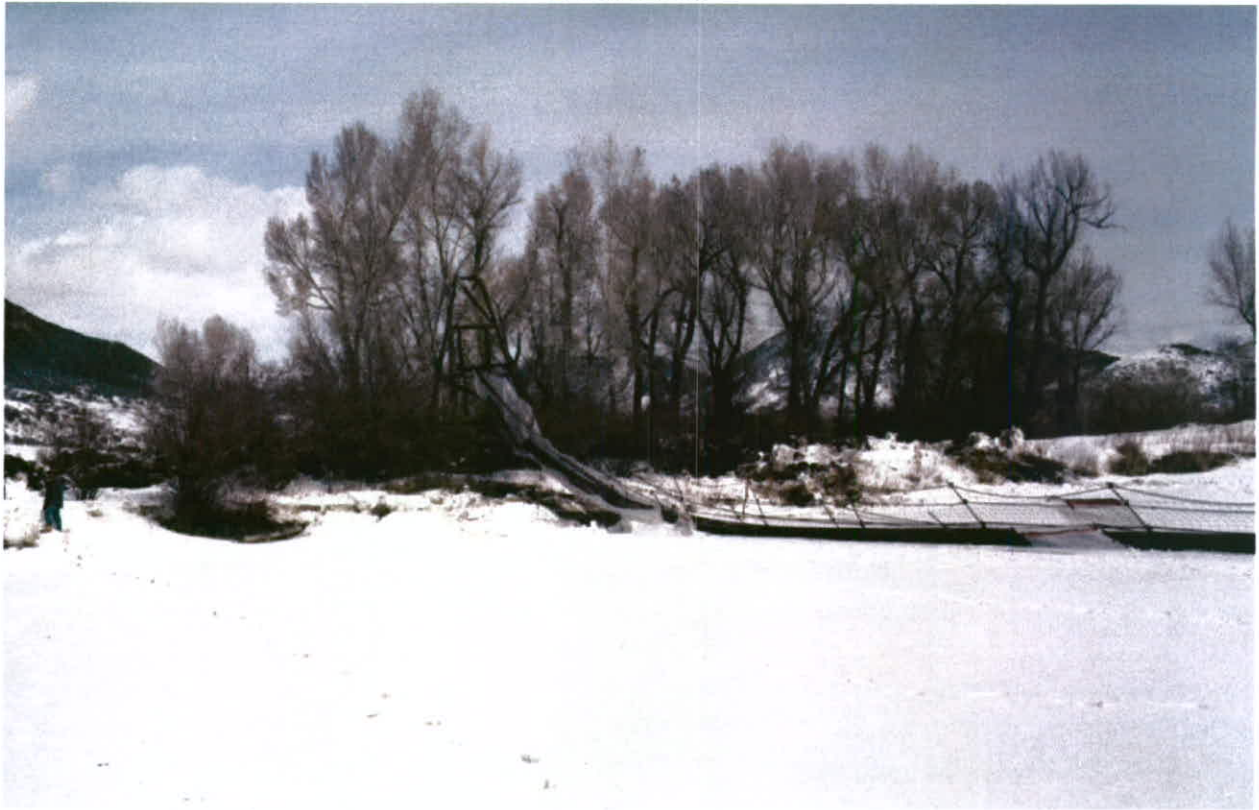
Photo 14 - View of north abutment with bridge lying on ice after south support cables were cut.

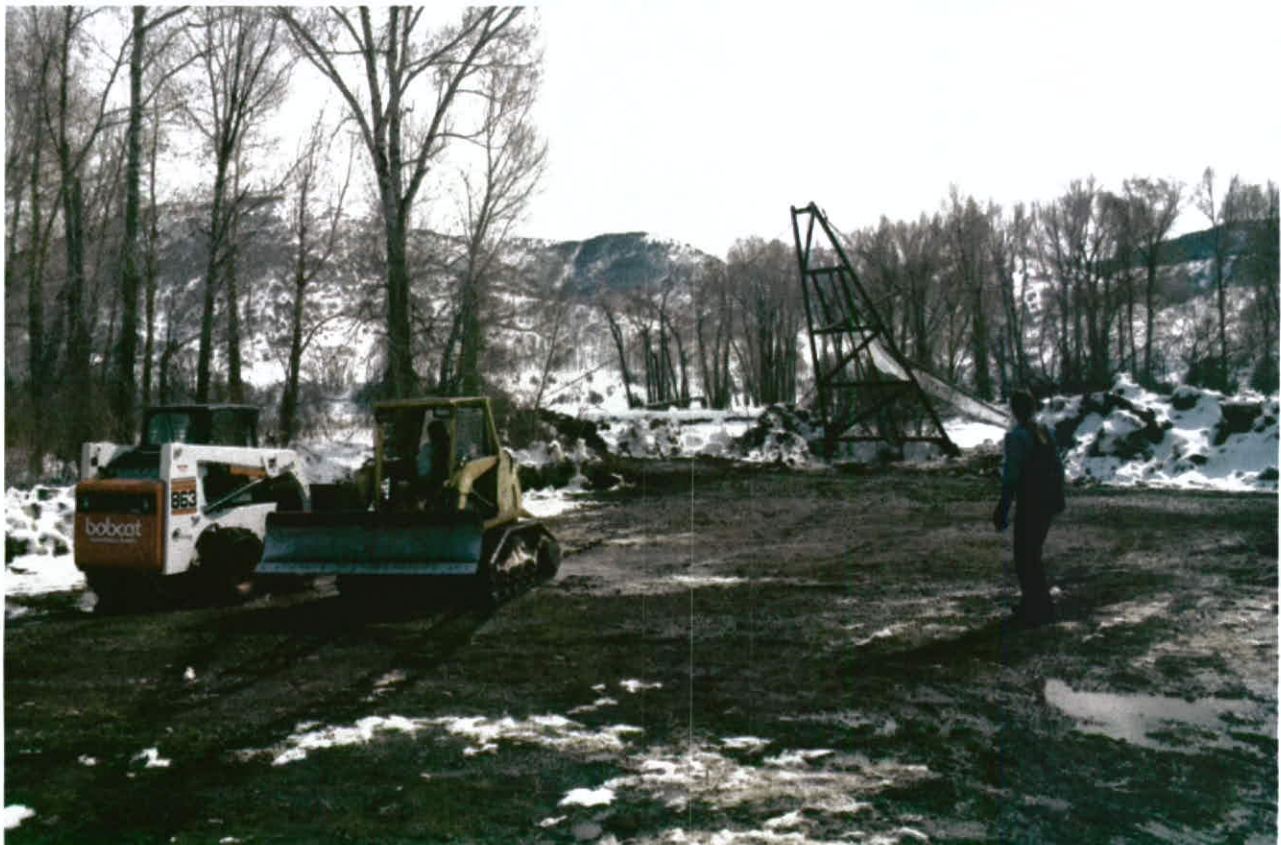
Photo 15 - View of north abutment as dozer and skid steer pull cables to drag bridge across river.

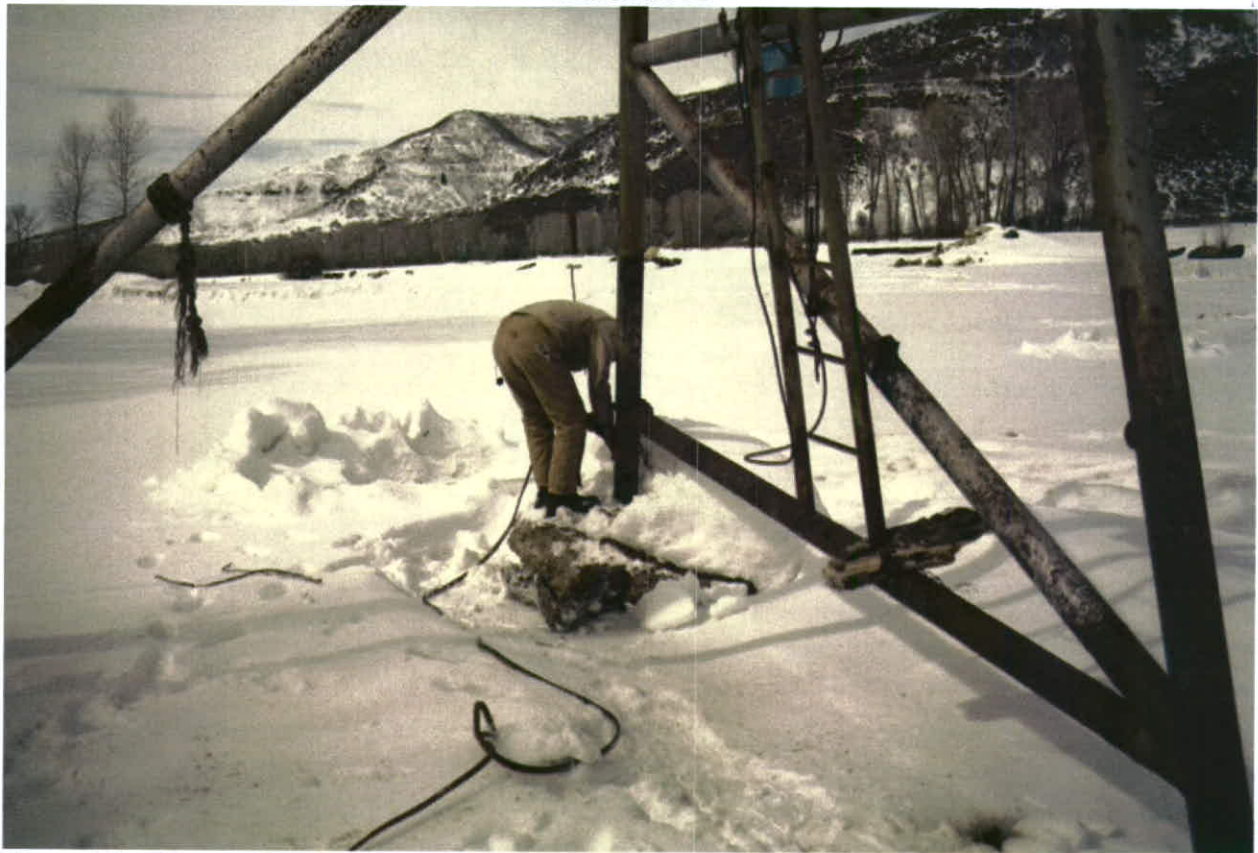
Photo 12 – View of worker cutting notch in supports to south bridge abutment.

After the asbestos containing insulation was removed from the bridge, Sloan began preparing the bridge for demolition. The non-structural pipelines and cables were detached from the abutments and the steel supports to the abutments were notched at the base so they would fall towards the north when the suspension cables were cut at the south abutment. Sloan then cut the suspension cables from the dead-men on the south side of the river and the south bridge abutment fell towards the north lowering the bridge onto the ice. Once the bridge was lowered to the ice, the wooden planks were removed, double-wrapped in plastic and placed in the truck with the pipeline sections.

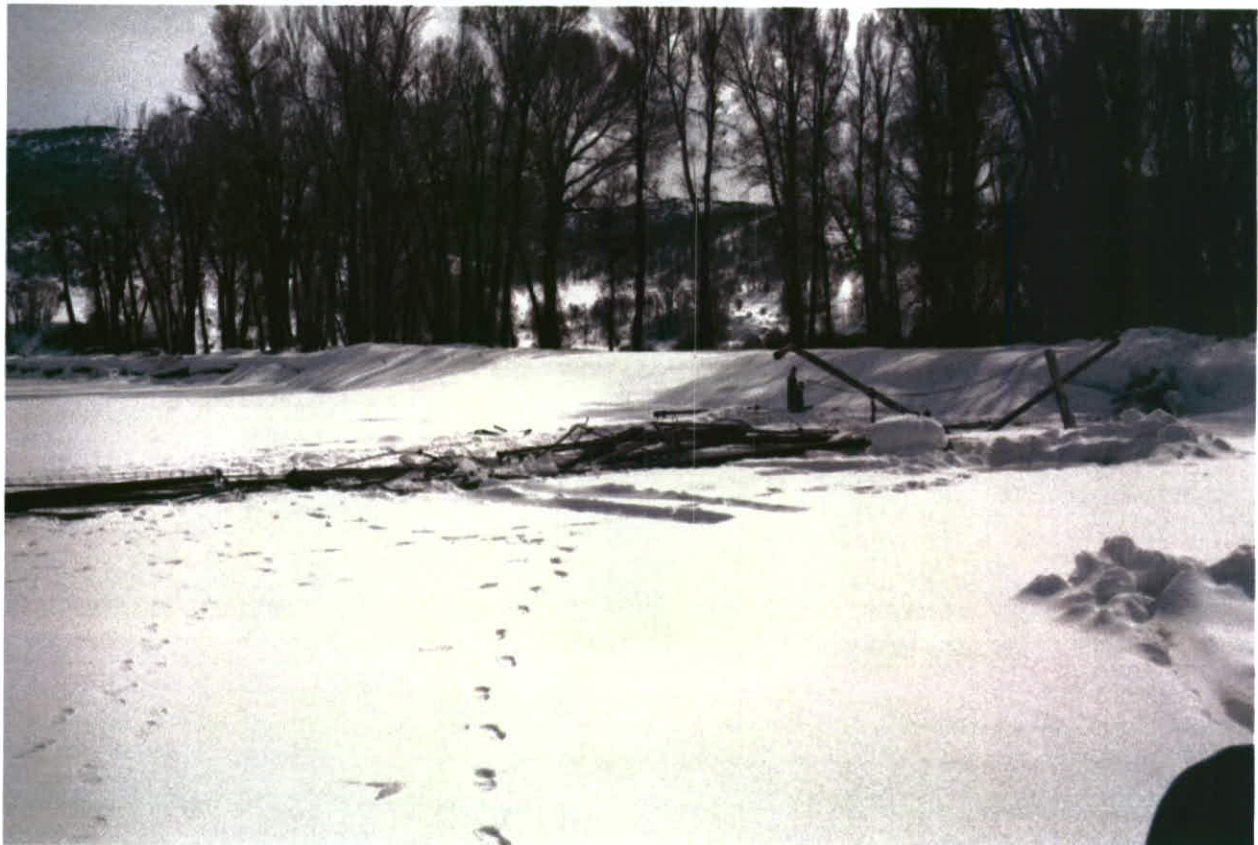
Photo 13 – View of south abutment lying on ice after support cables were cut.

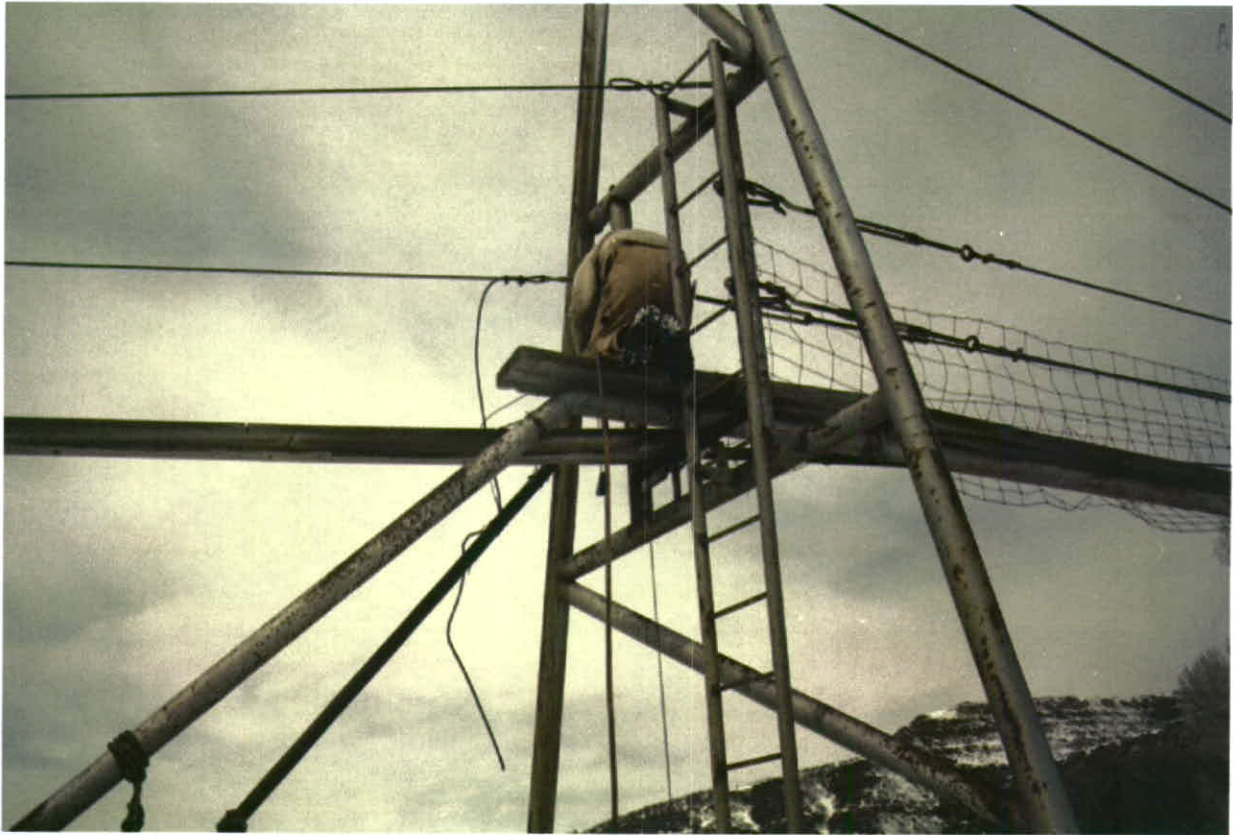
Photo 10 – View of worker cutting pipes and cables connected to south bridge abutment.

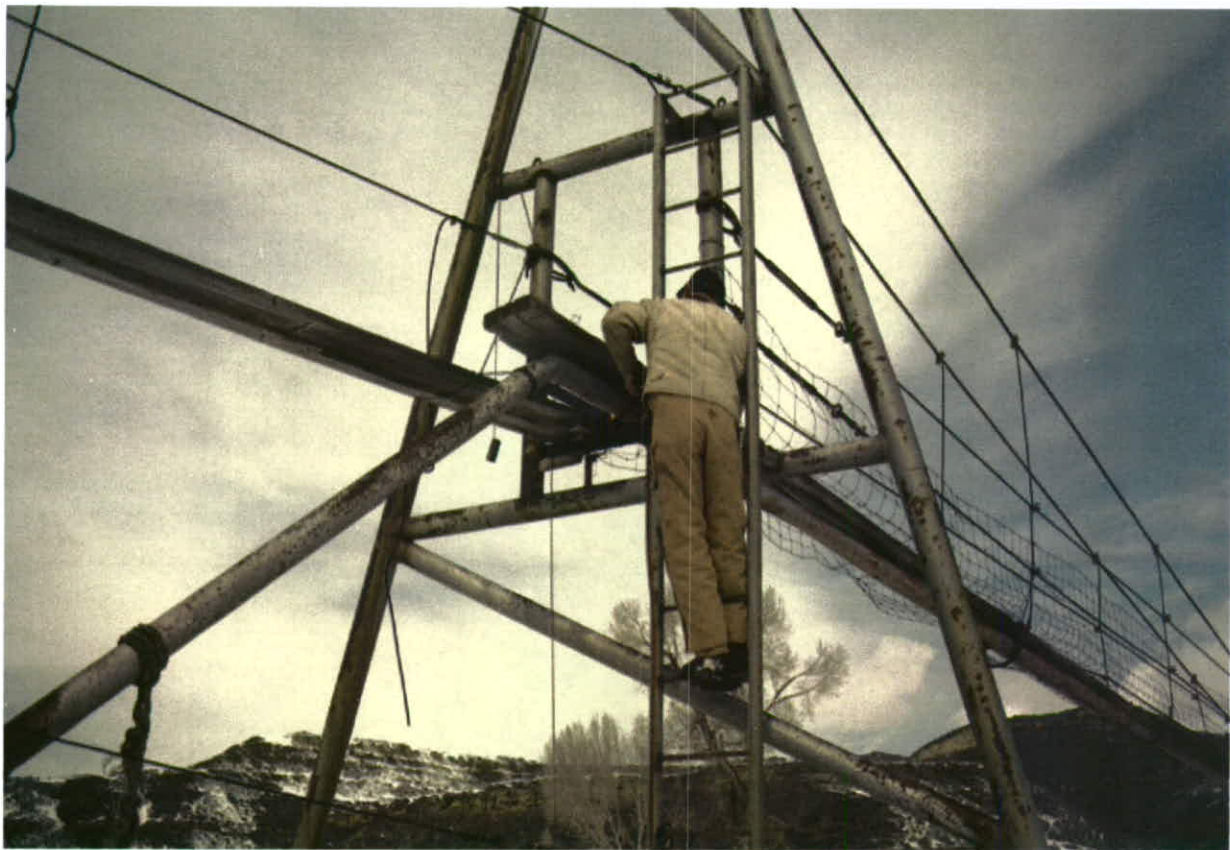
Photo 11 – View of worker cutting pipe under planks at south side of bridge.

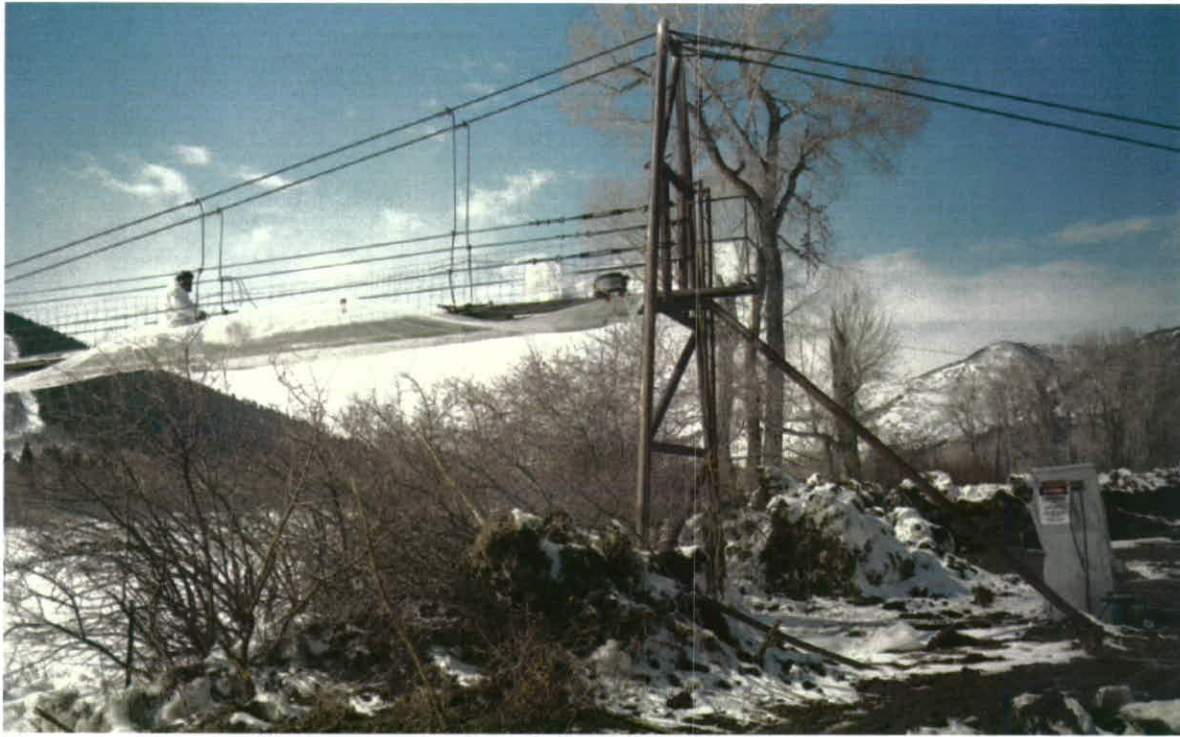
Photo 8 – View looking west at the installation of the plastic drape under the bridge.

Knight-Armour began the abatement work on Friday morning. First they installed a plastic containment shroud under the work areas on the suspension structure. After the plastic was in place, they began the asbestos abatement work. The workers bagged the loose insulation in-place. The sections of pipeline where the insulation was intact were first double-wrapped in plastic glove-bags then cut into small sections and removed from the bridge. After the pipeline was removed from the bridge, the workers vacuumed the planks and plastic shroud to remove the loose insulation. The double wrapped sections of pipe were placed in their truck for transportation to the Denver-Arapahoe Disposal Site. The asbestos abatement work was completed on Saturday morning, March 3, 2001. Copies of the disposal documentation are included in Attachment 2.

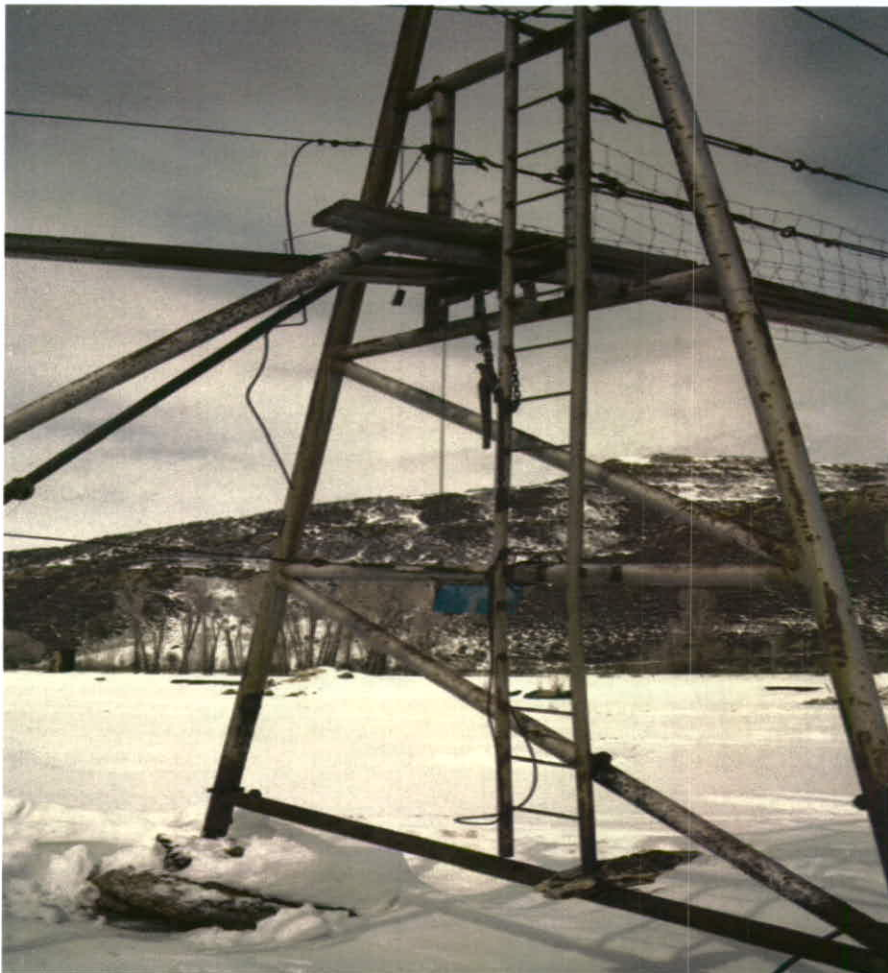
Photo 9 – View looking northwest at the south bridge abutment.

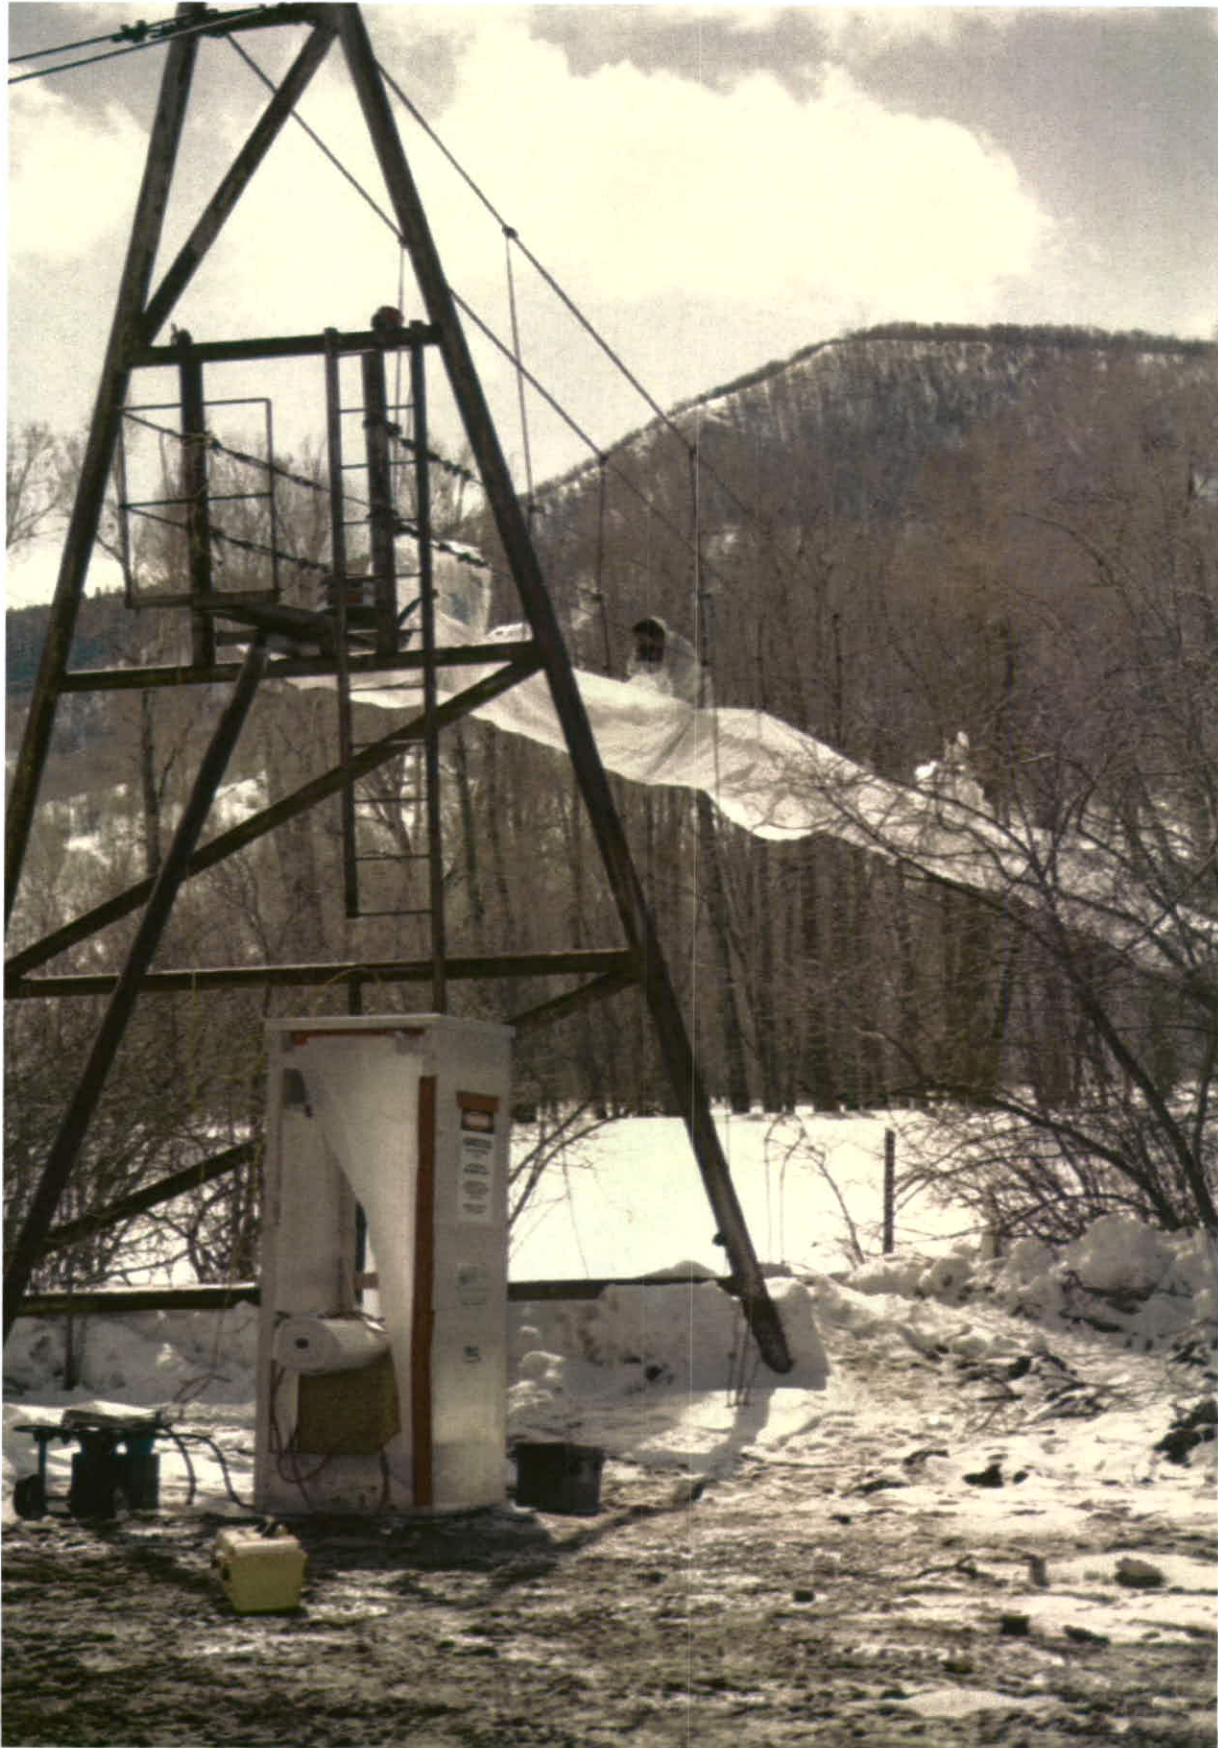
Photo 7 – View of installing plastic drape under north end of Tow Creek Bridge looking south.

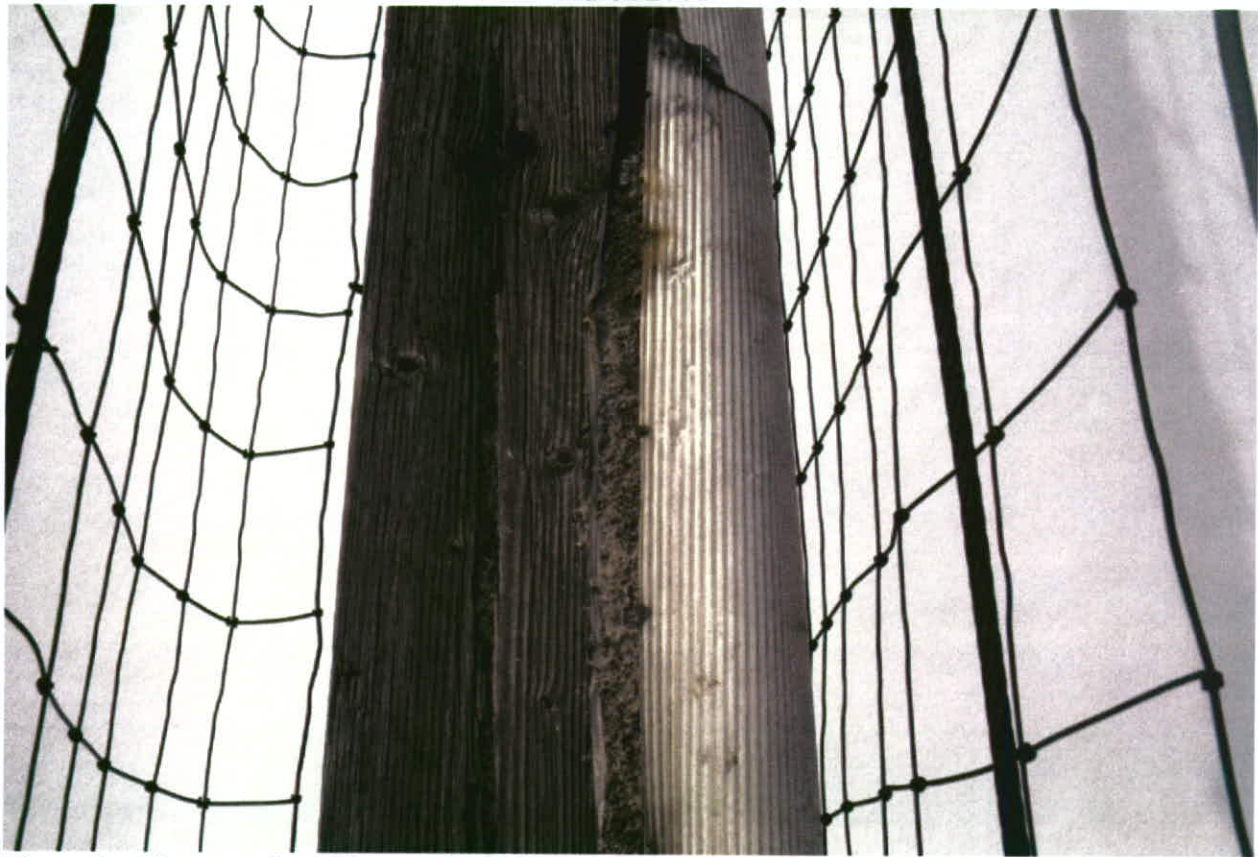
Photo 5 – Close up view of opened seam in metal jacket around asbestos insulation

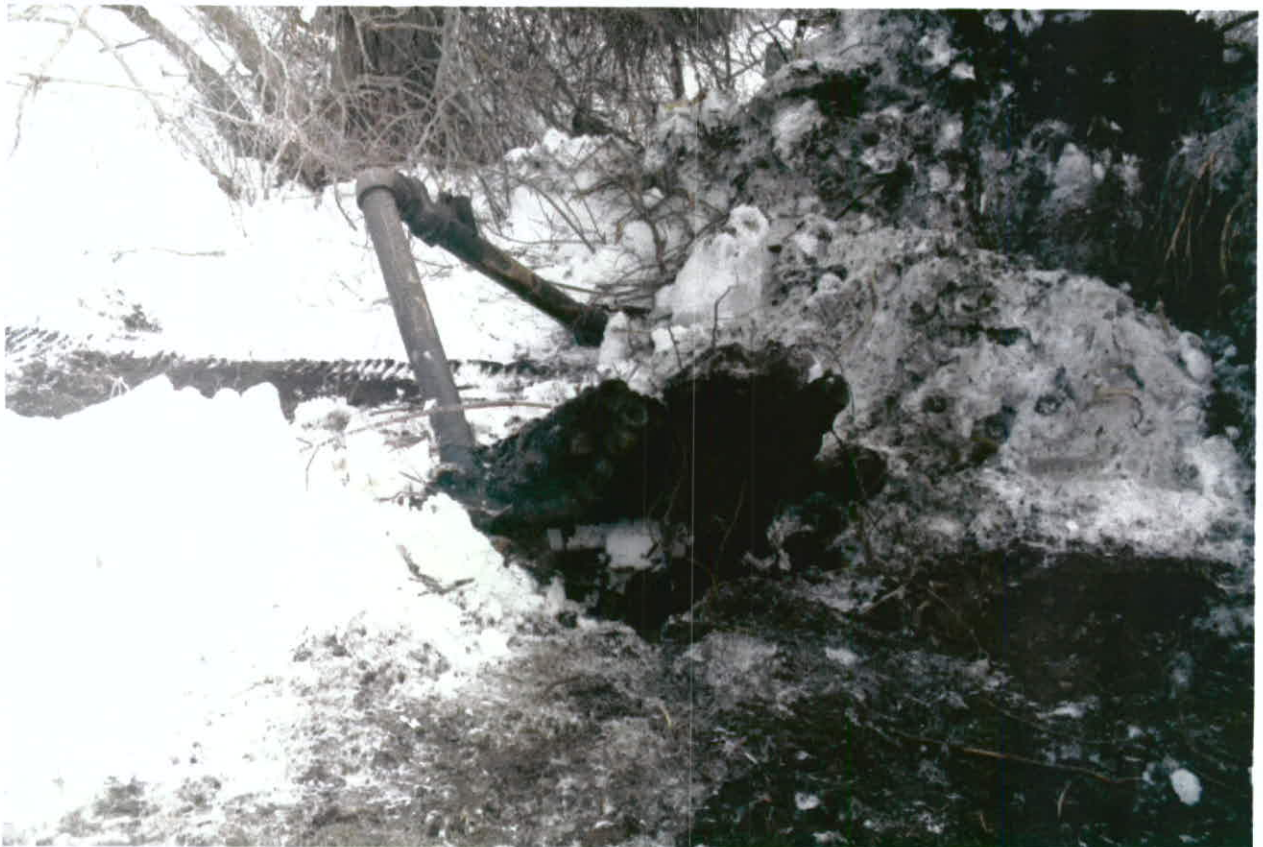
Photo 6 – View looking north at load out piping as it is removed.

The work crews mobilized to the site on Friday March 2, 2001 to perform the asbestos abatement activities. Prior to beginning the abatement work, Sloan construction had cleared the snow from the area around the north bridge abutment to provide a work area and had removed the piping from the product load out facilities located north of the bridge.

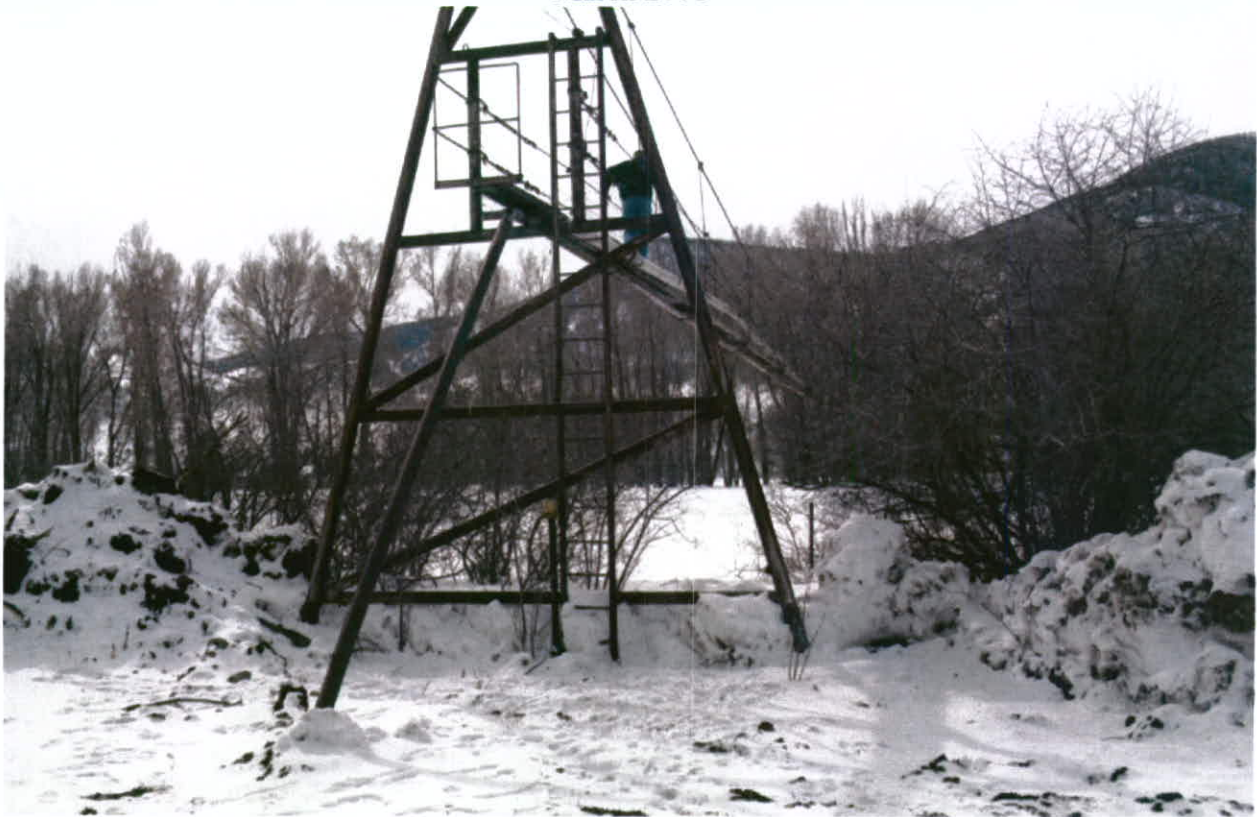
Photo 3 – View looking southeast in March 2001 at the north bridge abutment.

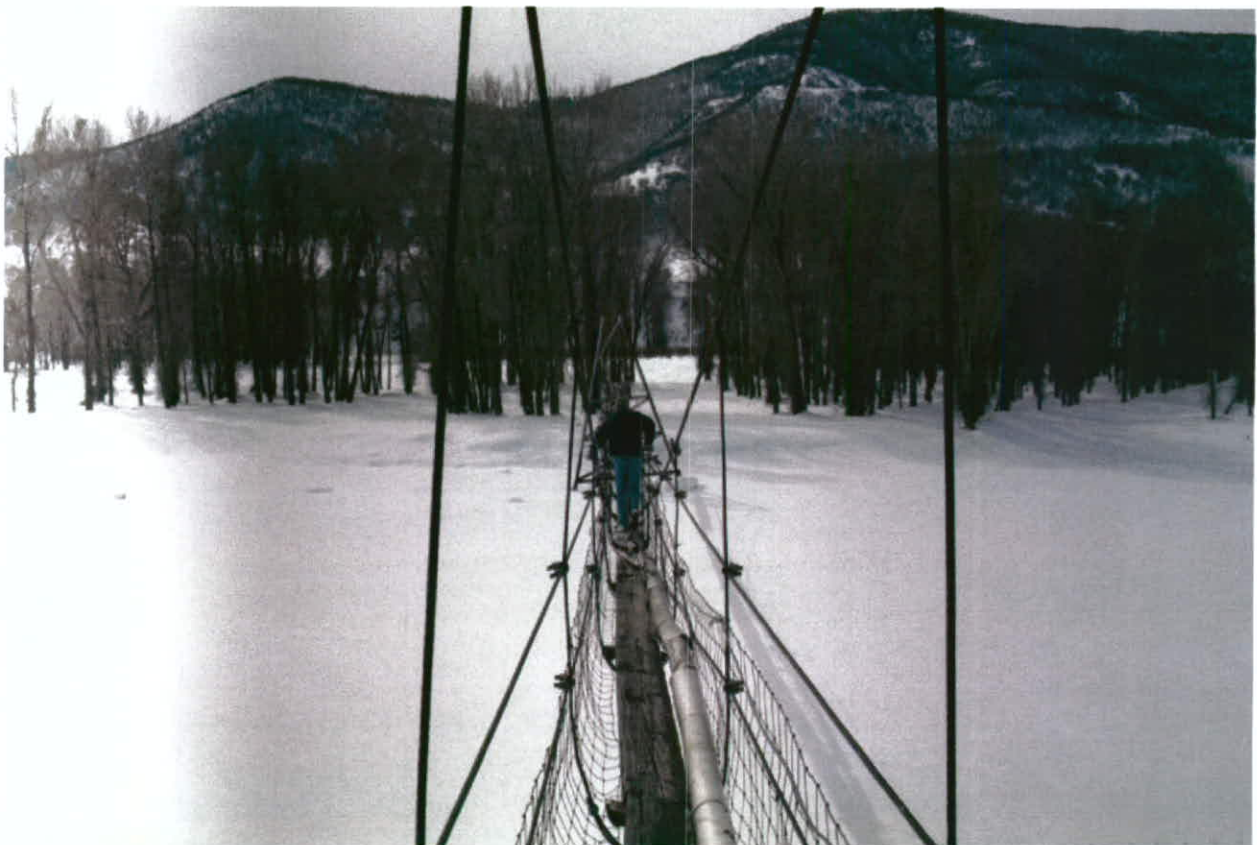
Photo 4 – View looking south in March 2001 across the bridge.

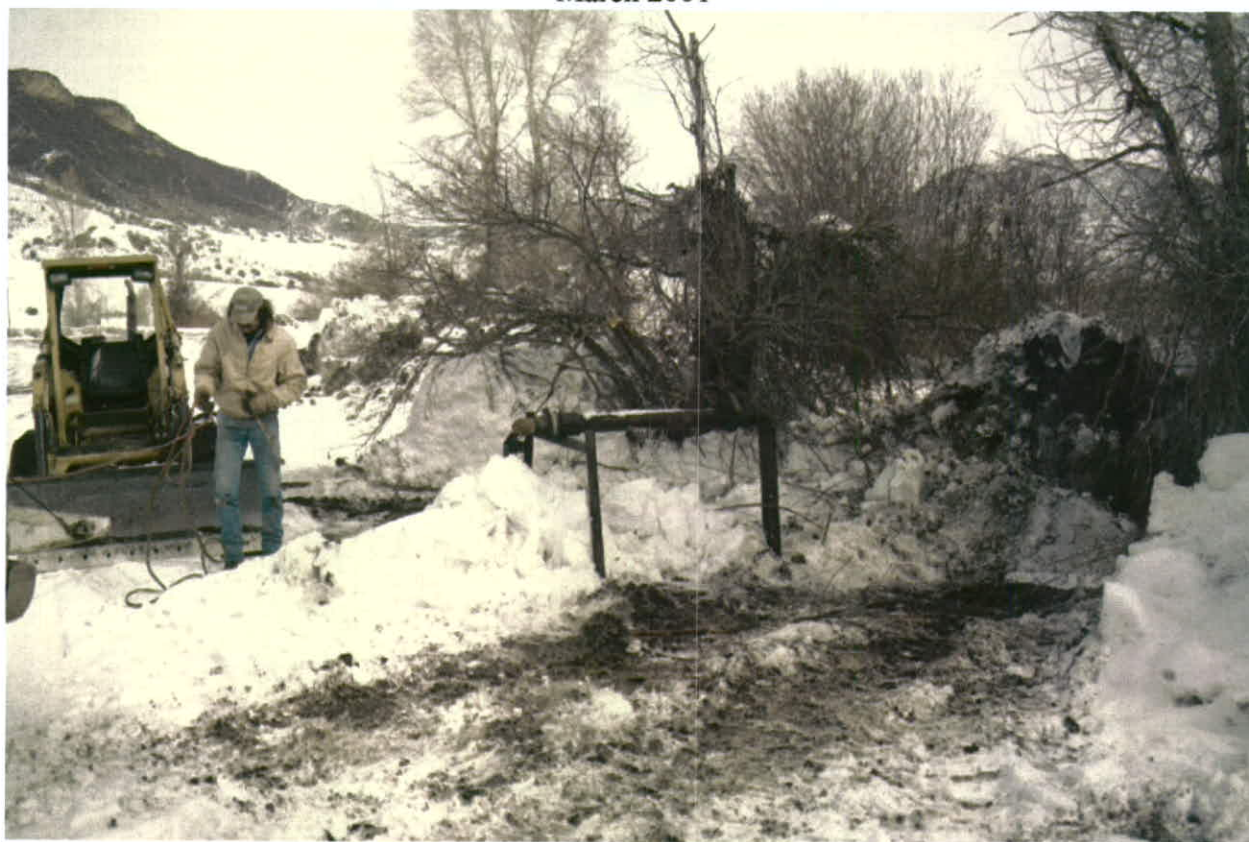
Photo 1 – View looking north at the product load out pipes in March 2001.

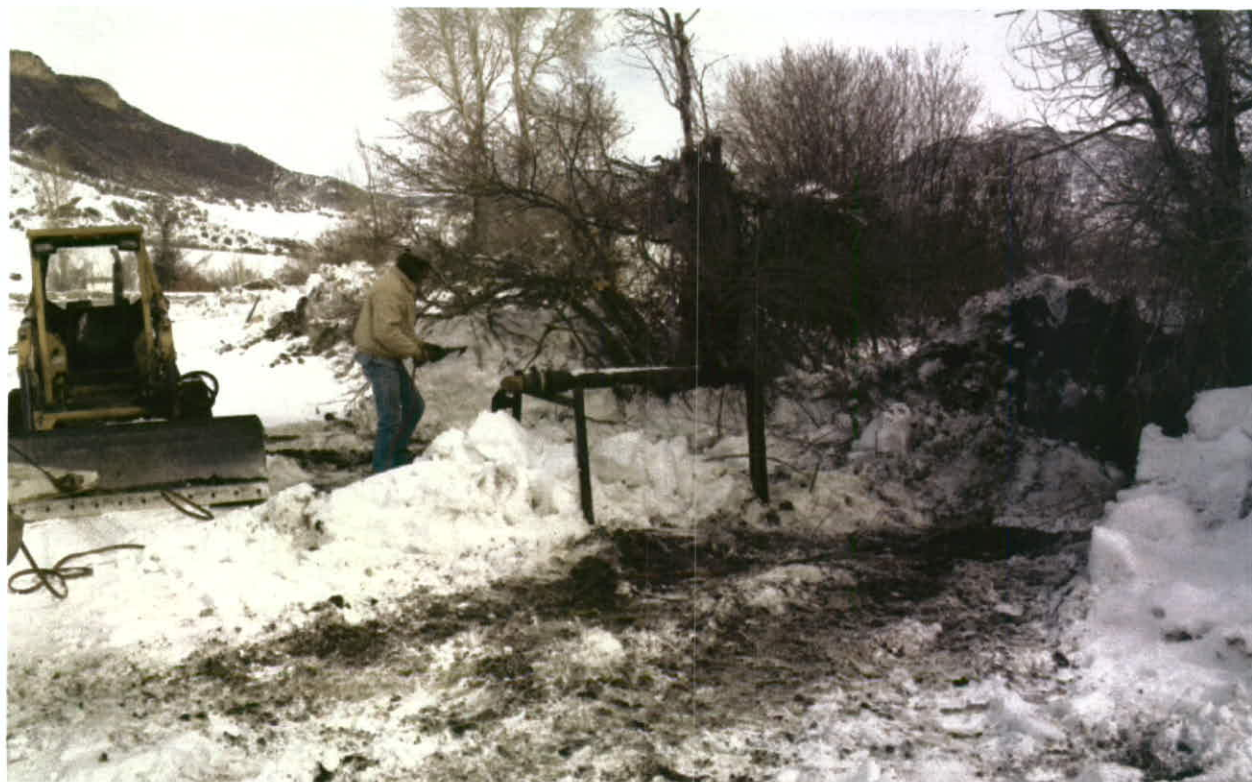
Photo 2 – View looking north at the product load out facility in March 2001.
