# **FRUITLAND OUTCROP INITIAL RECONNAISSANCE REPORT**

**ARCHULETA COUNTY, COLORADO**

**NOVEMBER 2004**

**LT ENVIRONMENTAL, INC.  
4400 West 46<sup>th</sup> Avenue  
Denver, Colorado 80212  
(303) 433-9788**

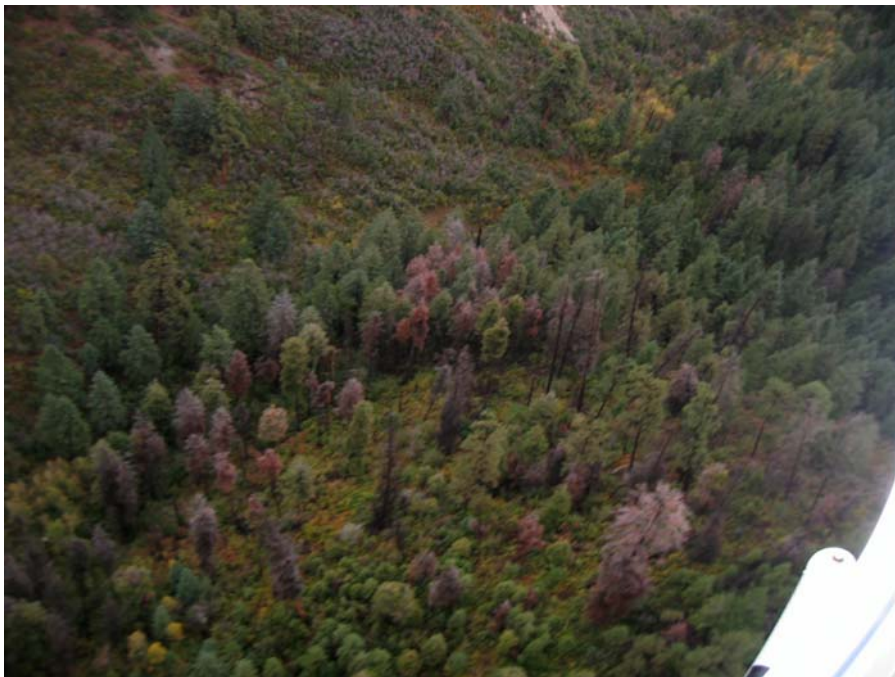
Dead tree area,  
(likely beetle  
kill) east of  
Beaver Creek

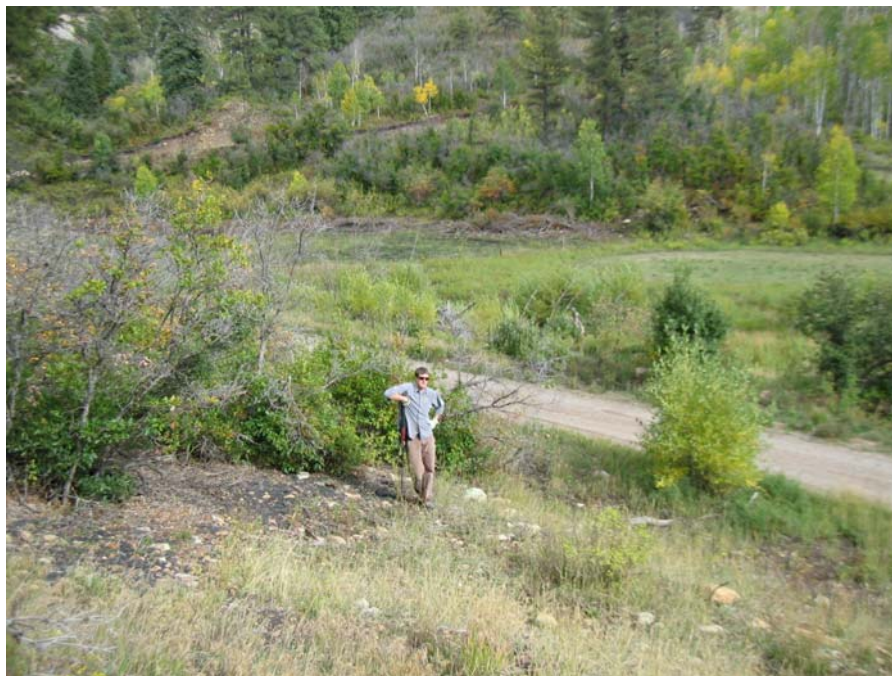
LTE inspected the valley floor of the Beaver Creek area and also looked for visible seeps within the creek. LTE collected field measurements from eight sample locations. No methane was detected at any of the locations. LTE did not identify any areas that contained dead or stressed vegetation that appeared to be impacted by methane with the exception of a small area on the Peinado parcel, at the north end of the valley (BVC-2, Figure 5). Some non-vegetated areas were noted on the valley floor but it is likely that this area was disturbed by brush clearing activities rather than methane. LTE did not have access to the Peinado parcel to confirm the presence or absence of methane in the cleared area.

Beaver Creek Valley, view east.

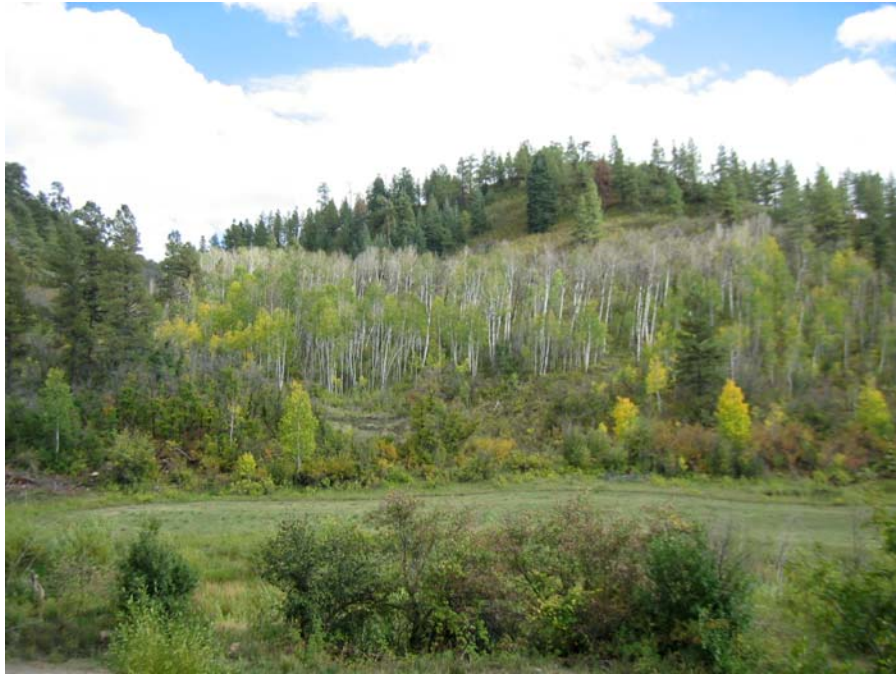
During inspection of the Beaver Creek area, LTE noted a large aspen tree grove on the east side of the valley that was not fully vegetated. It is likely that the trees have already begun to lose their leaves for the fall. However, previous studies conducted by BP in the western portion of the northern rim of the SJB have related some aspen tree groves to existing or historic methane

Aspen grove on  
Watson Property,  
view east.

seep areas. The relationship posited by BP is based on aspen trees being the first trees to grow back after a die-back of a forest, or based on subsurface structures (like fractures and faults) causing increased water flow in the subsurface. The increased water flow may also increase gas seepage flow but also provide the good watering system needed for aspen growth. This grove is located on the Watson property where LTE was not granted access.

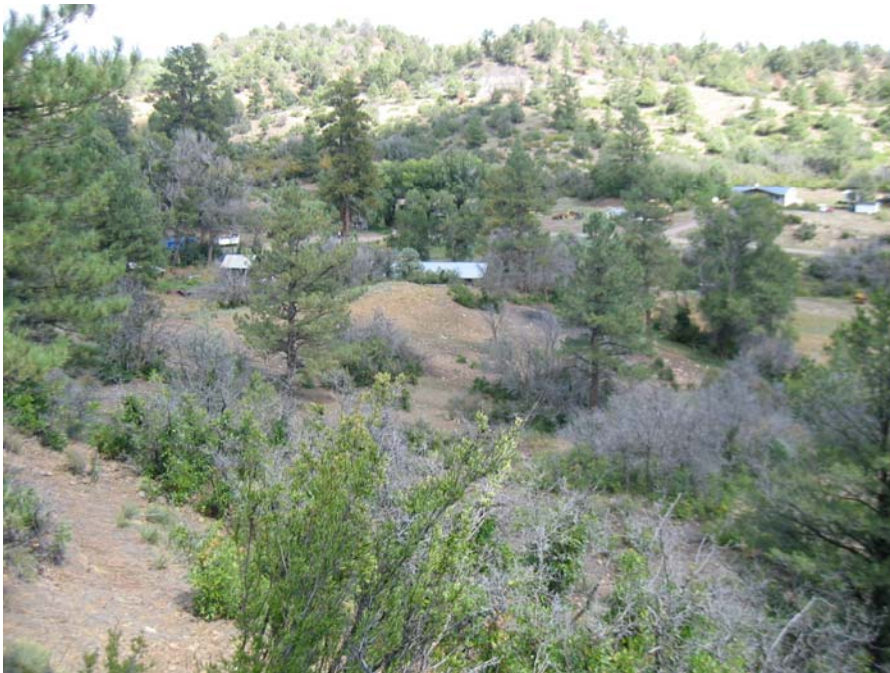
LTE inspected the area on foot on September 22, 2004. A total of 25 subsurface methane measurements were collected at Candelaria Ranch. No methane was detected in any of the areas. Much of the dead/stressed vegetation appears to be from stock animals trampling on the vegetation. In addition, a large outcrop of coal and shale also accounts for a large area of non-vegetation (CR-2, Figure 9).

Candelaria  
residence/ranch,  
view northeast.

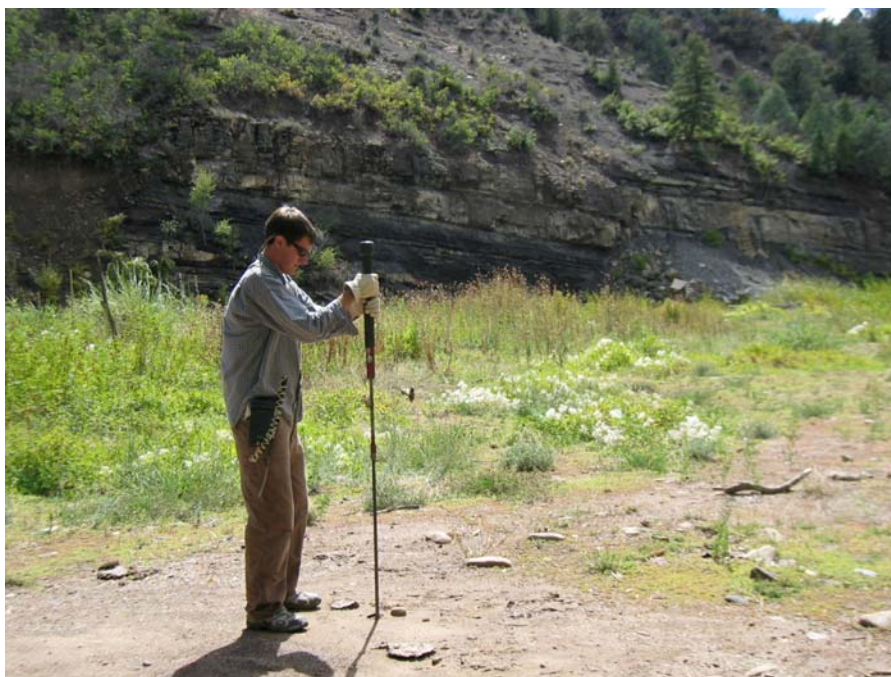
LTE conducted the ground activities on September 23, 2004. LTE walked along the river and tried to identify seeps within the surface water body. However, the area had received large amounts of precipitation several days prior to the field activities resulting in high turbid flows within the river which made identifying seeps difficult. LTE did not identify any visible seep activity along the banks of the river. No methane was detected in any of the 19 subsurface measurements collected along the valley floor.

Subsurface methane measurement location adjacent to the Piedra River, view south.

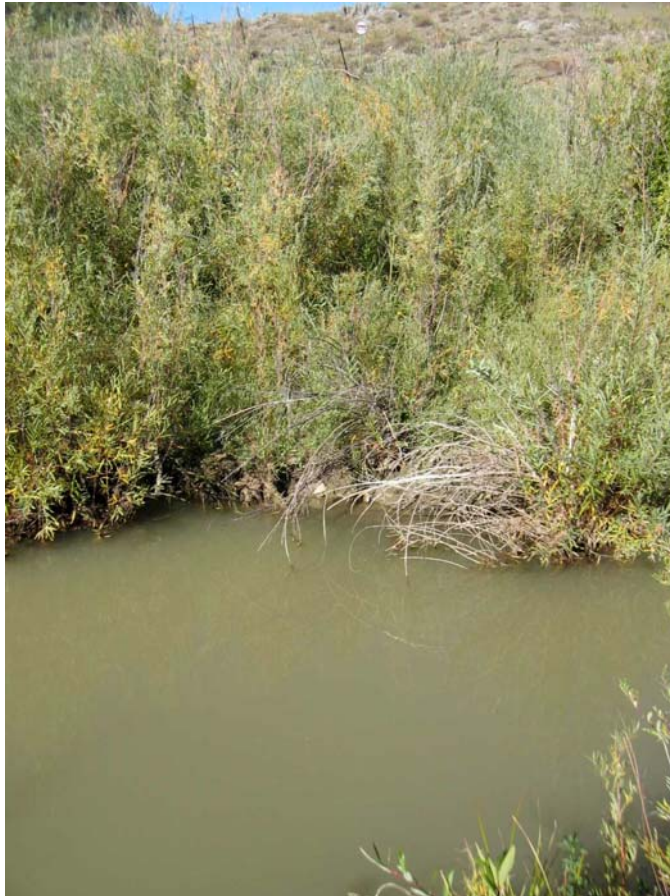
LTE collected 36 subsurface methane measurements along the valley floor of Stollsteimer Creek. No methane was detected at any of the locations. LTE also inspected the surface water within Stollsteimer Creek, which was flowing at the time of the field work, to determine if any methane seep activity was present. LTE identified one small seep within the creek that appeared to be gas (SC-2, Figure 11). The seep would consistently appear on an interval of approximately one to

Seep in Stollsteimer Creek above natural gas pipeline, view west.

three minutes. After further investigation of the area, LTE noted that a natural gas pipeline crosses the creek at the precise location where the seep bubbles were observed. Based on the absence of any other naturally occurring seep activity and the presence of the buried natural gas pipeline, LTE believes that the seep is a result of a leaking pipeline rather than natural seepage of coal bed methane.

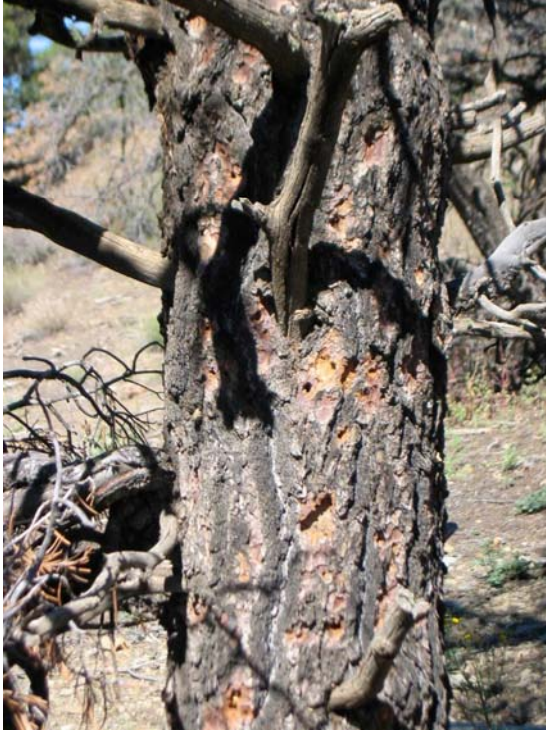
LTE investigated an upland area north of Stollsteimer Creek and south of Chimney Rock. A large suspect area was observed during the aerial reconnaissance. Upon inspection, it is obvious that the area has been impacted by beetle infestation (SC-3, Figure 12). No methane was detected at any of the 10 subsurface measurement locations in the upland area.

Beetle infestation,  
pine tree.

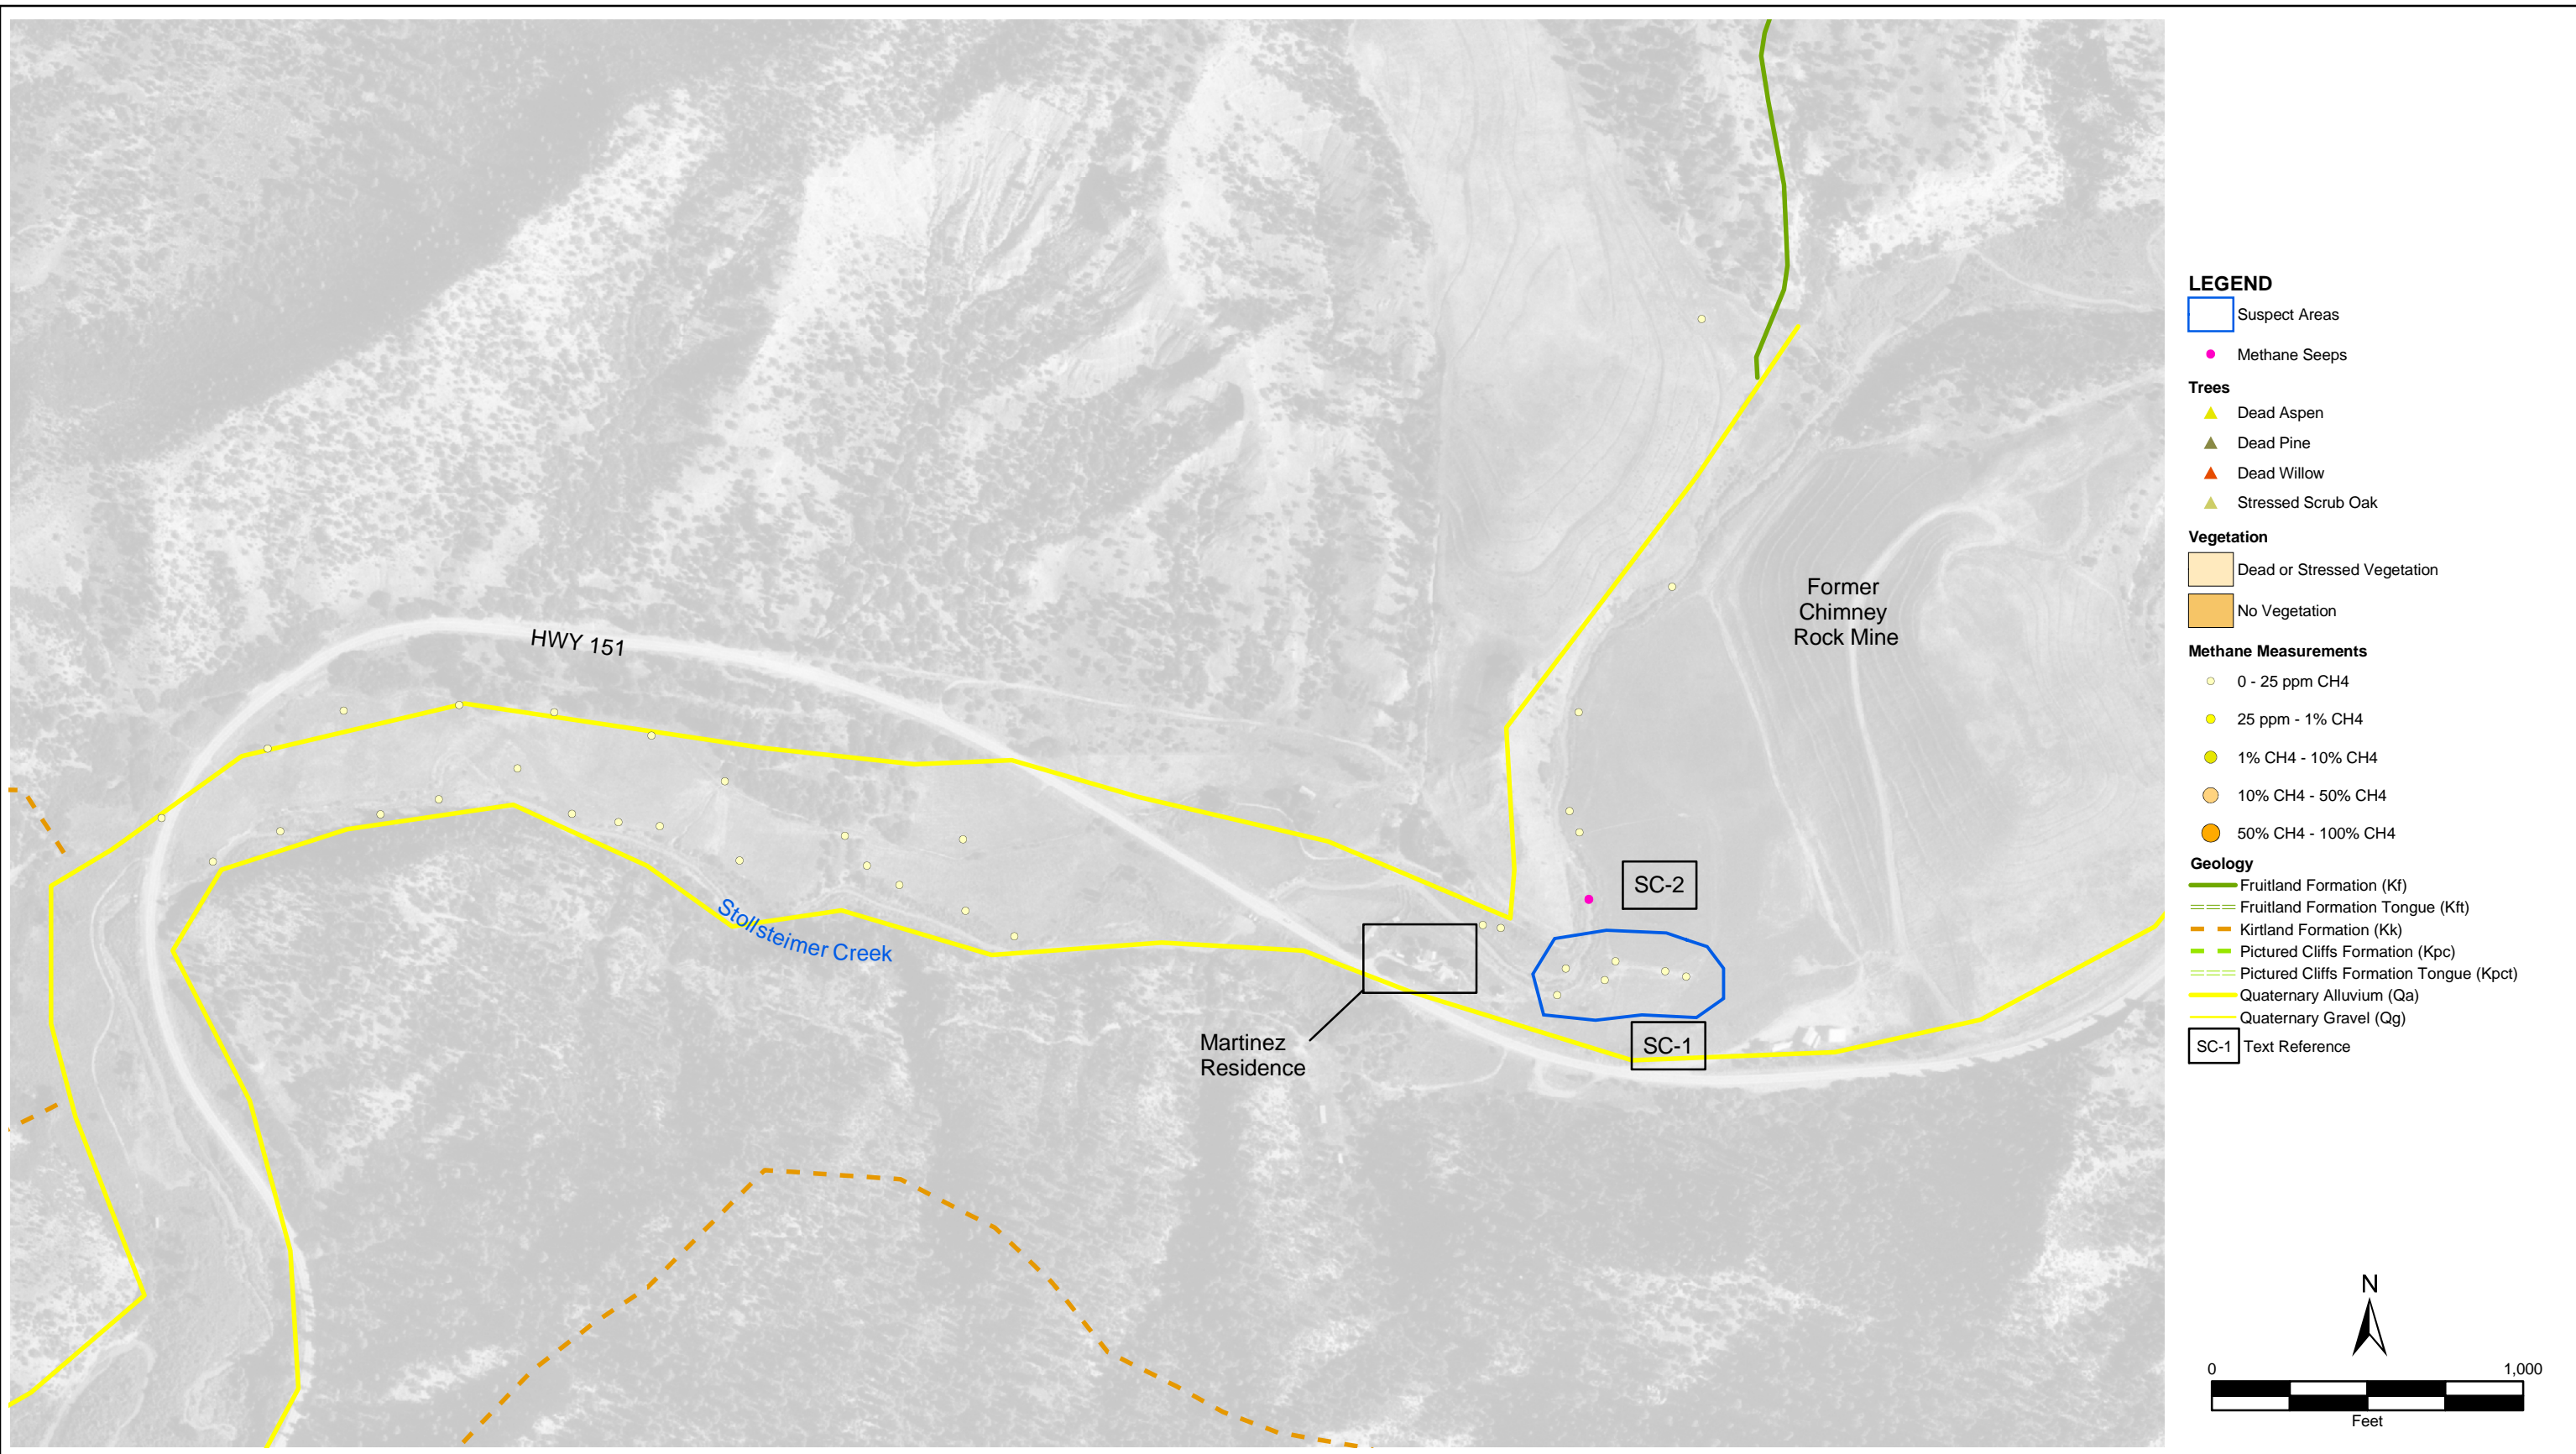
**FIGURE 11**  
**2004 INITIAL RECONNAISSANCE MAP**  
**STOLLSTEIMER CREEK**

Upon investigation on the ground, LTE did not identify any methane in the subsurface at any of the suspect areas. The suspect area identified during the aerial reconnaissance in the lowlands east of the Martinez residence appeared to be a result of damage from stock animals (SC-1, Figure 11).

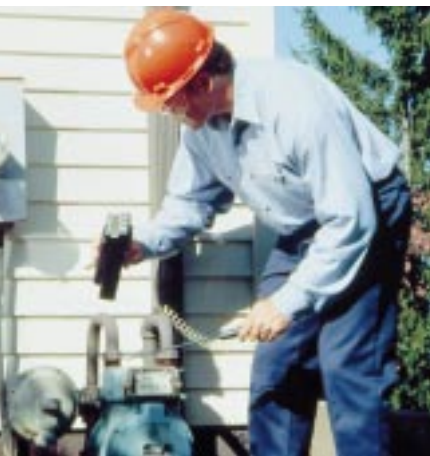
The Gasport Gas Tester is designed for gas utility workers to detect methane and certain toxic gases. It is a reliable, simple, versatile tool to help your service technicians get the job done quickly! With multiple ranges and sensing capabilities built into one rugged housing, the Gasport Tester simplifies your work by reducing the number of meters you have to carry on the job.

The Gasport Tester's poison-tolerant methane sensor provides three measurement ranges for your daily service needs:

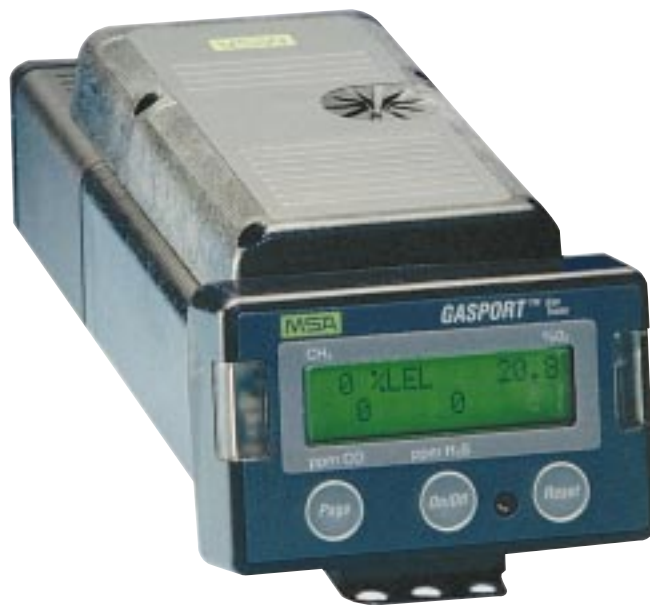
Gas	Range	Resolution
Methane	0–5000 ppm	50 ppm
Methane	0–100% LEL or 0–5% CH <sub>4</sub>	1 % LEL or 0.1% CH <sub>4</sub>
Methane	5–100% CH <sub>4</sub>	1% CH <sub>4</sub>
Oxygen	0–25%	0.1%
Carbon Monoxide	0–1000 ppm	1 ppm
Hydrogen Sulfide	0–100 ppm	1 ppm
